AIRCRAFT EVACUATIONS - THE CANADIAN EXPERIENCE

Lois Kyle-Issenman
Human Performance Division
Transportation Safety Board of Canada

This paper provides an executive summary of *A Safety Study of Evacuation of Large, Passenger-Carrying Aircraft (SA9501)* conducted by the Transportation Safety Board of Canada. The objective of the study was to examine the Canadian experience, identify safety deficiencies and, where warranted, recommend remedial safety action. Twenty-one aircraft evacuations occurring between 1978 and 1991 were reviewed. The safety issues identified were fire, smoke and toxic fumes, exit and slide operation, communication and passenger preparedness. As a result of the study, the Board made five safety recommendations to the Department Transport. A brief account of Transport Canada's response and an update of the current situation in relation to those recommendations is included.

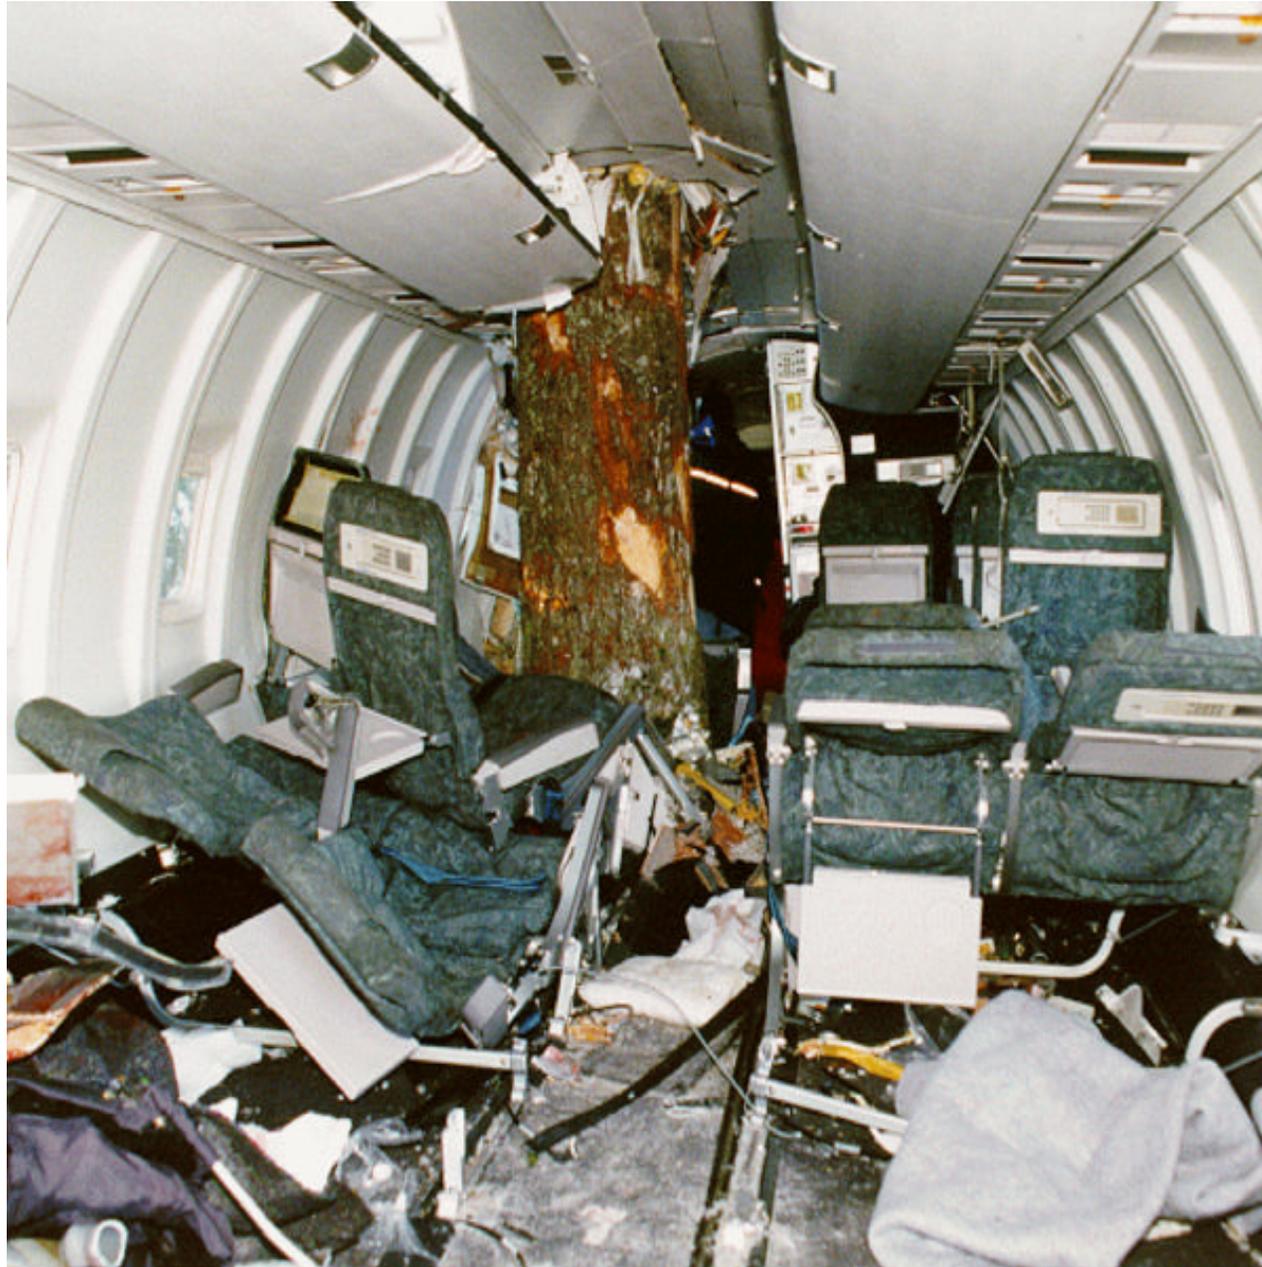
Appendix B.
Photo from A98H0011

On 16 December 1997, at the Fredericton Airport, Air Canada Flight 646, a Canadair CL600-2B19 Regional Jet (CL-65) struck the runway while attempting a go-around in low visibility conditions. When the aircraft struck the runway it then traveled - at full power and uncontrolled - about 2100 feet from the first impact point, struck a large tree and came to rest. An evacuation was conducted: however, seven passengers were trapped in the aircraft until rescued. Of the 39 passengers and 3 crewmembers, 9 were seriously injured. The accident occurred at 2348 hours. Flight 646 was an approved single cabin crew operation.
