DOT/FAA/AR-00/56

Vertical Drop Test of a Narrow- Body Transport Fuselage Section With a Conformable Auxiliary Fuel Tank Onboard

September 2000

Final Report

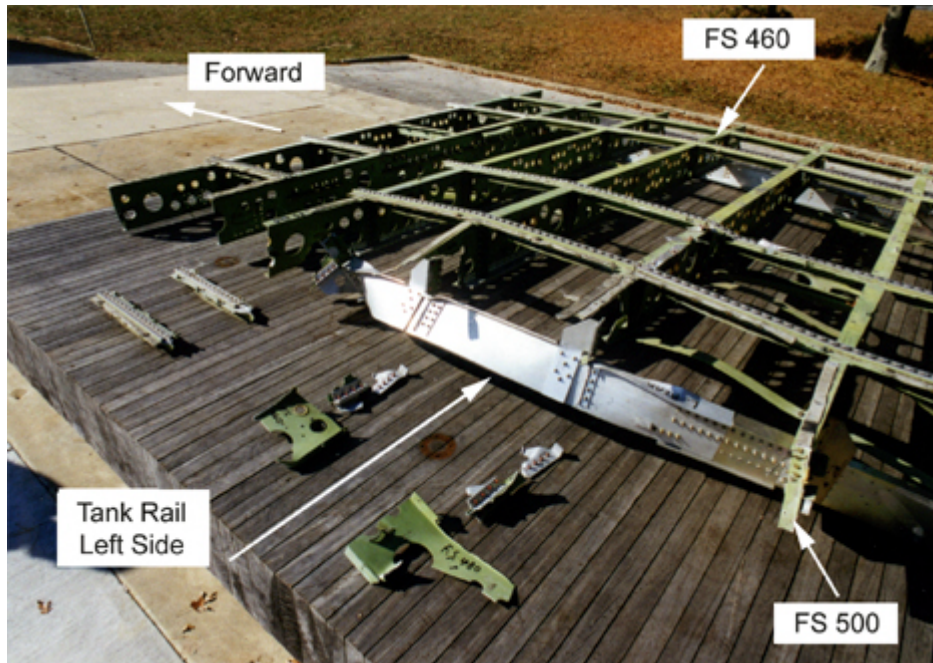
FIGURE 23. CABIN FLOOR BEAMS AND FUEL TANK RAIL MOUNTING BRACKET DAMAGE

CABIN FLOOR BEAMS AND FUEL TANK RAILS. The cabin floor, seat tracks, and fuel tank mounting rails experienced significant deformation. As discussed in the Data Analysis section, the fuselage frame flexed laterally to the right while the fuel tank continued to drop vertically. During this time, the fuel tank slid off the right rail and loaded the left tank mounting system and floor beams. As the fuselage shifted to the right and continued crushing, the floor beams located at FS 460 and FS 480 impacted the top of the fuel tank. This impact provided sufficient energy to push the floor beams up into the cabin area and buckled the floor. Figure 23 shows the damage to the cabin floor beams and fuel tank rail mounting bracket. The left fuel tank mounting rail was bent in a U-shape, with the apex of the U near location FS 470. All four of the mounting brackets that secured the rails to the beams remained attached to the rail. Only the mounting brackets at FS 500 remained attached to the floor beam. In the other three locations where the mounting brackets were attached, they separated from and fractured the beam. The floor beams located at FS 460 and FS 480 fractured. The floor beams at FS 440 and FS 500 remained intact.

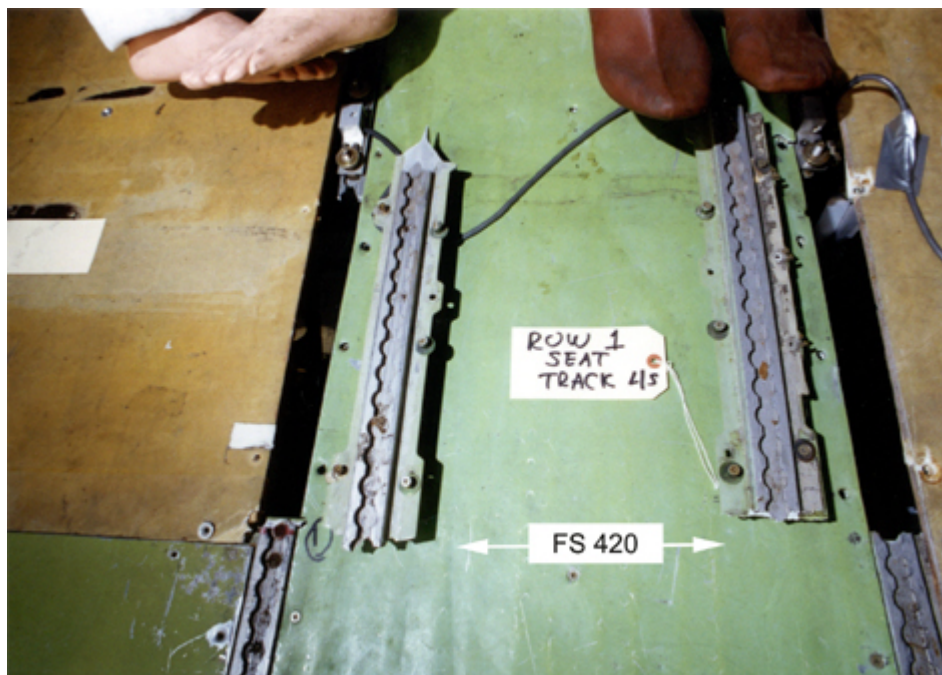
FIGURE 24. FRACTURED SEAT TRACKS

The loading due to the impact's resultant deformation caused cracking of the upper face of the inner and outer left side seat tracks at FS 460. No damage was observed at FS 480 where the two lengths of seat track were spliced. There were no visible cracks on the inner or outer seat tracks located on the right side of the cabin. The inner and outer seat tracks at FS 420 and FS 438 on the left side were fractured and separated from the floor (figure 24). This resulted in the rear legs of the first row seat displacing into the cargo area (figures 25, 26, and 27). The fracturing was due to the loading from the seat legs of Seats A, B, and C of Row 1 and the loading imposed by the tank below. The legs of the mannequins and the ATDs located in Rows 2 and 3 supported the seat backs in Rows 1 and 2, respectively (figures 28 and 29). The seat track fractured where the cross-sectional area was minimal (figure 30). A similar fracture and separation was also observed at the inner left side seat track at FS 483 (Seats B/C Row 3). The outer left side seat track was not fractured (Seats A/B Row 3). Analysis of the H/S film in conjunction with the postcrash inspection indicated that the cross tube supporting Seat A row 3 bent and separated during the test. The reduced loading of the seat leg on the outer left side seat track and the loading due to the deformation of the floor were not sufficient to fracture the seat track.

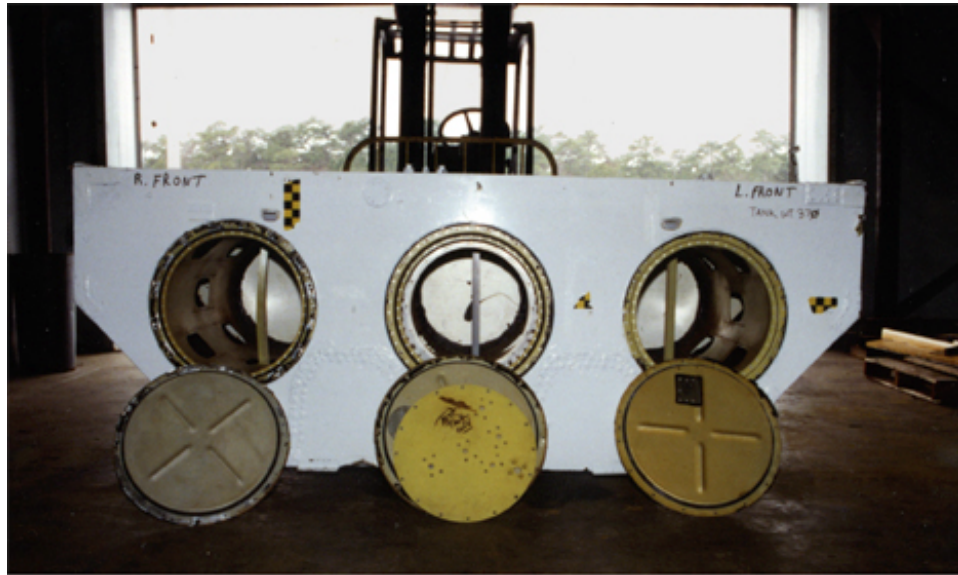
FIGURE 31. POSTCRASH—CONFORMABLE AUXILIARY FUEL TANK

The fuel tank sustained no noticeable change to its physical dimensions (figure 31). The tank was viewed as a stiff, rigid, reinforced structure that proved capable of retaining its shape despite intense compressive loading. An inspection of the inside of the tank revealed that a stiffening member supporting the right side was bent (figure 31).

The bent member was attributed to the fuel tank side wall impacting the reinforced lip on the lower edge of the doorframe. The bottom of the tank sustained substantial damage. The fuselage cargo floor frames, metal members, and cargo floor tracks (figure 32) penetrated the bottom of the tank (figures 33 and 34). This damage resulted in significant simulated fuel leaking from the tank.

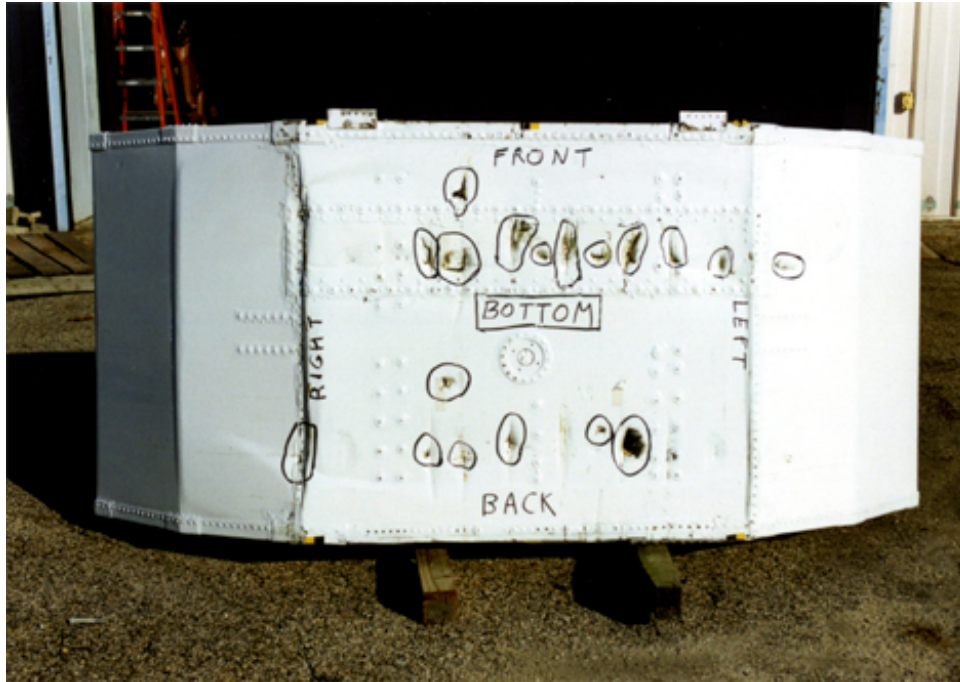
FIGURE 34. POSTCRASH—FUEL TANK DAMAGE

5. The bottom of the conformable auxiliary fuel tank was punctured in numerous locations resulting in simulated fuel spillage. The fuel tank was very strong and rigid in its construction thus allowing it to maintain its structure. This resulted in the fuel tank fracturing the floor beams directly above it; consequently, the floor beams penetrated the passenger cabin.

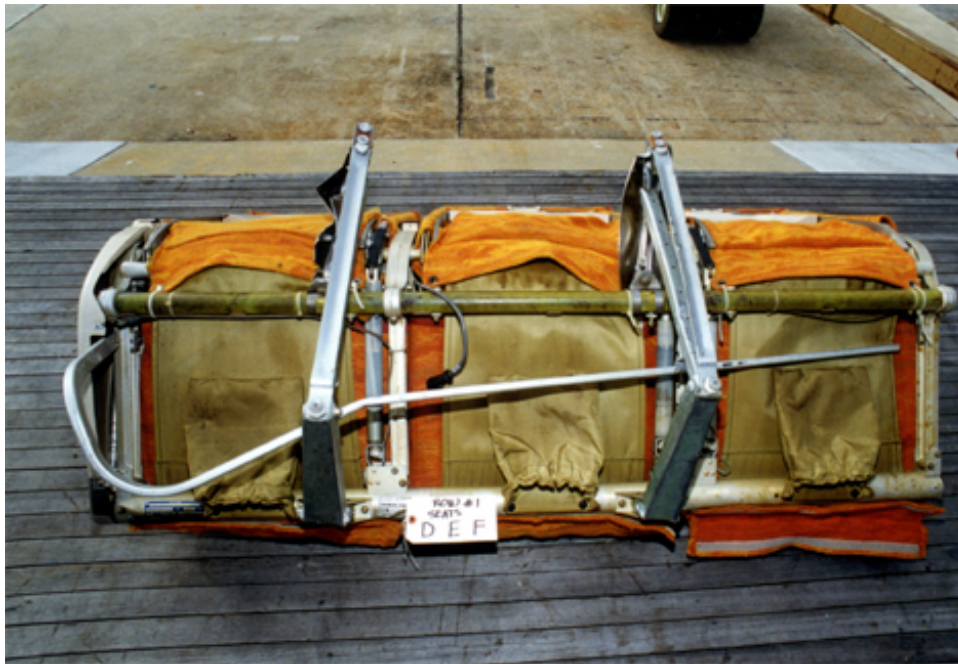
FIGURE 35. POSTCRASH—ROW 1, UOP SEAT, BOTTOM VIEW

A postcrash inspection determined that all seat pans remained intact; all seat legs remained attached to the seat tracks; and only four seats located in the last row sustained seat back damage (i.e., excessive reclining). The legs of the mannequins and the ATDs, located in Rows 2 and 3, supported the seat backs in Rows 1 and 2 respectively. A camera mounted on the floor closely behind the back of the UOP aisle seat, located in the last row, provided sufficient support to prevent seat back damage. The Weber seat located in the last row at position A did not sustain seat back damage. This was attributed to the bending of the cross tube support and subsequent separation of the seat from the frame. Seat damage was remarkably different for the two types of seats. The UOP seat predominately suffered from the bending of the leg supports (figures 35 through 40). The Weber seat suffered from bending and severing of the cross tubes and spreader tubes (figures 41 through 46). A list of the seat damage is found in table 14. As was previously mentioned, the seats were not of primary interest in this test. The test was primarily structured to be a fuel tank test. An actual crash impact imparts a longitudinal drag load on the aircraft that will significantly change the load distribution in a seat. Thus, the seat fracture modes observed in this test are not necessarily reflective of what may occur in service. Therefore, special consideration must be given when considering the results of seat test data obtained from this vertical drop test.
