Vertical Drop Test of a Narrowbody Transport Fuselage Section With a Conformable Auxiliary Fuel Tank Onboard

**Gary Frings
Crashworthiness Project Manager
FAA William J. Hughes Technical Center
Atlantic City Int'l. Airport, New Jersey
October 24, 2001**

TEST OBJECTIVE

Determine the interaction between a typical transport airplane fuselage, particularly its floor structure, and a conformable auxiliary fuel tank under severe, but survivable, impact conditions.

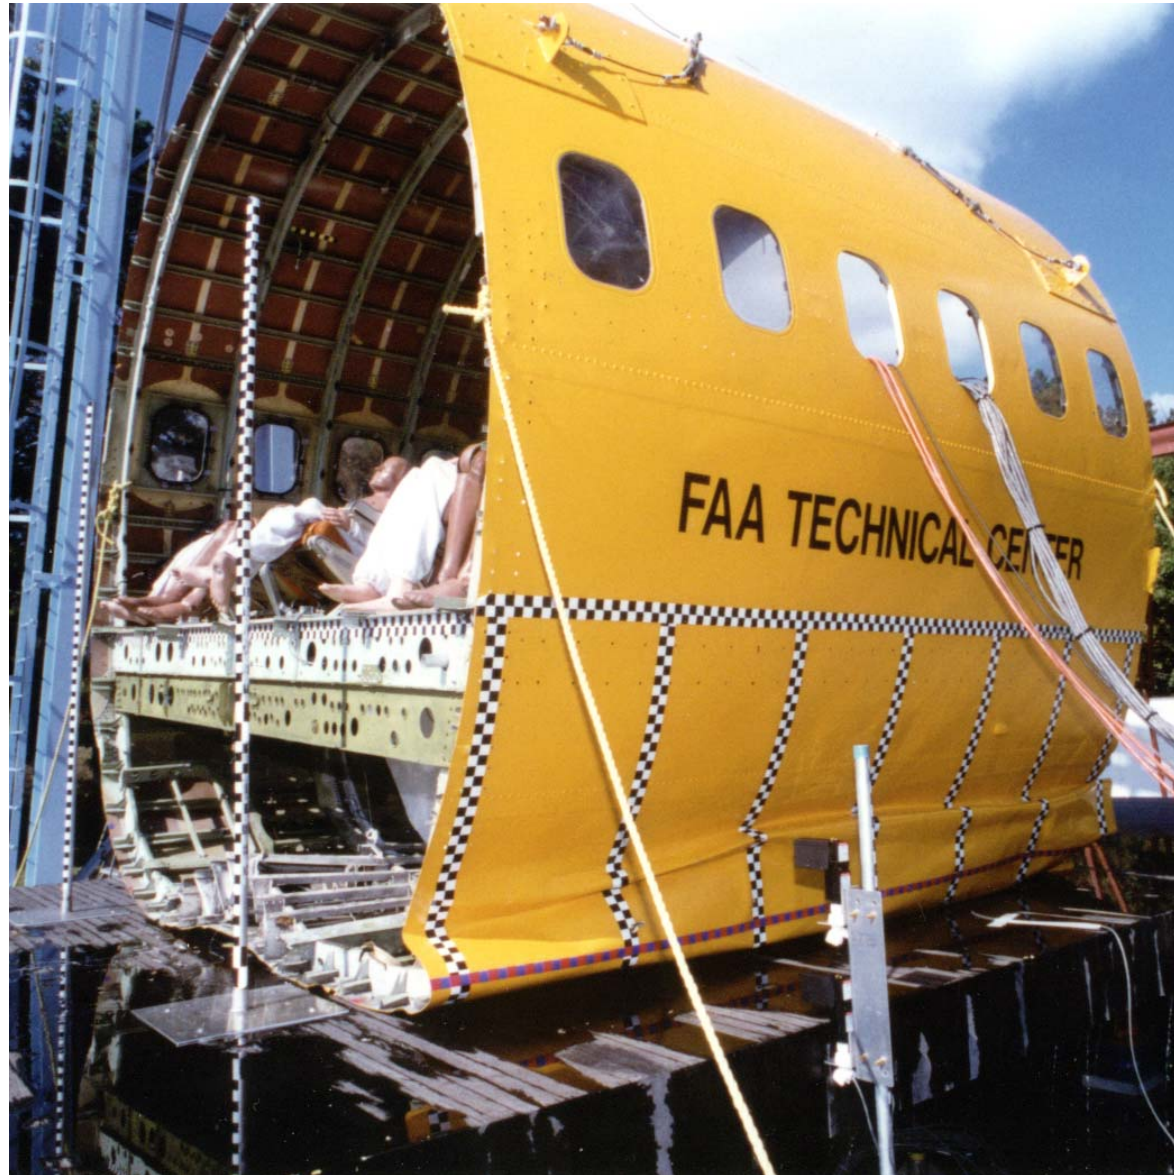
- Right side static crush – 11 inches
- Left side static crush – 21 inches
