NATIONAL TRANSPORTATION SAFETY BOARD

SAFETY STUDY

Emergency Evacuation
of Commercial Airplanes

**NTSB/SS-00/01
PB2000-917002
Notation 7266
Adopted June 27, 2000**

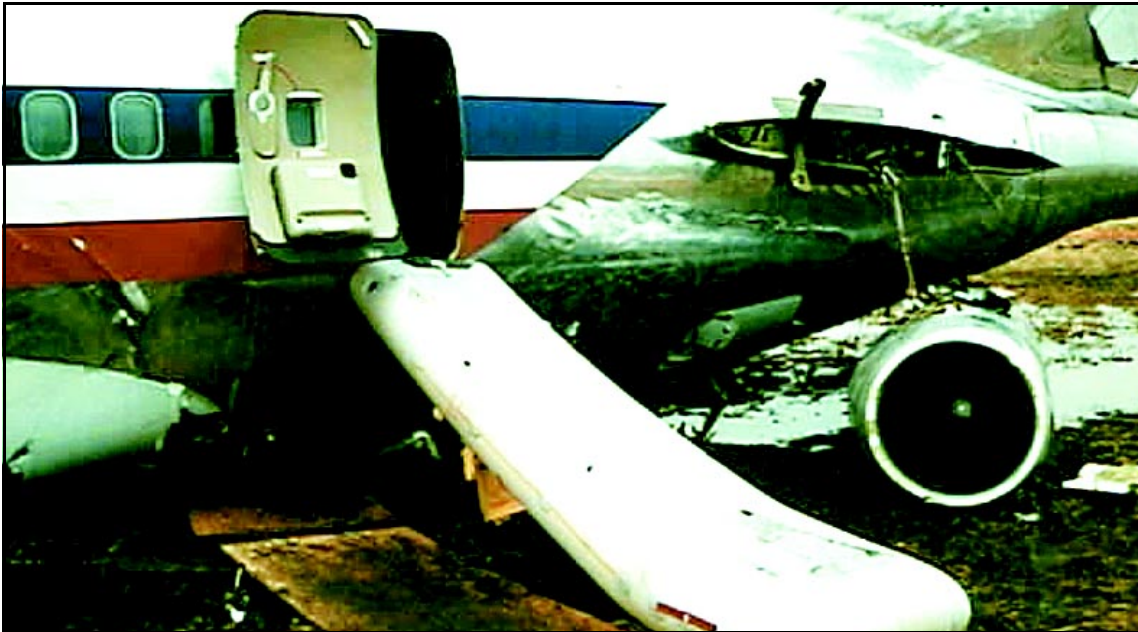
In the 727 accident in Chicago (case 9), the aircraft landed short of the runway, striking a light structure and the runway threshold. A liferaft ceiling panel door⁵³ fell open, blocking the main aisle to the L1 exit.⁵⁴ The flight attendant assigned to the L1 exit decided not to use the exit because the ceiling panel blocked access to the exit. Passengers evacuated through the R1, overwing, and L2 exits (figure 5–4).

Figure 5–4. View of a slide used in the Boeing 727 evacuation on February 9, 1998, Chicago, Illinois (case 9).
