National Transportation Safety Board

Fire Issues

October 23, 2001

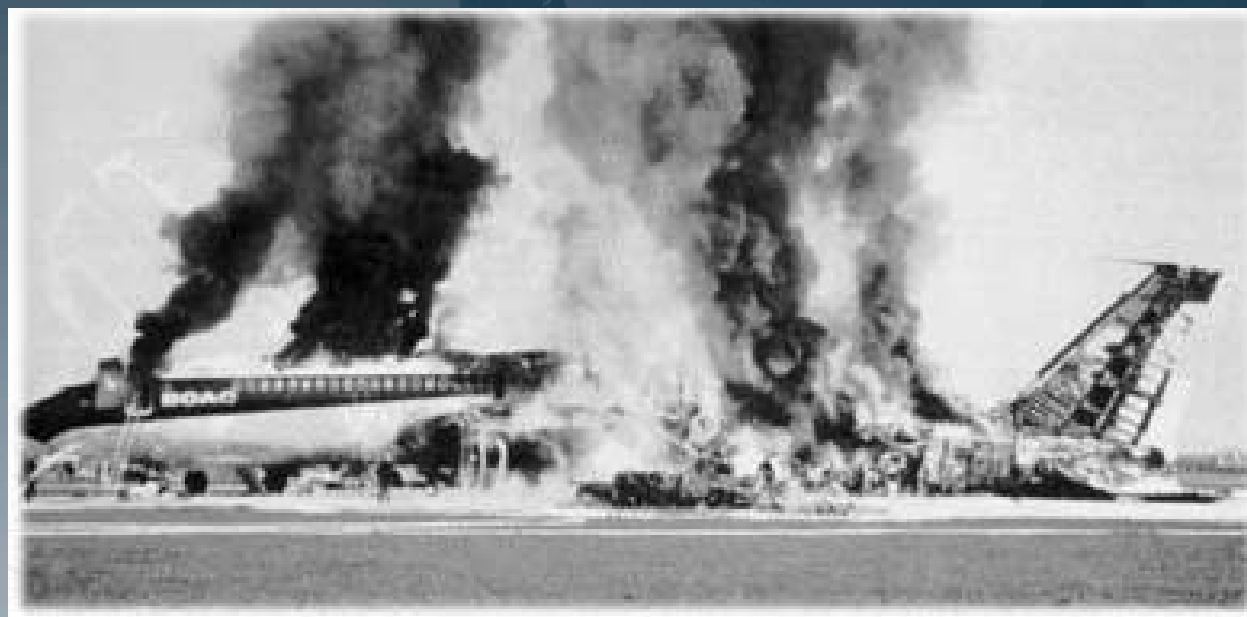
BOAC 707 uncontained engine failure results in in-flight fire, engine separation, then fuel ignition during emergency landing. Five fatalities. April 8, 1968

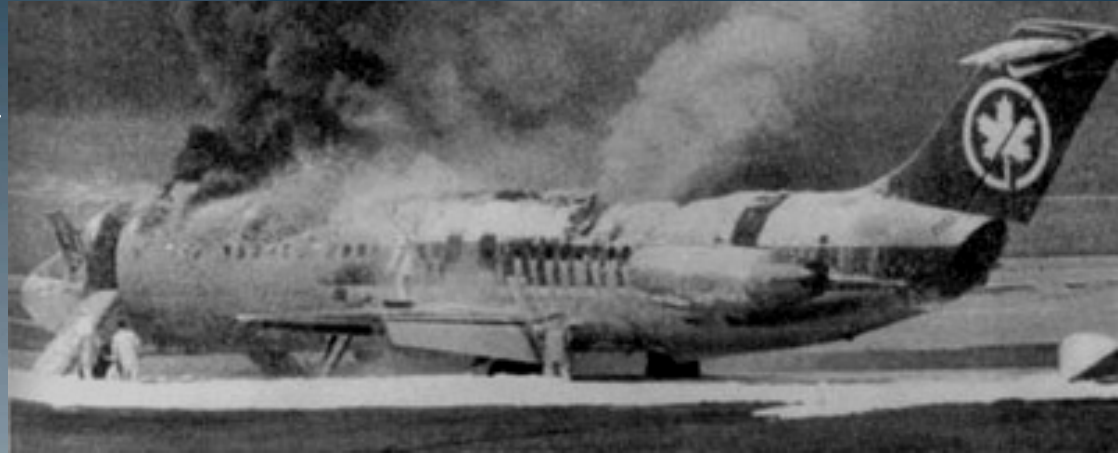
June 2, 1983, Air Canada DC-9 in-flight fire led to recommended changes.

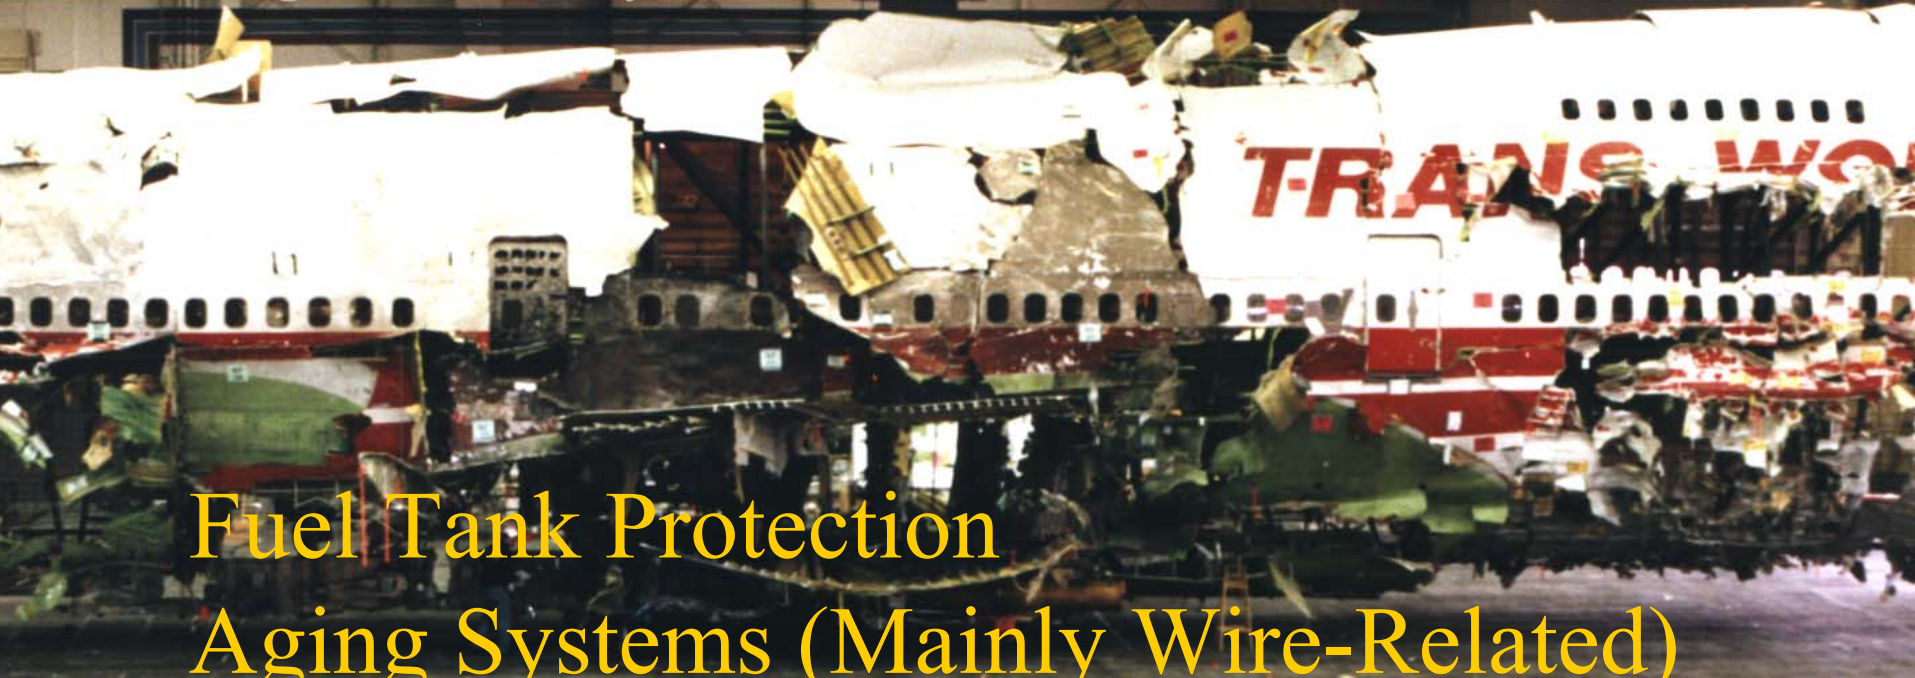
TWA flight 800, July 17, 1996:

Fuel Tank Protection
Aging Systems (Mainly Wire-Related)

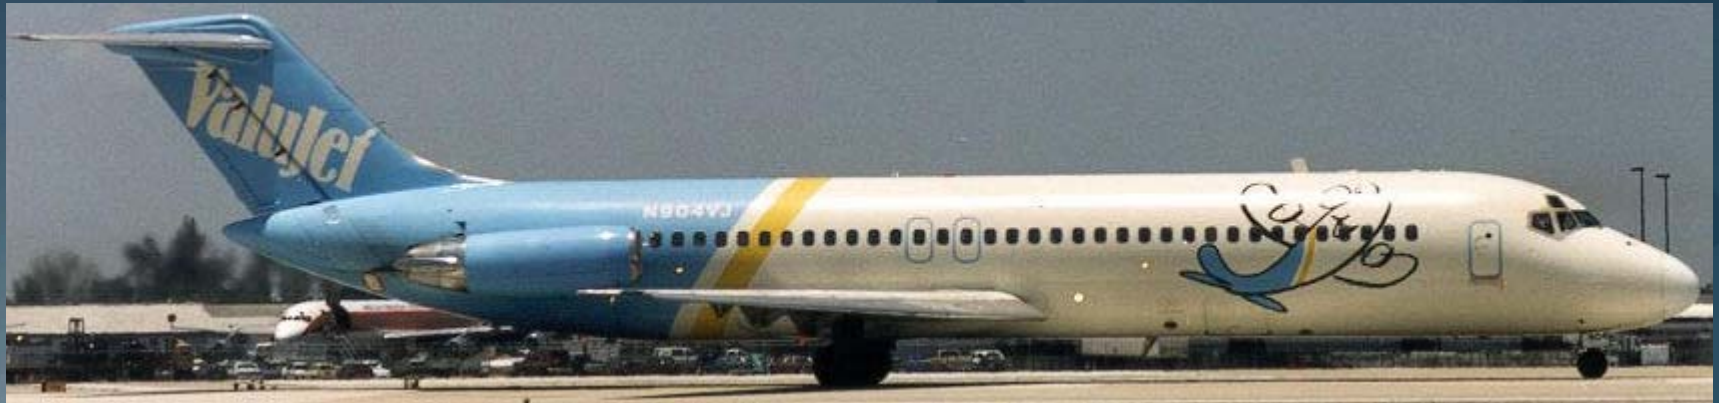
ValuJet 592 as a Legacy Event

- ValuJet Safety Issues Included:
- Minimization of the Hazards Posed by Fires in Class D Cargo Compartments;
- Equipment, Training, and Procedures for Addressing In-Flight Smoke and Fire;

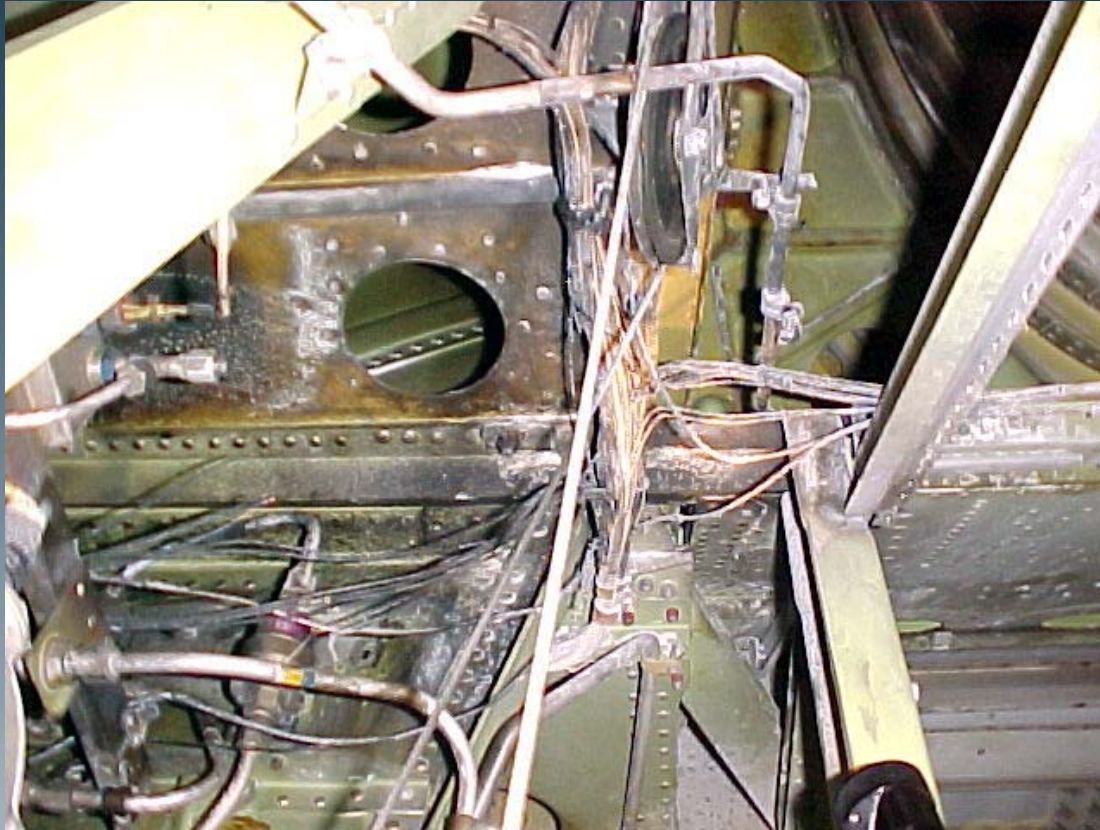
May 2001 Fire in 727 Air-stair Area Resulted in All-Base Operators Message & Fleet Inspections

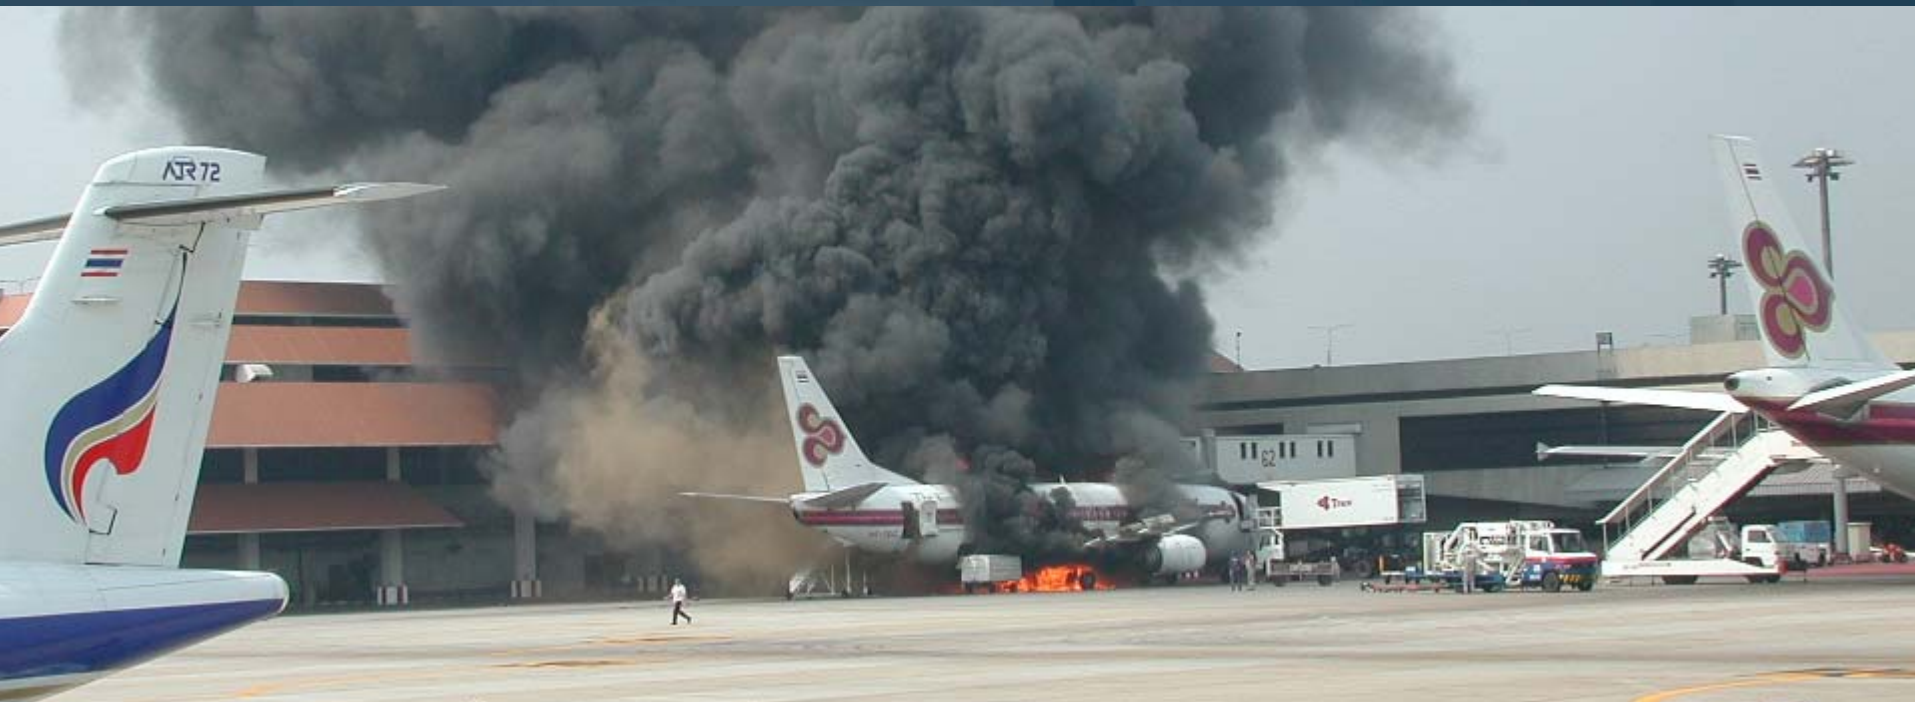
Thai 737 Fuel Tank Explosion of March 3, 2001

No evidence of bomb.

Fuel pump testing about to begin.

Electrical and fuel quantity systems still under investigation

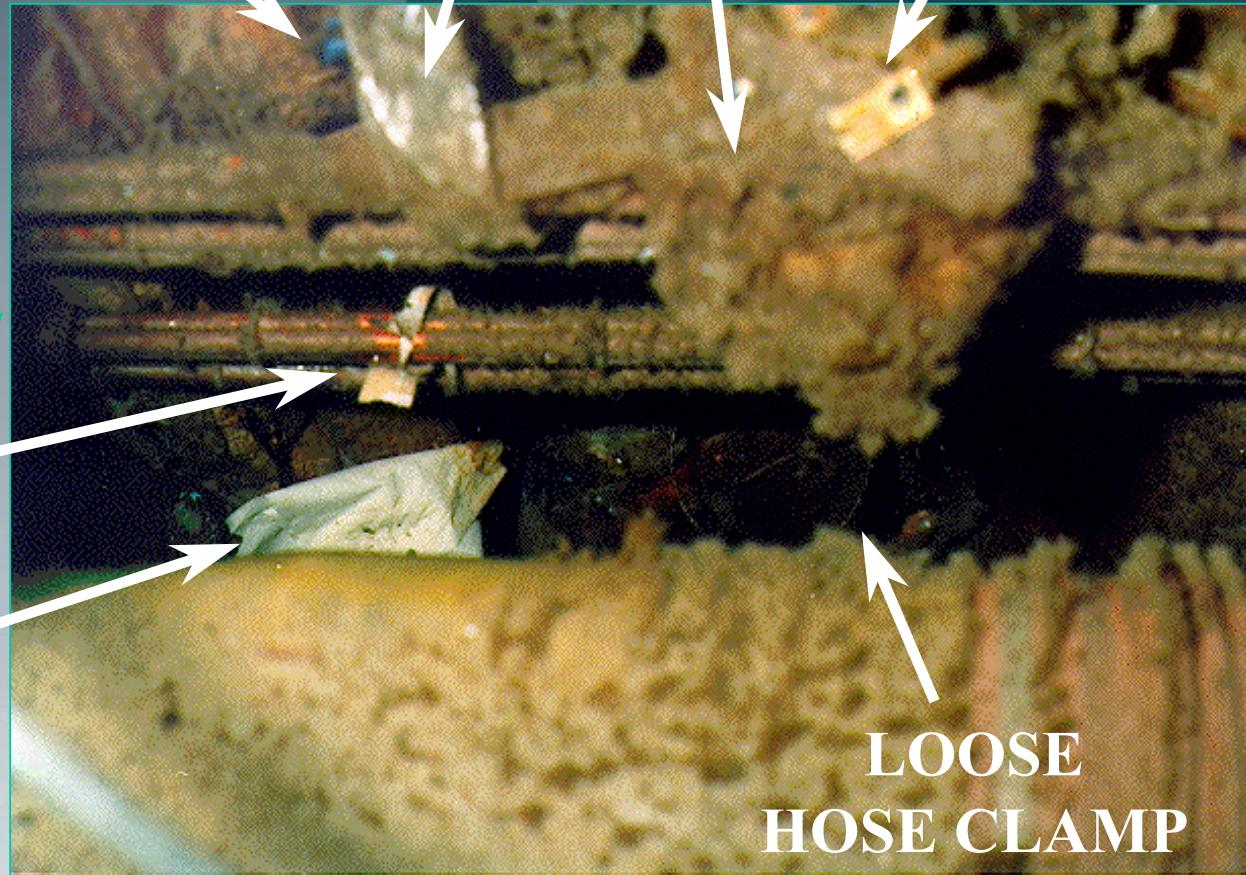
FOIL WRAPPER
IN GEN. CABLES

PAPER

LOOSE
HOSE CLAMP

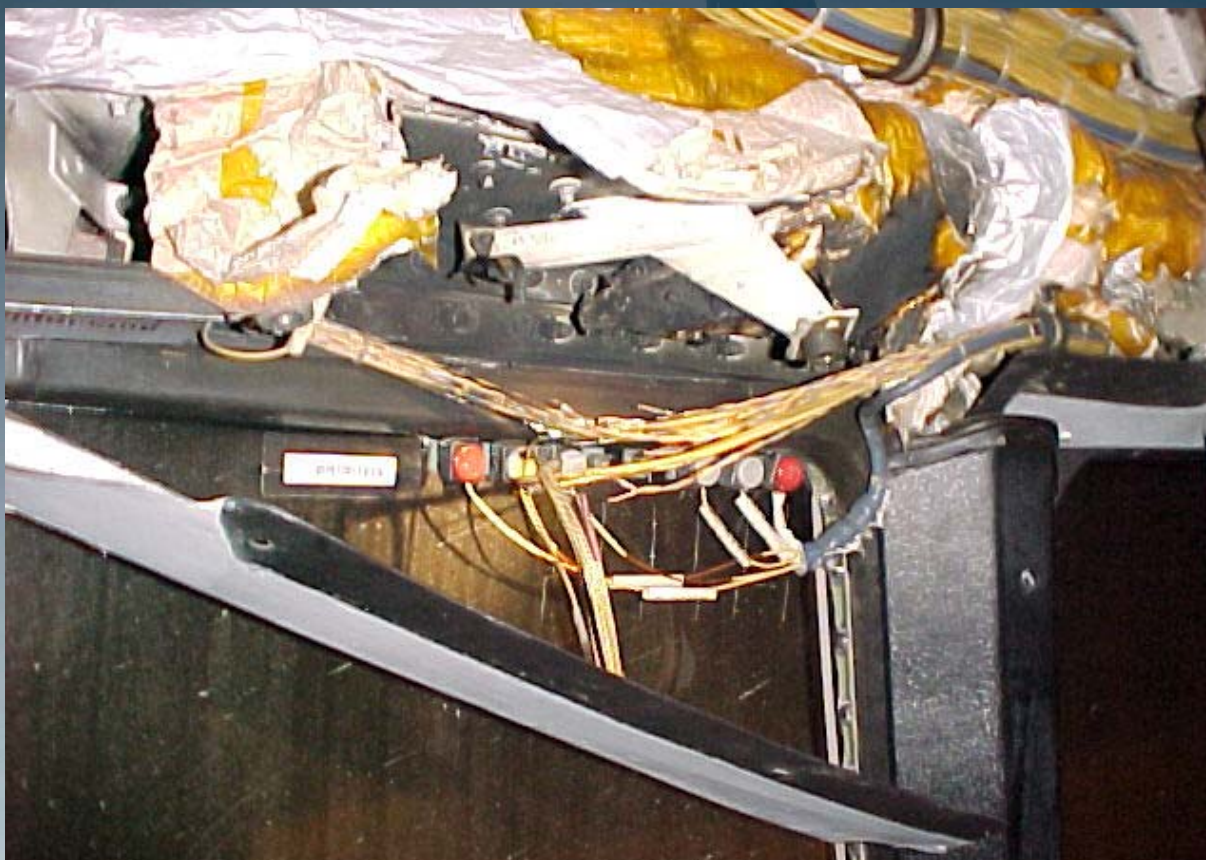
December 2000, LOCKHEED L-1011-385. Wire fire above
First Officer Window.

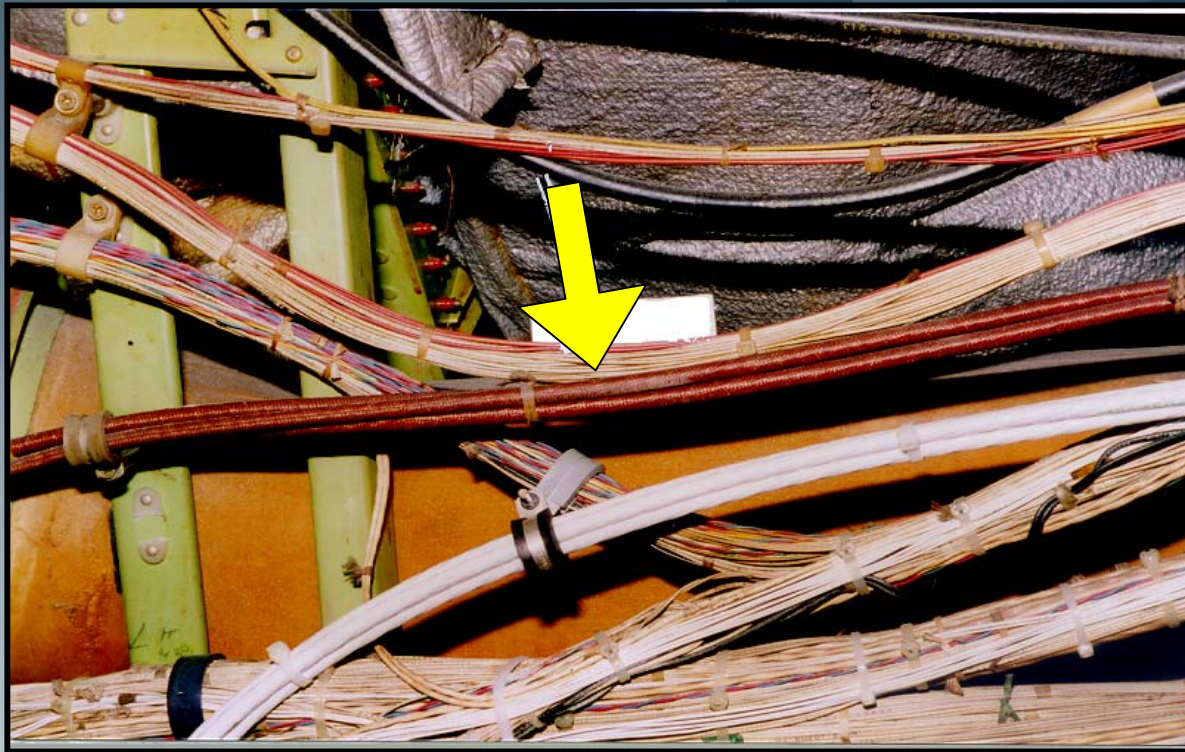
Chafe of Fuel & Galley Power Wires (747)

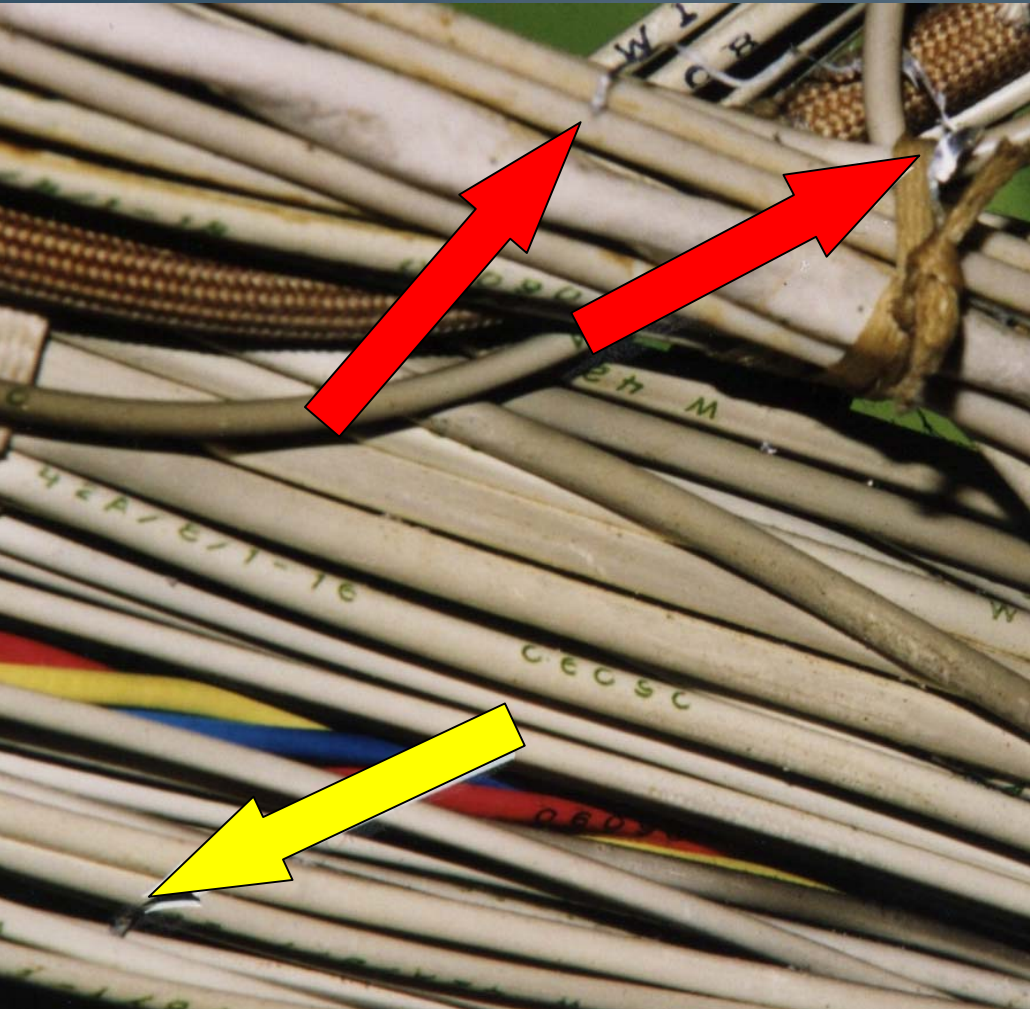
Shavings On Top
Of Wires And Coming
Through Bundle (747)

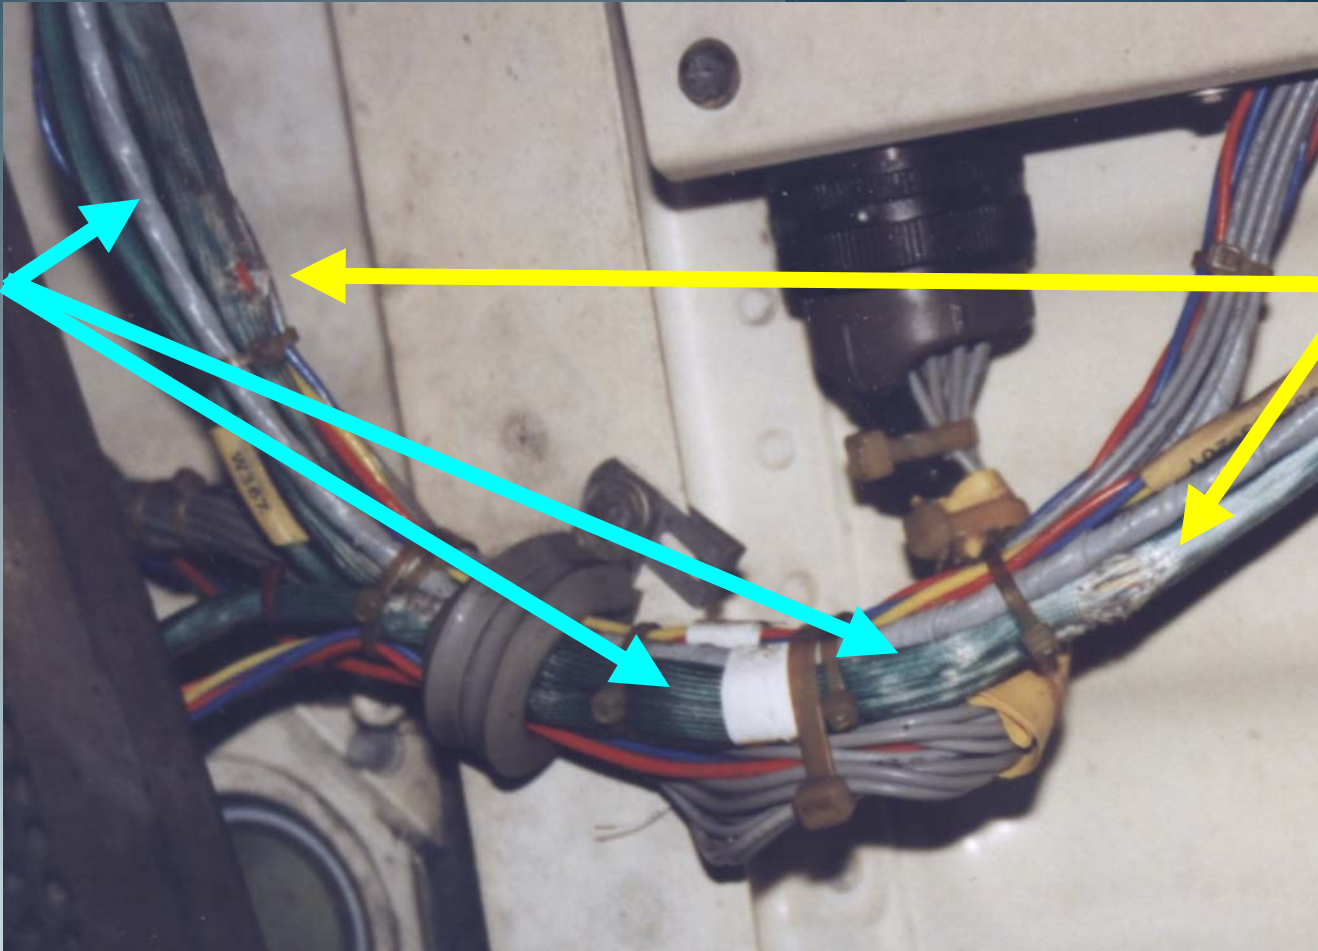
Potential Problems Found During TWA 800 Investigation Into Aging Aircraft Lavatory Fluid Stains (737)

Blue
Lavatory
Fluid
Stains

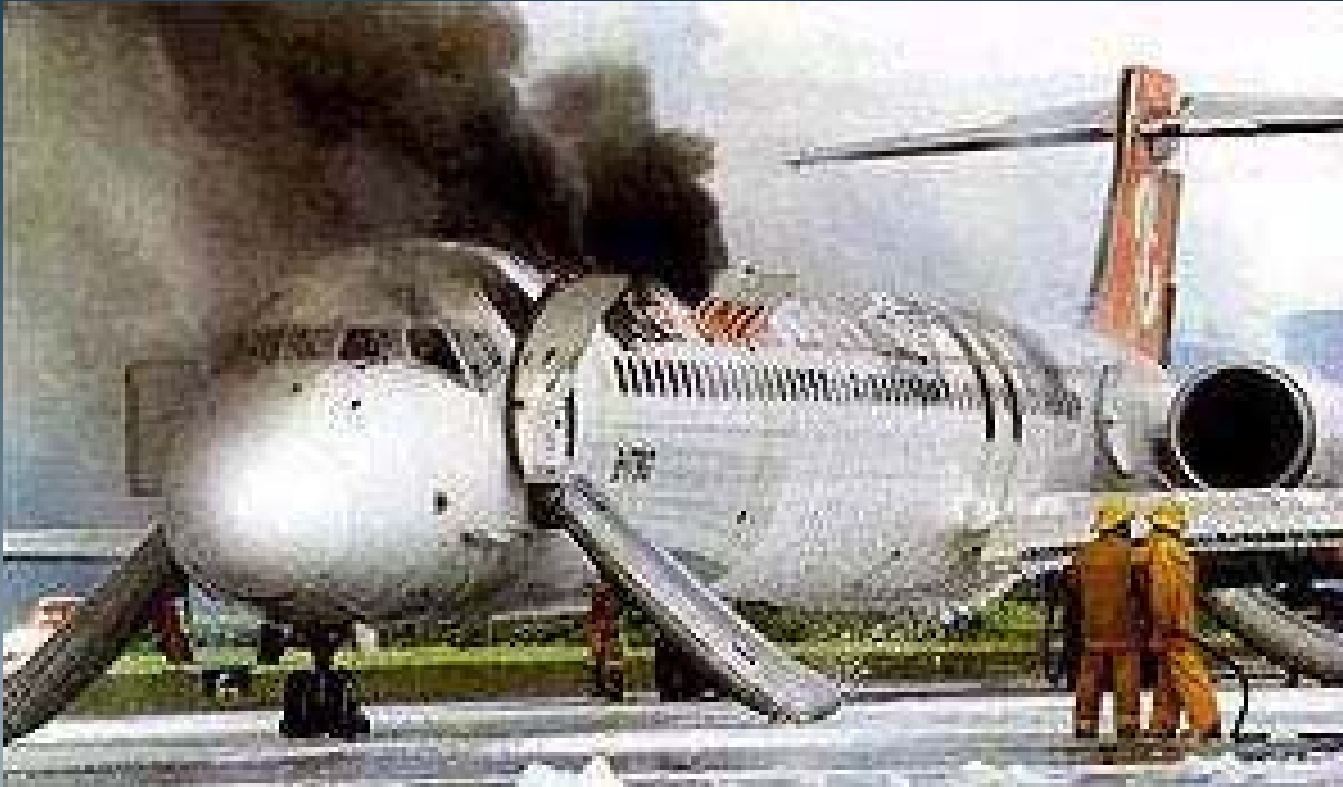
Gasoline carried in overhead luggage.
Uni Air MD-90 cabin fire at Hualian, Taiwan,
on August 24, 1999.

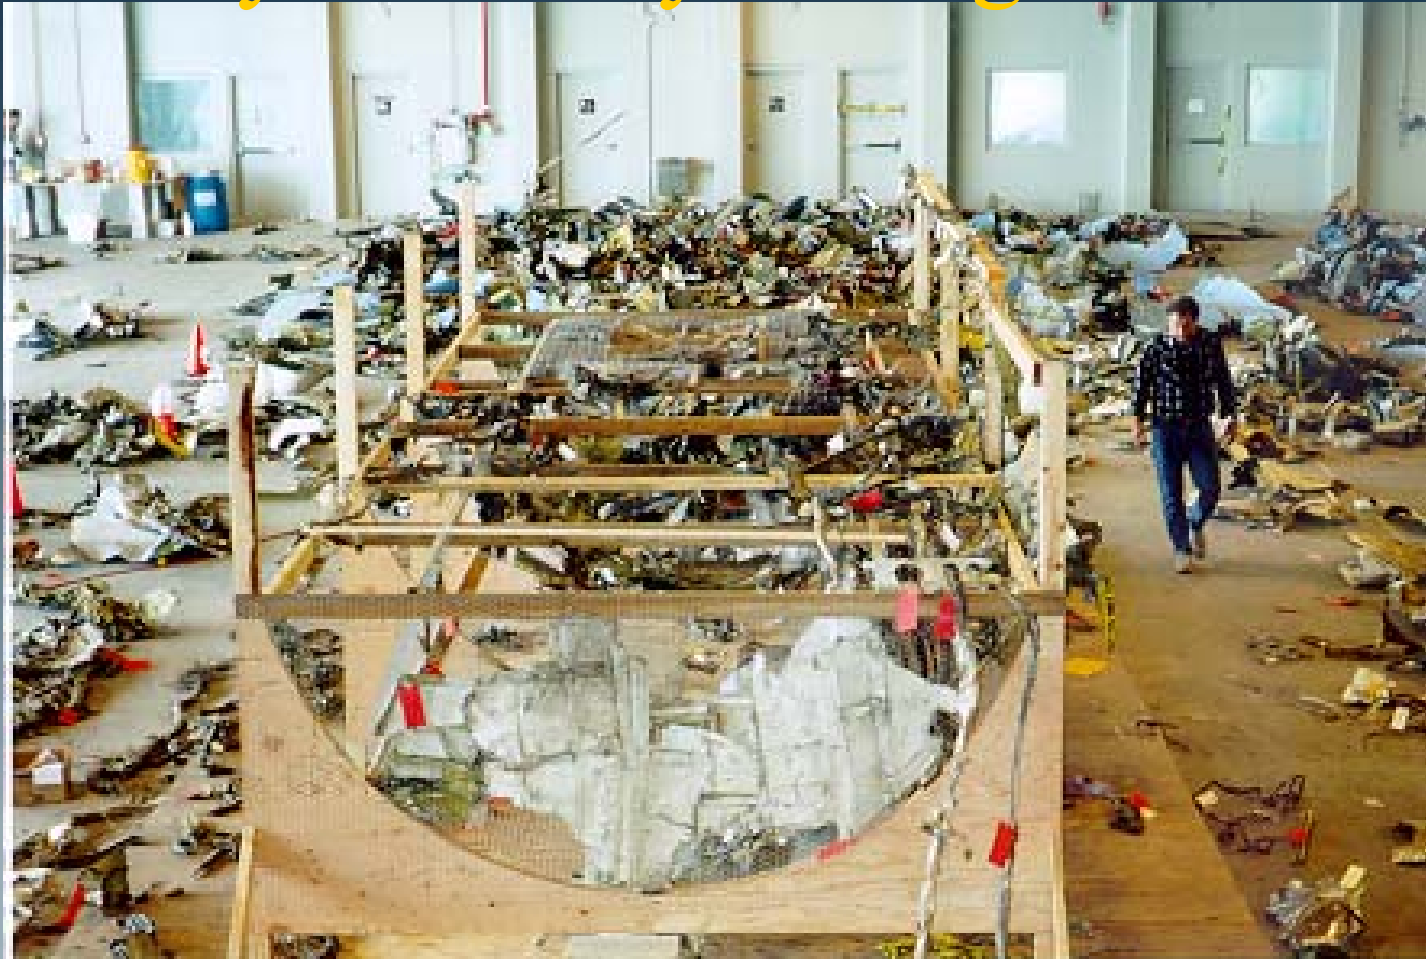
DCA96MA054, VALUJET AIRLINES DC-9, May 11, 1996,
Everglades, Florida, about 10 minutes after take off.
