NATIONAL TRANSPORTATION
SAFETY BOARD

Third Triennial International Fire & Cabin Safety Research Conference

Cynthia Keegan
NTSB

Investigations Involving In-Flight Fire

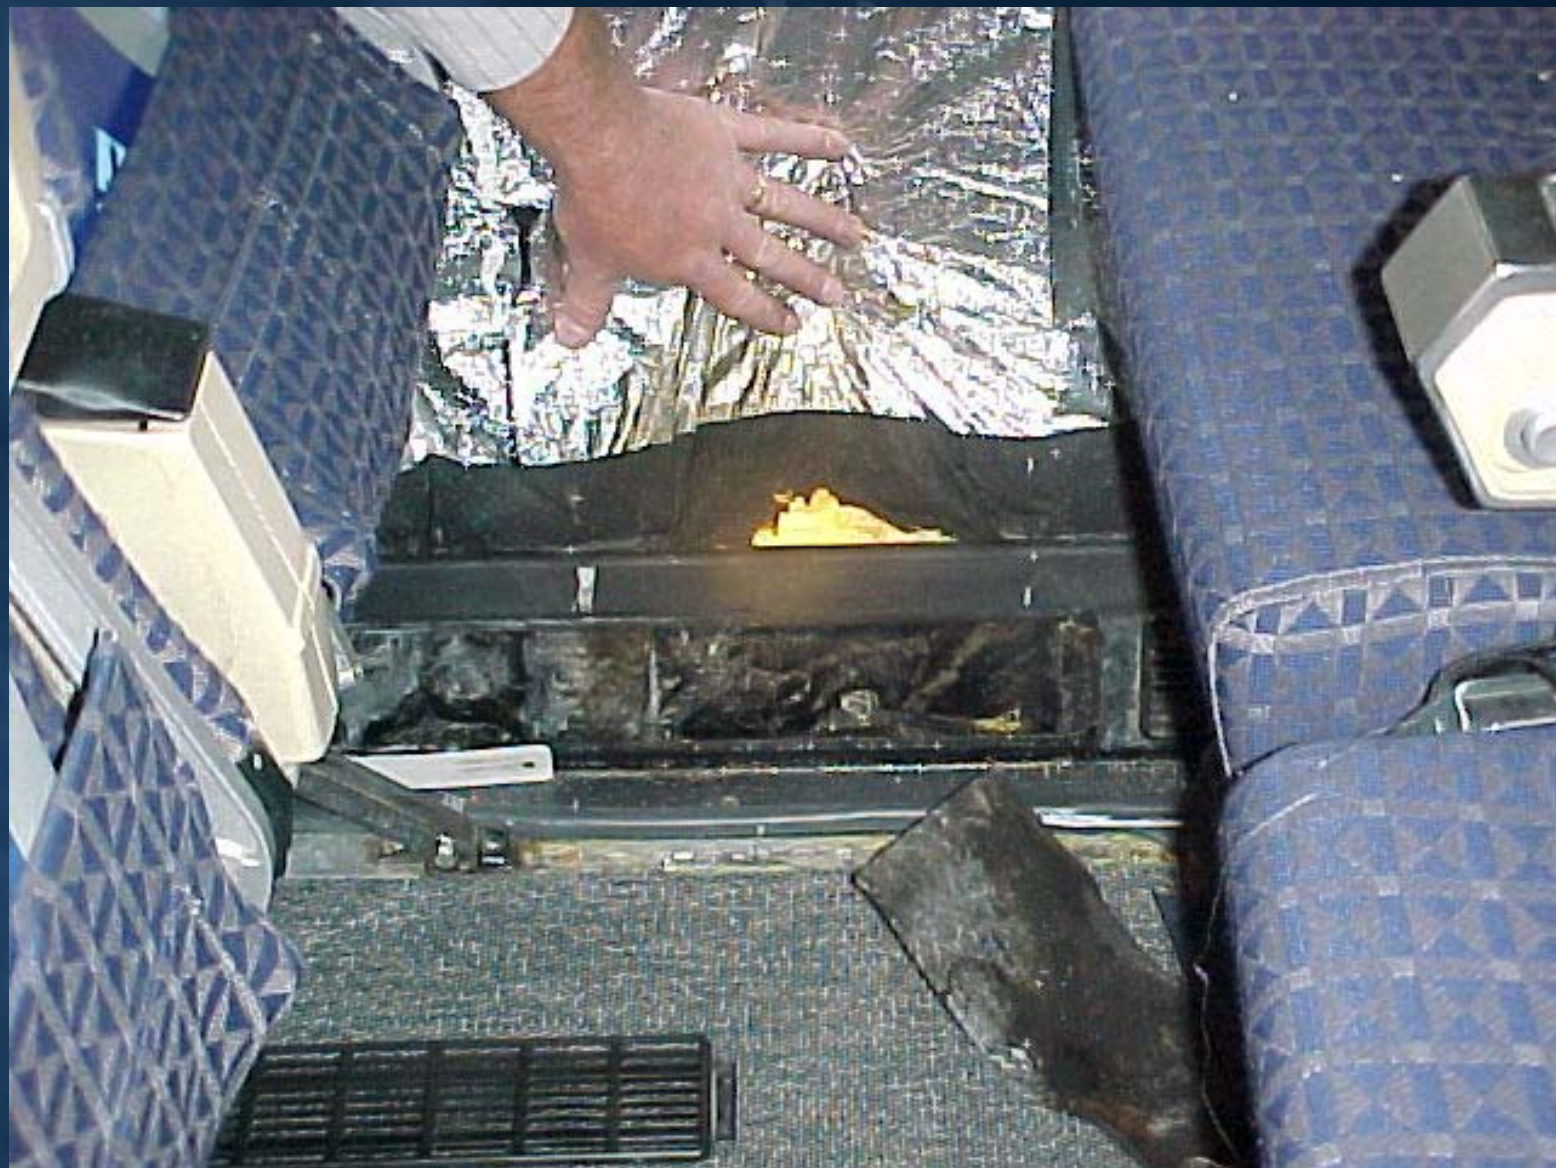
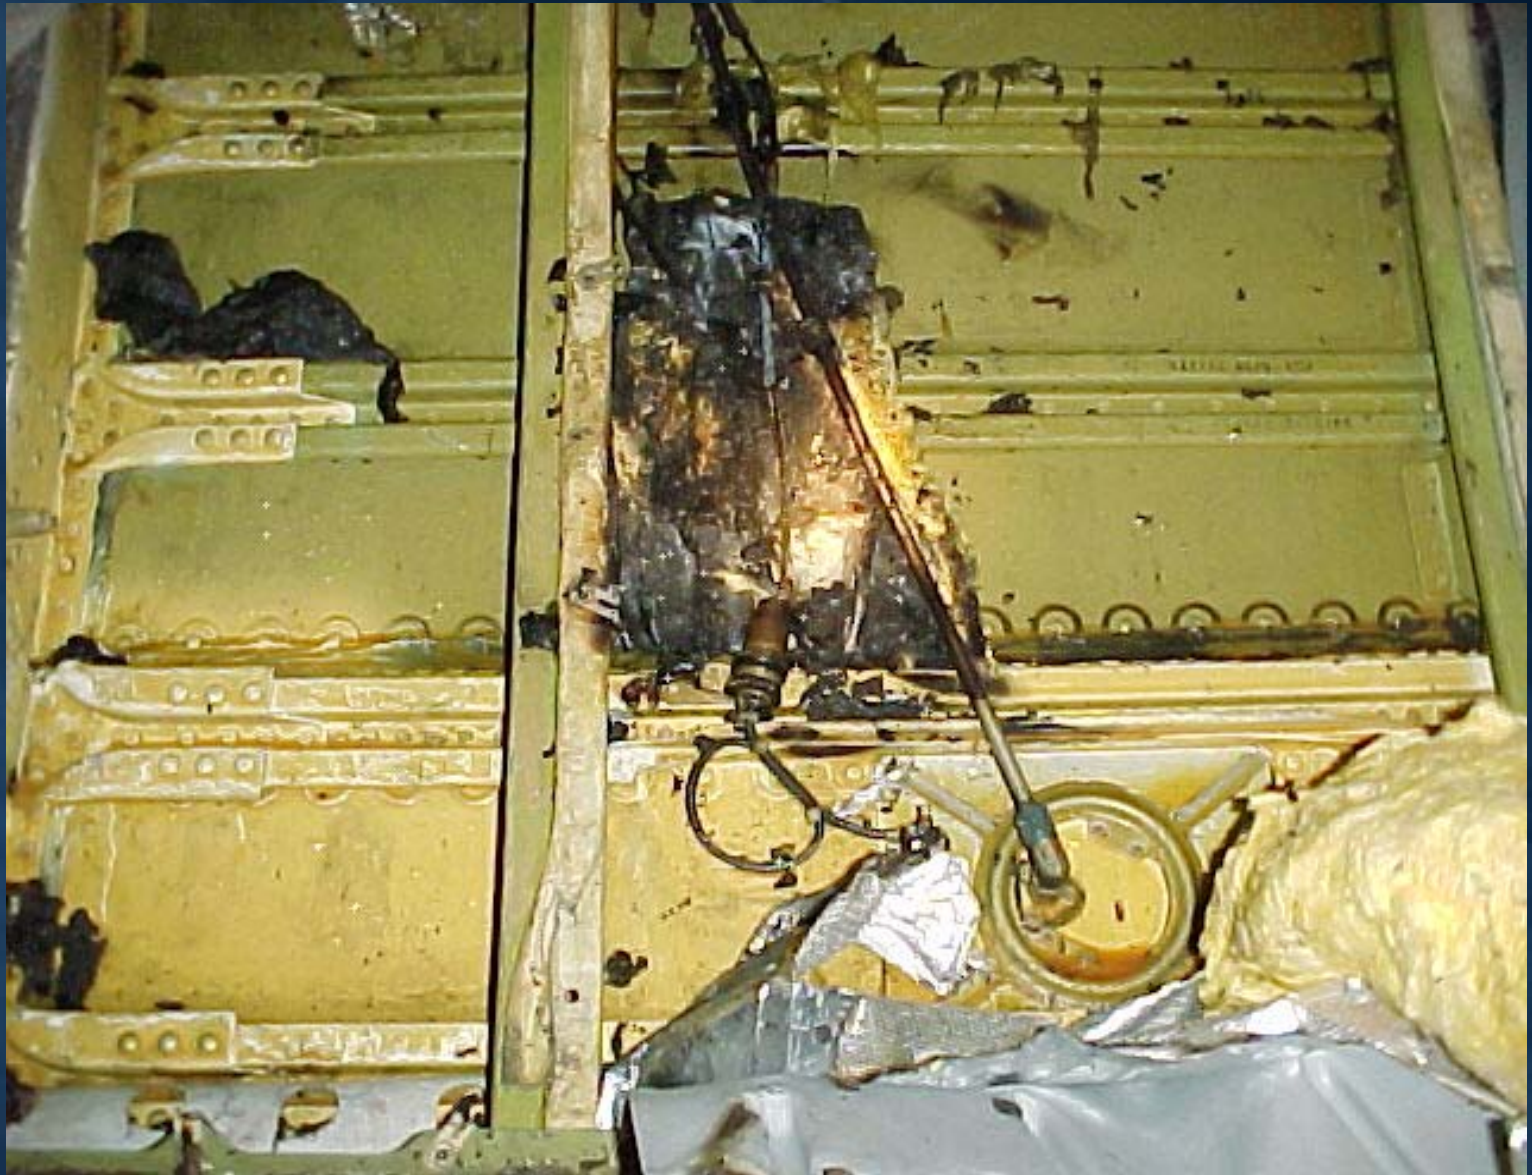
- A carry-on bag that was stowed next to the right sidewall was scorched
- F/A reported a flickering glow beneath the vent to the flight crew.
- The Captain told the No. 1 flight attendant not to use Halon in the cabin but another F/A had already discharged Halon into the vent and the glow disappeared.
- The No. 1 F/A became alarmed that a Halon fire extinguisher had been discharged in the cabin.

- Source of the smoke was a smoldering insulation blanket in the cargo compartment that was adjacent to a static port heater. Electrical arcing from the heater had ignited the blanket.
- The Safety Board issued 3 safety recommendations to the FAA regarding the static port heater and replacement of the insulation blankets with an alternate material.

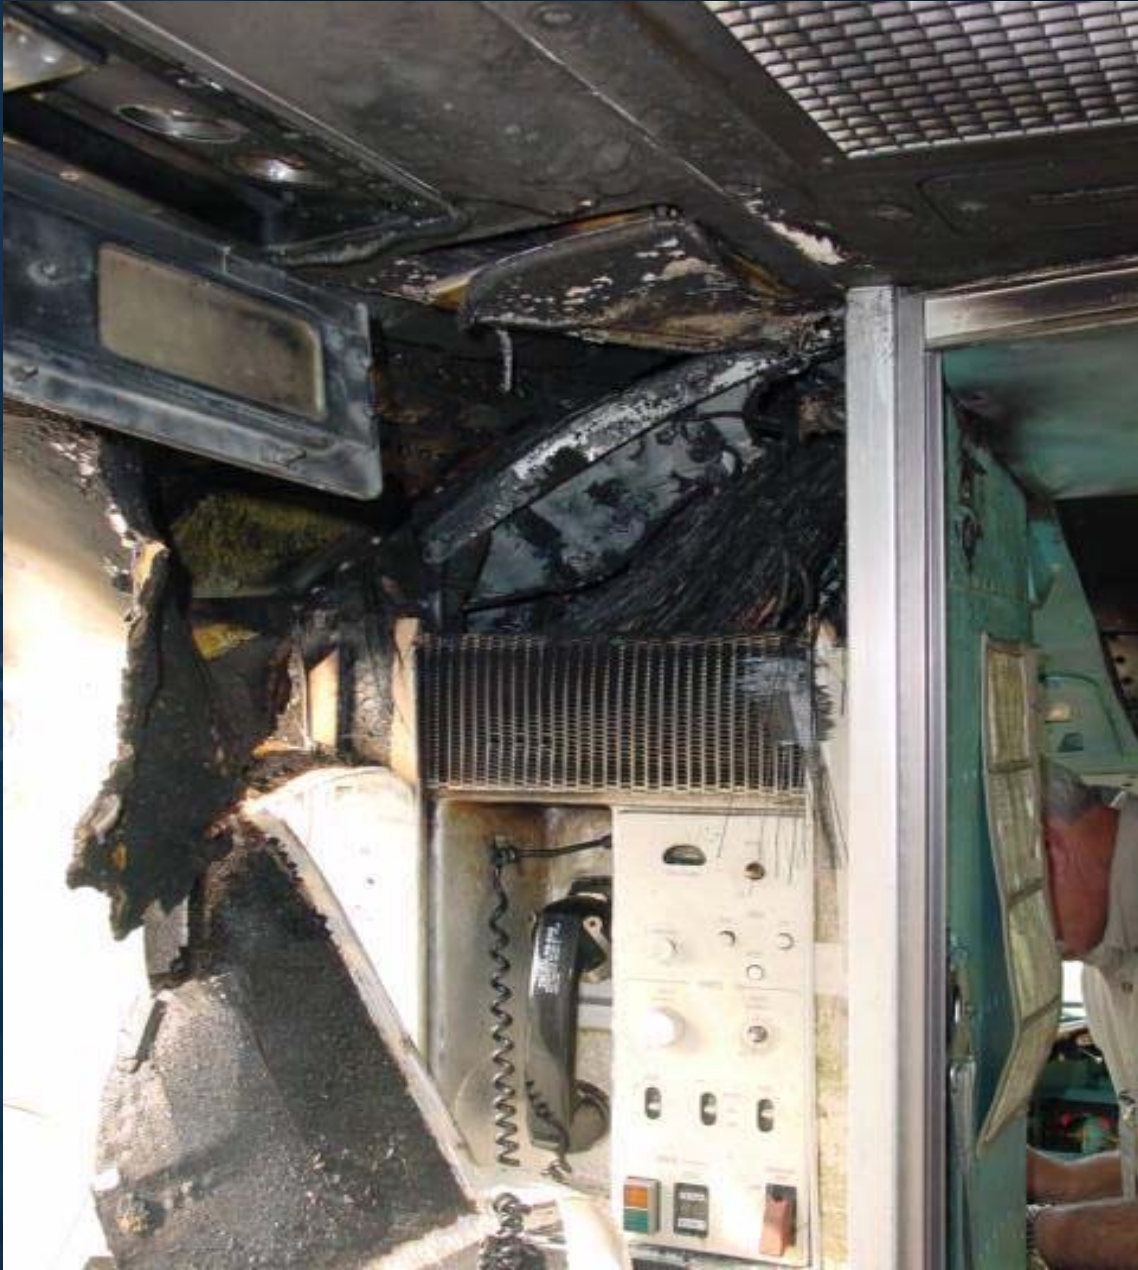
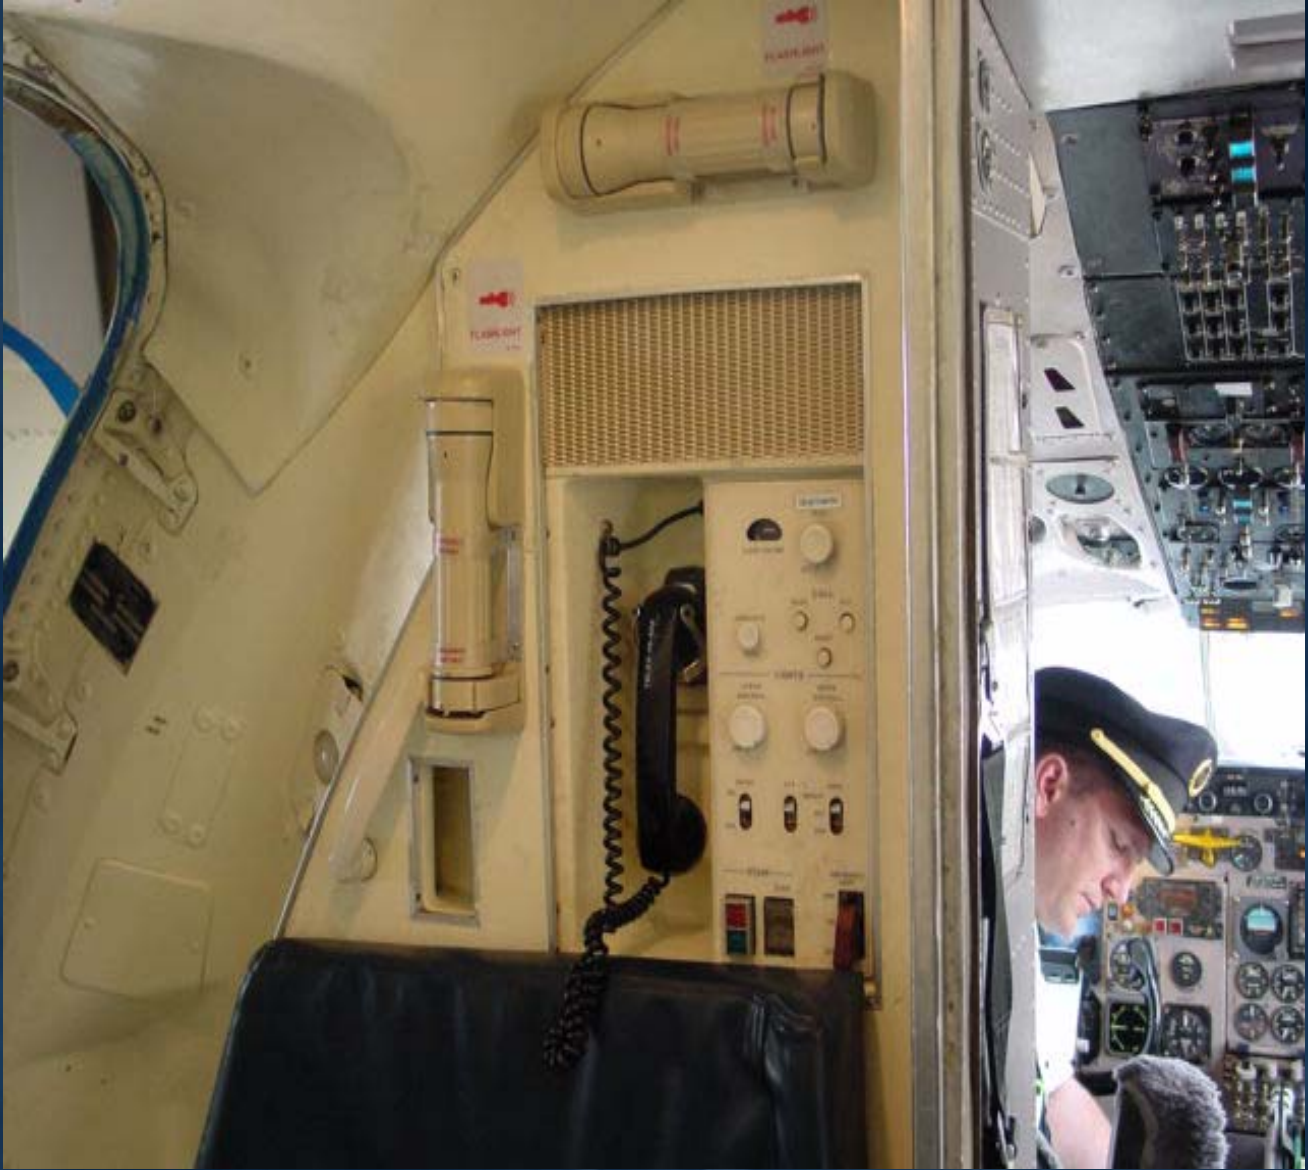
- Smoke became so dense in the cabin that the F/A's could no longer see the forward galley.
- Neither F/A made any effort to locate the source of the smoke or to use any fire-fighting equipment.
- F/A saw a large amount of electrical “arcing and sparking” and heard “popping” noises but debated whether to use the Halon because she was unsure where to aim it.

- Smoke in the forward cabin caused by electrical arcing in the bulkhead behind the captain's seat.
- The arcing ignited interior panels which continued burning after the airplane landed and passengers evacuated the airplane.
- The fire was extinguished by airport rescue and firefighting personnel.

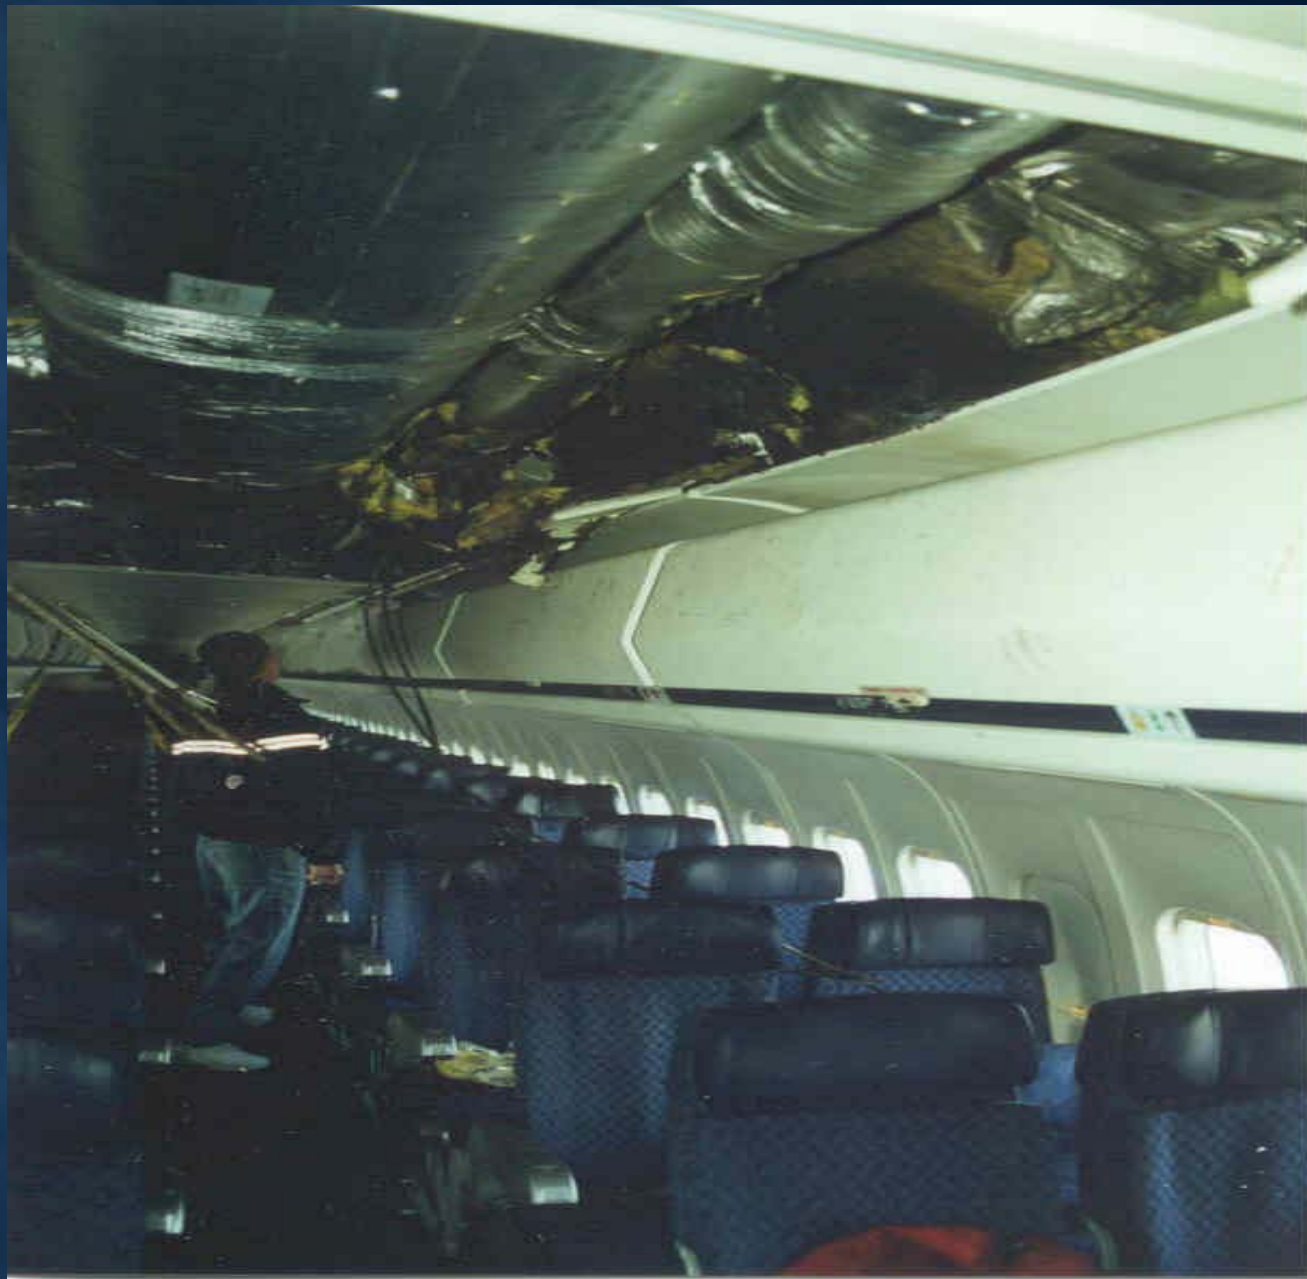
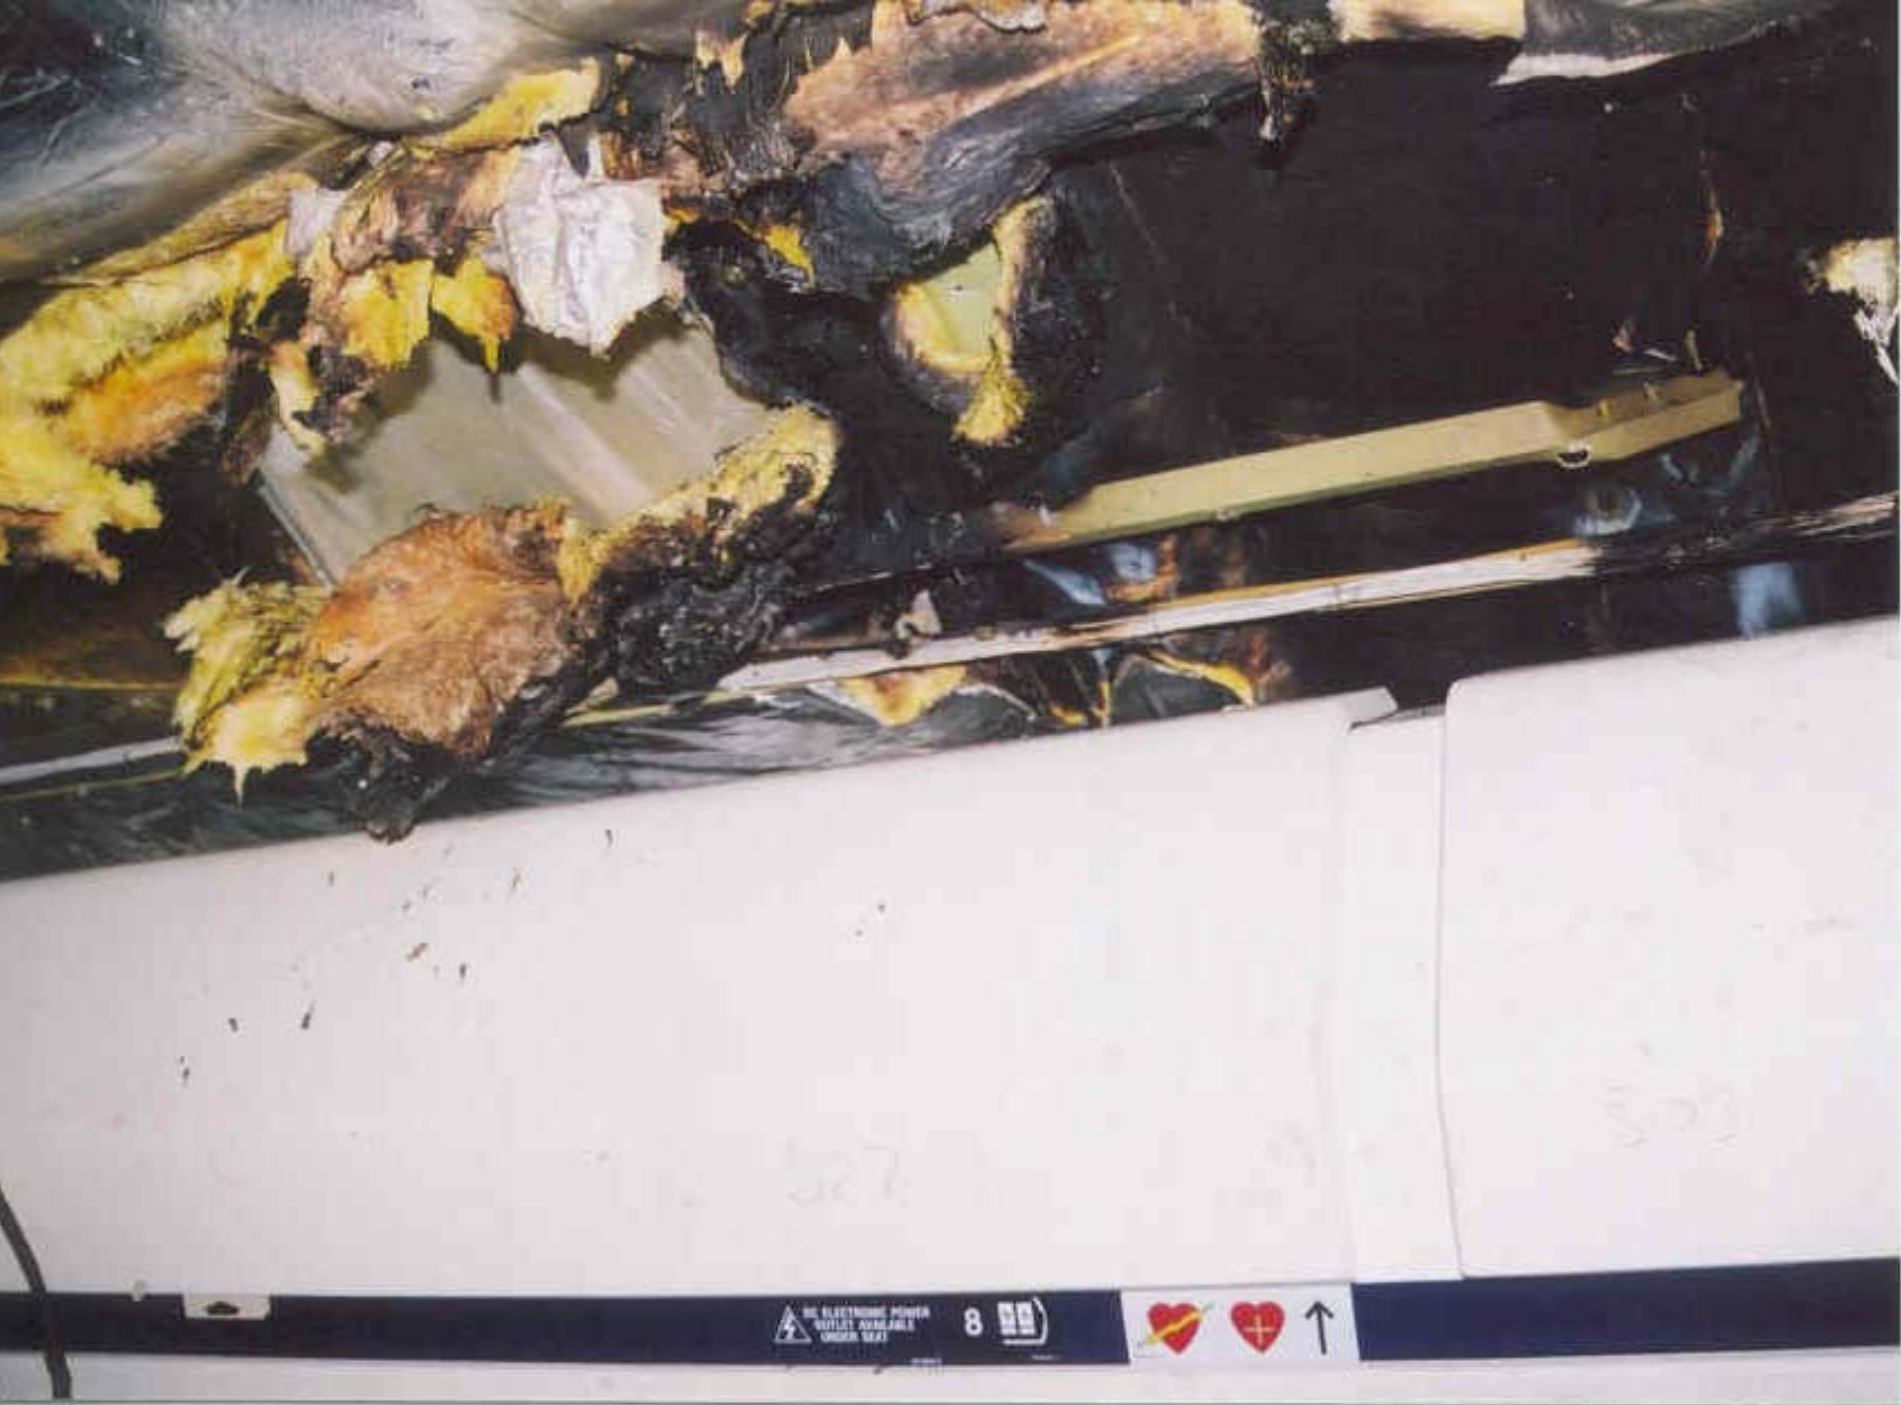
- F/As saw a flash and heard a boom on the right side of the airplane.
- A F/A saw smoke coming from a fluorescent light fixture in the forward entry area and shut the light off and pulled the circuit breaker.
- Dark, dense black smoke also came from the ceiling panel above rows 7 & 8.

- Before the emergency landing the F/A gave the passenger in seat 9E a Halon fire extinguisher, instructed him on its use, and told him to “use it as needed”
- The Safety Board's investigation is ongoing, but preliminary findings indicate that a lightning strike caused arcing in the airplane wiring above the ceiling panels and ignited adjacent materials.

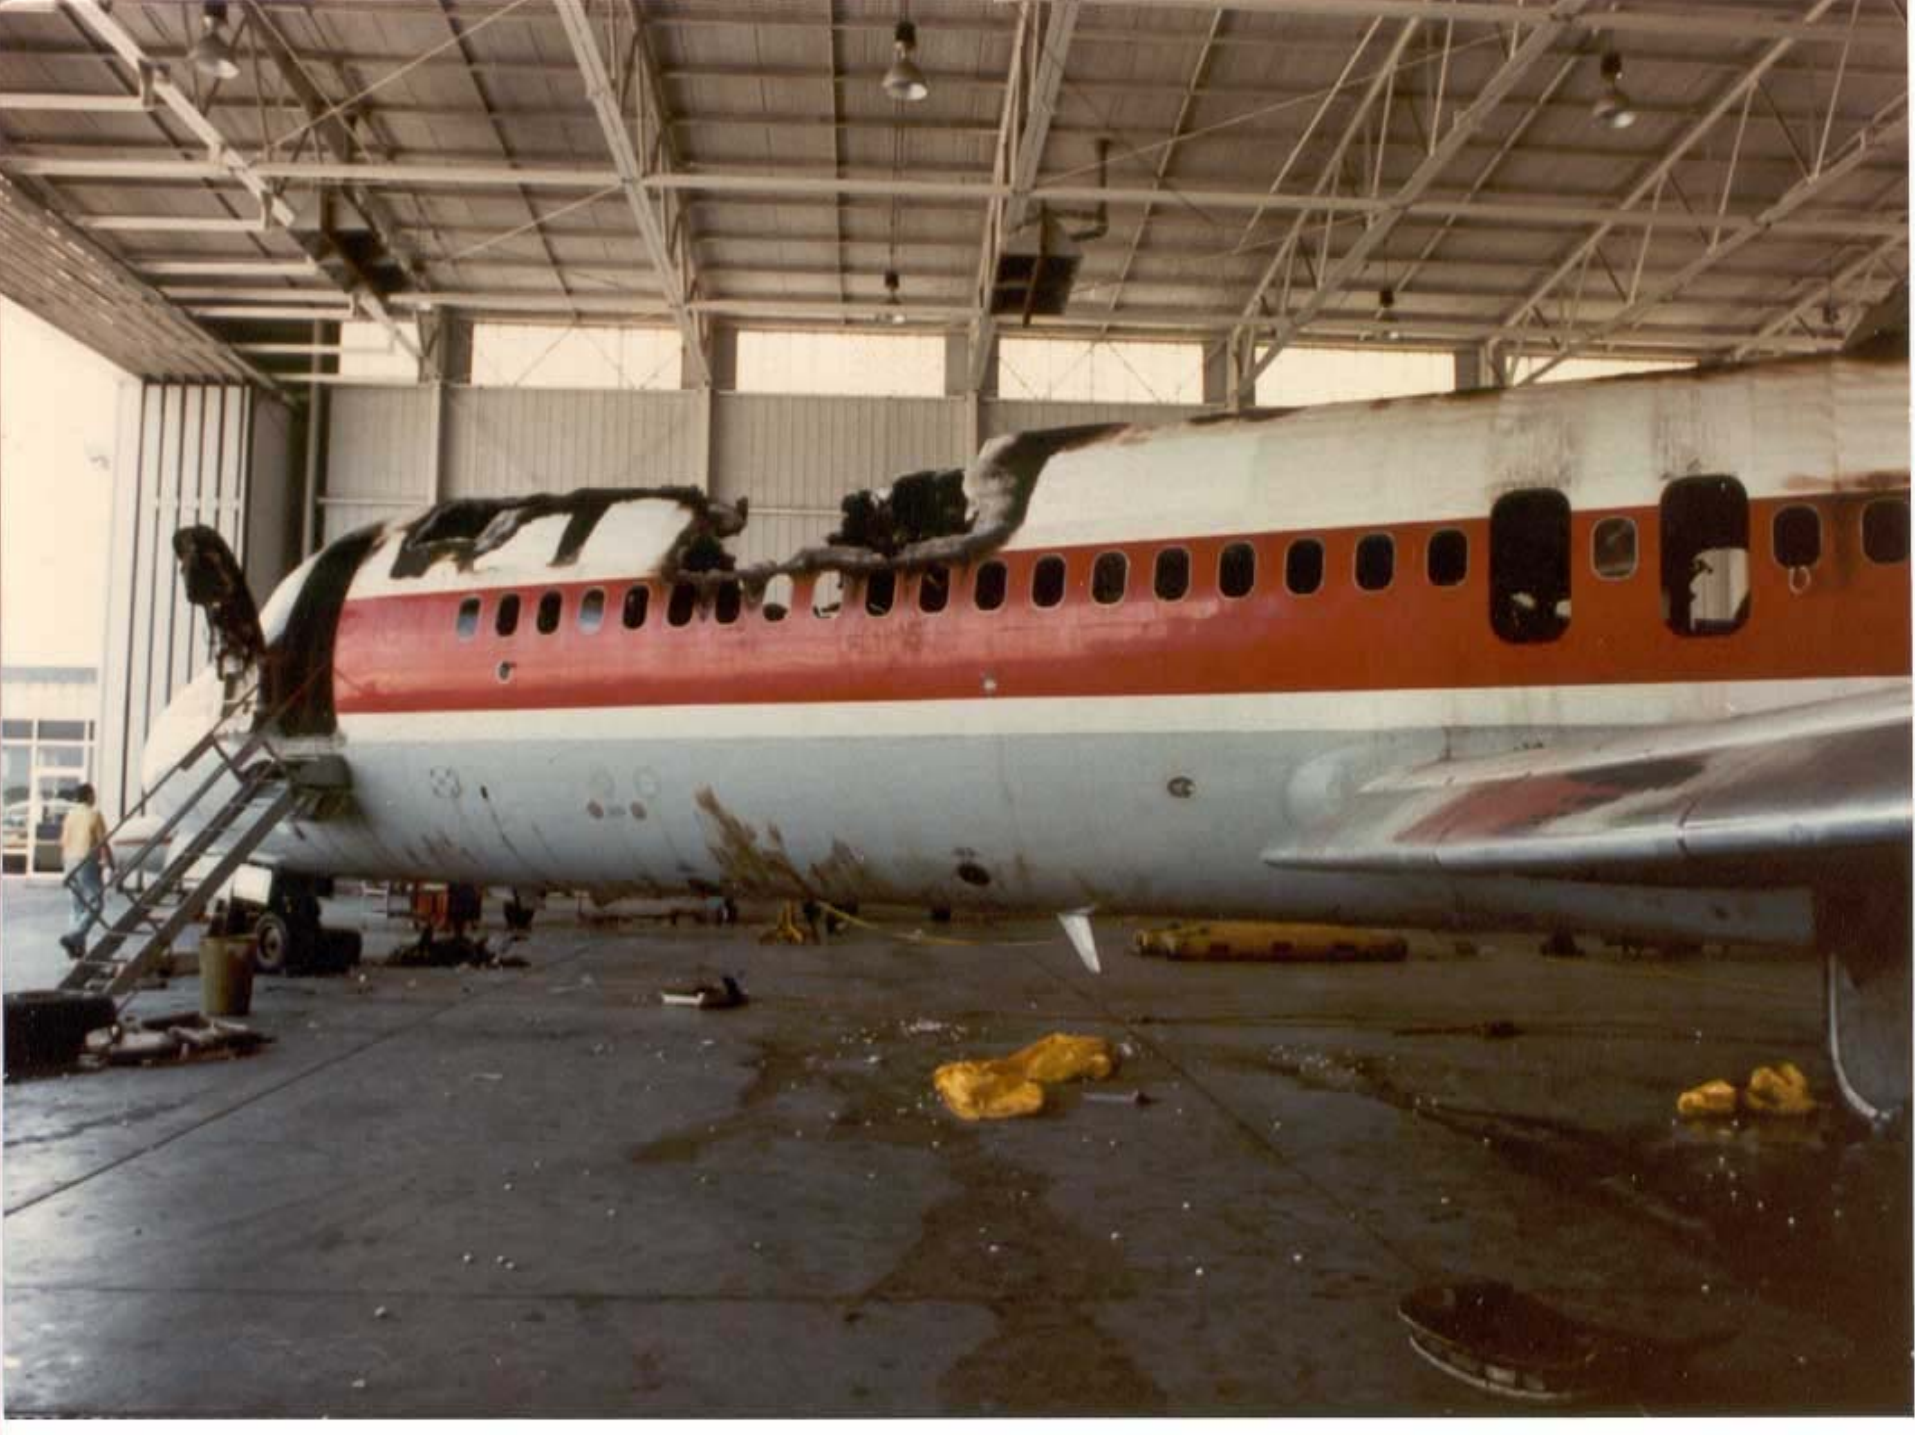
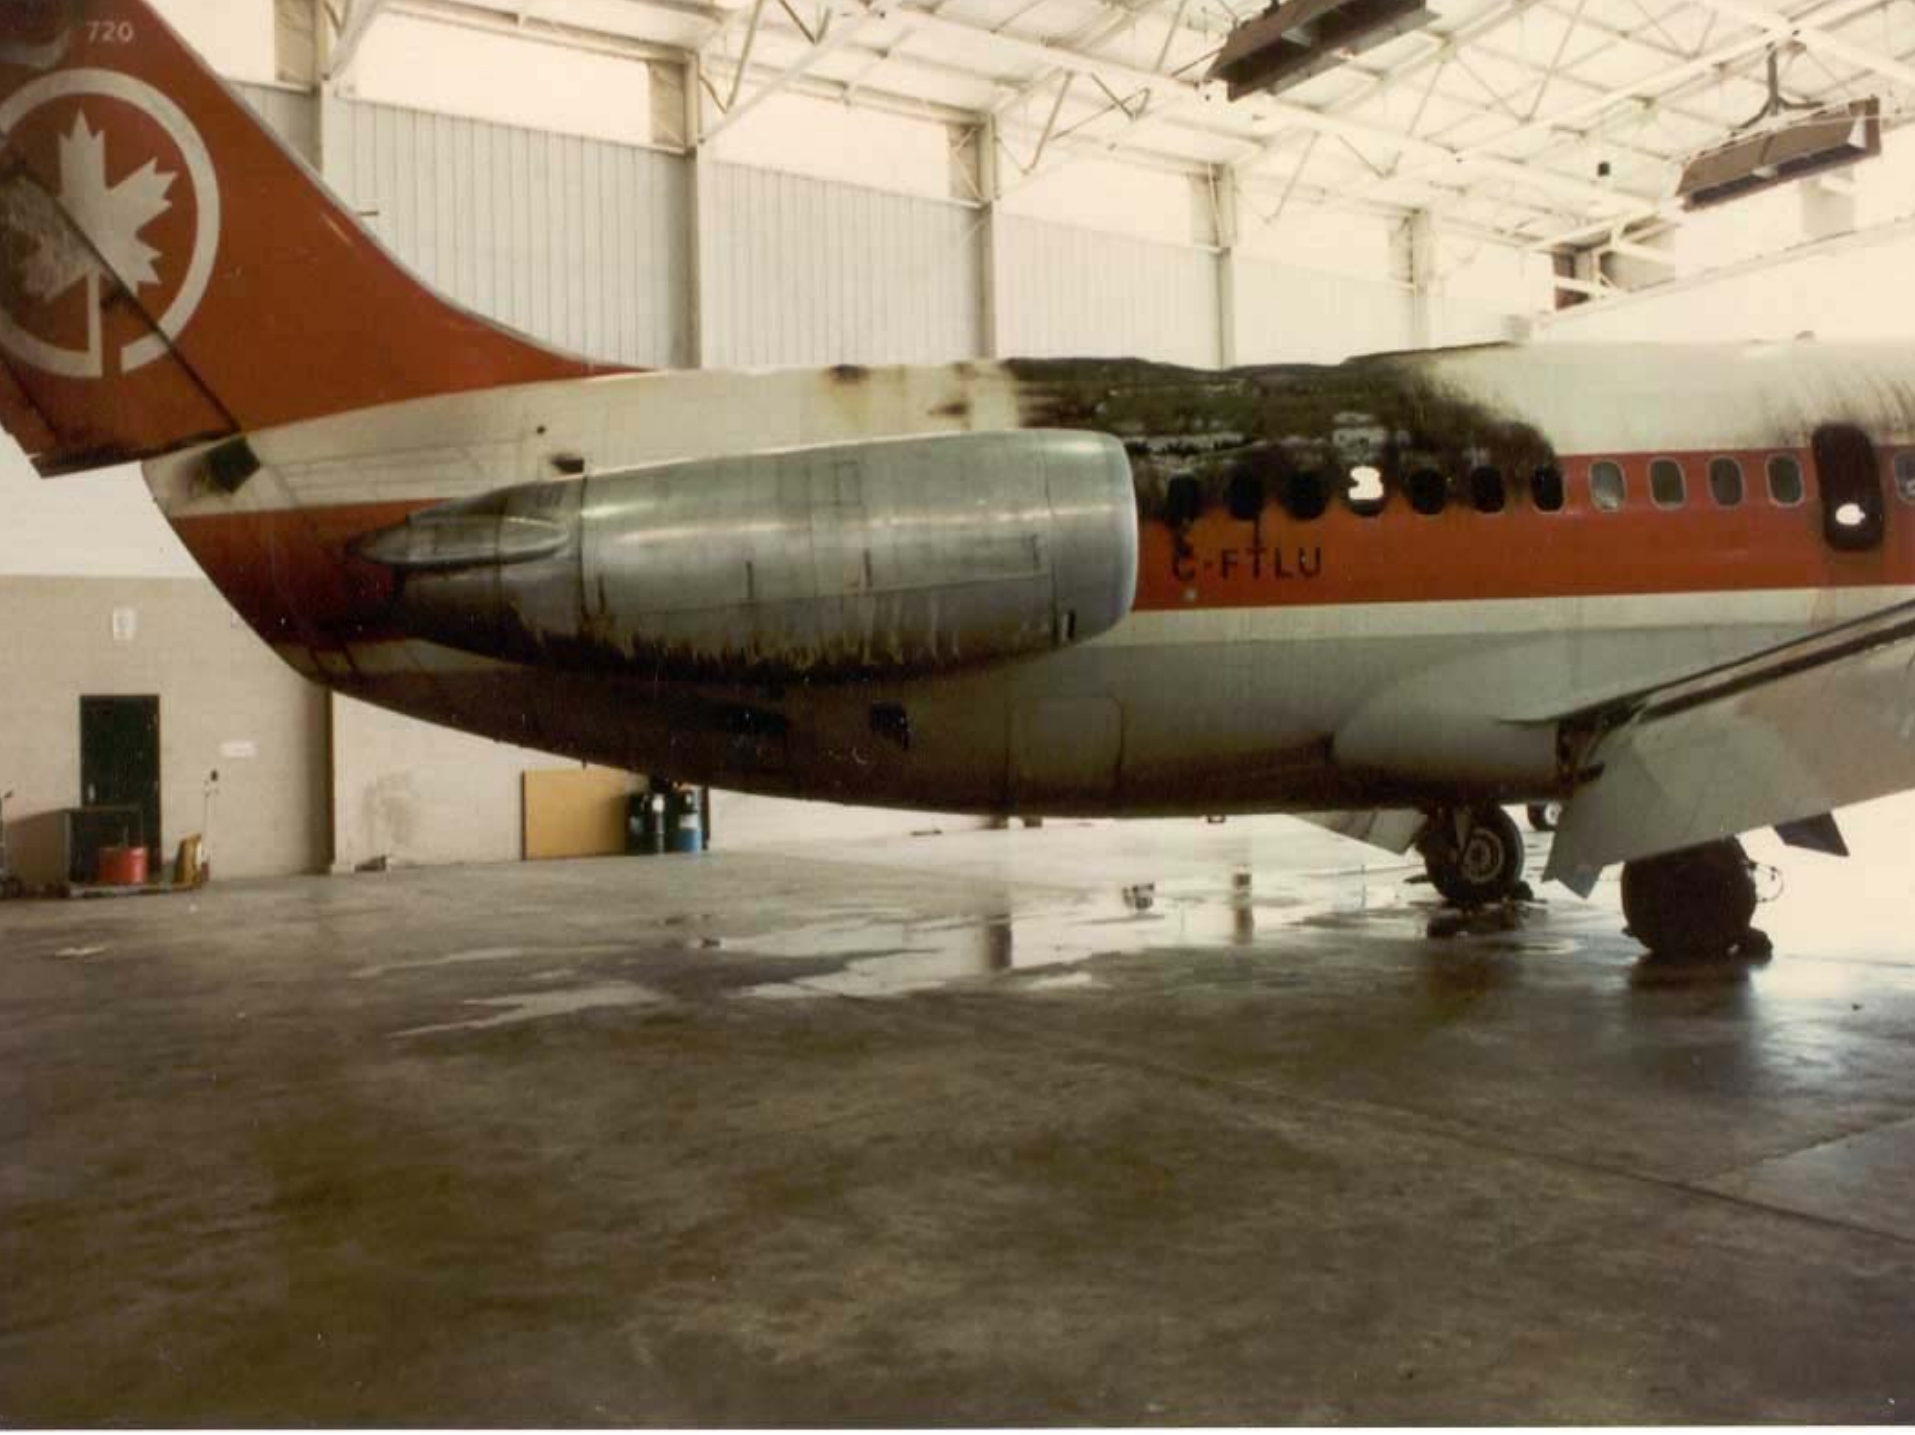
- After the F/A discharged the CO₂ into the lavatory he closed the door.
- When the 1st Officer came back he felt the door and noticed it was hot and told the F/A not to open it, and then informed the captain that they better land the airplane.
- During the descent the smoke increased and moved forward in the cabin.

- The discharge of the fire extinguisher into the lavatory “had little or no effect on the fire...in order for the extinguishing agent to be effective it must be applied to the base of the flames.”
- Probable Cause: “A fire of undetermined origin, an underestimate of fire severity, and conflicting fire progress information provided to the captain.
- Contributing: The flight crews delay to institute an emergency descent.
