DOT/FAA/AR-09/19

A Study of the Effects of Engine Configuration, Fuselage Breaks and Ruptures in Aircraft Accidents Involving Ground Pool Fires

June 2009

Final Report

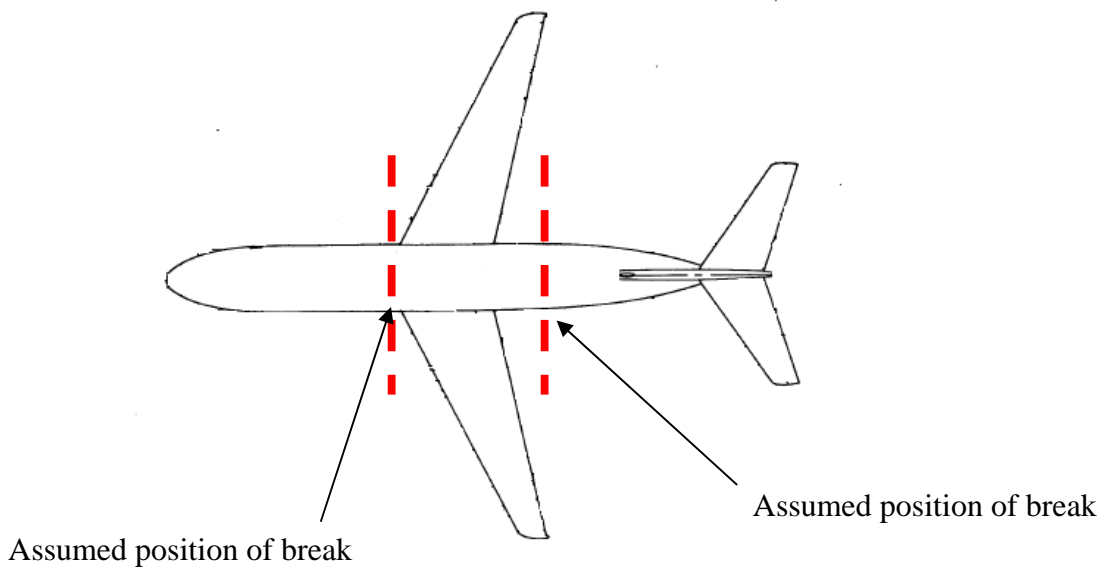
Occupant Egress & Fire Entry

The accident report also states that two flight attendants evacuated through a break near the ventral stairs. However it is considered that this break is the one that occurred near the wing trailing edge (the empennage on this aircraft is relatively close to the wing trailing edge)
