**DOT/FAA/TC-14/24**

# **Thermal Acoustic Insulation Contamination Research**

September 2014

Final Report

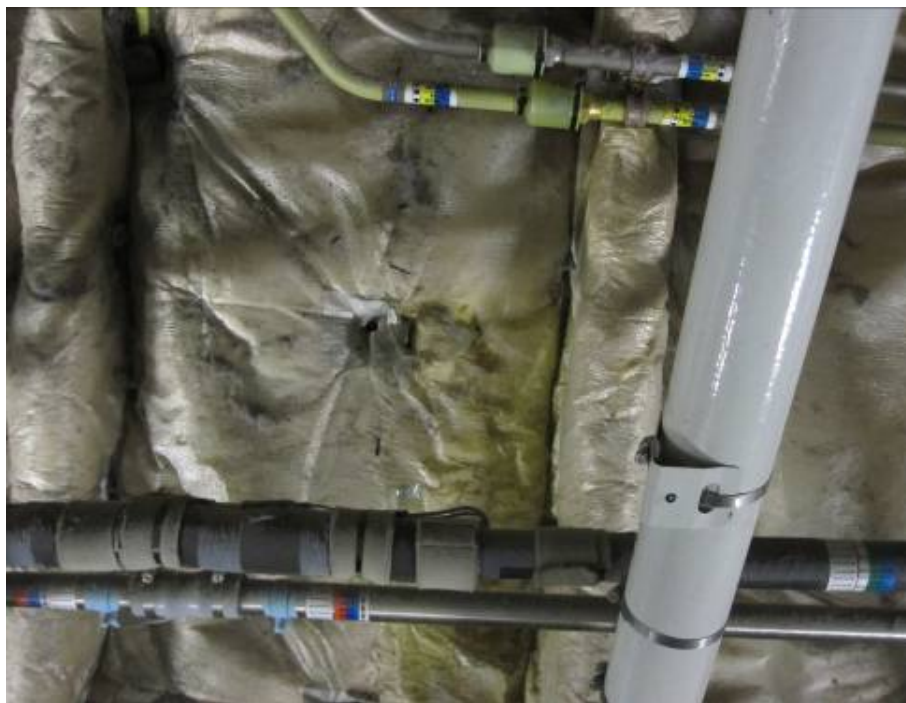
A TAI blanket heavily contaminated with hydraulic fluid was extracted from an in-service airplane - see figure 9.

Figure 9. TAI Contaminated with Hydraulic Fluid

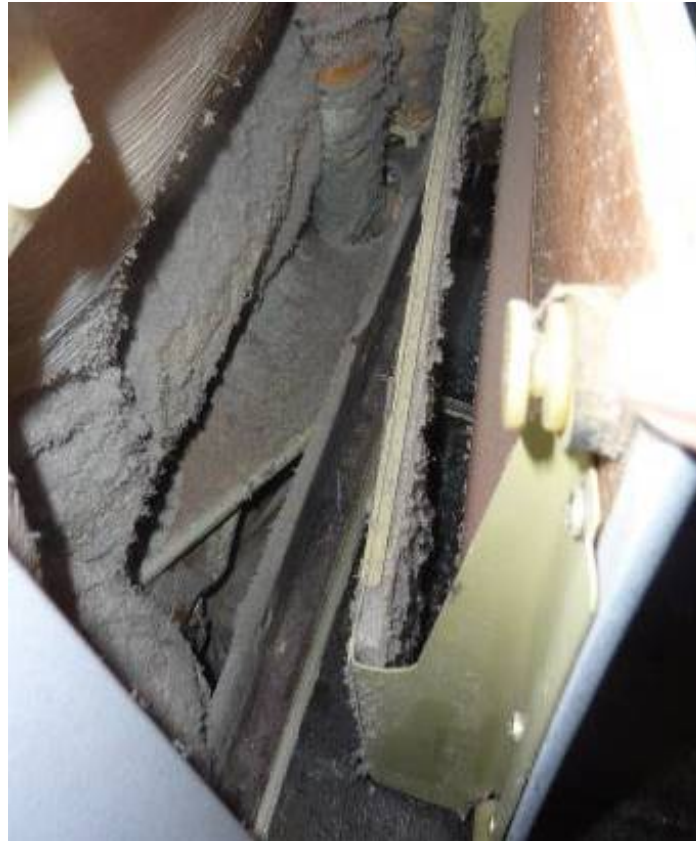
In all surveys, the heaviest deposits of dust and lint were located on thermal acoustic insulation and EWIS behind the dado panels<sup>7</sup> just above the cabin floor close to the cabin return air grills. There were variations in the level of contamination along the length of the cabin. Figure 10 shows a typical dado panel installation with dust and lint concentrated on the thermal acoustic insulation surface behind the panel in a location that corresponds to the path of the cabin return air flow. Thermal acoustic insulation and EWIS located further above the air return grills were free from dust and lint contamination.

Figure 10. Dust and Lint Deposits Behind Dado Panel

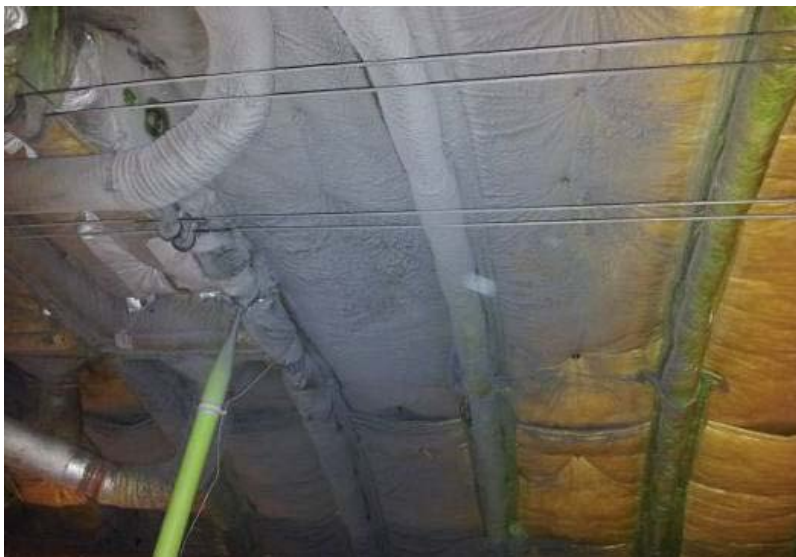
However, on one airplane type the cabin air supply system included air recirculation outlets in the attic area above the cabin ceiling. Dust and lint had been ejected from the outlets on to the surface of the thermal acoustic insulation, EWIS, and system control cables as illustrated in figure 12.

Figure 12. Dust and Lint Above Cabin Ceiling Ejected From Air Recirculation Outlet

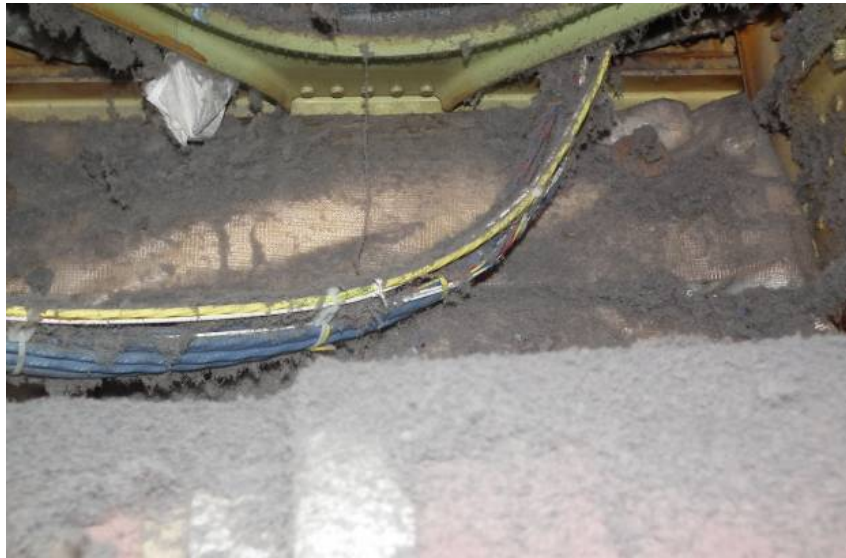
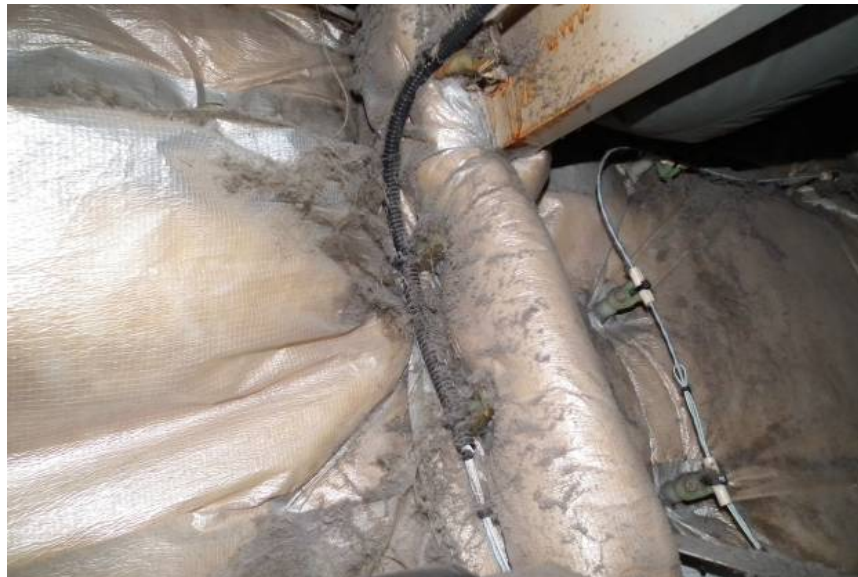
Significant accumulations of dust and lint were also visible on thermal acoustic insulation and EWIS immediately below the cabin floor in the fuselage cheek hidden areas located behind the cargo bay lining panels. The contamination level in these areas was visibly no greater than above the cabin floor. Again, the contamination level varied along the length of the fuselage. Typical accumulations are illustrated in figure 13 and figure 14.

Figure 13. Dust and Lint Accumulation Below Cabin Floor

Figure 14. Dust and Lint Accumulation Below Cabin Floor

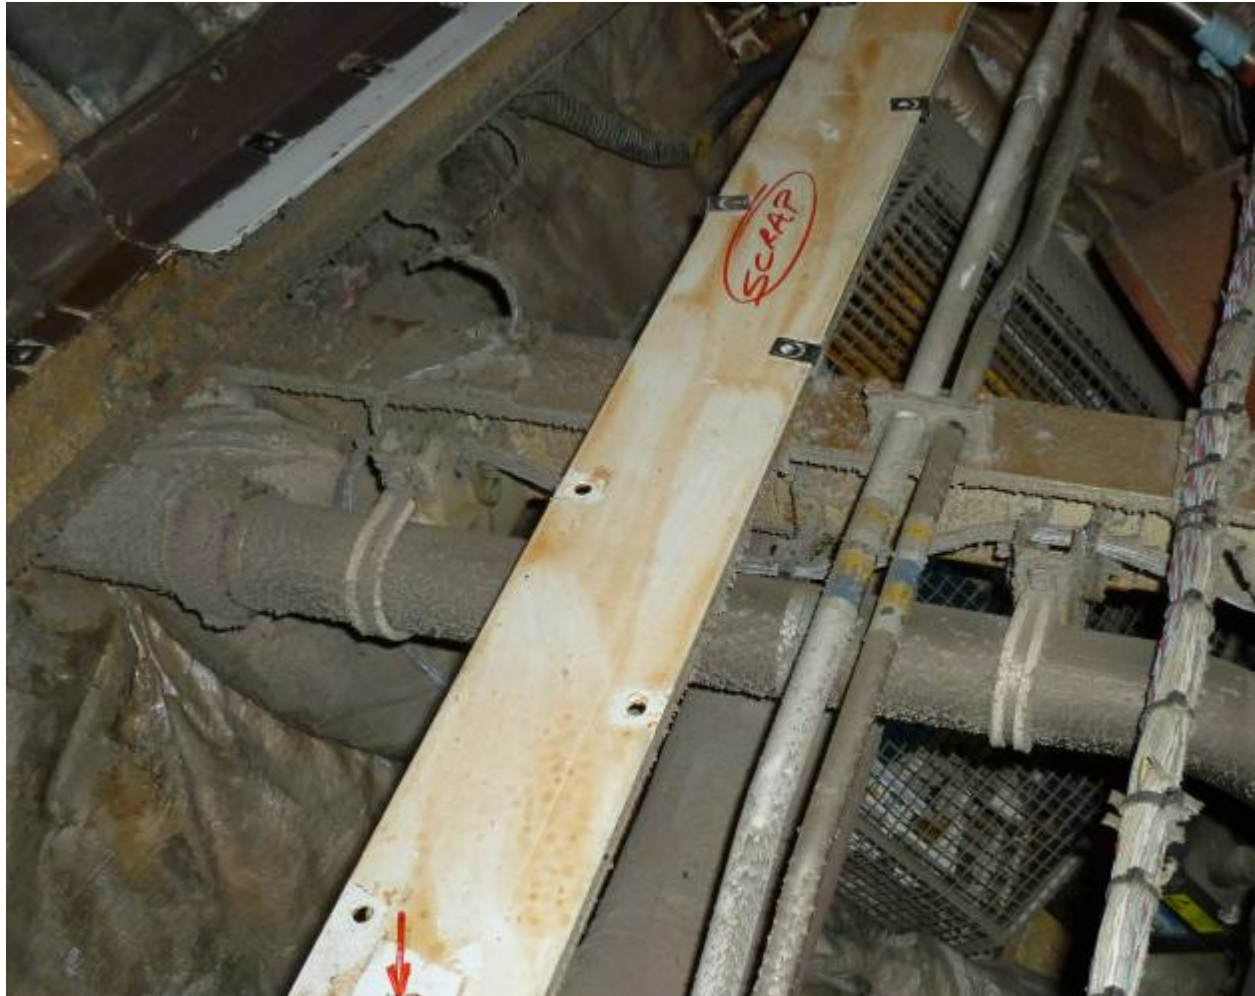
Accumulations of dust and lint in the proximity of the cabin air outflow valve (figure 15) and recirculation system inlets (figure 16) covered TAI and EWIS over a wider area than other areas beneath the cabin floor. In the other areas, any significant dust and lint accumulations were typically localized just beneath the cabin floor. However, the thicknesses of the accumulations near the cabin air outflow valve and recirculation system inlet were no greater than in any other areas.

Figure 15. Significant Accumulations of Dust and Lint on TAI, EWIS, and Structure Near to Cabin Air Outflow Valve (Outflow valve is located behind mesh guard)

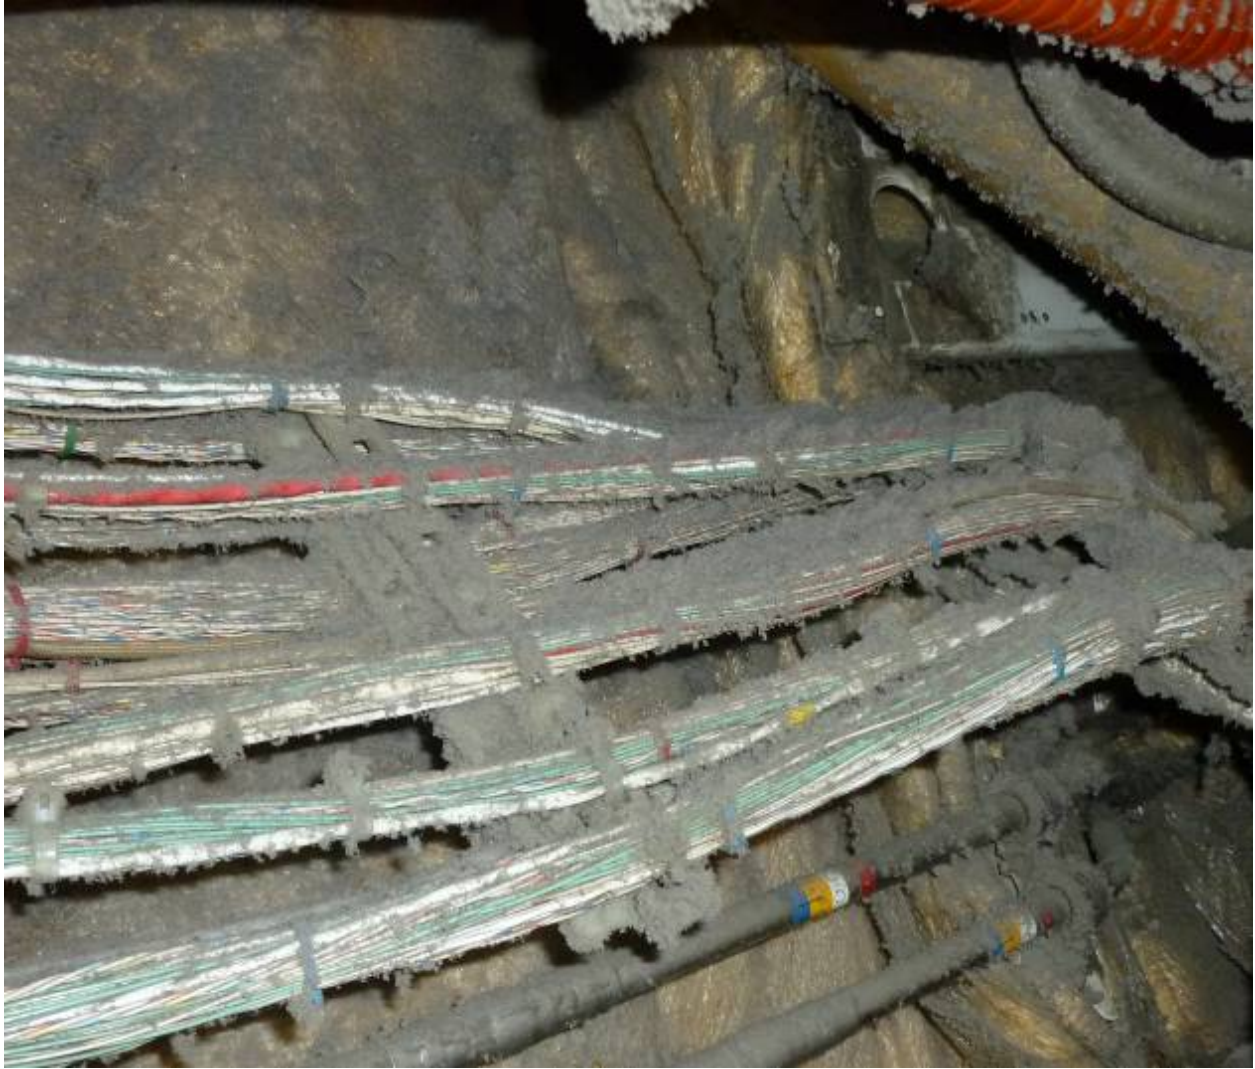
Figure 16. Significant accumulations of Dust and Lint on TAI and EWIS Near to Cabin Air Recirculation Inlet in the Under-Floor Cheek Area

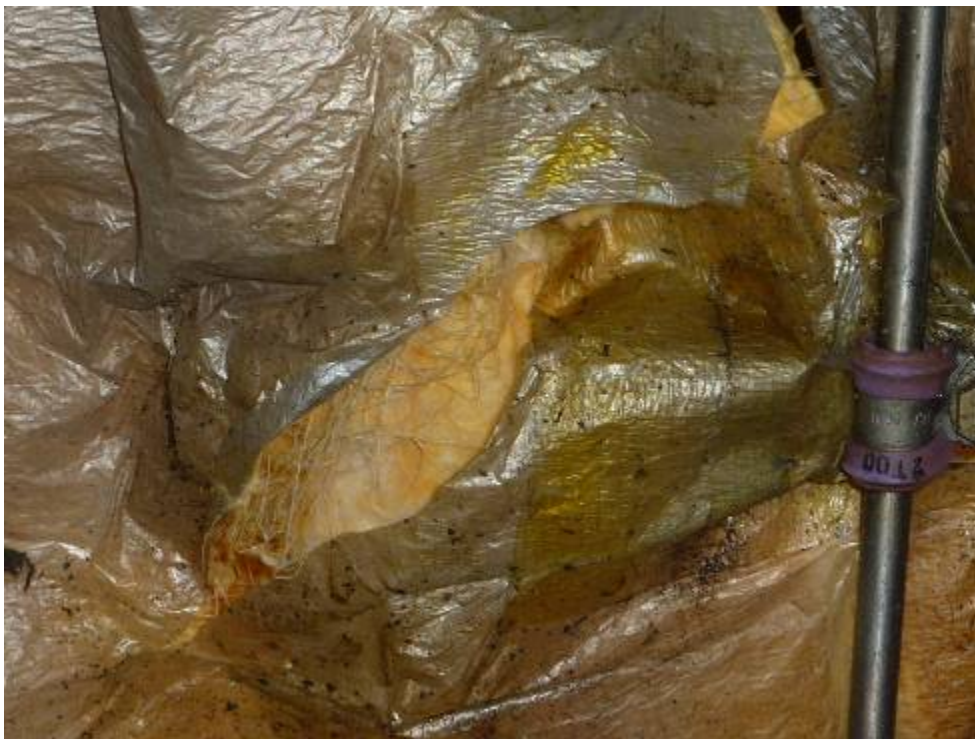
During the survey of fourteen airplanes, hydraulic fluid contamination of thermal acoustic insulation was found on one airplane. Figure 18 shows the hydraulic fluid contamination on the TAI lining. The thermal acoustic insulation bagging film was locally damaged, but hydraulic fluid had not permeated into the fiberglass on this occasion. It was not possible to confirm that the TAI damage was a consequence of the hydraulic fluid leak.

Figure 18. Hydraulic Fluid Leakage and Damaged TAI

- Recommendation 3: Hydraulic Fluids: Maintenance personnel should be provided with guidance advising of the significance of damaged thermal acoustic insulation bagging film materials, in zones which may contain hydraulic fluids, and the necessity for repair or replacement at the earliest opportunity. 68

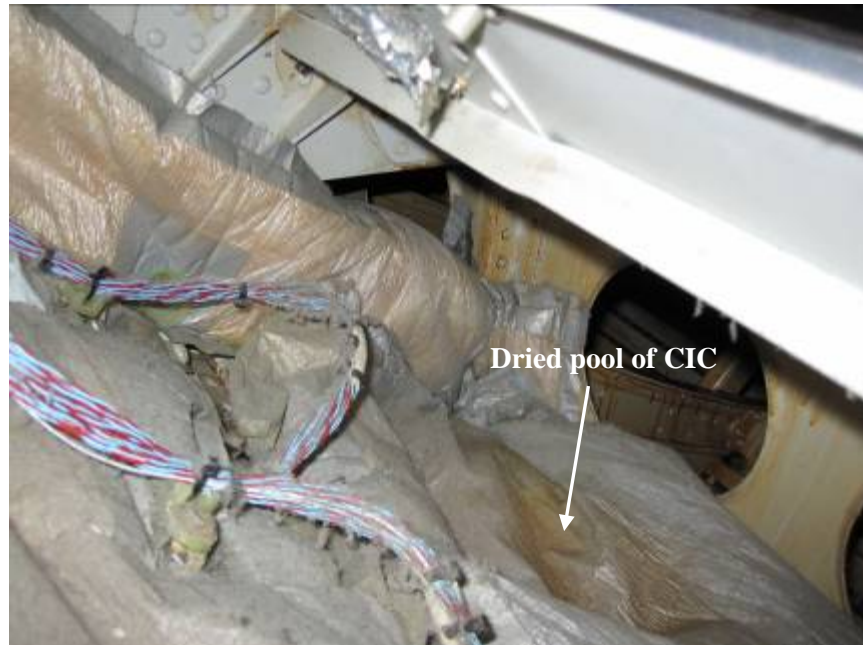
No evidence of any significant CIC contamination was found on any of the fourteen airplanes surveyed. Any small amounts are likely to have been obscured by general dirt on the surface of the thermal acoustic insulation. However, a localized area of CIC contamination was noted on a single airplane survey carried out in the early part of this study. This is shown in figure 19.

Figure 19. Localized Area of CIC Contamination on TAI

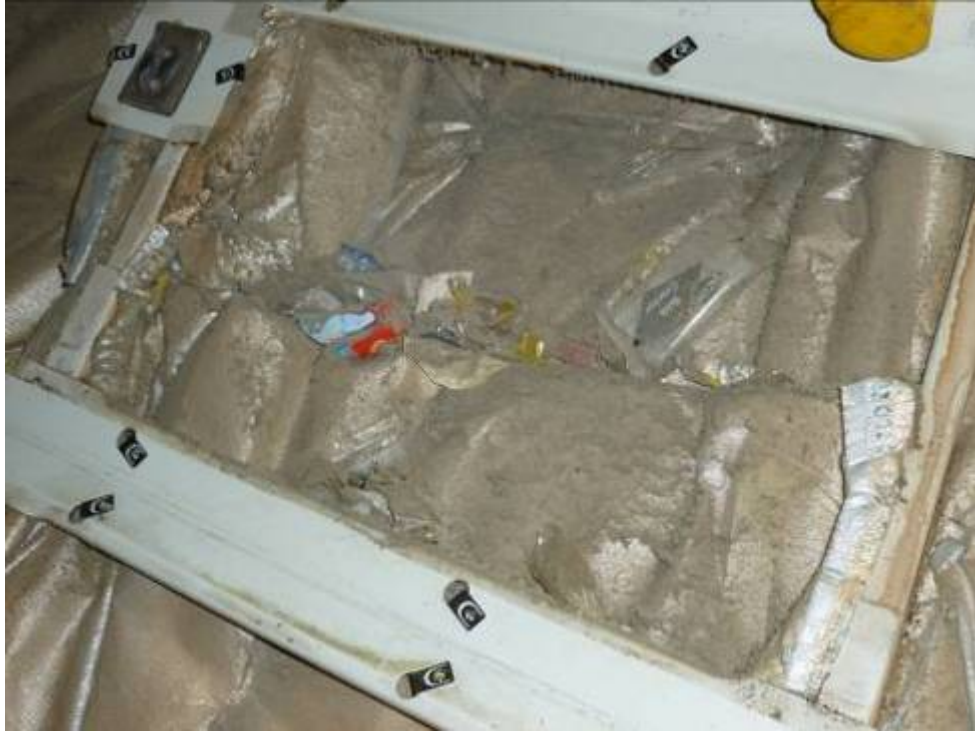
On one survey, food wrappers were found lying on thermal acoustic insulation located behind cargo bay liners below the rear galley as shown in figure 20. It is likely that the wrappers had dropped down from a waste container in the galley above.

Figure 20. Food Wrappers Lying on TAI

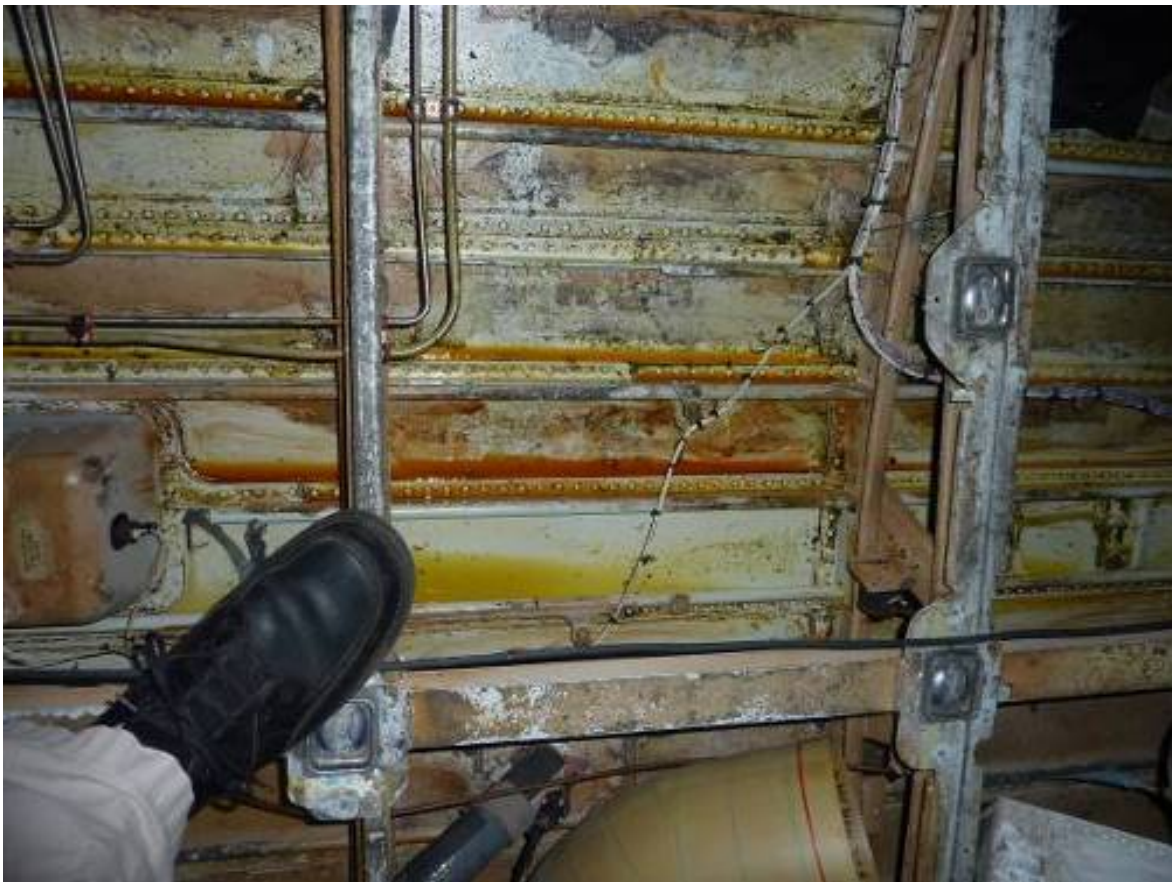
However, if the liquid were to be flammable, it might contribute to an already established fire. It is understood from the airplane maintainer that further occurrences of identical contamination have been observed on other examples of the airplane type.

Figure 21. Pools of CIC Dissolved by Hydraulic Fluid in Keel Structure

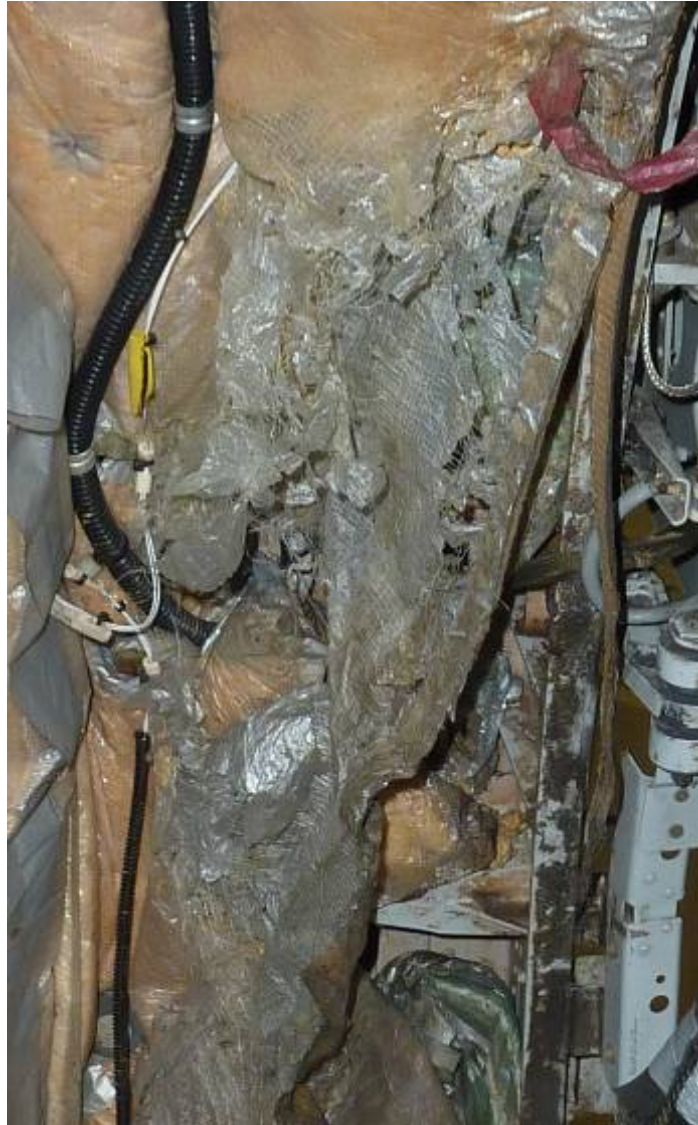
Two examples of severe moisture degradation of thermal acoustic insulation were observed. Both were in 'wet' areas prone to condensation. One example was observed on thermal acoustic insulation installed adjacent to a passenger door surround (figure 22) and the other was observed on TAI within the fuselage keel (figure 23).

Figure 22. Degraded TAI in 'Wet' Area Near Passenger Door Surround

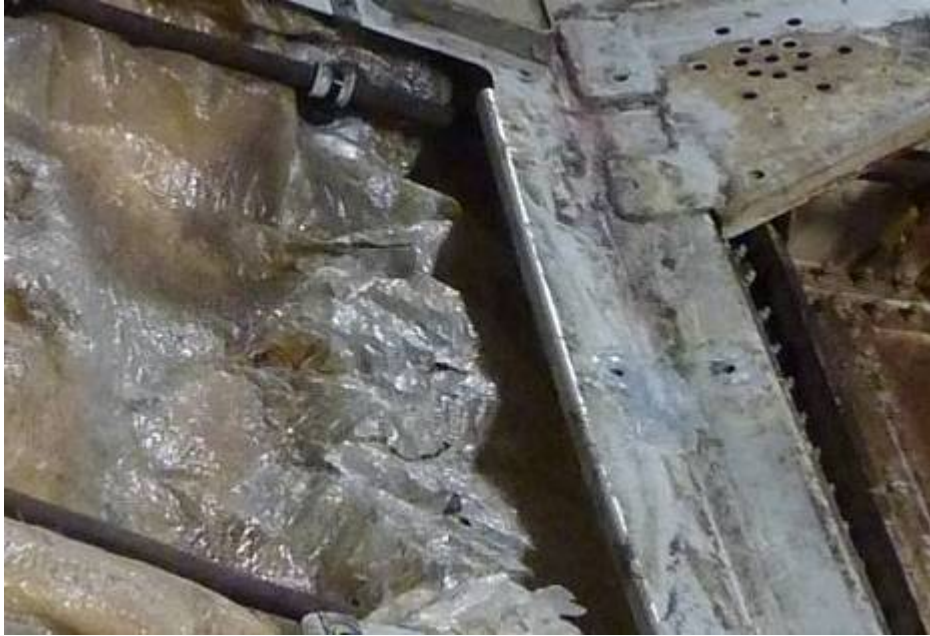
Figure 23. Degraded TAI in 'Wet' Area in Fuselage Keel

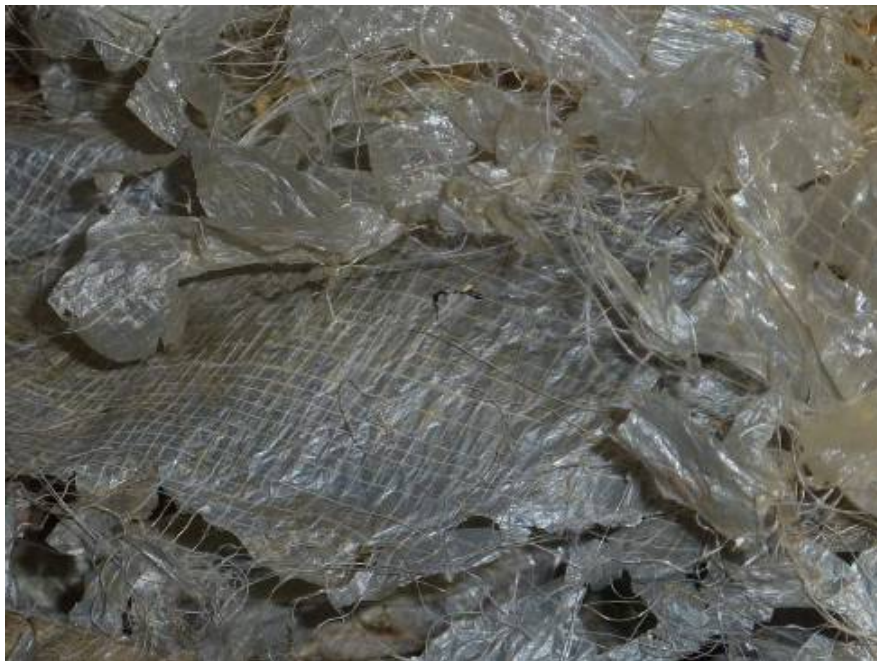
It is likely that where degradation exists to the extent observed, the flammability properties of the thermal acoustic insulation might also be significantly degraded. The thermal acoustic insulation reinforcing scrim, when exposed as shown in figure 24, could potentially be ignitable and propagate a fire.

Figure 24. Exposed Reinforcing Scrim on Degraded TAI

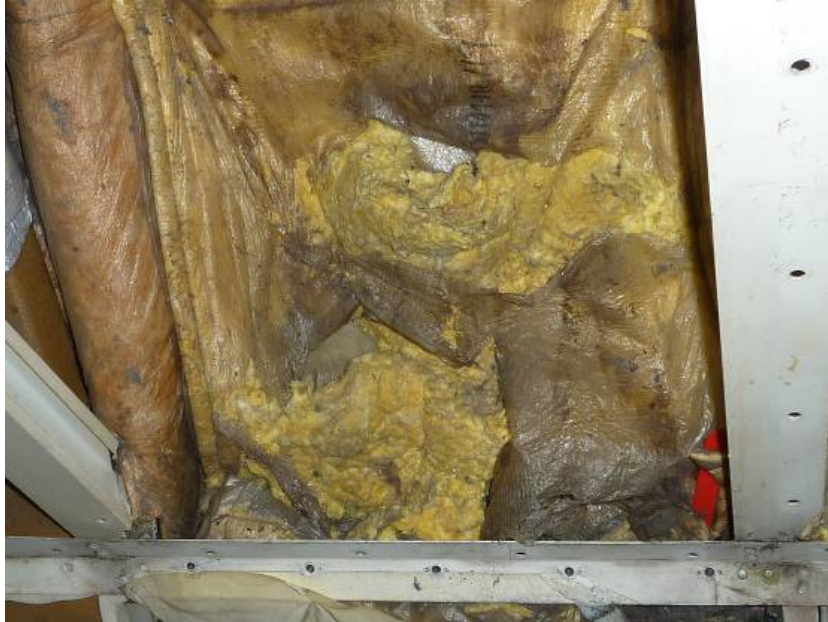
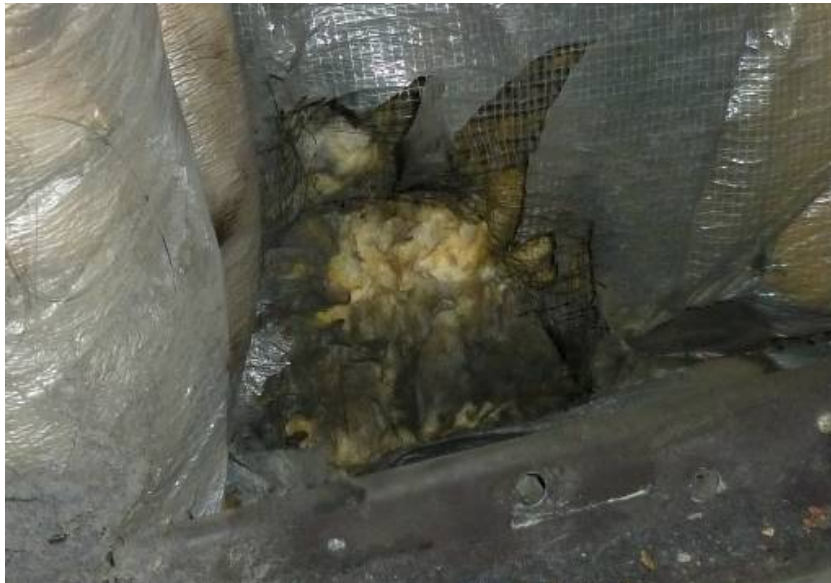
Several occurrences of thermal scoustic insulation degradation with unidentifiable causes were observed. These are shown in figure 25 and figure 26. The flammability properties of the degraded thermal acoustic insulation are unknown.

Figure 25. Degraded TAI

Figure 26. Degraded TAI

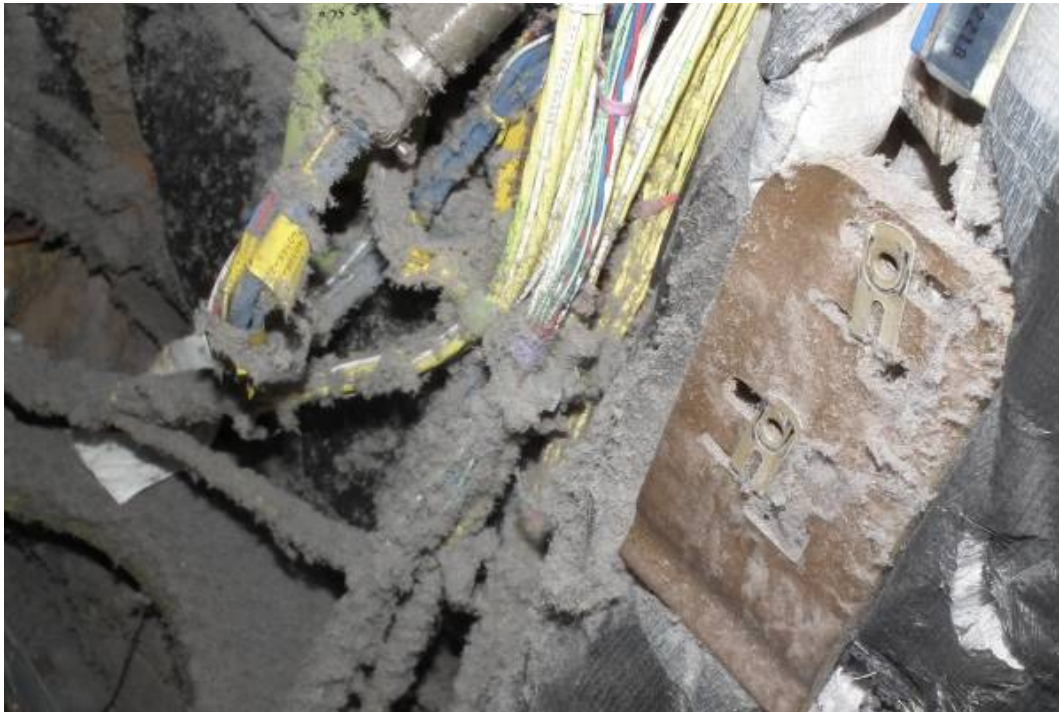
Many examples of EWIS heavily contaminated with dust and lint were observed during the surveys. Moreover, as illustrated in figure 32, many examples were observed where contaminated EWIS was adjacent to or resting on contaminated TAI. This situation could be regarded as a worst case flammability threat, because not only is there a potential risk of ignition from the contaminated EWIS, there is also a risk of fire propagation across the contaminated thermal acoustic insulation<sup>9</sup>.

Figure 32. Dust and Lint Contaminated EWIS and TAI

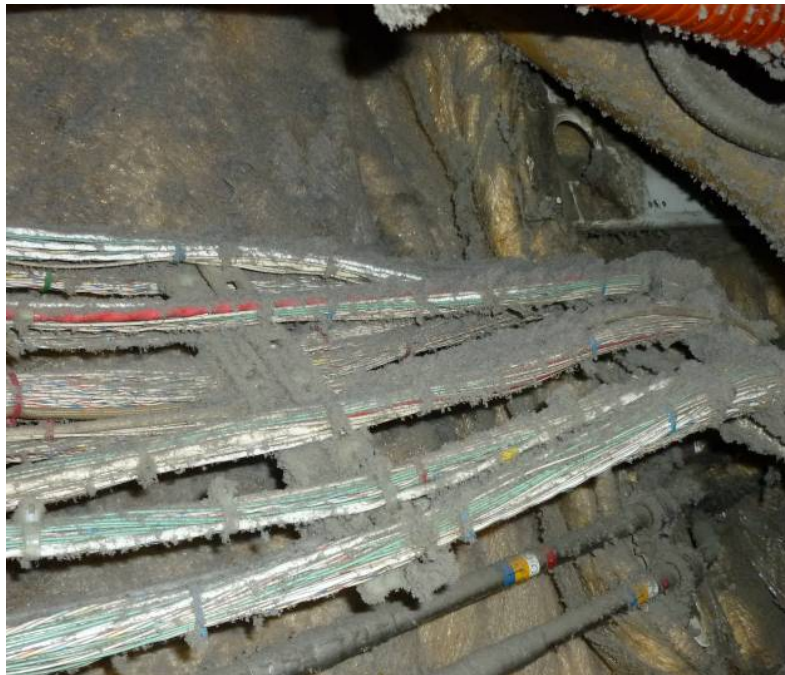
Figure 37 illustrates the levels of dust and lint contamination of thermal acoustic insulation and EWIS that may be experienced on in-service airplanes.

Figure 37. Significant Accumulations of Dust and Lint on TAI and EWIS Near to Cabin Air Recirculation Inlet in the Under-Floor Cheek Area

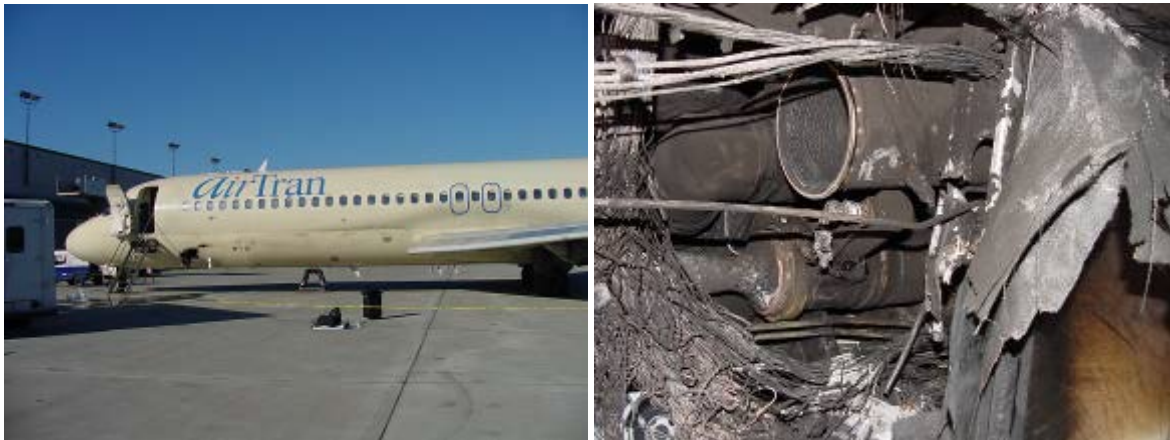
Figure A-2. Atlanta, 29-Nov-00

Examination of the airplane revealed fire damage to an area of the left fuselage below and aft of the forward passenger entry door, and to the adjacent forward cargo and main cabin floor areas. Wiring, ducts, and hydraulic lines located in this area were also burned.

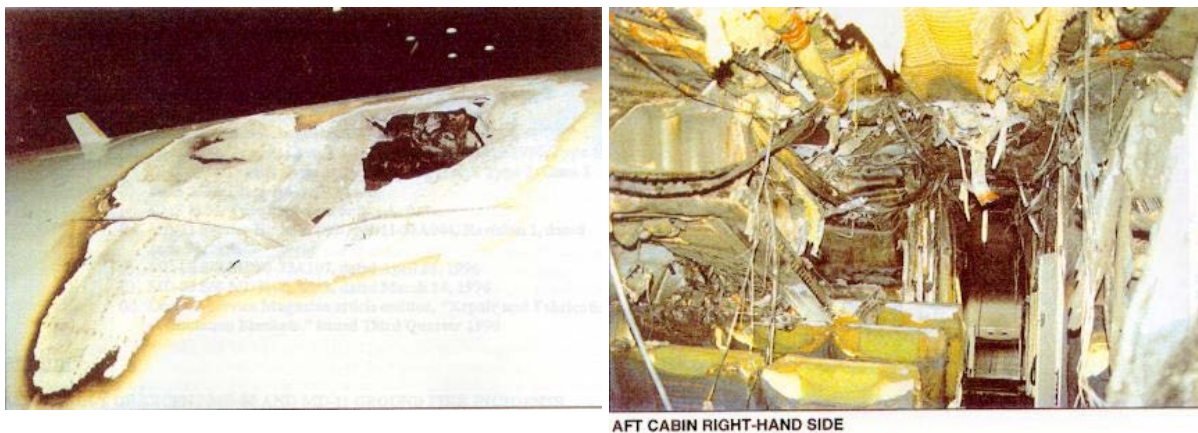
Figure A-3. Copenhagen 24-Nov-93

The seats in row 21 to 23 were severely heat damaged as they had been exposed not only to heat but also to hot/burning debris falling on them. The right-hand stowage closet and the right-hand galley, which had been exposed to direct fire and very high temperatures, exhibited severe heat deformation mainly around the upper and outboard parts of the units.

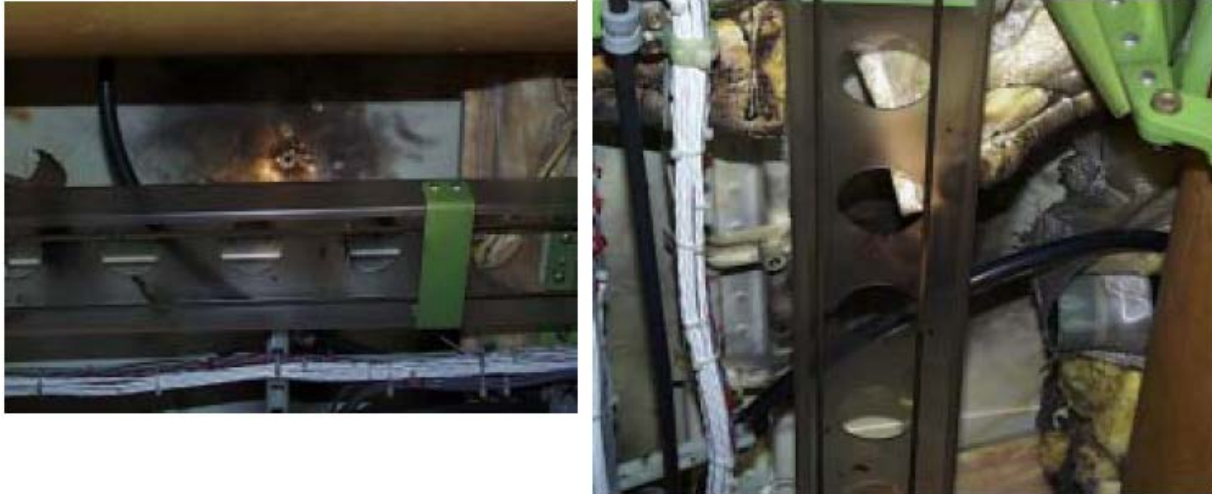
Figure B-1. Copenhagen 15-Nov-00

This incident shows that the energy in this lightning was adequate to penetrate the fuselage skin. The heat from the penetration was sufficient to cause a singeing of the insulation blanket and smoke was developed in the cabin. The damage caused by this lightning strike indicates that the energy in the lightning was higher than normally encountered.

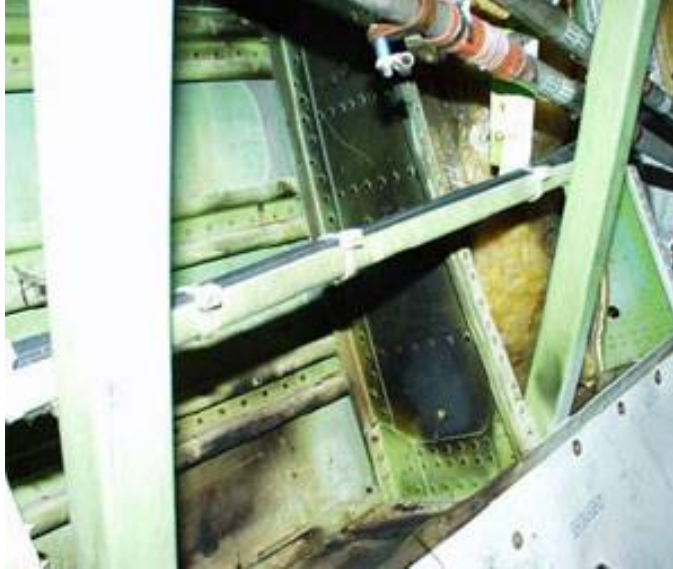
Figure B-4. Sydney 10-Aug-02

The fiberglass sidewall lining between STA880 to STA900 was visibly heat damaged with discoloration observed on the side facing into the cargo compartment. Inspection of the reverse side revealed burned layers of fiberglass confined to a localized area approximately 30 cm x 45 cm. The insulation blankets that lined the aircraft skin were made of a fiberglass core with a metallized Tedlar™ film on one side and a Mylar™ film on the other and had been subjected to localized heat and fire.
