DOT/FAA/CT-83/10

Evaluation of an Improved Flame Resistant Aircraft Window System

Final Report
May 1984

US Department of Transportation
Federal Aviation Administration
Technical Center
Atlantic City Airport, N.J. 08405

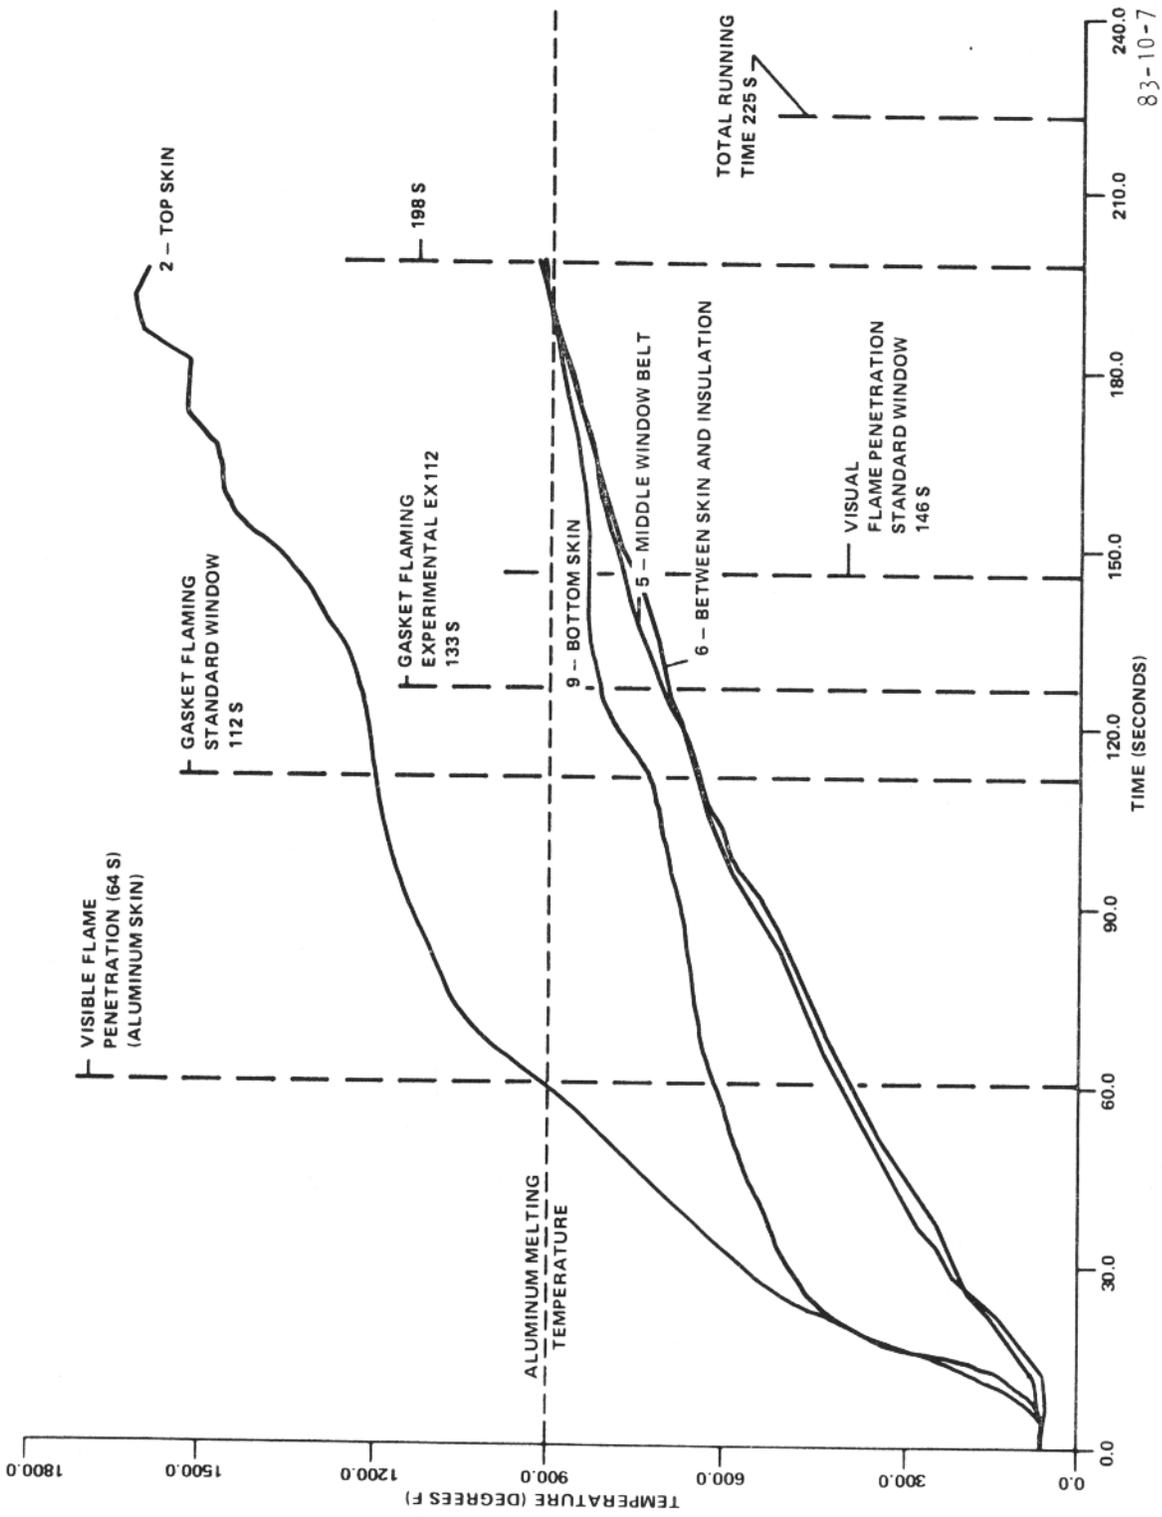
FIGURE 7. TEMPERATURE RISE OF THE DC-10 SKIN, BELT AND THE INTERFACE BETWEEN THE INTERIOR PANEL AND INSULATION BATT (TEST 1)

RESULTS: The temperature rise of the DC-10 fuselage segment during fire exposure in test 1 is indicated by the profiles presented in figure 7 for the aluminum skin and belt areas. These data show that the aluminum skin above the windows started to melt in 64 seconds (1.07 minutes) which was confirmed by an analysis of the photographic coverage. However, the skin below the windows and belt area did not reach the incipient melting temperature for aluminum of 900° F until 198 seconds (3.3 minutes) after fuel ignition. The fire damage to the skin above the improved (EX 112) window system is shown in figure 8 and above the acrylic window in figure 9. A more detailed interior view of the failure mode of the fuselage skin in these areas is presented in figure 10. An overall exterior view of the fire damage sustained by the DC-10 fuselage segment is presented in figure 11.

The sequence in which the fuselage components failed in this first test is considered noteworthy. The data in figure 7 shows that the aluminum skin (0.090 inch thick) above the belt was the first element to fail (64 seconds or 1.1 minutes), followed by the pyrolysis of the silicone rubber gaskets in 112 seconds (1.9 minutes) for the standard acrylic window and in 133 seconds (2.2 minutes) for the improved (EX 112) window, which was followed by visual flame penetration through the standard acrylic window in 146 seconds (2.4 minutes). The bottom fuselage skin, belt (0.350-inch thick) and the thermocouple between the fuselage skin and Kaowool insulation all reached the incipient melting temperature of aluminum (900° F) in 198 seconds (3.3 minutes). Only minor flame penetration was observed through several narrow cracks in the experimental EX 112 fail-safe pane over the duration of the test which was 225 seconds (3.75 minutes). Therefore, the desirability of increasing the thermal resistivity of the aircraft windows to flame penetration from an adjacent fuel fire to maintain fuselage integrity is apparent.

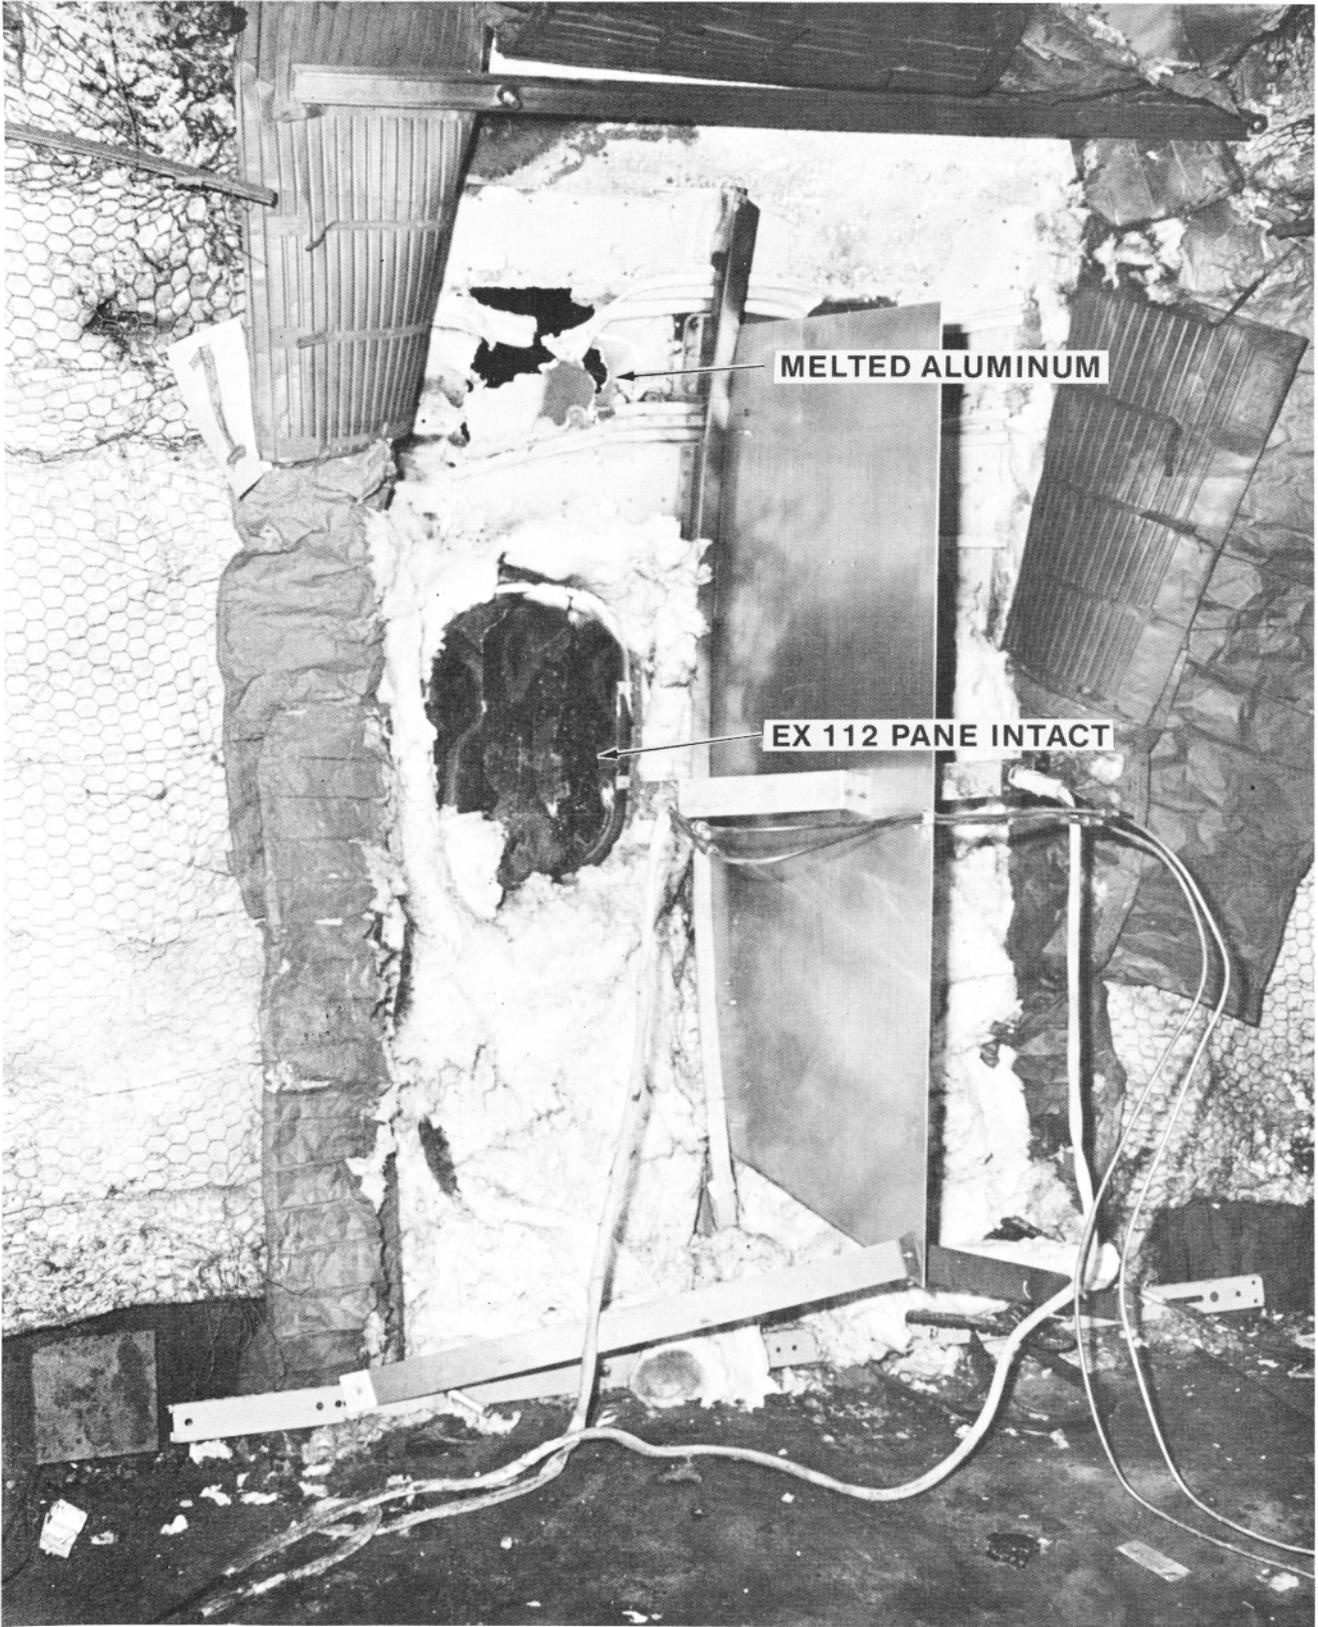
FIGURE 8. FIRE DAMAGE TO THE THERMALLY IMPROVED DC-10 WINDOW SYSTEM SHOWING THE FAIL-SAFE (EX 112) PANE IN PLACE (TEST 1)

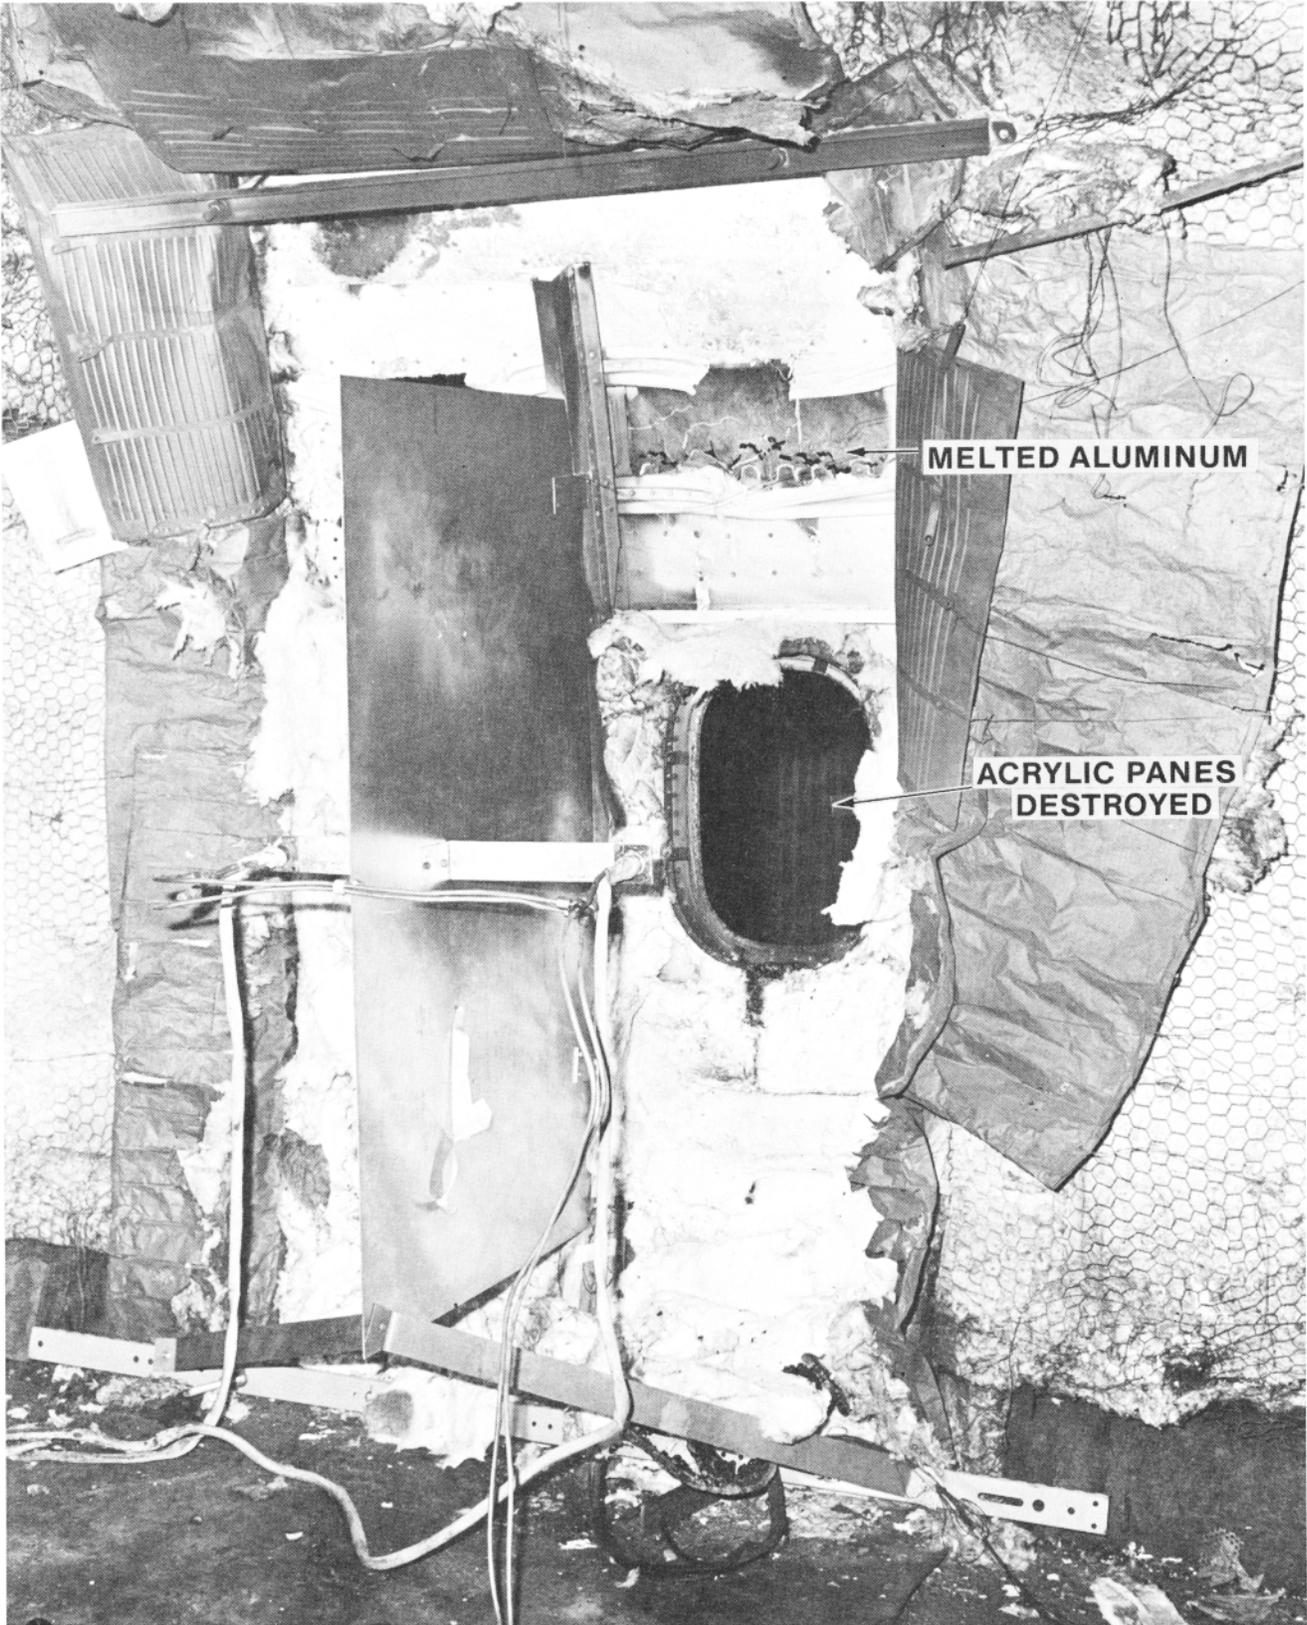
FIGURE 9. FIRE DAMAGE TO THE STANDARD DC-10 WINDOW SYSTEM SHOWING THE COMPLETE DESTRUCTION OF THE ACRYLIC WINDOW PANES (TEST 1)

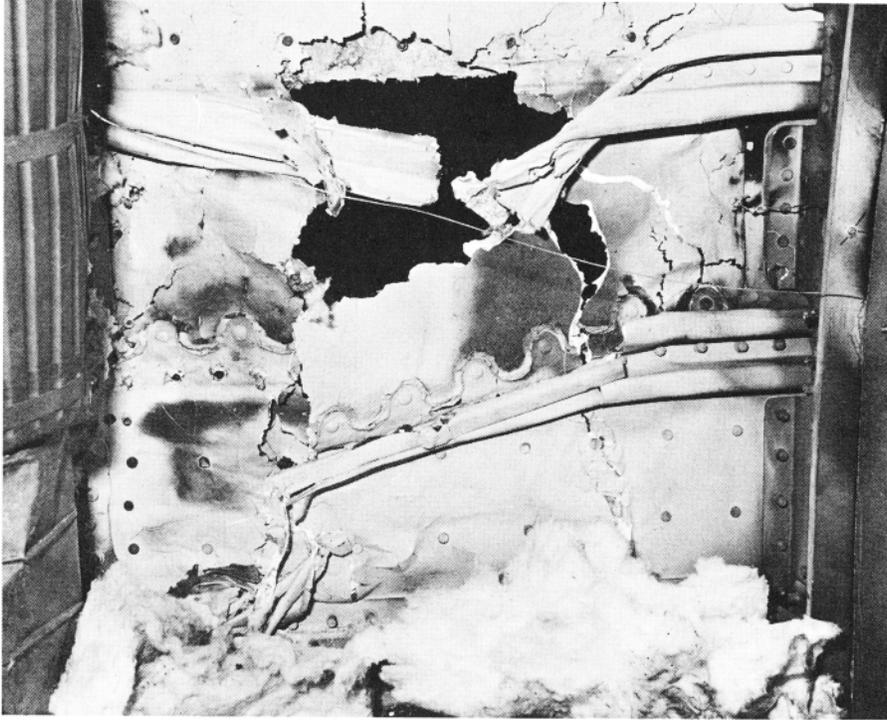
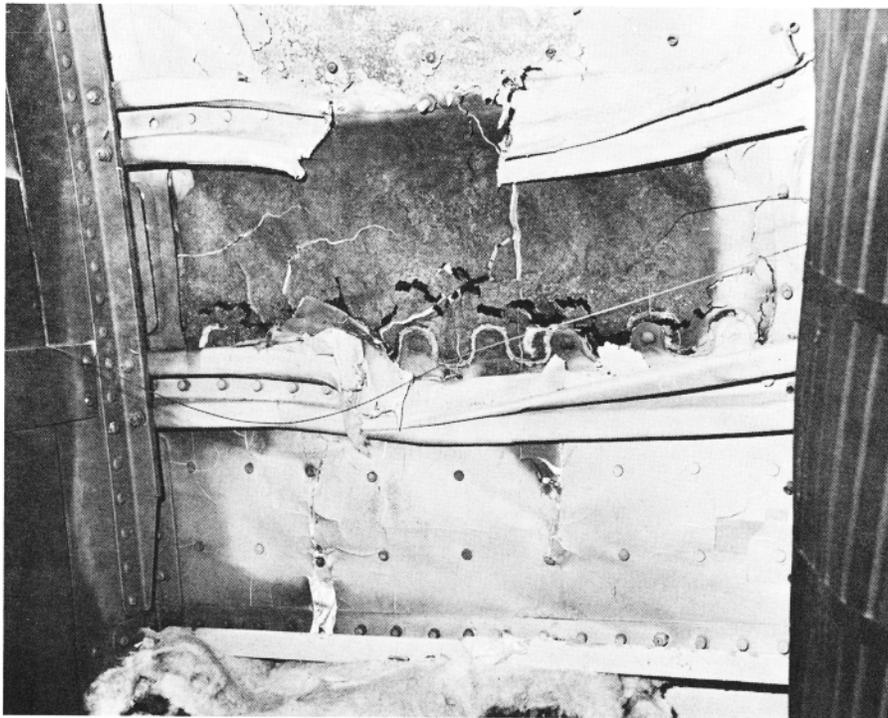
(a) Thermally Improved (EX 112) Window System

(b) Standard Acrylic Window System

FIGURE 10. ALUMINUM SKIN FAILURE (MELTING) MODES ABOVE THE AIRCRAFT WINDOWS

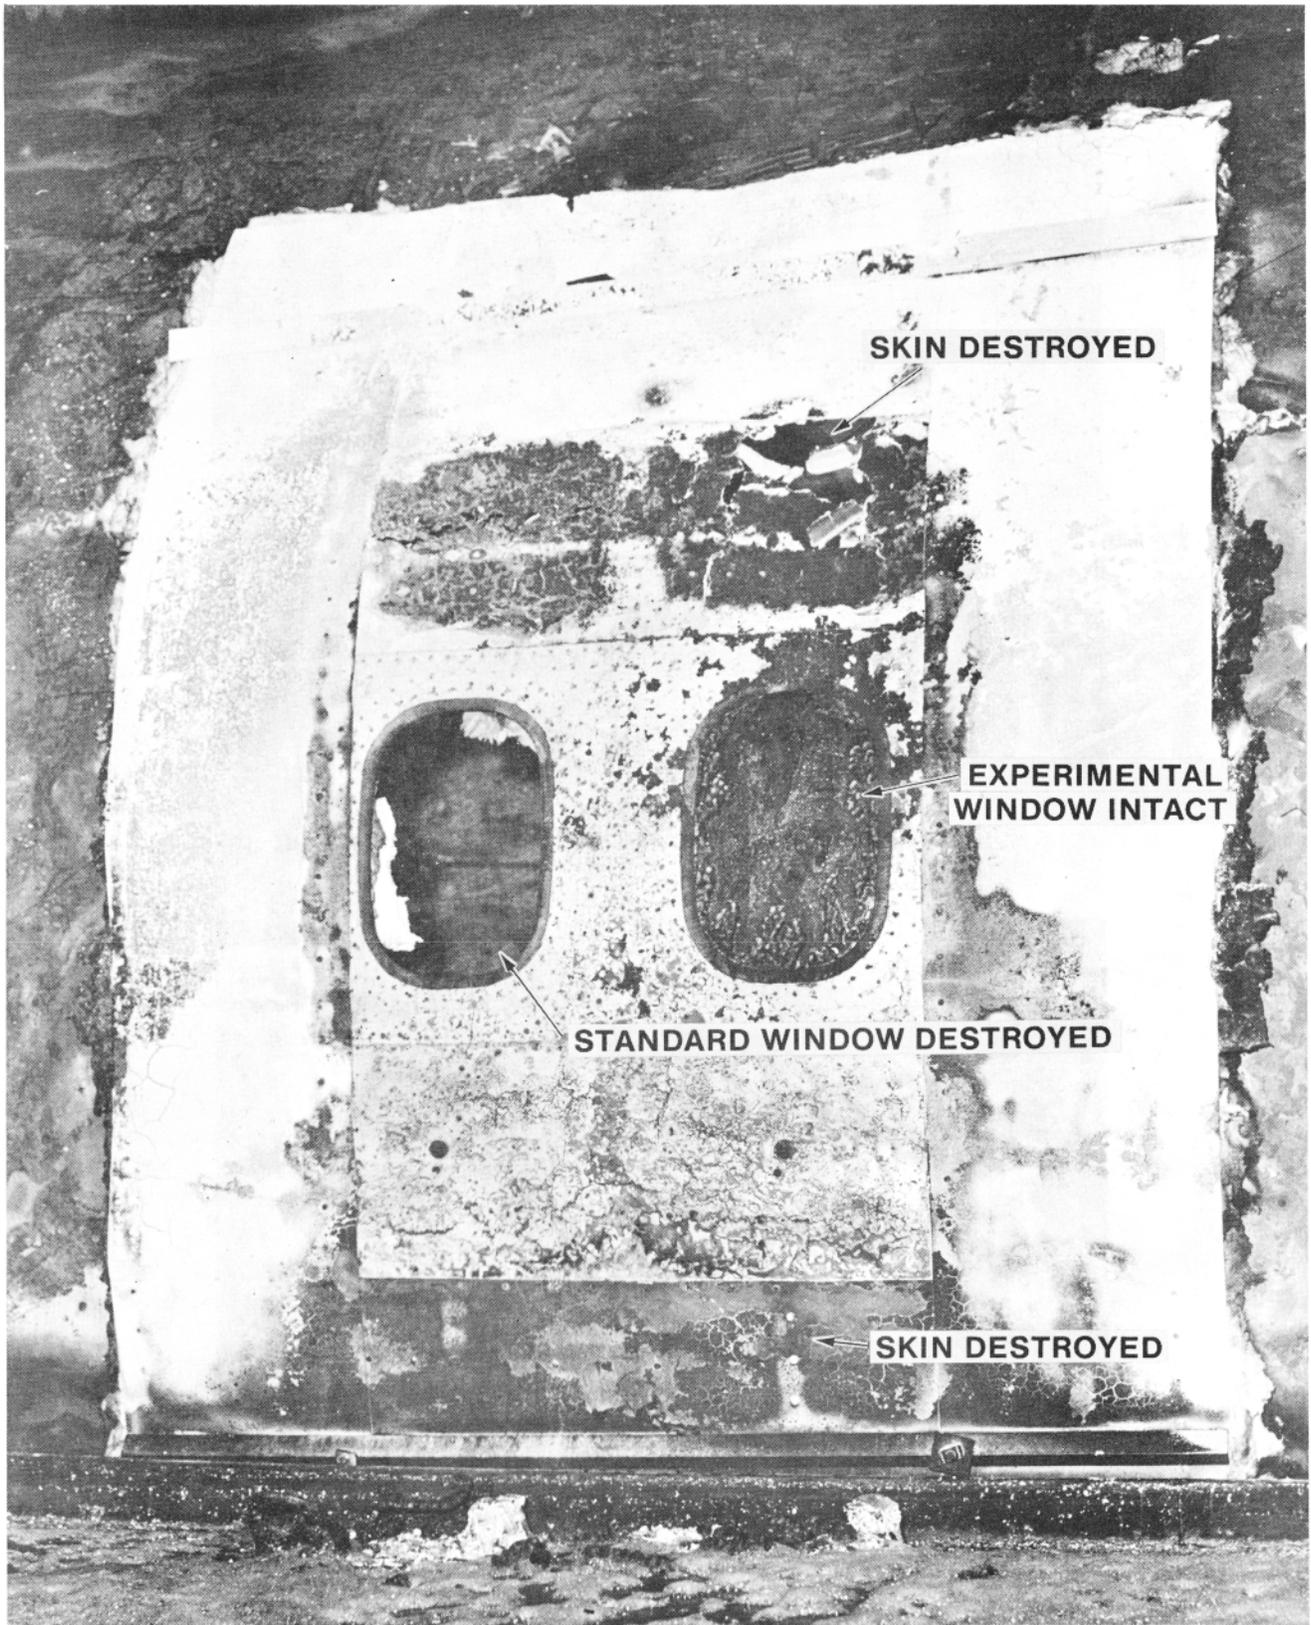
FIGURE 11. EXTERNAL FIRE DAMAGE TO THE DC-10 WINDOW SYSTEMS (TEST 1)

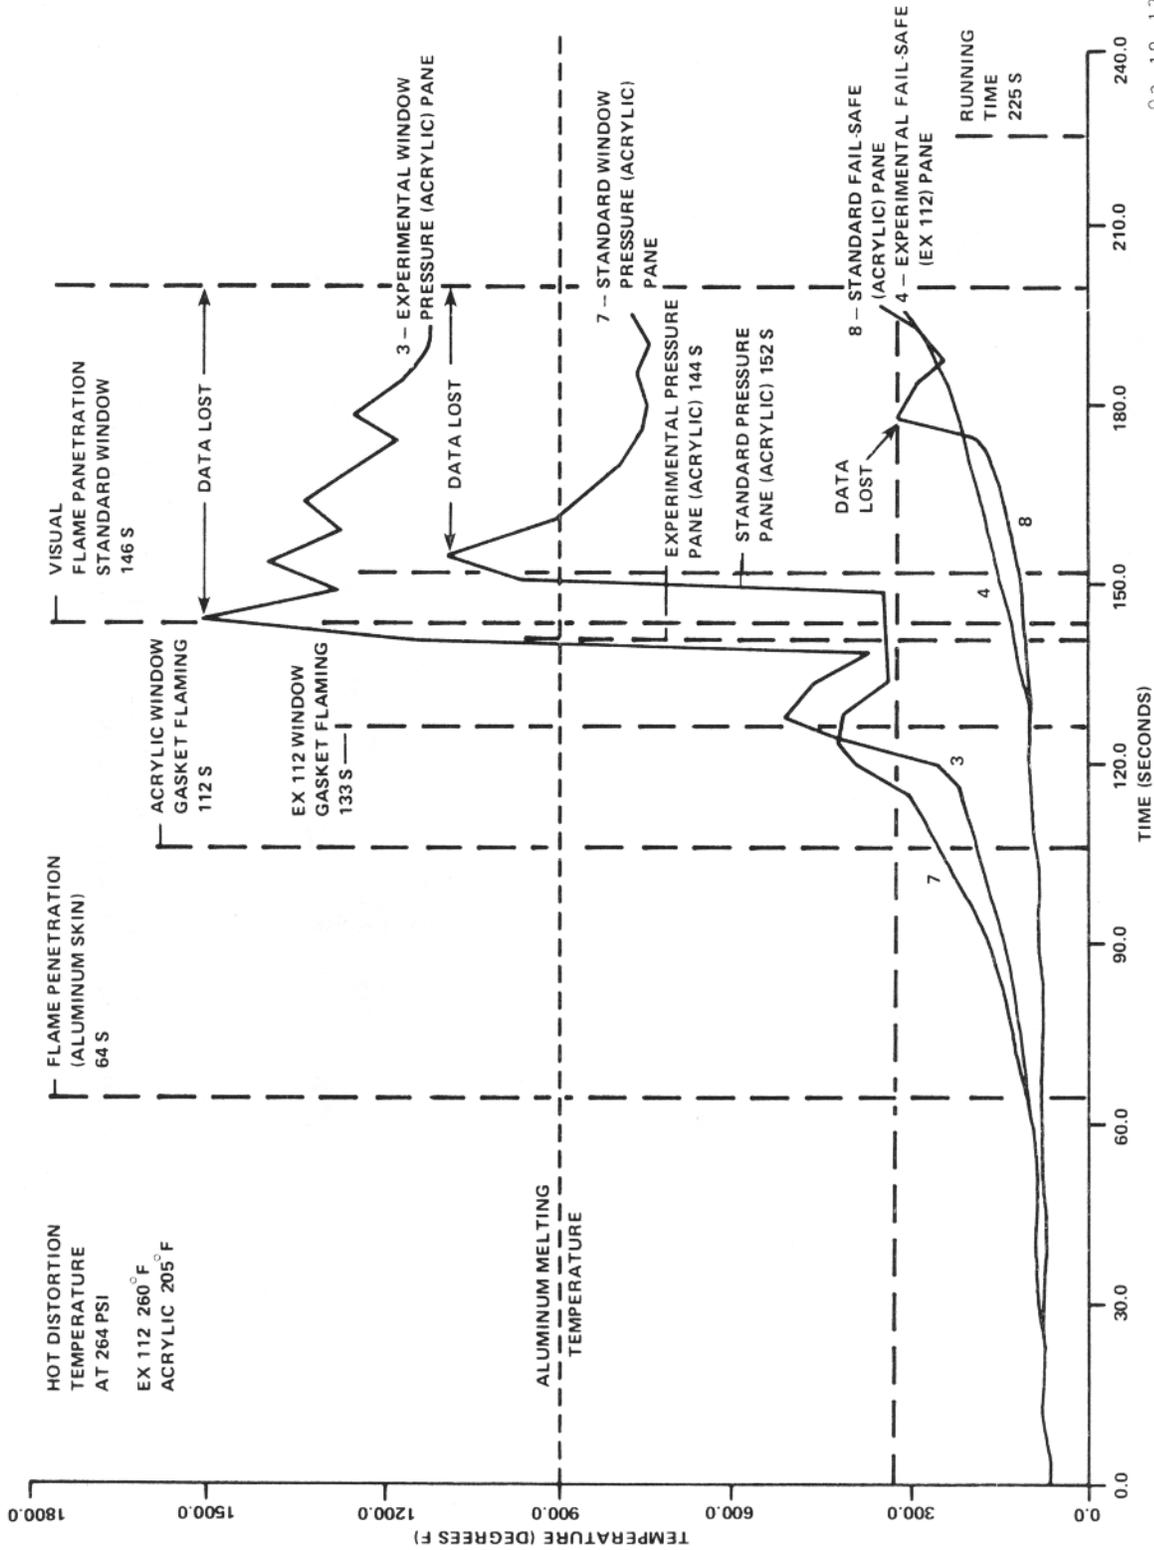
The temperature data obtained from the thermocouples embedded in the pressure and fail-safe window panes for both the experimental (EX 112) and standard (acrylic) window systems are presented in figure 13. The profiles numbered 3 and 7 show that the temperature rise of the pressure panes on the experimental and standard window systems reached 900° F in 144 seconds (2.4 minutes) and 152 seconds (2.5 minutes), respectively. The temperature profiles obtained for the experimental (EX 112) and standard acrylic fail-safe panes show that the EX 112 pane reached approximately 314° F in 199 seconds (3.3 minutes) and that the temperature data for the acrylic pane was lost. Additional data superimposed on the time temperature profiles in figure 13 show that the first visual flame penetration through the standard acrylic window system occurred in 146 seconds (2.4 minutes) after fuel ignition. While only very minor flame intrusion was observed through several small cracks in the EX 112 fail-safe pane (figure 14) after 225 seconds (3.75 minutes), which was the duration time of the test. The condition of the standard acrylic and experimental EX 112 fail-safe panes with their respective silicone rubber gaskets are shown in figure 15.

FIGURE 13. TEMPERATURE RISE OF THE STANDARD (ACRYLIC) AND THERMALLY IMPROVED (EX 112) WINDOW SYSTEMS DURING FIRE EXPOSURE (TEST 1)

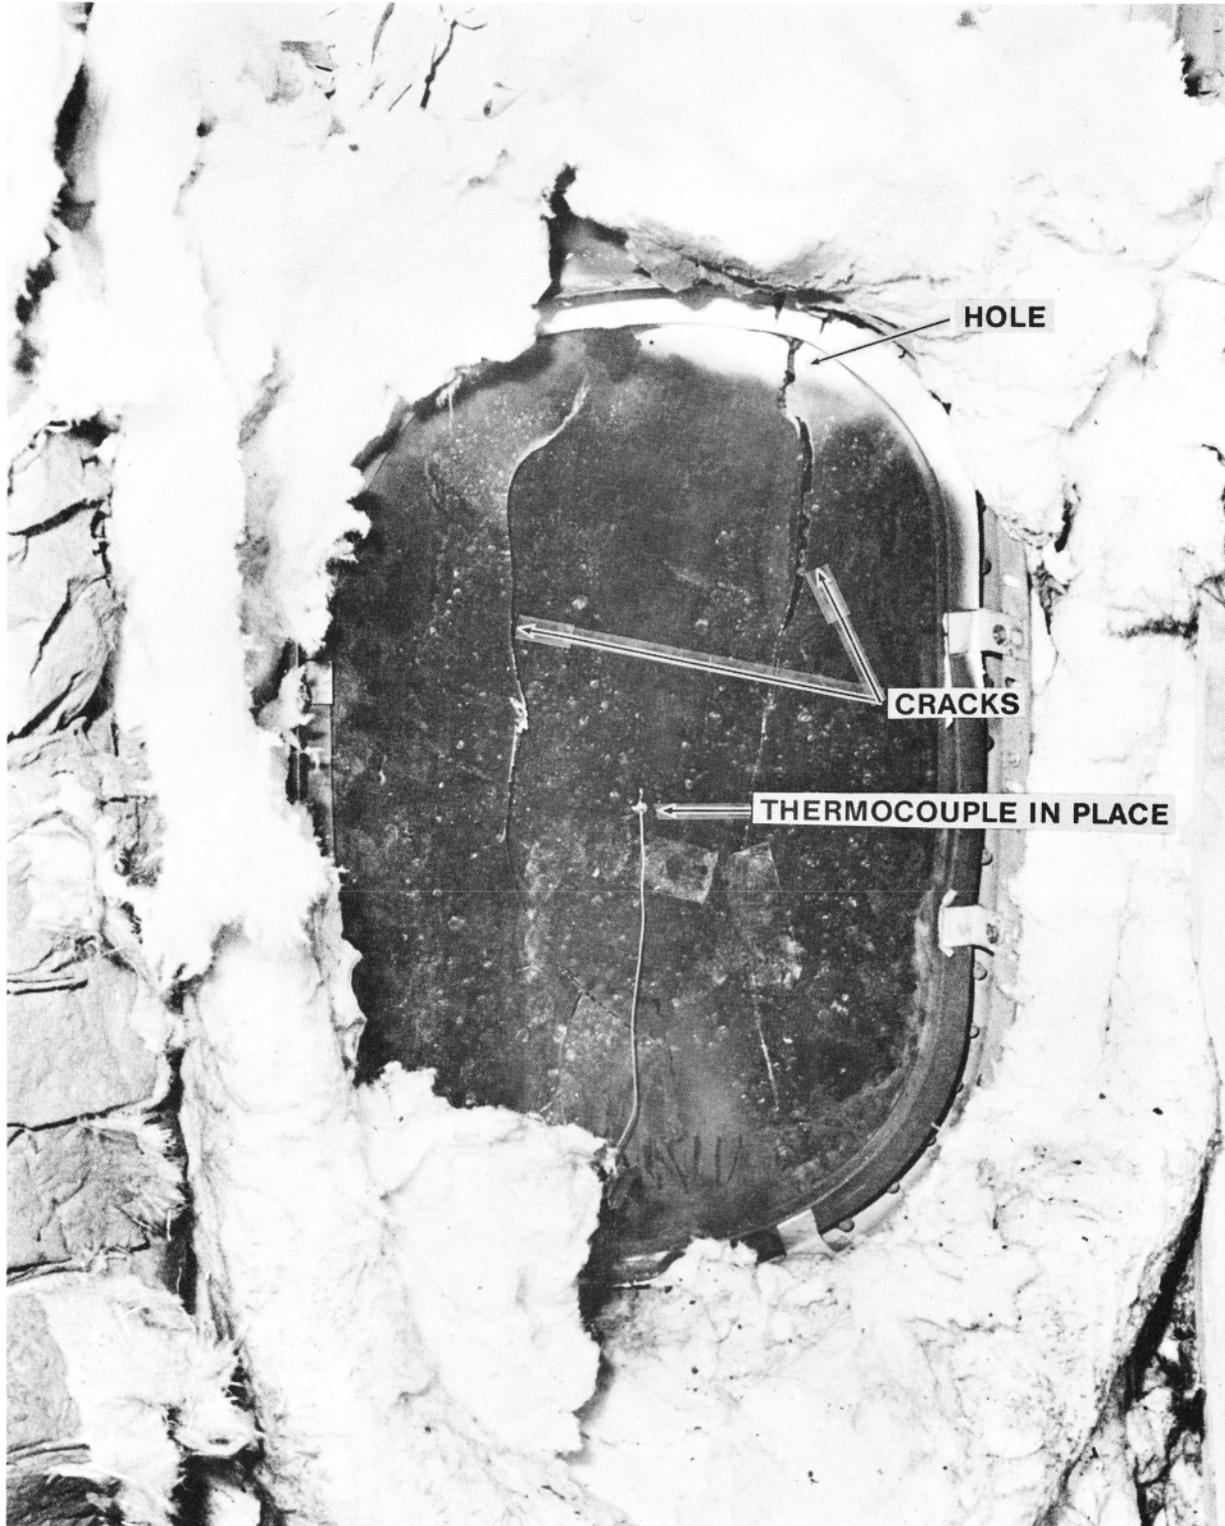
FIGURE 14. CLOSE-UP VIEW OF THE FIRE DAMAGE TO THE FAIL-SAFE (EX 112) WINDOW PANE (TEST 1)

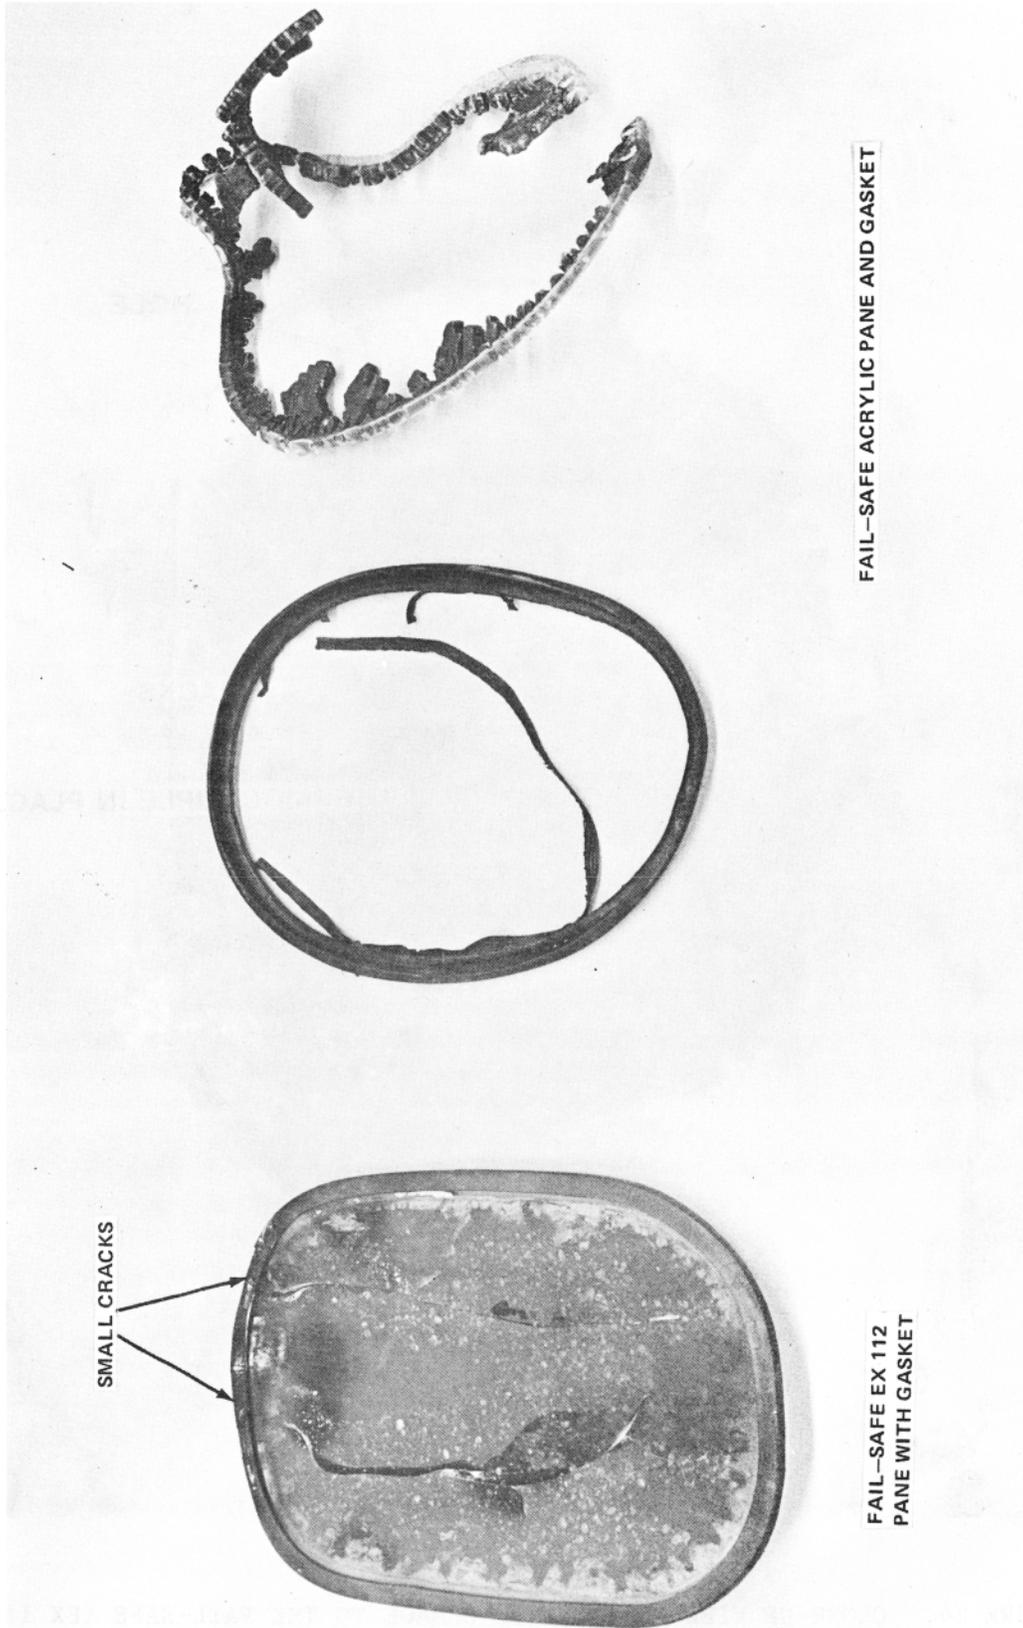
A detailed examination of the condition of the silicone gasket after it was removed from the window frame revealed it had retained a large part of its structural integrity and flexibility (figure 15). The thermal resistivity demonstrated by the gasket under severe fire exposure is noteworthy and its survival is attributable in part, to the thermal resistance of the EX 112 fail-safe pane, the relatively high specific heat of aluminum and the mass of metal comprising the belt system.

SMALL CRACKS

FIGURE 15. FIRE DAMAGE SUSTAINED BY THE IMPROVED EX 112 FAIL-SAFE PANE AND THE STRETCHED ACRYLIC PANE (TEST 1)

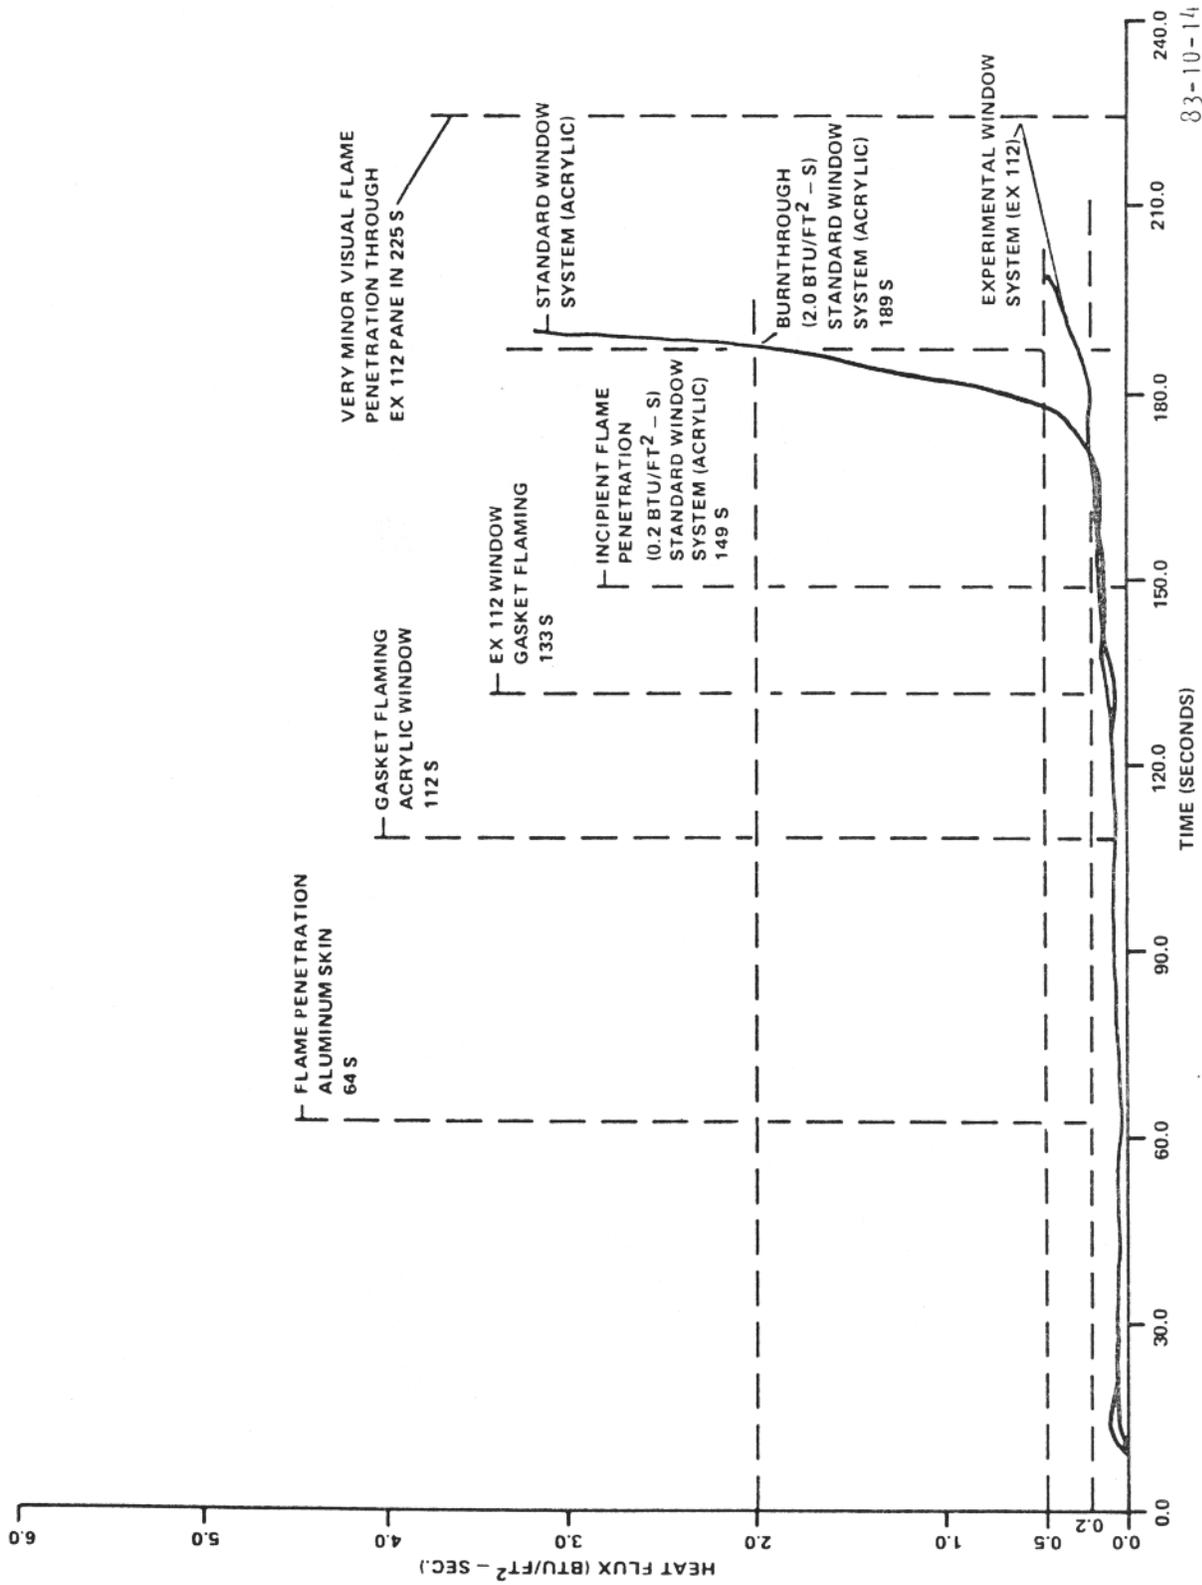
The thermal response of the radiometers to the radiant energy transmitted through the standard and thermally improved window systems is indicated by the profiles in figure 16. Preliminary experiments performed with the two window configurations indicated that the transmittance was equivalent for both systems. The profile generated for the standard window system indicates that incipient failure (0.2 BTU/ft²-s) occurred within 149 seconds (2.5 minutes) after fuel ignition which confirms the failure time observed in the photographic analysis. The data further show that within 24 seconds (0.4 minute) after flame penetration was detected through the standard window system the heat flux rose from 0.2 to 2.0 Btu/ft²-s, thereby confirming the complete destruction of the standard window system. After the failure of the standard acrylic windows, the heat flux through the experimental window system rose from 0.2 to 0.5 Btu/ft²-s in 43 seconds (0.7 minute). This delay in transmittance was attributable, in part, to the gradual development of a carbonized surface layer that insulated the substrate from further pyrolysis for the duration of the test.

FIGURE 16. HEAT FLUX THROUGH THE STANDARD (ACRYLIC) AND THERMALLY IMPROVED (EX 112) WINDOWS DURING FIRE EXPOSURE (TEST 1)

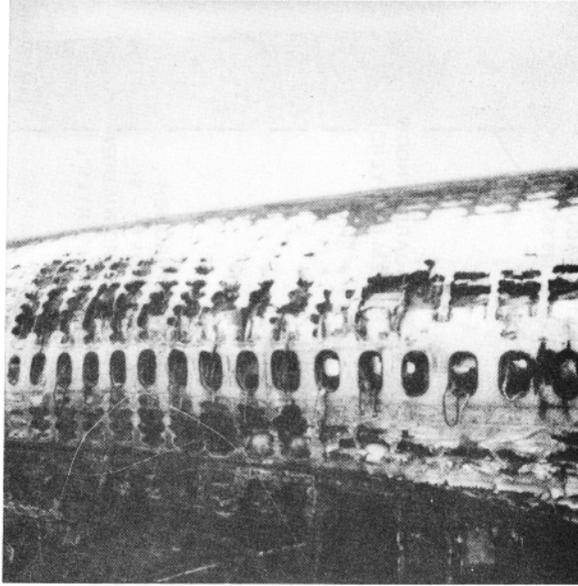
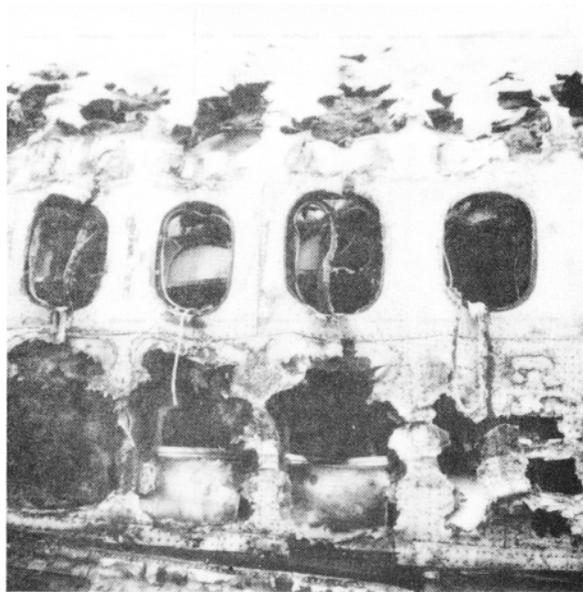
The higher heat resistance of the belt system over the fuselage skin is evident in the photographs presented in figure 17 of the Continental Airlines DC 10-10 accident on March 1, 1978 at the Los Angeles International Airport. This failure mode, in general, was consistent with that observed in the first and subsequent tests conducted in the C-133 fire test bed.

FIGURE 17. FAILURE MODES OF THE CONTINENTAL AIRLINES DC-10 AIRCRAFT FUSELAGE SKIN AND WINDOW BELT SYSTEM

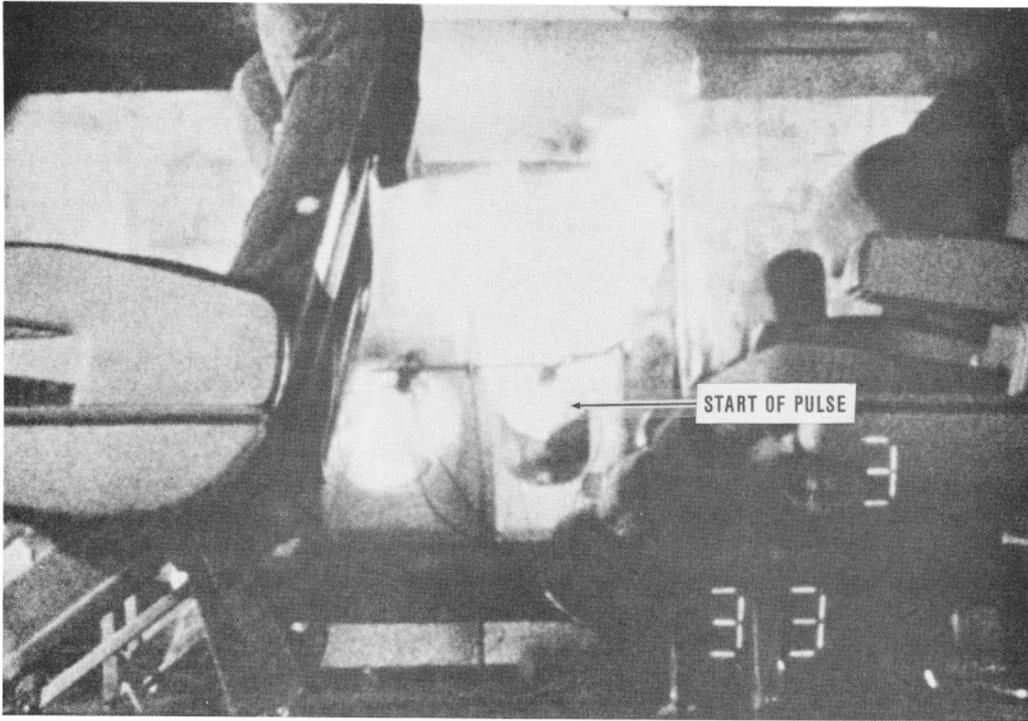
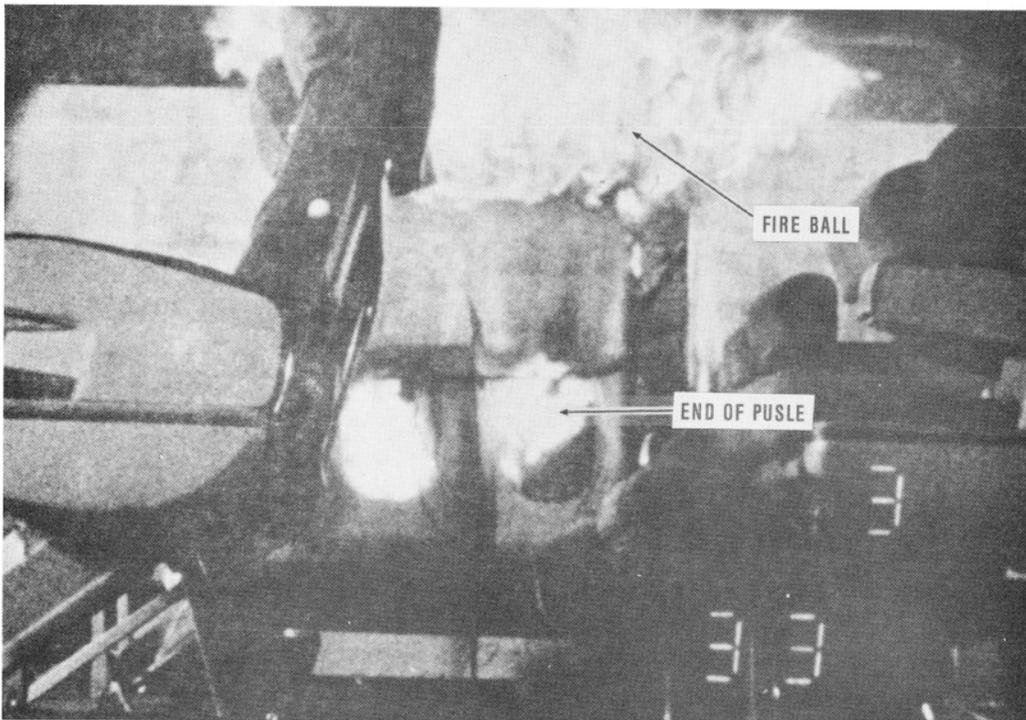
Concurrently with the failure of the acrylic window system, the external fire plume penetrated into the cabin interior. The series of photographs presented in figure 18 show the flame plume pulsating at approximately one second intervals through the window opening after the destruction of the acrylic window panes. This condition continued for the duration of the test and would pose a severe threat to passenger survival during egress from an aircraft and serve as an ignition source for the interior cabin furnishings.

FIGURE 18. PHOTOGRAPHIC SEQUENCE SHOWING FLAME PULSATION THROUGH THE ACRYLIC WINDOW OPENING

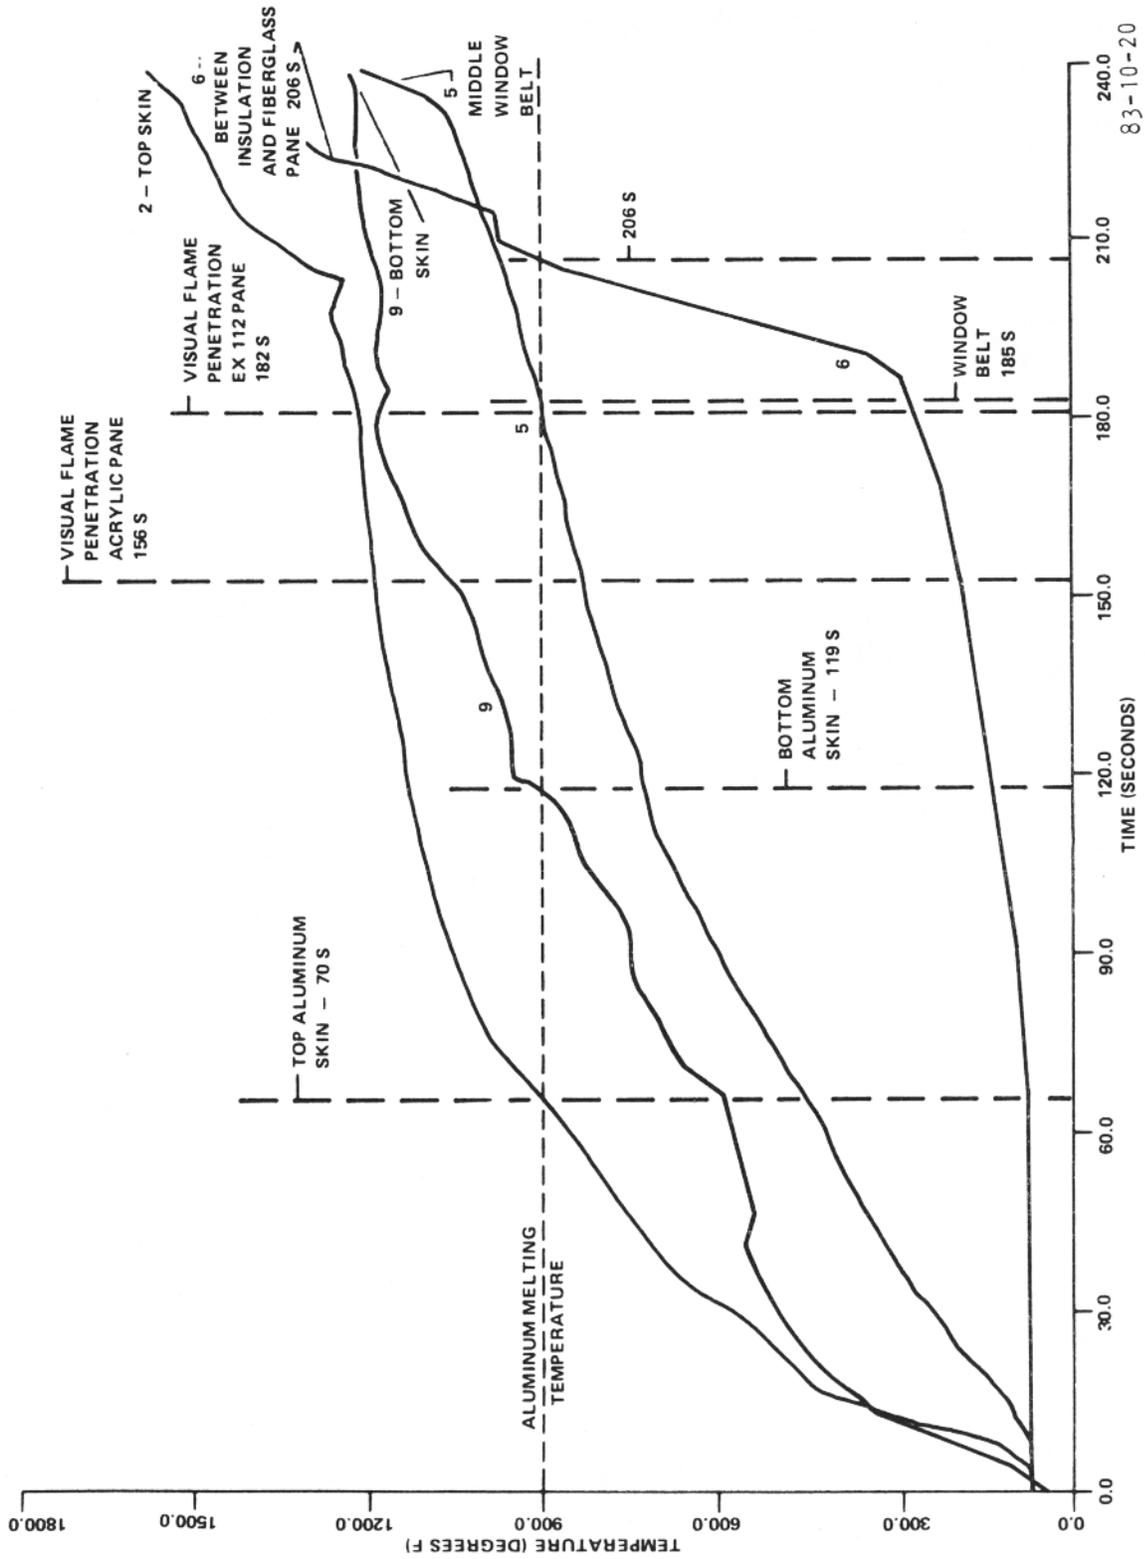
The sequence in which the major fuselage components failed during fire exposure in the second test is significant in identifying the most heat sensitive component in the exterior fuselage structure. The information presented in figure 21 shows that the aluminum skin (0.090 inch thick) above the belt failed in 70 seconds and that the skin below the belt failed in 119 seconds. Visual flame penetration through the standard acrylic window system occurred within 156 seconds and through the thermally improved window (EX 112 fail-safe pane) in 182 seconds, thereby demonstrating an improvement in flame resistivity of 26 seconds. The belt (0.350 inch thick) reached the incipient melting temperature of aluminum (900° F) shortly (3 seconds) after flames were observed to penetrate the EX 112 fail-safe pane. The temperature between the glass fiber insulation batt and the glass fiber interior panel rose to 900° F within 206 seconds after fuel ignition. These data show that the failure time of the EX 112 fail-safe pane was approximately equal to the failure time of the belt system.

FIGURE 21. TEMPERATURE RISE OF THE DC-10 SKIN, DOUBLER AND BELT DURING FIRE EXPOSURE (TEST 2)
