DOT/FAA/CT-83/10

Evaluation of an Improved Flame Resistant Aircraft Window System

Final Report
May 1984

US Department of Transportation
Federal Aviation Administration
Technical Center
Atlantic City Airport, N.J. 08405

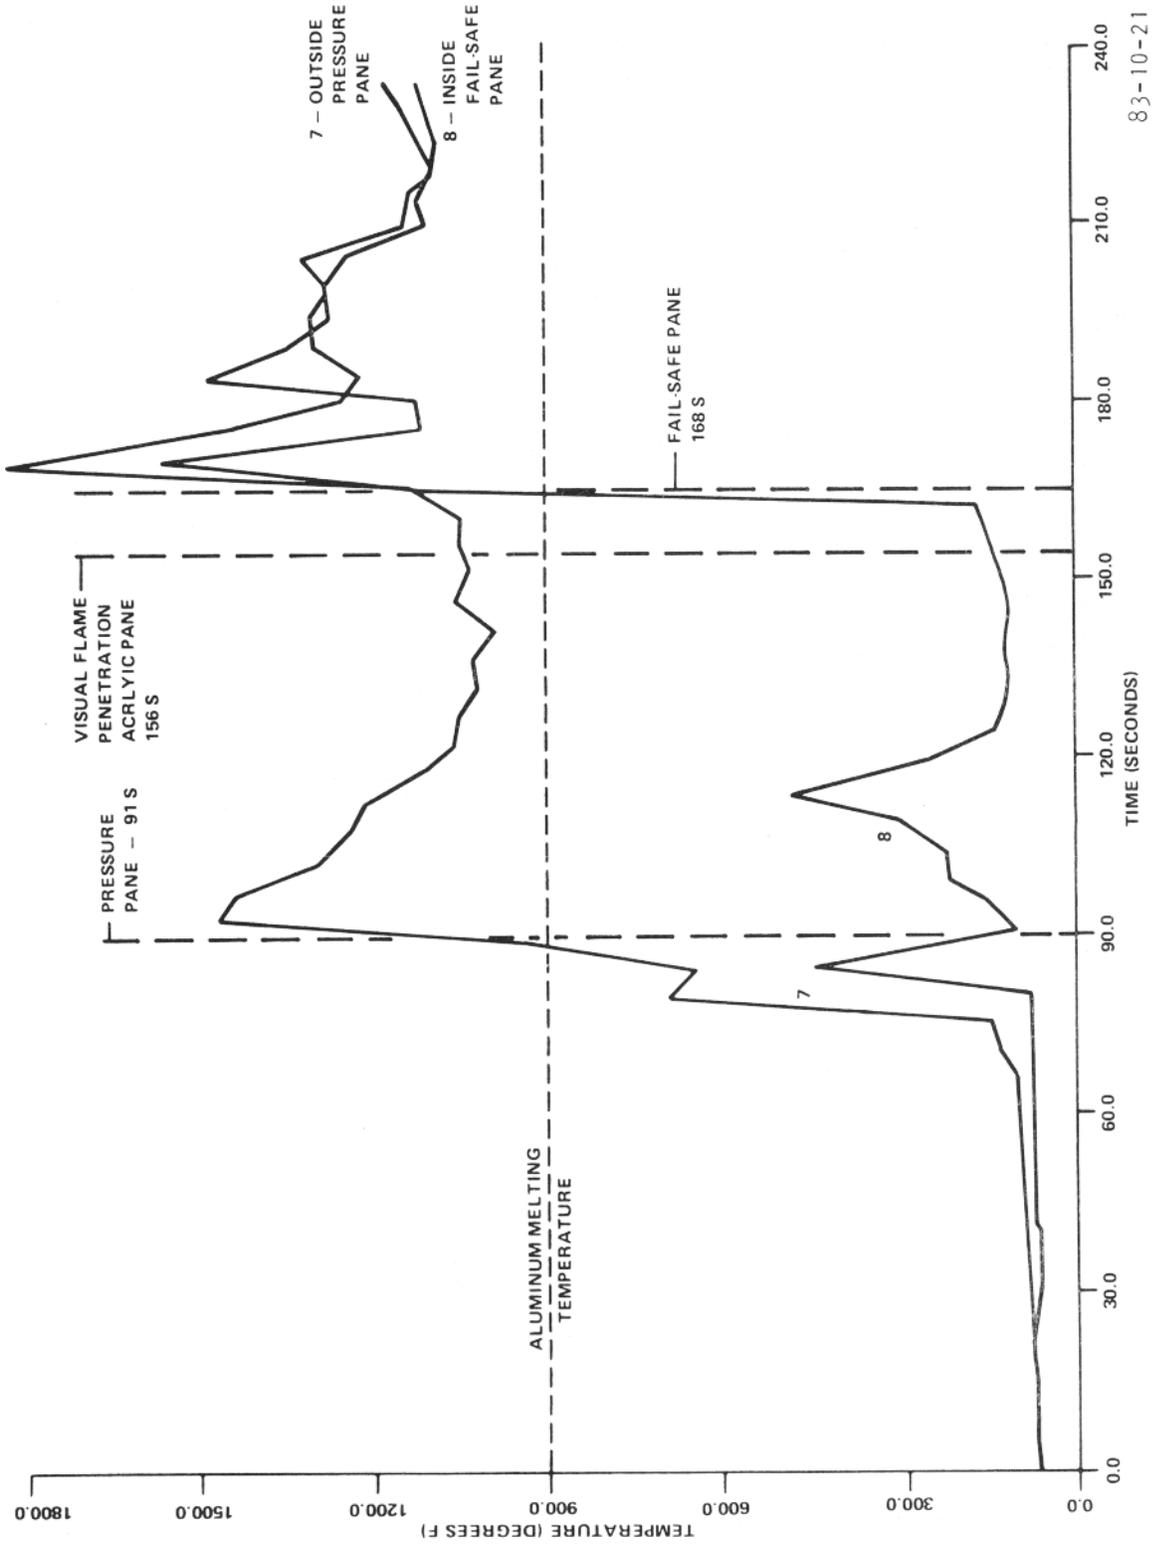
The temperature data (figure 22) provided by the thermocouples imbedded in the standard (acrylic) window panes indicate that the pressure pane reached the melting point of aluminum (900° F) in 91 seconds (1.5 minutes), which is approximately 695° F above the hot distortion temperature of acrylic polymers (205° F under 265 pounds per square inch); therefore, it is assumed that the outer acrylic pane failed. However, the fail-safe pane did not reach 900° F until 168 seconds (2.8 minutes) after fuel ignition, which was only 12 seconds (0.2 minute) longer than the observed (visual) failure time of 156 seconds (2.6 minutes) for the standard window system.

FIGURE 22. TEMPERATURE RISE OF THE STANDARD (ACRYLIC) WINDOW PANES DURING FIRE EXPOSURE (TEST 2)

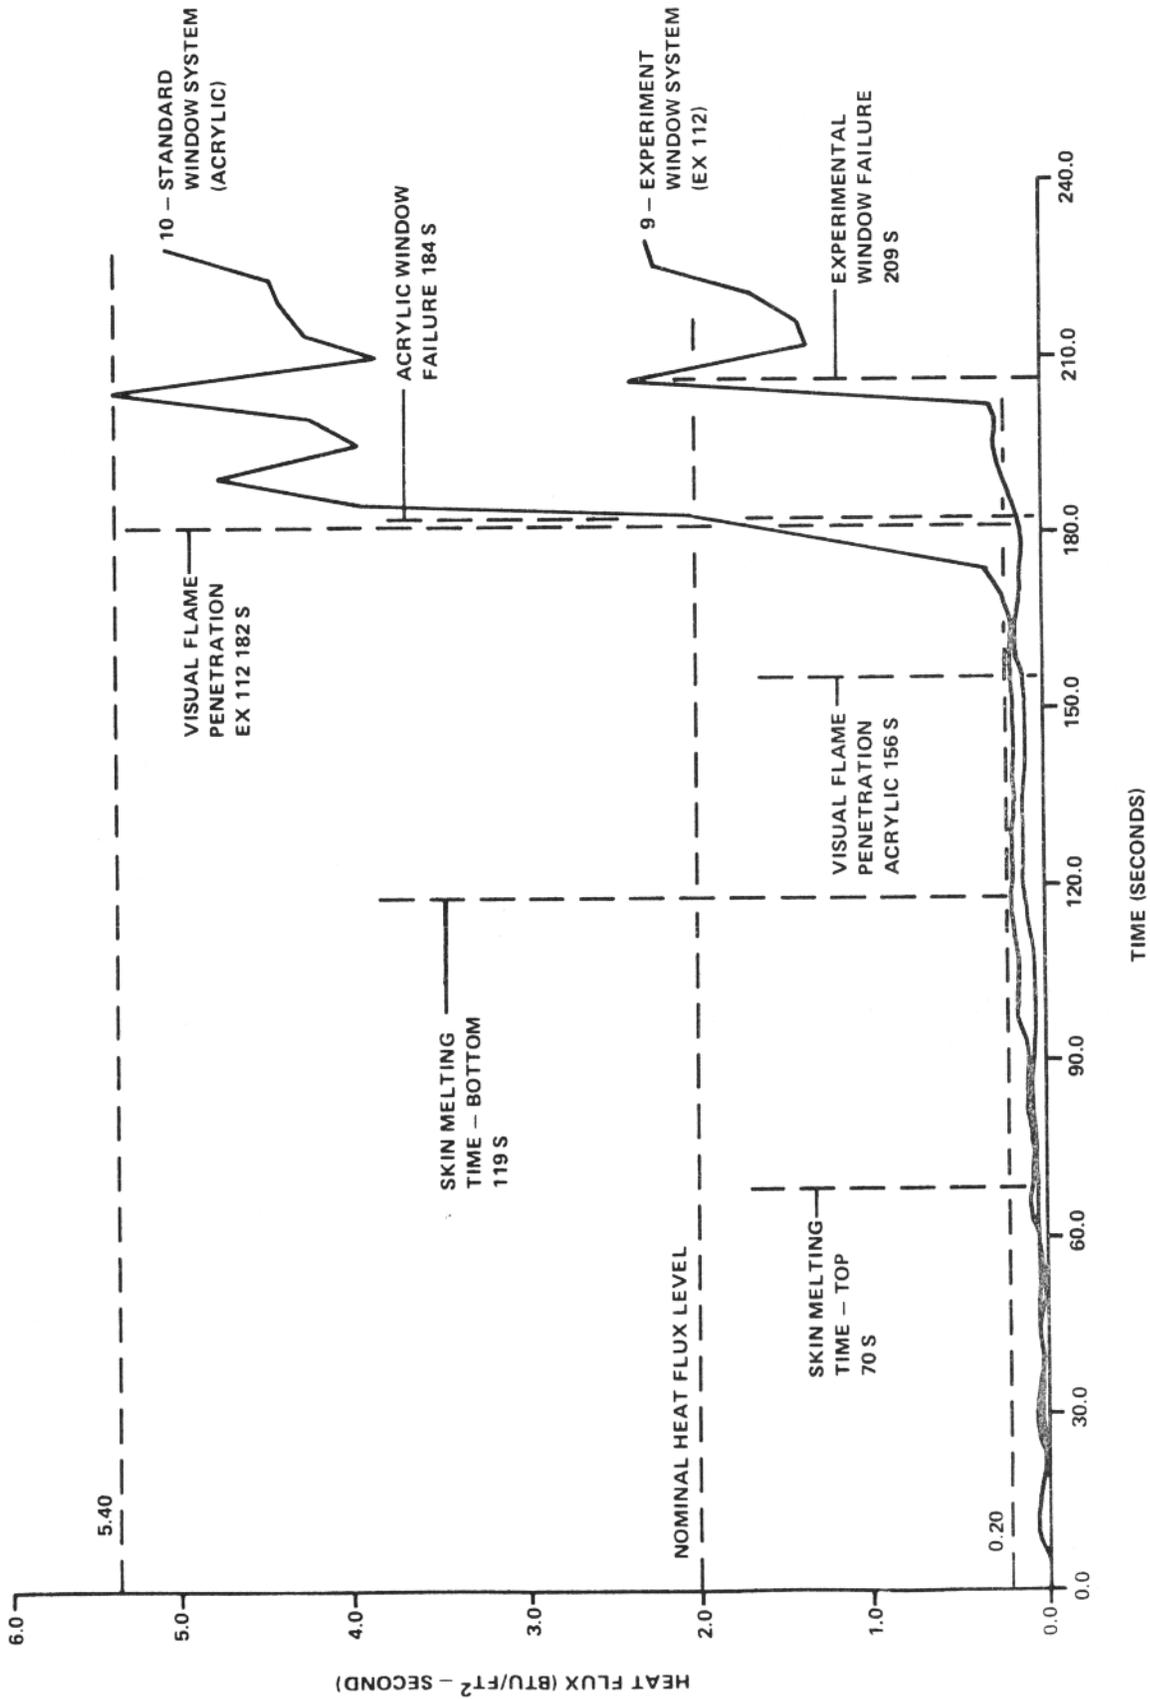
83-10-23

The failure times of the DC-10 windows as determined from the thermal response of the radiometers is indicated by the profiles presented in figure 23. These data show that the heat flux through the standard acrylic and experimental EX 112 windows was low (0.2 Btu/ft²-s) until the time of severe failure when the heat flux rose rapidly to 2.0 Btu/ft²-s. This massive failure (2.0 Btu/ft²-s) required 184 seconds (3.1 minutes) for the standard acrylic window and 209 seconds (3.5 minutes) for the experimental EX 112 window. Visual observation showed that there was an approximate difference of 26 seconds (0.4 minutes) between the time the first flicker of flame penetrated the fail-safe acrylic pane and the EX 112 fail-safe pane.

FIGURE 23. HEAT FLUX THROUGH THE STANDARD (ACRYLIC) AND THERMALLY IMPROVED (EX 112) WINDOWS DURING FIRE EXPOSURE (TEST 2)

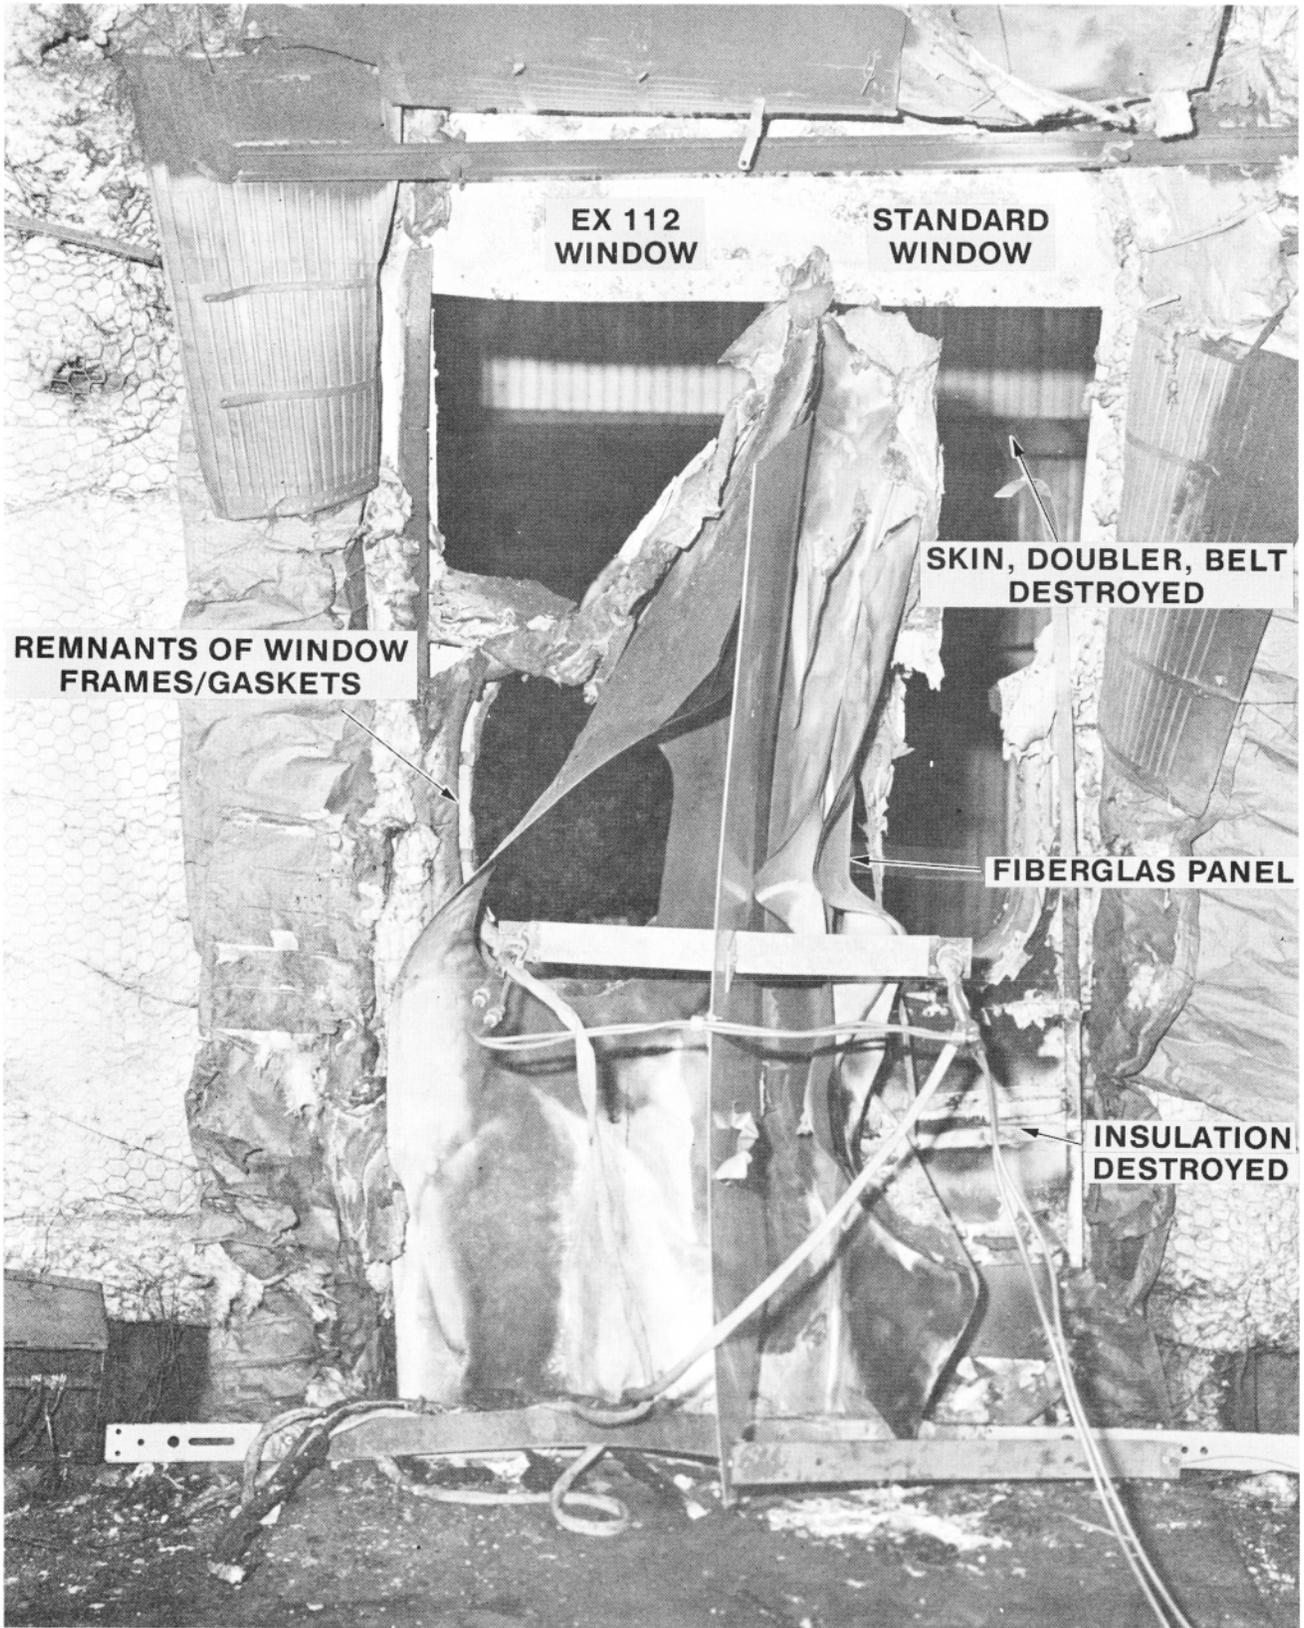
The visual fire damage to the aluminum fuselage structure around the thermally improved and standard window configuration is shown in figure 24. A more detailed interior view of the fire damage to the improved EX 112 window system is presented in figure 25. Figure 24 shows a portion (approximately 25 percent) of the silicone rubber gasket still mounted in position in the window opening around the thermally improved window system. From these photographs it is evident that the integrity of any window system comprising a pressure and fail-safe pane mounted in a rubber gasket is dependent heavily upon maintaining the structural and thermal integrity of the belt and window framing material.

FIGURE 24. FIRE DAMAGE TO THE STANDARD (ACRYLIC) AND IMPROVED (EXIT 112) WINDOWS (TEST 2)

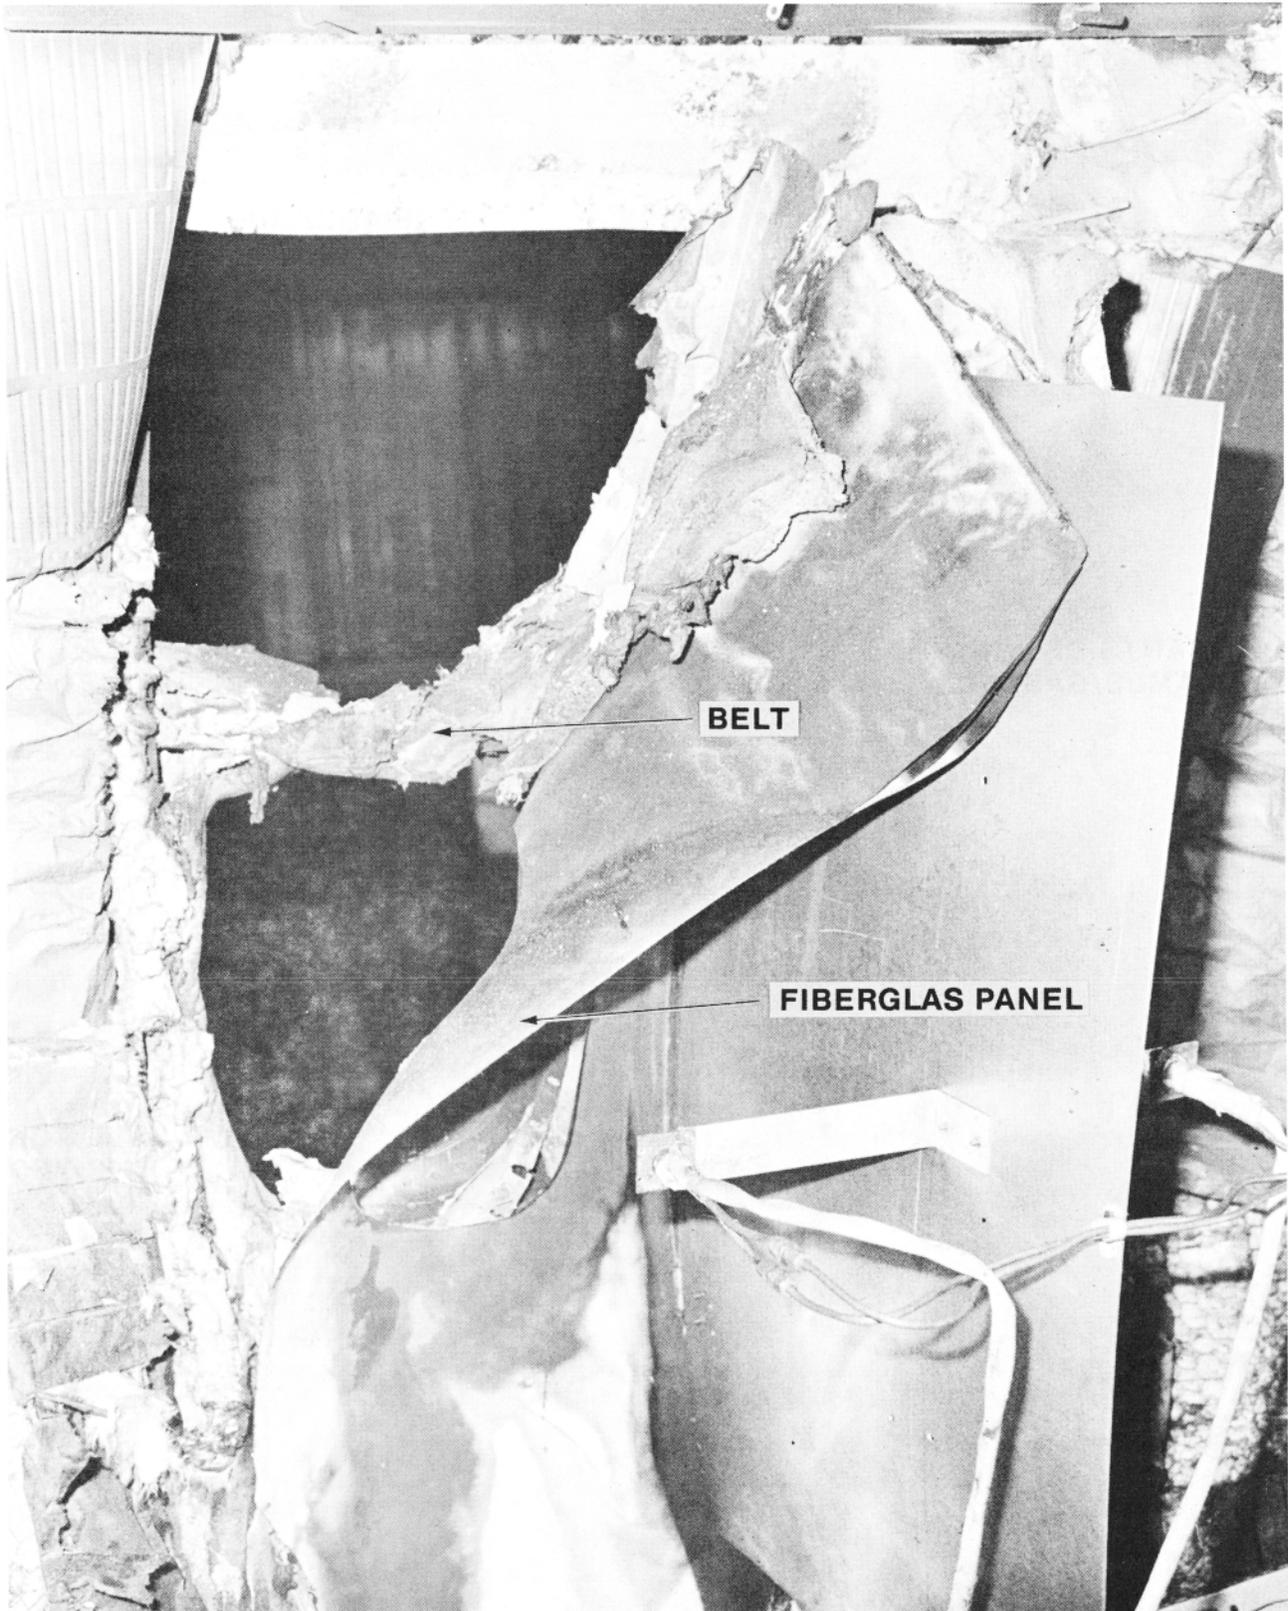
FIGURE 25. CLOSE-UP VIEW OF THE FIRE DAMAGE TO THE IMPROVED (EX 112) WINDOW SYSTEM (TEST 2)

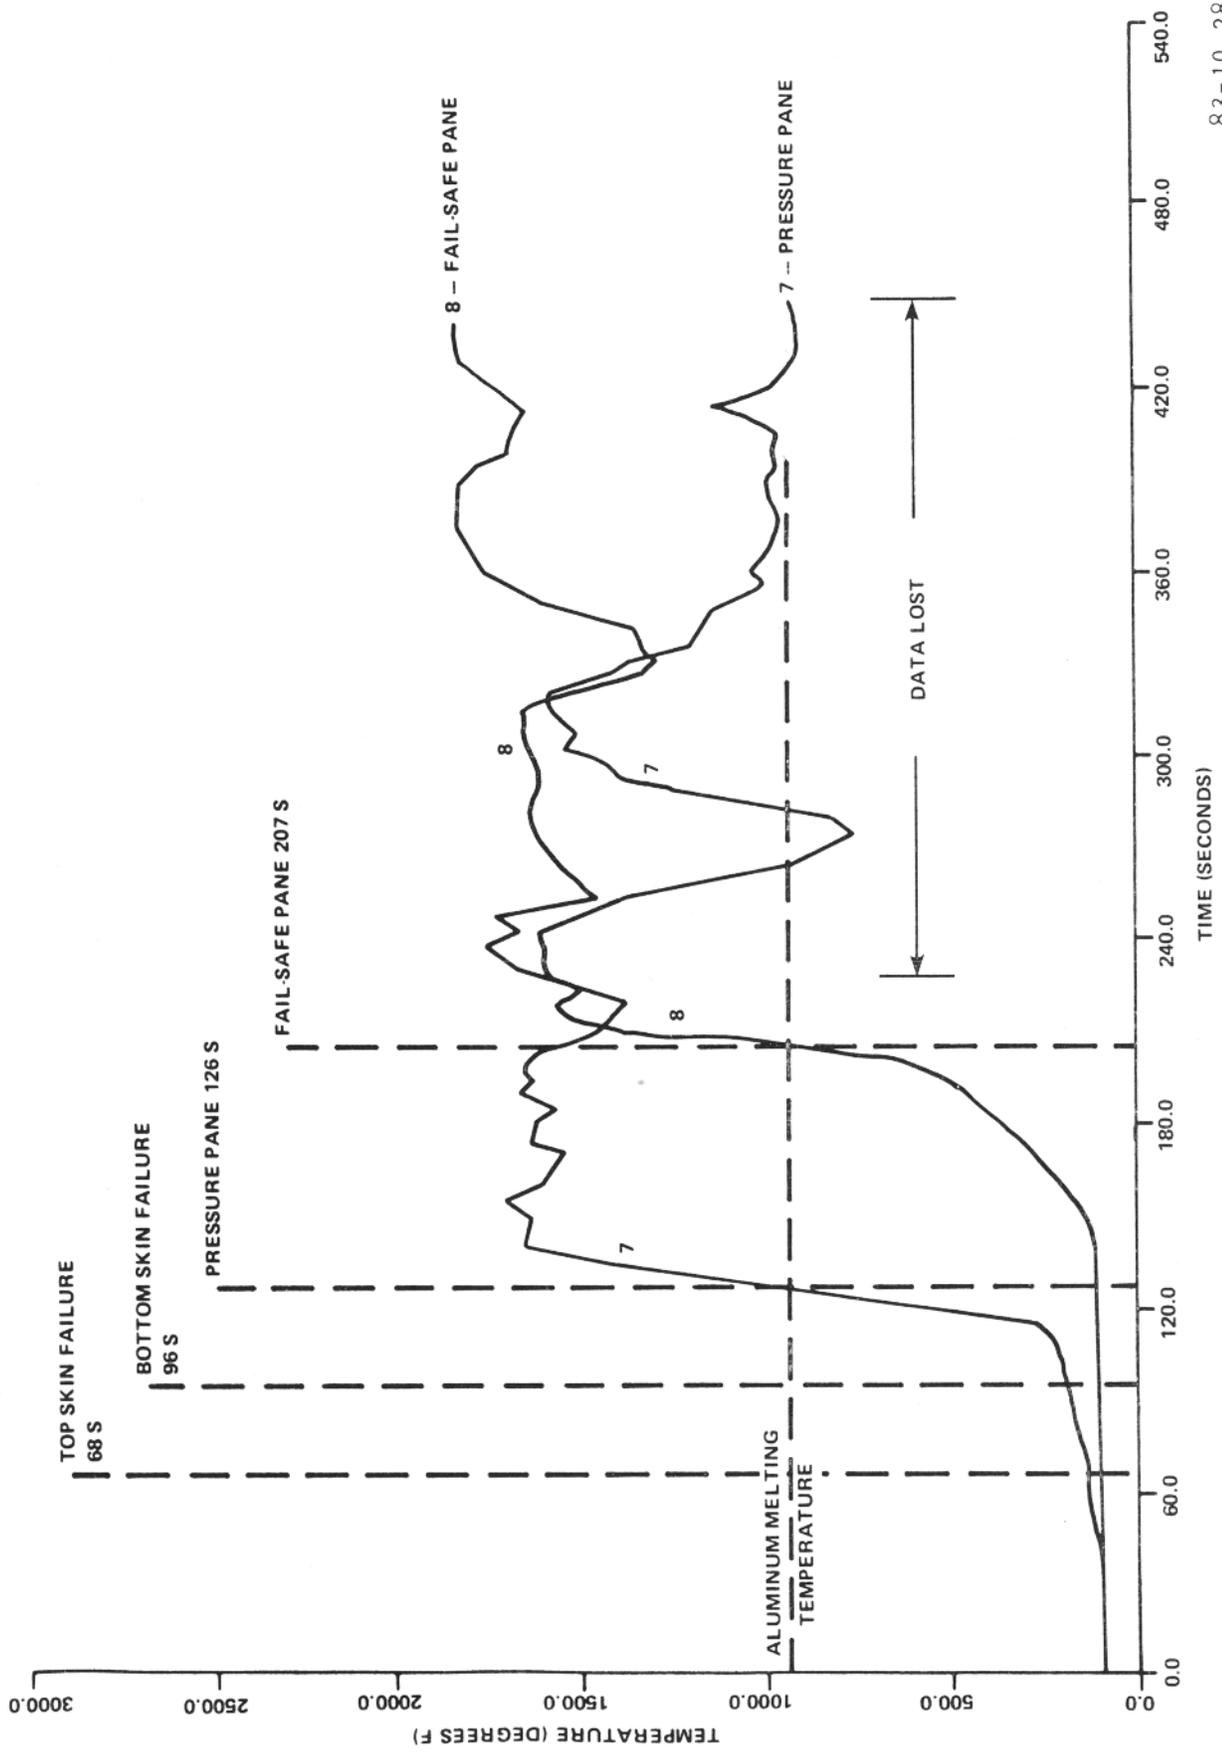
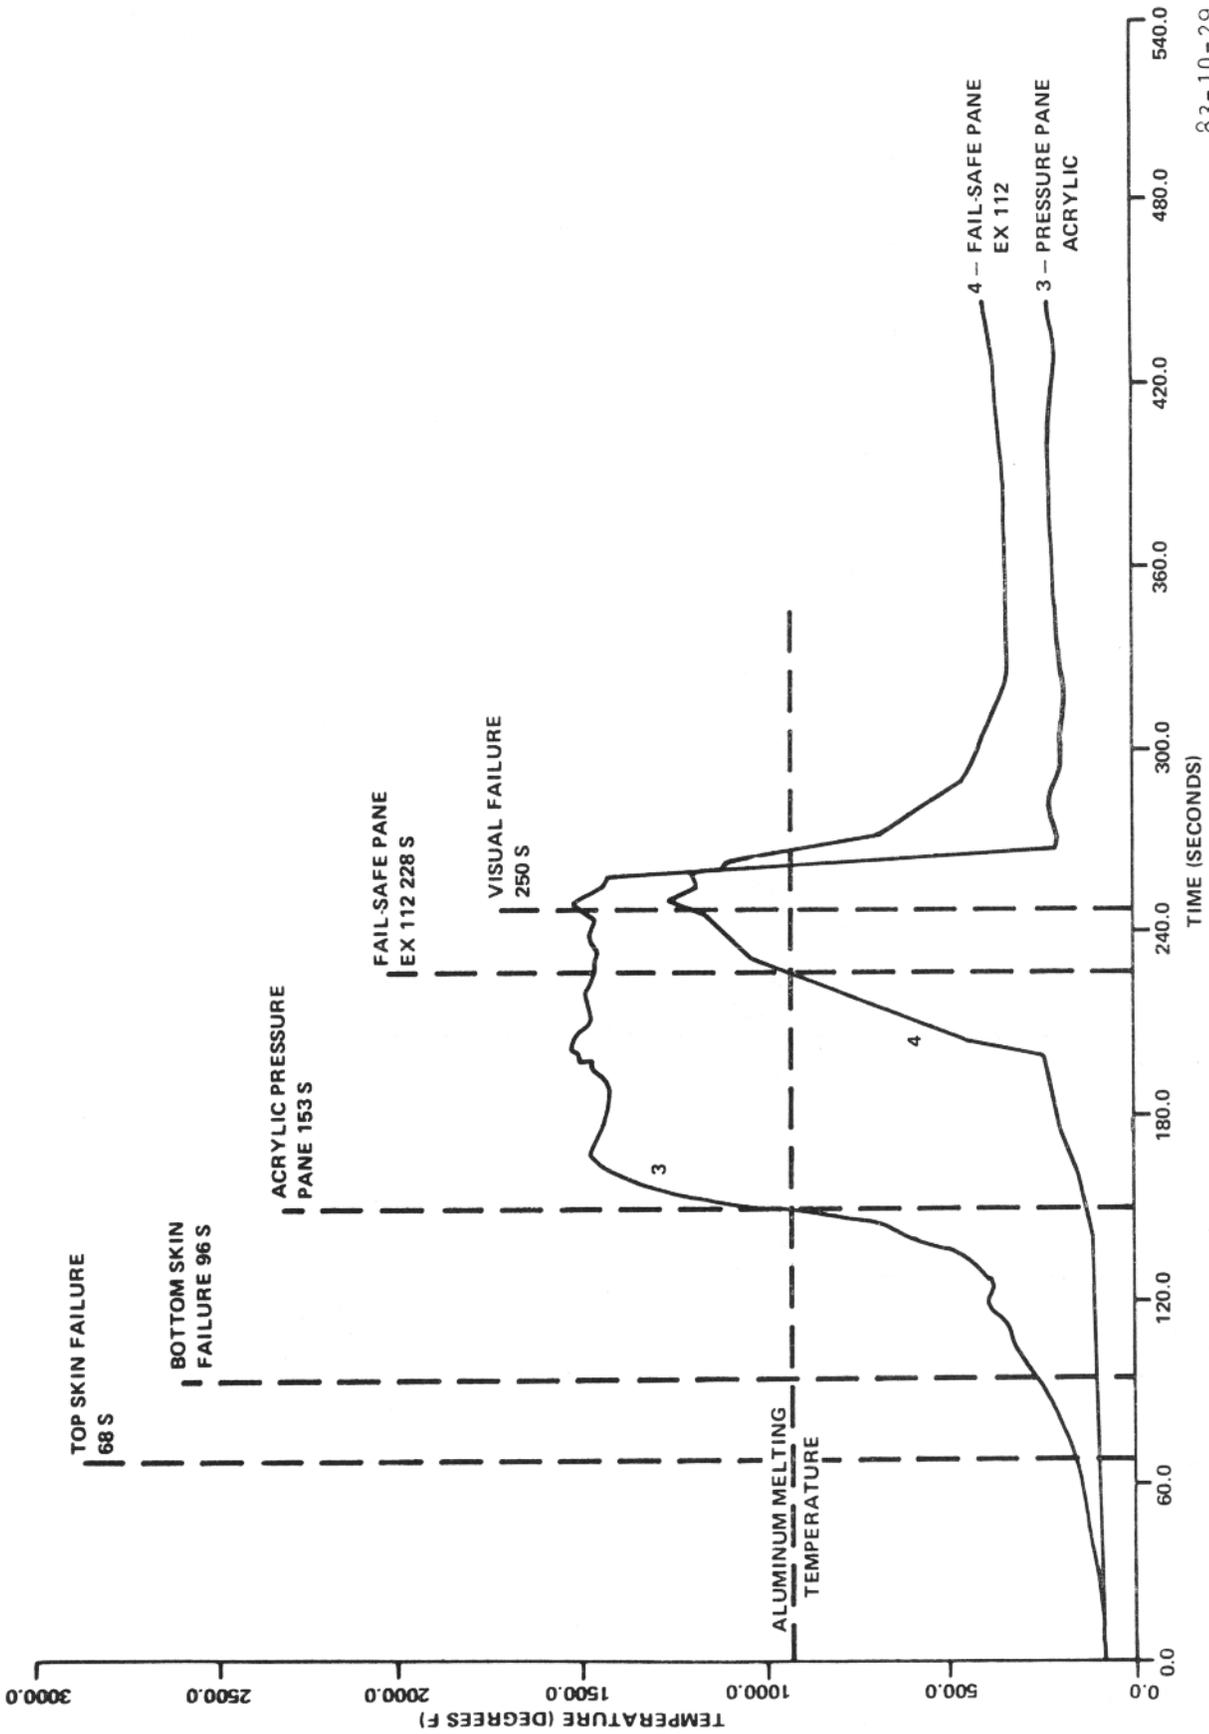
The temperature data provided by the thermocouples embedded in the standard (acrylic) window panes and the thermally improved experimental (EX 112) window system are presented in figures 28 and 29, respectively. The profiles presented in figure 28 show that the pressure pane reached the incipient melting point of aluminum in 126 seconds (2.1 minutes) and the fail-safe pane in 207 seconds (3.5 minutes) in the standard acrylic window system. Figure 29 indicates that the pressure pane in the thermally improved window system reached 900° F within 153 seconds (2.6 minutes) after fuel ignition while the fail-safe pane (EX 112) required 228 seconds (3.8 minutes) of fire exposure. The failure time of 228 seconds (3.8 minutes) for the EX 112 pane correlates well with the incipient failure time of 225 seconds (3.75 minutes) obtained in the first experiment.

FIGURE 28. TEMPERATURE RISE OF THE STANDARD (ACRYLIC) WINDOW PANES (TEST 3)

FIGURE 29. TEMPERATURE RISE OF THE THERMALLY IMPROVED (EX 112) FAIL-SAFE WINDOW PANE AND STANDARD (ACRYLIC) PRESSURE PANE DURING FIRE EXPOSURE (TEST 3)

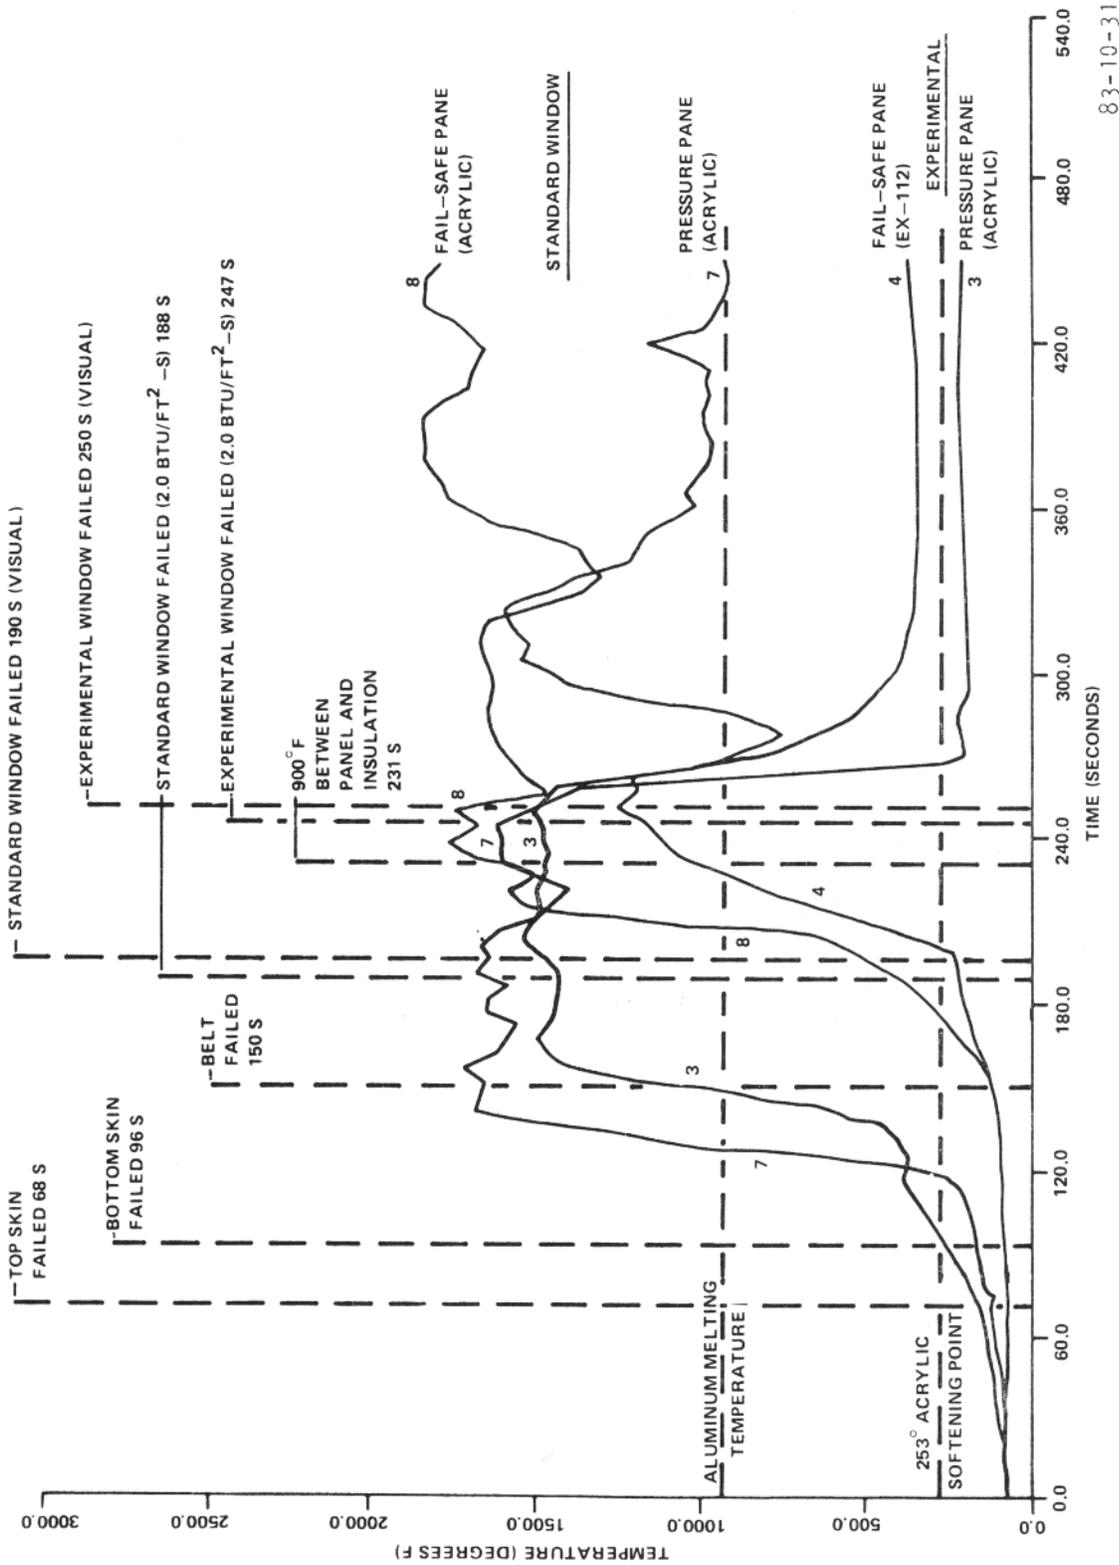
83-10-31

The data presented in figure 31 summarizes the basic information obtained during the third test which employed a faithful mockup of a DC-10 fuselage section using a honeycomb interior cabin panel. It is noteworthy that the failure times obtained for the standard acrylic window panes were 190 seconds (3.2 minutes) by visual observation (cameras) and 188 seconds (3.1 minutes) based upon heat flux measurements (radiometers) which resulted in a difference of only 2 seconds between the two methods, for an overall average of 189 seconds (3.2 minutes).

FIGURE 31. SUMMARY OF EXPERIMENTAL DATA OBTAINED FROM TEST 3 EMPLOYING THE STANDARD AND THERMALLY IMPROVED WINDOW SYSTEM WITH THE DC-10 INTERIOR HONEYCOMB PANEL CONFIGURATION

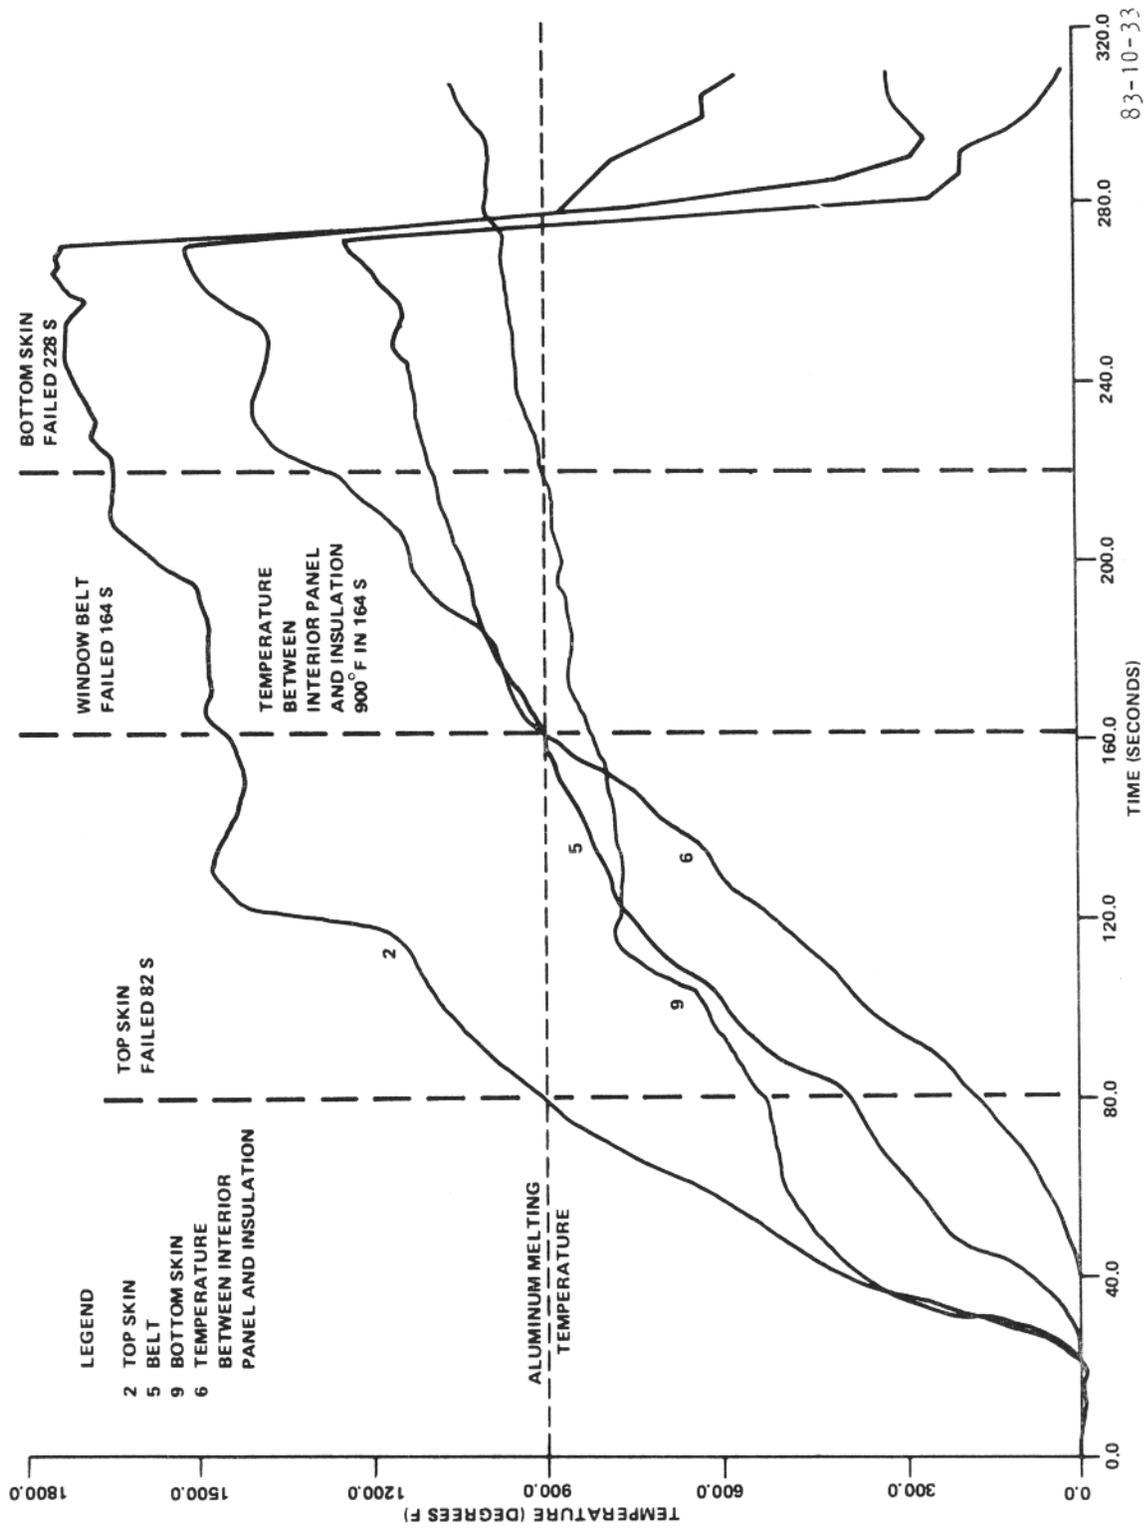
RESULTS: The temperature rise of the aluminum structural components of the DC-10 fuselage section are indicated by the profiles presented in figure 32. These data show that the aluminum skin above the belt reached the incipient melting temperature of aluminum (900° F) in 82 seconds (1.4 minutes) after fuel ignition, while the skin below the belt required 228 seconds (3.8 minutes) to failure. The temperature of the belt between the windows reached 900° F in 164 seconds (2.7 minutes) after fuel ignition. Accordingly, the fuselage skin above the windows failed (melted) approximately 146 seconds (2.4 minutes) before the bottom skin as a consequence of the temperature gradient within the flame plume (appendix B). The longer survival time (82 seconds, 1.4 minutes) demonstrated by the belt (0.35 inch thick) resulted from the greater mass of metal which had to be heated.

FIGURE 32. TEMPERATURE RISE OF THE DC-10 SKIN, BELT AND THE INTERFACE BETWEEN THE INTERIOR PANEL AND INSULATION BATT (TEST 4)

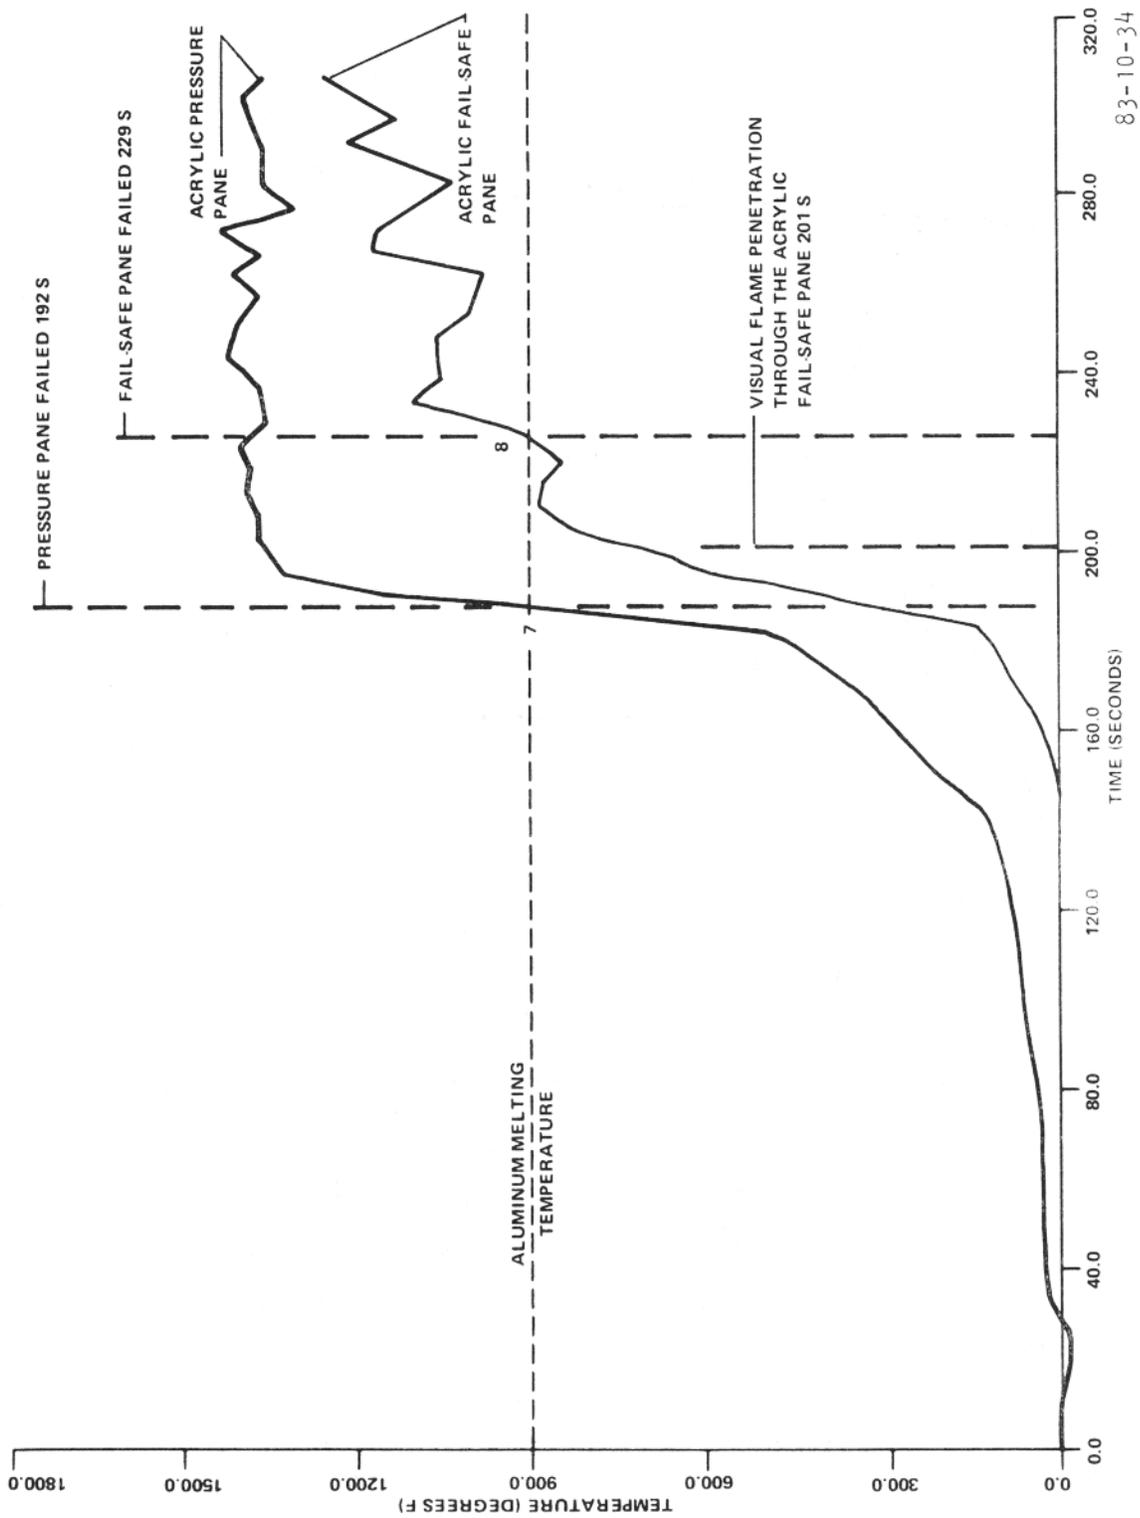
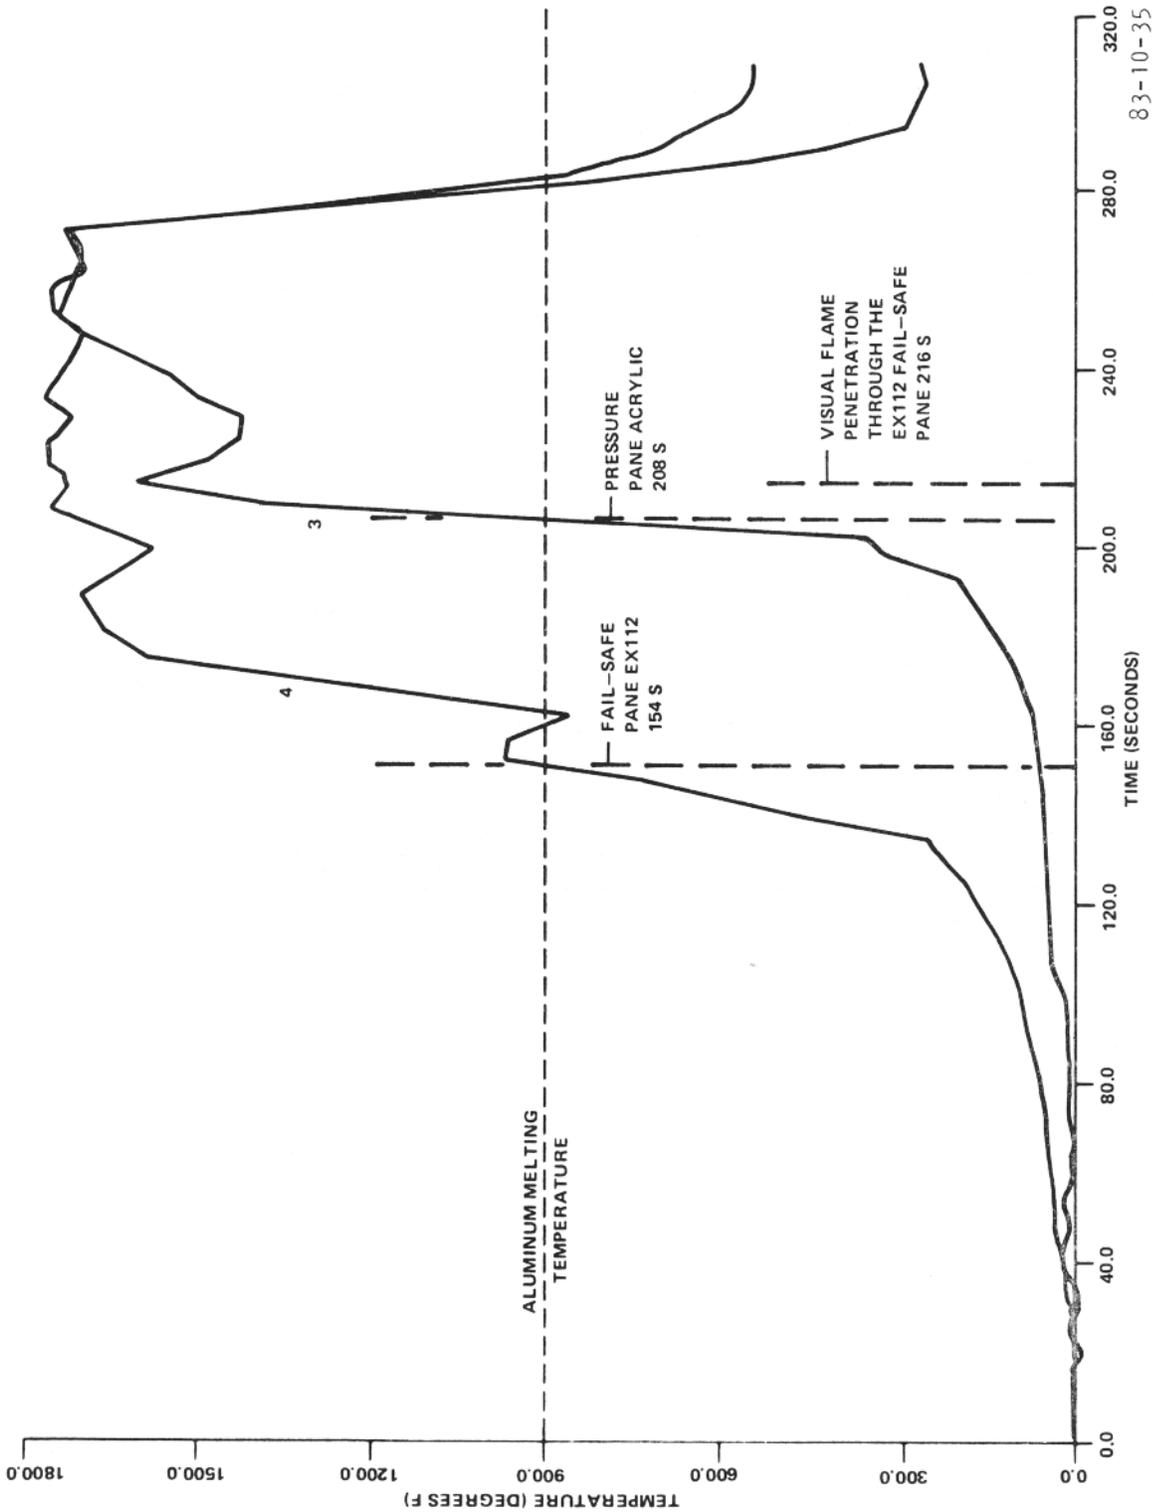
The temperature data provided by the thermocouples embedded in the standard (acrylic) window system and the thermally improved experimental (EX 112) window system are presented in figures 33 and 34, respectively. The profiles presented in figure 33 show that the pressure pane reached the incipient melting point of aluminum (900° F) in 192 seconds (3.2 minutes) and the fail-safe pane in 229 seconds (3.8 minutes) in the standard window system.

Figure 34 indicates that the pressure pane in the thermally improved window system reached 900° F within 208 seconds (3.5 minutes) after fuel ignition while the fail-safe pane (EX 112) apparently required only 154 seconds (2.6 minutes) to attain the same temperature. This anomalous performance by the thermocouple embedded in the (EX 112) pane is attributable to a malfunction in the monitoring equipment. The rationale is evidenced by the visual (cameras) incipient failure time of the EX 112 fail-safe pane in 216 seconds (3.6 minutes) and by the heat flux measurements (figure 35) through the window opening of 2.0 Btu/ft²-s in 308 seconds (5.1 minutes) upon failure.

FIGURE 33. TEMPERATURE RISE OF THE STANDARD (ACRYLIC) WINDOW PANES DURING FIRE EXPOSURE (TEST 4)

FIGURE 34. TEMPERATURE RISE OF THE THERMALLY IMPROVED (EX 112) WINDOW PANE AND STANDARD (ACRYLIC) PRESSURE PANE DURING FIRE EXPOSURE (TEST 4)
