DOT/FAA/CT-83/10

Evaluation of an Improved Flame Resistant Aircraft Window System

Final Report
May 1984

US Department of Transportation
Federal Aviation Administration
Technical Center
Atlantic City Airport, N.J. 08405

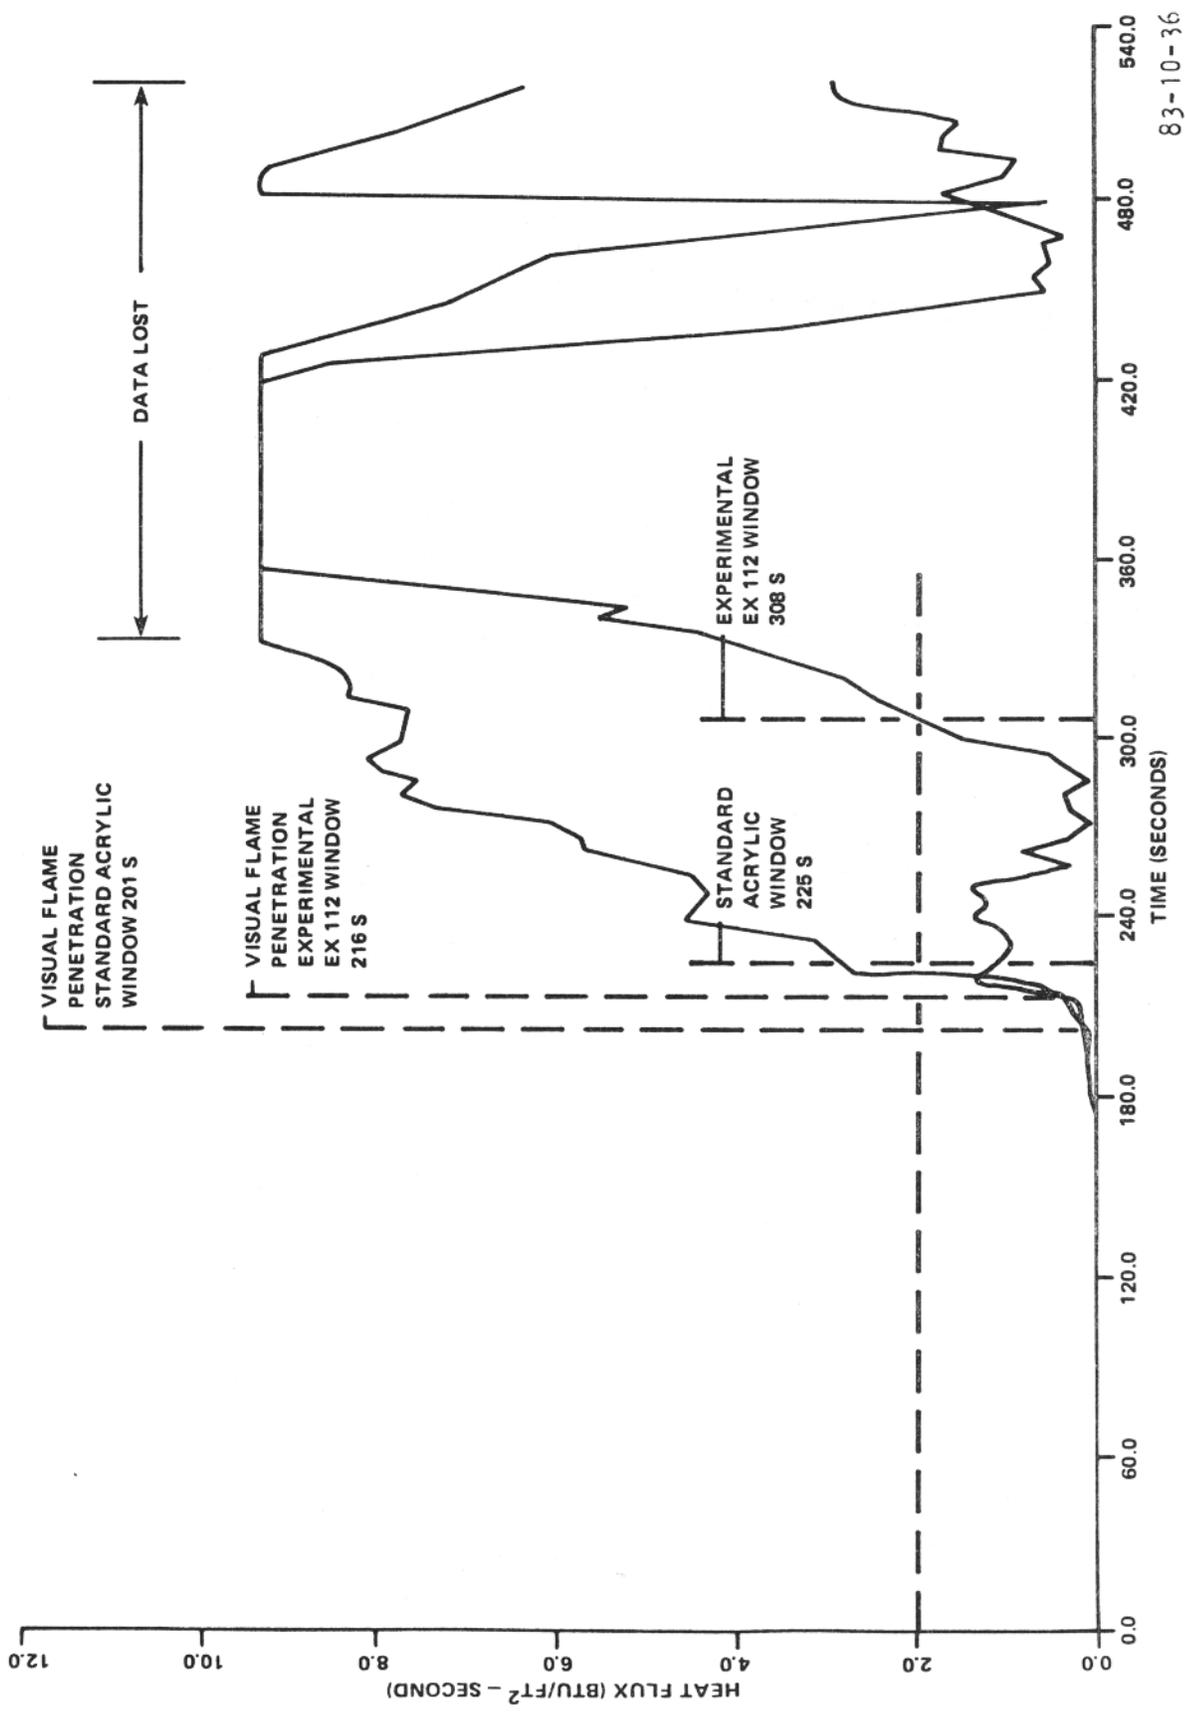
83-10-36

The real-time flame penetration through the windows was determined from an analysis of the radiometer profiles in figure 35 and from the motion picture coverage. The radiometer profiles show that the standard and experimental window systems failed in 225 seconds (3.75 minutes) and 308 seconds (5.1 minutes), respectively, as evidenced by a surge in heat flux equivalent to 2.0 Btu/ft²-s when the flames penetrated the cabin.

The difference in the failure times of the two window systems of 83 seconds (1.4 minute), based upon the time for each to permit a heat flux of 2.0 Btu/FT²-s to enter the aircraft cabin, was attributable to the charring characteristics of the EX 112 fail-safe pane in contrast with the standard acrylic fail-safe pane which simply shrank, melted, burned, and fell from the window opening.

FIGURE 35. HEAT FLUX THROUGH THE STANDARD (ACRYLIC) AND THERMALLY IMPROVED (EX 112) WINDOWS DURING FIRE EXPOSURE (TEST 4)
