**UNDERWRITERS LABORATORIES INC.**

File R8758  
Project 78NK5345

CABLE RACEWAY PROTECTION SYSTEMS  
FIRE TEST INVESTIGATION

Babcock & Wilcox  
Augusta, Georgia

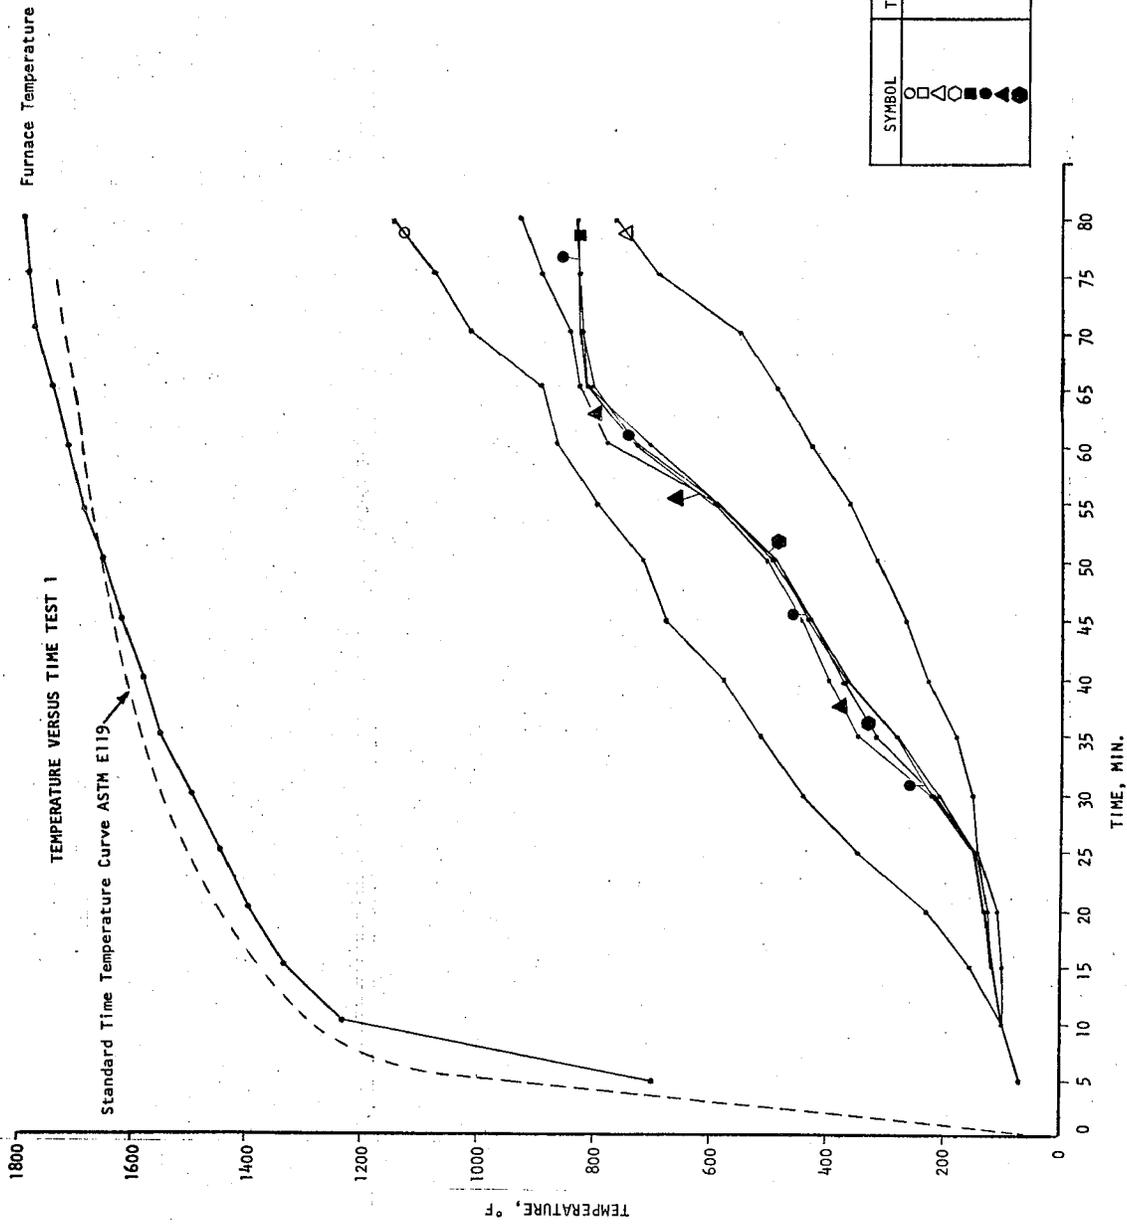
III, 11  
R 8758

Temperatures - The temperatures within and on the cable tray, and within the conduit for each test are shown in ILLS. 11, 13, 15 and 17.

<u>Circuit No.</u>	<u>Time of Failure, Min/Sec Into Test</u>
1	51:00
20	56:00
11	57:00
19	58:30
3	58:30
18	61:00
17	65:00
5	67:00
4	69:30
2	70:00
8	70:00
6	70:00
15	70:00
7	70:00
12	75:00
Test Terminated	77:00

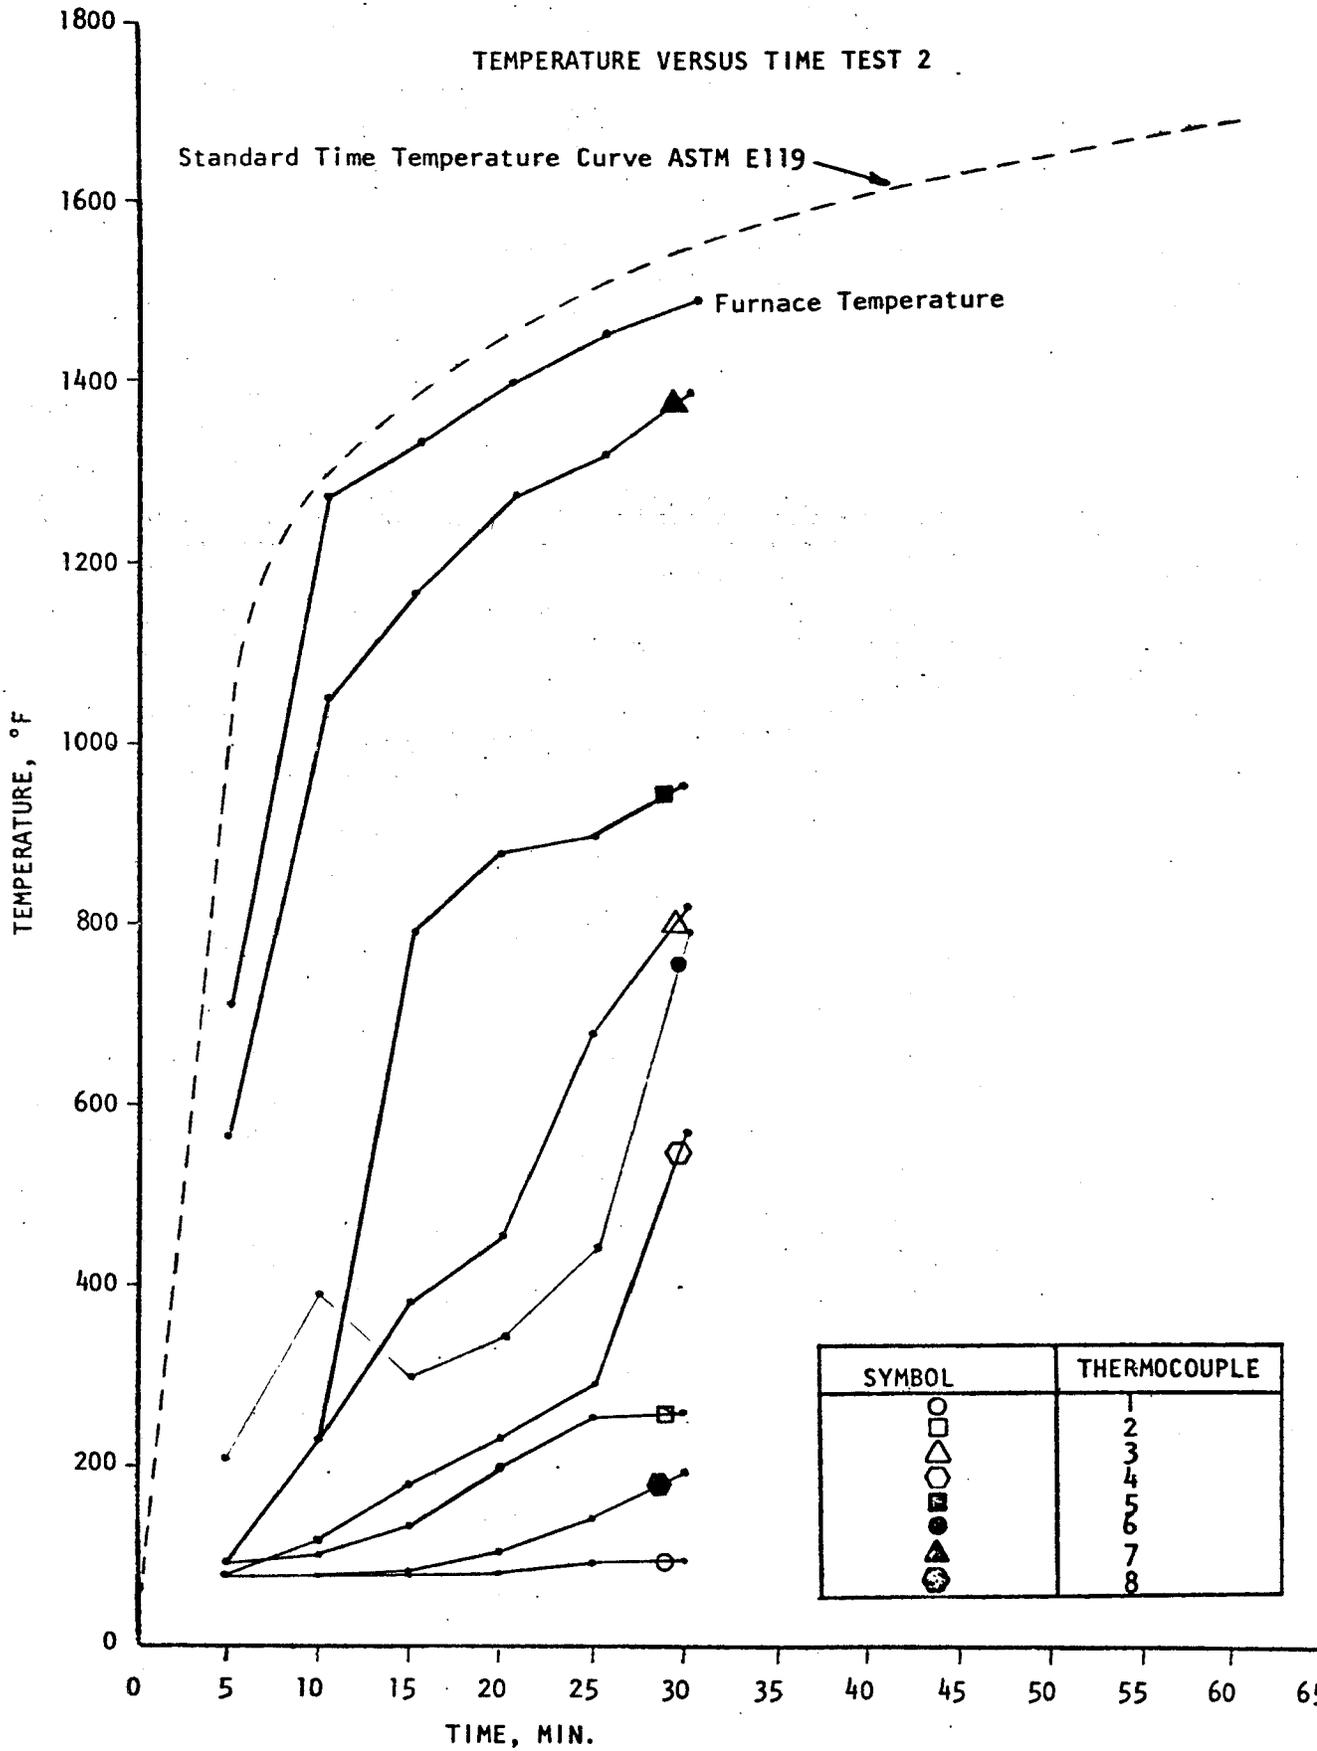
TEMPERATURE VERSUS TIME TEST 2

<u>Circuit No.</u>	<u>Time of Failure, Min/Sec Into Test</u>
2	11:30
5	11:40
7	12:30
8	13:20
6	13:35
9	14:00
3	14:45
11	14:50
1	17:30
4	18:30
10	22:15
14	26:00
Test Terminated	30:00

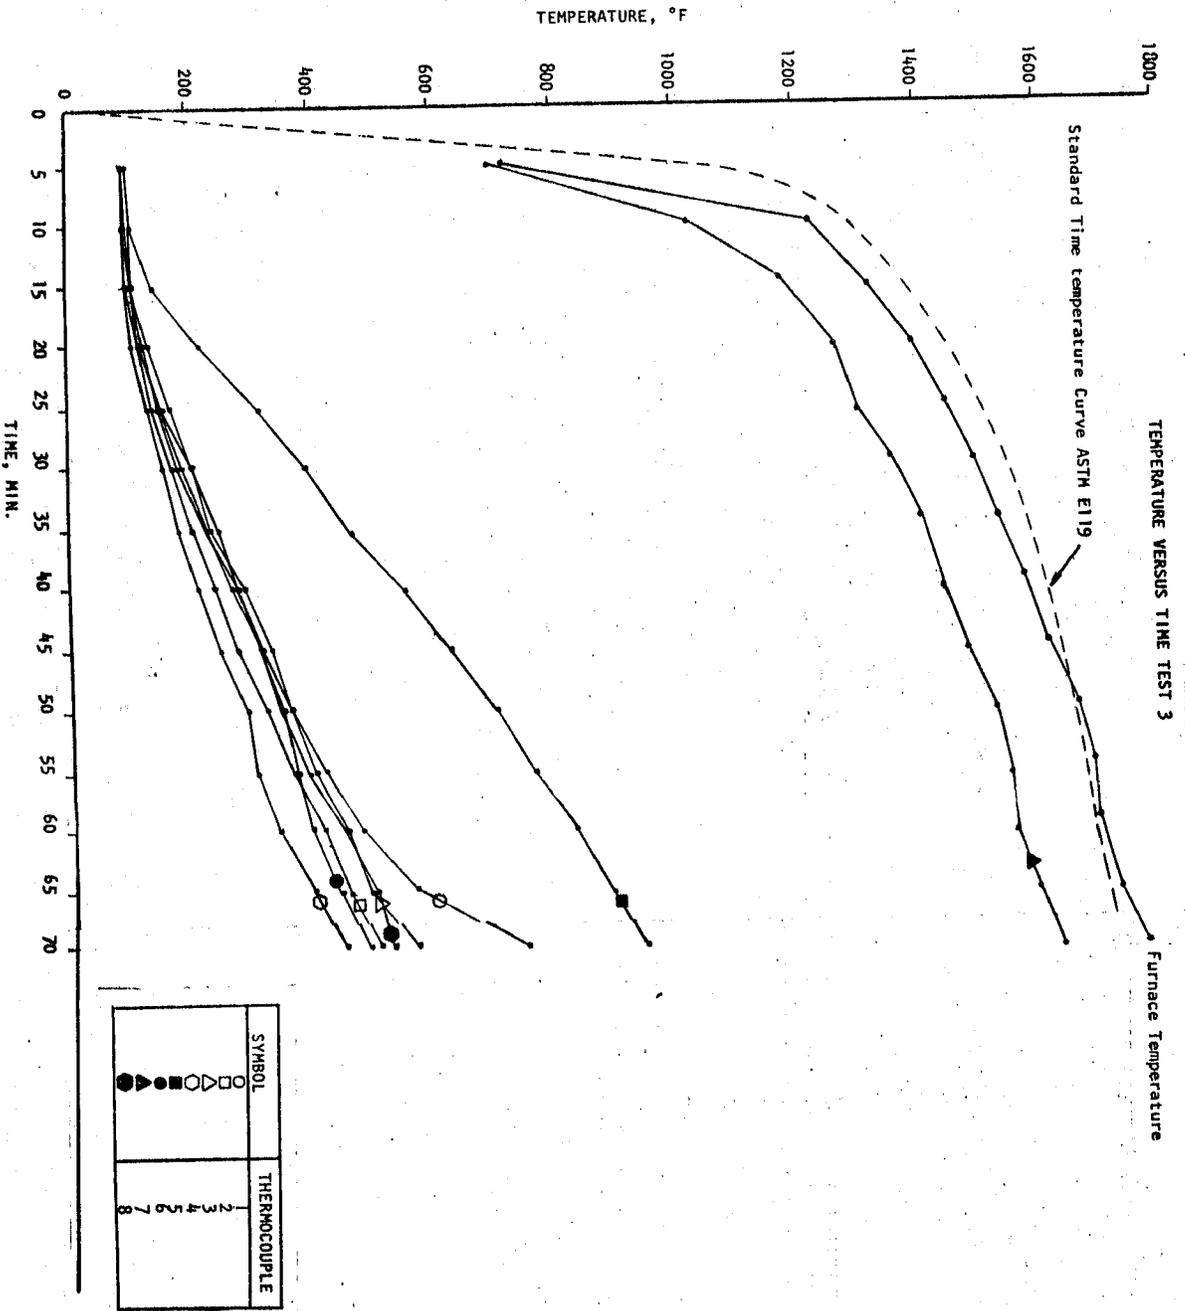
ILL. 15  
R 8758

<u>Circuit No.</u>	<u>Time of Failure, Min/Sec Into Test</u>
1	61:30
16	62:00
19	65:10
2	66:00
20	67:30
5	68:30
3	69:25
4	70:20
18	71:20
Test Terminated	73:00

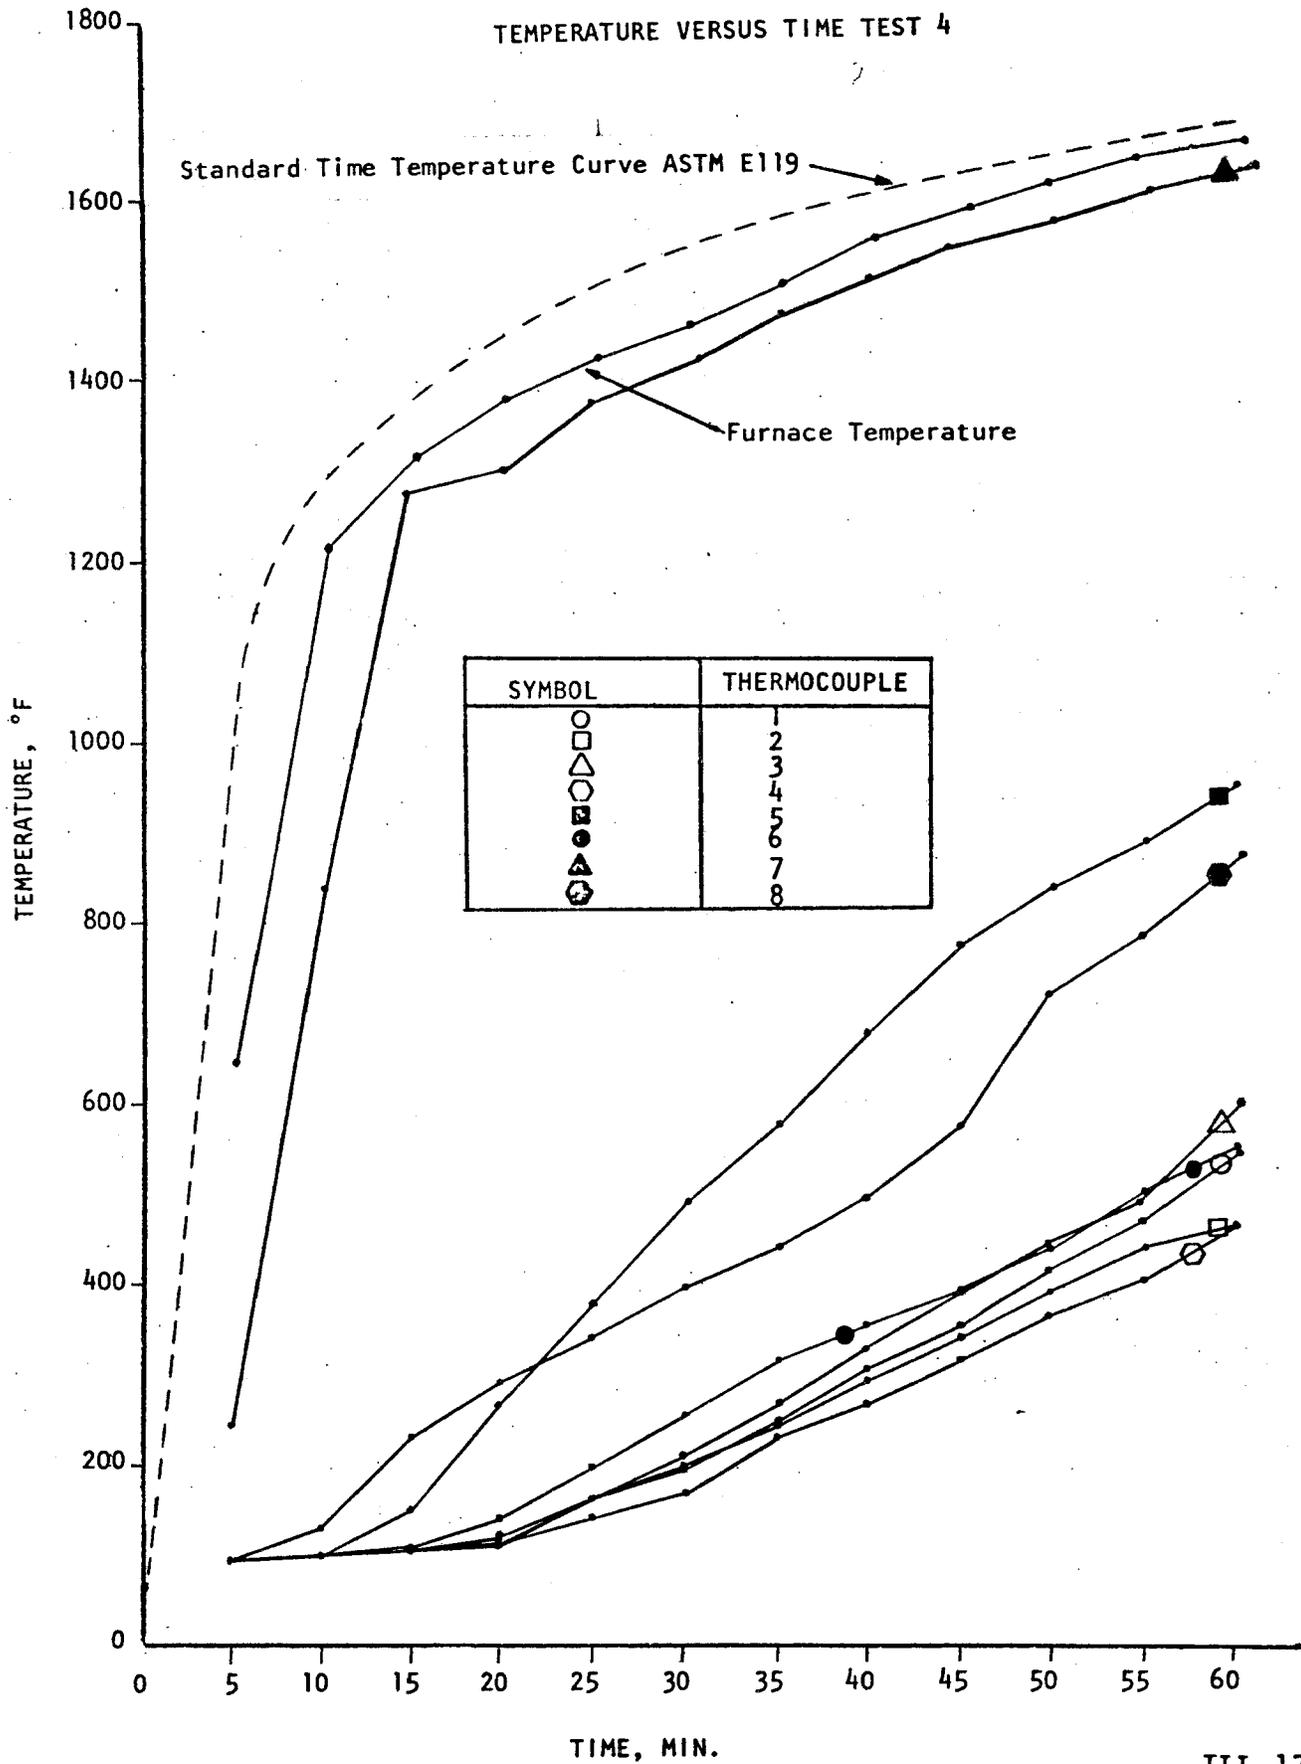
# TEMPERATURE VERSUS TIME TEST 4

<u>Circuit No.</u>	<u>Time of Failure, Min/Sec Into Test</u>
1	40:00
20	46:00
19	46:30
17	48:18
9	50:38
15	52:00
16	53:00
2	53:17
18	54:09
6	57:30
4	58:07
3	58:30
14	59:32
Test Terminated	60:00

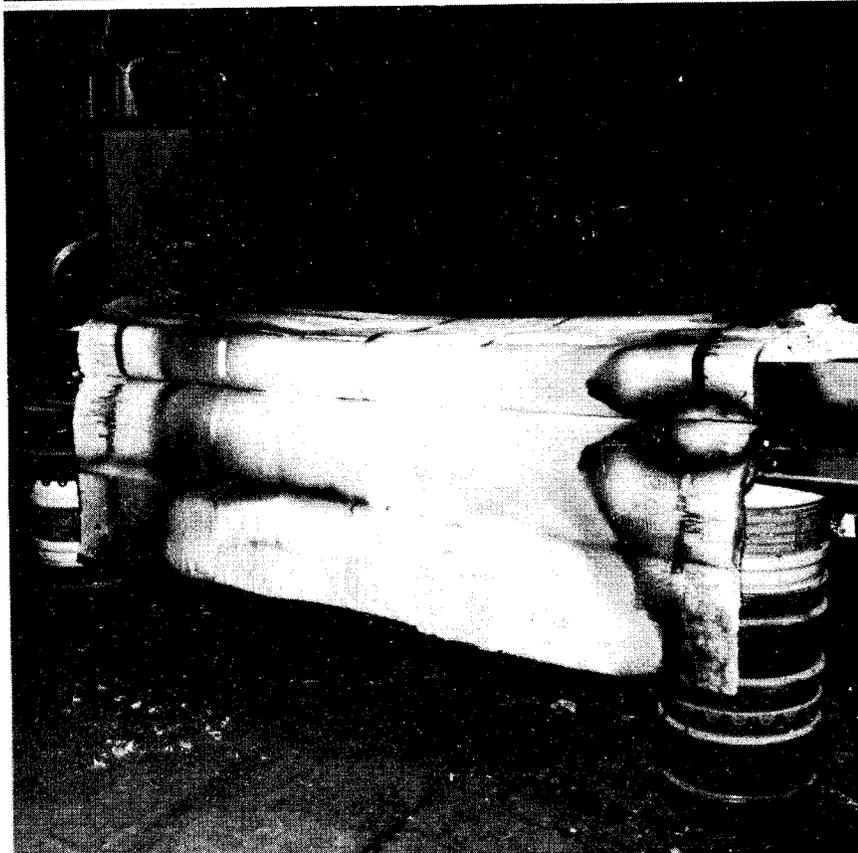
R8758  
Ill. 18

Post Test Observations - In general, the ceramic insulation appeared to have a brown char near each joint. The Okolon cable jacket material changed to white ash while the PVC cable jacket material decomposed exposing the copper sheath and leaving a black residue char. The general appearance of the insulation and cables after the test is shown in ILLS. 18 and 19.

GENERAL APPEARANCE AFTER TEST

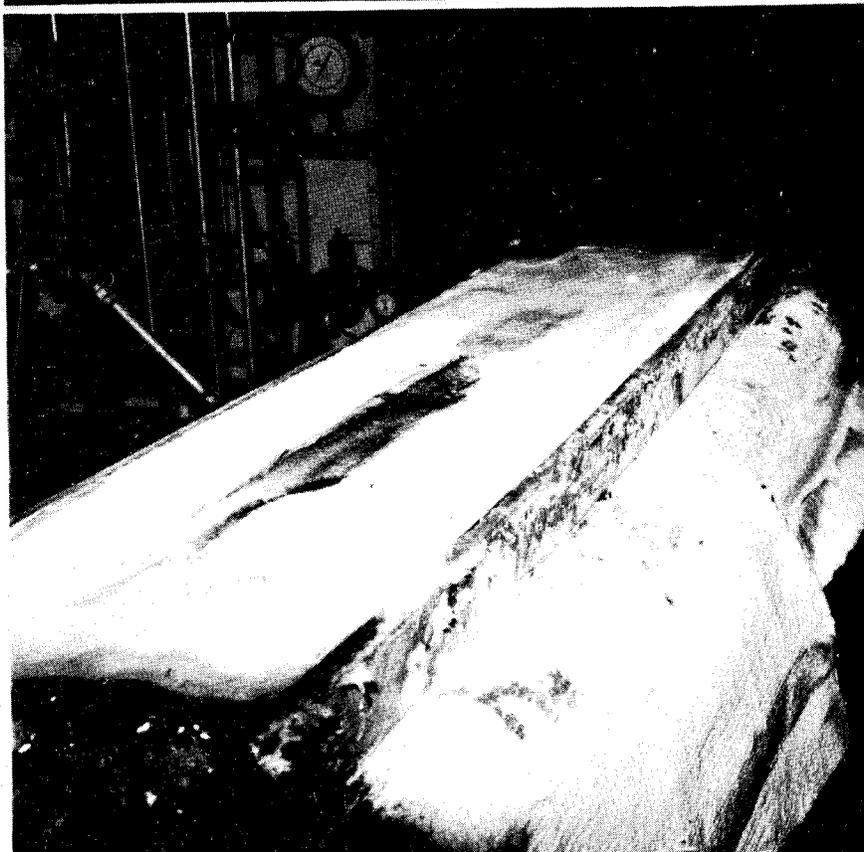
Ill. 19

GENERAL APPEARANCE AFTER TEST
