AN INVESTIGATION OF METHODS TO CONTROL POST-CRASH FUEL SPILL FROM INTEGRAL FUEL TANKS

K. D. Robinson
The Goodyear Tire and Rubber Company
1144 E. Market Street
Akron, Ohio 44316

DECEMBER 1971

FINAL REPORT

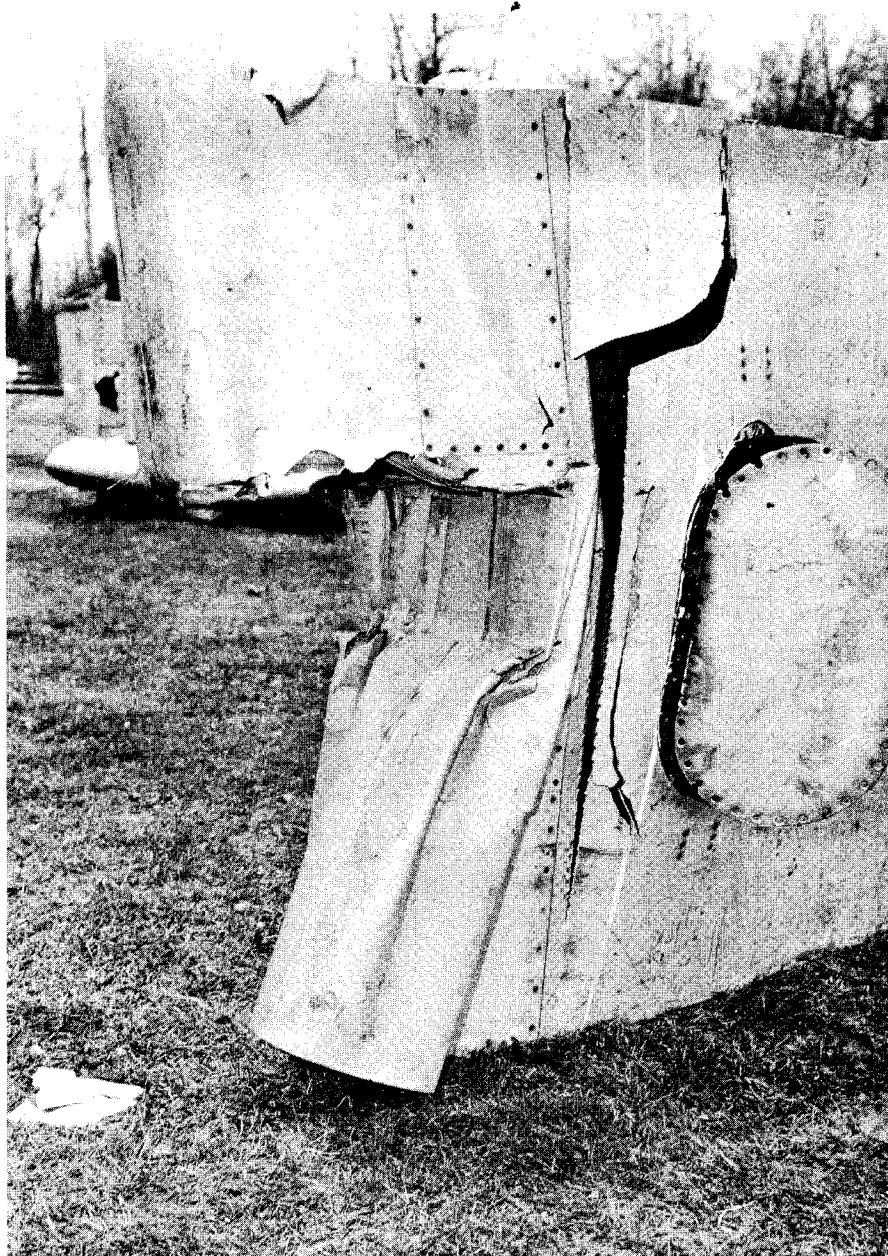
FIGURE 3 TYPICAL DAMAGE SUSTAINED BY DC-7 TANK AFTER BUCKLING TEST

Buckling Test - The buckling test was conducted on the simulated wing sections with a 15-foot drop and on the aircraft wing sections with a 40-foot drop. The buckling obstacle was a vertical stack of railroad ties approximately 7 inches wide. Crushable corrugated fiberboard columns were used each side of the obstacle to limit penetration to approximately one-half the depth of the forward fuel cavity. Guide plates were attached to the forward and trailing edges of the test sections and to the vertical cables to insure impact at the approximate center and at an angle of 90° to the front spar of the wing section and to the forward surface of the simulated wing section. See Figures 2 and 3.

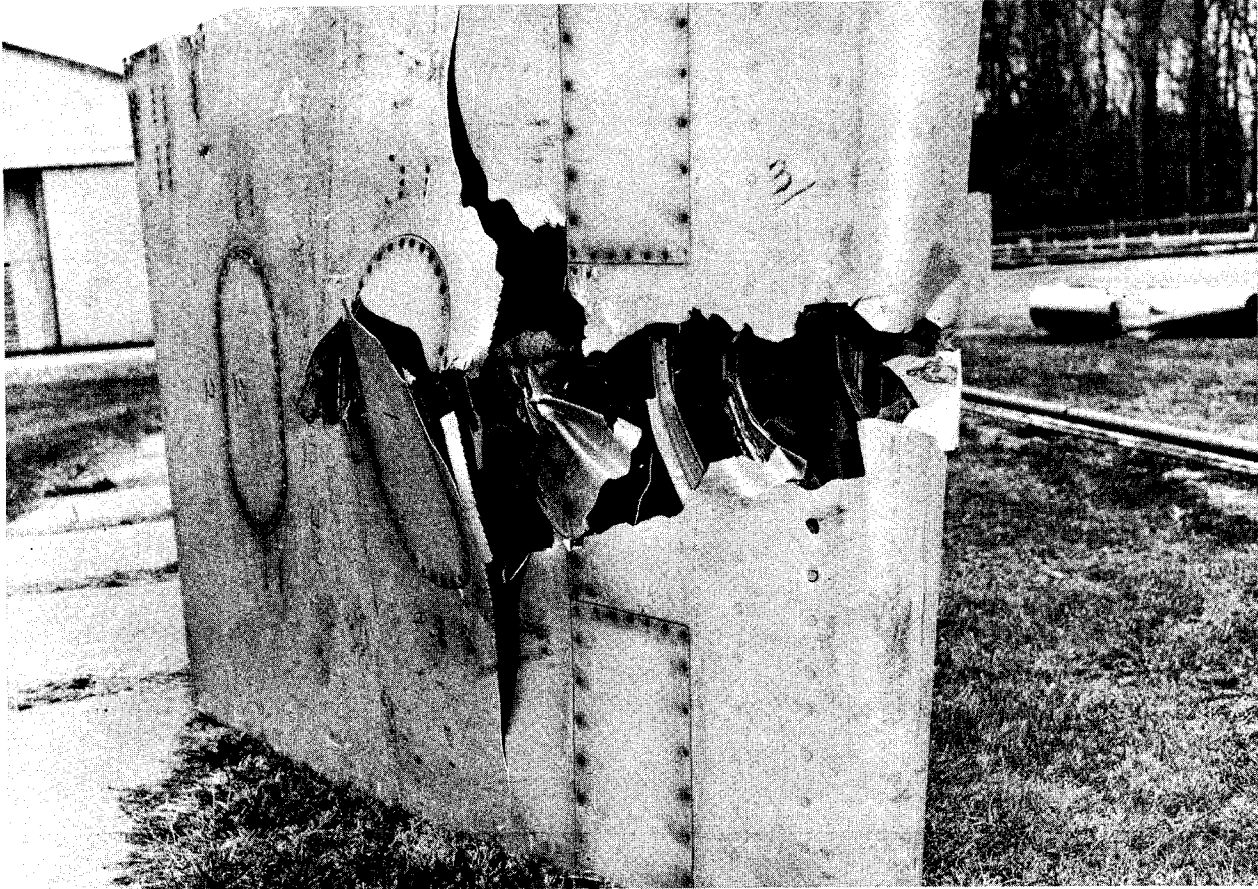
FIGURE 5 TYPICAL DAMAGE SUSTAINED BY DC-7 TANK
AFTER SLASHING TEST

Slashing Test - The slashing test was conducted on the aircraft wing sections only. The drop height was 20 feet. The slashing obstacle is the buckling obstacle with a 4-inch "I" beam attached to the top and extending beyond the end of the ties approximately 12 inches. The guide plates were attached to the wing so as to insure impact at the center lower half of the leading edge. Impact was normal to the wing bottom causing slashing of the wing bottom one-half to two-thirds the depth of the forward fuel tank. Depth of penetration was controlled by corrugated fiberboard columns located each side of the impact obstacle. See Figures 4 and 5.

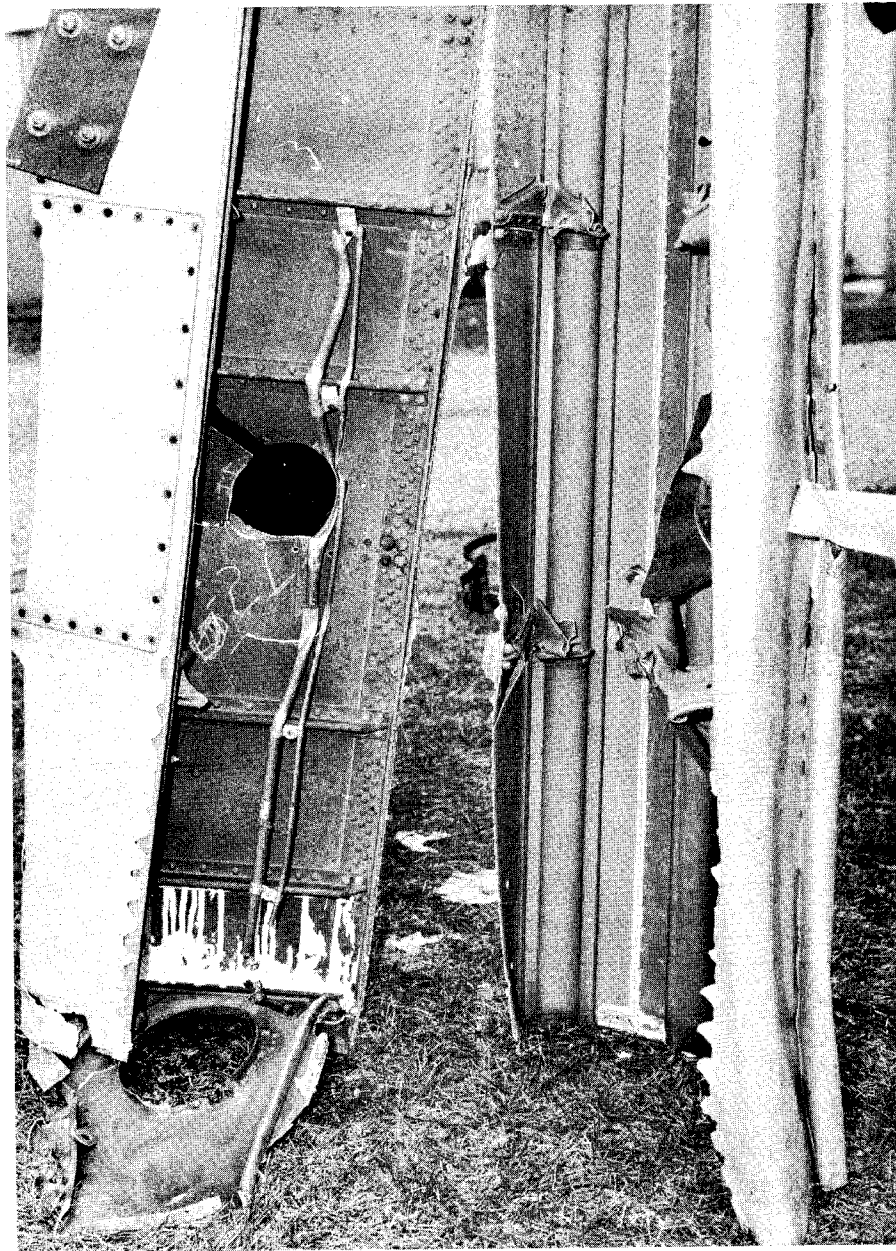
FIGURE 7 TYPICAL DAMAGE SUSTAINED BY DC-7 TANK
AFTER PENETRATION TEST

Penetration Test - The penetration test was conducted on the simulated wing sections with a 10 foot drop and on the aircraft wing sections with a 20 foot drop. The penetration obstacle was a 22-inch length of 4-inch pipe welded to a base plate and having a 2½-inch pipe placed inside and extending 7 inches above the 4-inch pipe. Guide plates were attached to the wing section so as to cause impact to occur on an axis extending through the front lower edge and the aft upper edge of the fuel cavity. The DC-7 wing tank sections had an impact angle of approximately 75° so that the penetrating obstacle fractured the lower forward wing spar before entering the fuel cavity. However, because of the comparatively small size of the simulated wing sections, the impact angle was set at 90° to the forward surface to insure impact and penetration. Corrugated fiberboard columns were used to limit penetration damage to the forward fuel cavity only. See Figures 6 and 7.

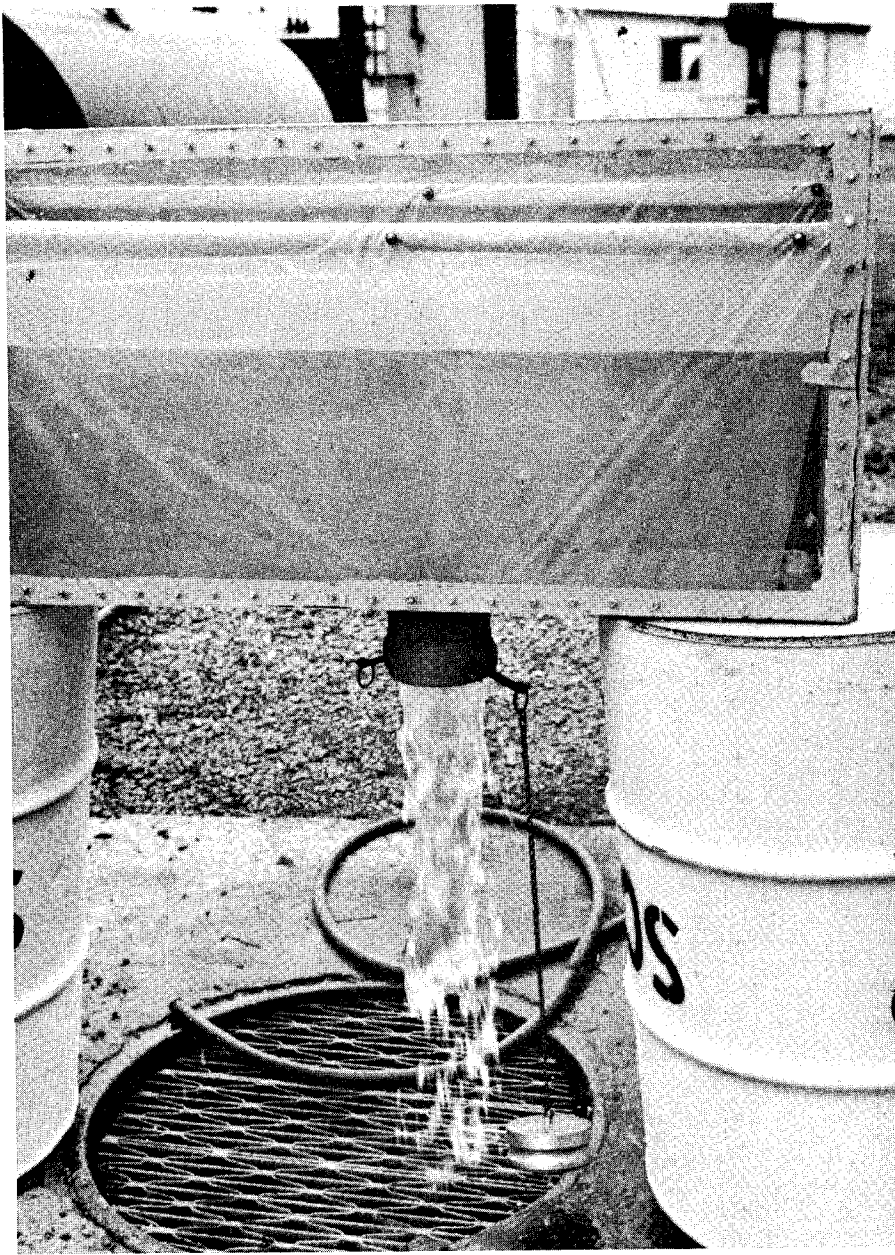
FIGURE 9 SIDE VIEW OF FUEL FLOW TEST SHOWING CURTAIN POSITION AT INITIAL VALVE OPENING

Fuel Flow Test - The fuel flow test fixture utilized in screening curtain concepts was a simulated wing test structure having a prearranged penetration wound. A quick disconnect fitting with a 4-inch inside diameter with jagged sheet metal tabs approximately 3 inches long attached to the fuel side was installed in the tank forward face to simulate the penetration wound. A clear plastic side and forward face were installed to allow visual observation of curtain action during fluid dumping tests. The test fixture with curtain installed was set on drums with the forward face oriented horizontally approximately 30 inches from the ground. The tank was filled with 40 gallons of test fluid (water). Upon opening the quick disconnect valve the fluid was dumped, the curtain action was observed and the total time to drain was noted. See sequence of flow test photographs, Figures 8, 9, and 10.

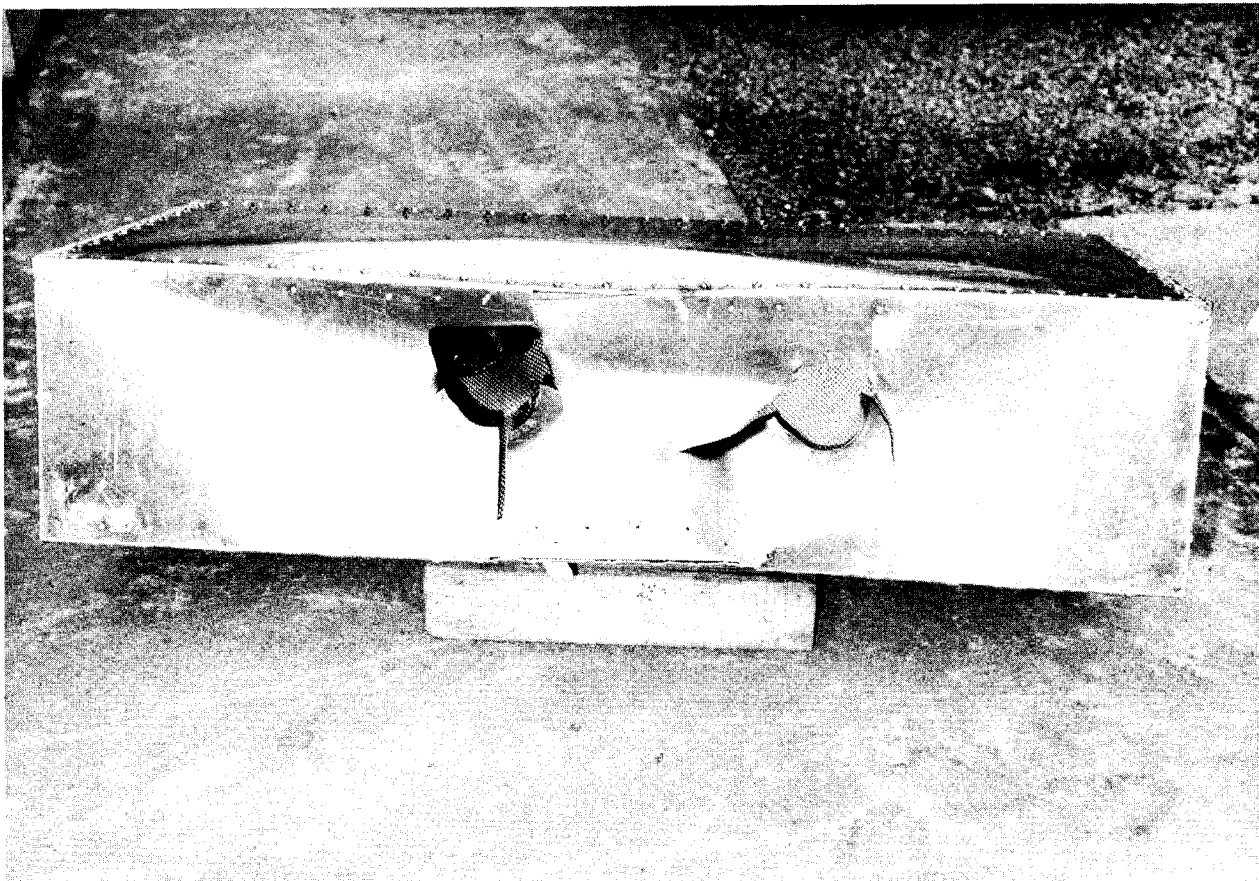
FIGURE 13 PENETRATION TEST ON SIMULATED WING SECTION
(OUTSIDE VIEW)

Penetration Test - The pipe penetrated the structure but did not pierce the liner. There was no loss of test fluid. The test structure was dropped a second time with impact occurring approximately 12 inches from the first impact area. Depth of penetration was deeper than the previous drop. There was no damage to the liner in the area of the second impact; however, a jagged piece of structure at the original impact area cut the fabric and the liner (2-inch cut). Fluid loss on the second drop was 6 gpm. A 4-inch diameter hole was punched in the structure on the first drop and a 5-inch diameter hole on the second drop. The welded seams, top and bottom edge of the leading surface, failed between the two impact areas during the second drop. Instrumentation recorded 15 G's during both drop tests. Figures 13 and 14 show the results of the above penetration test performed on a structure with the leading surface fairing removed and seams welded.

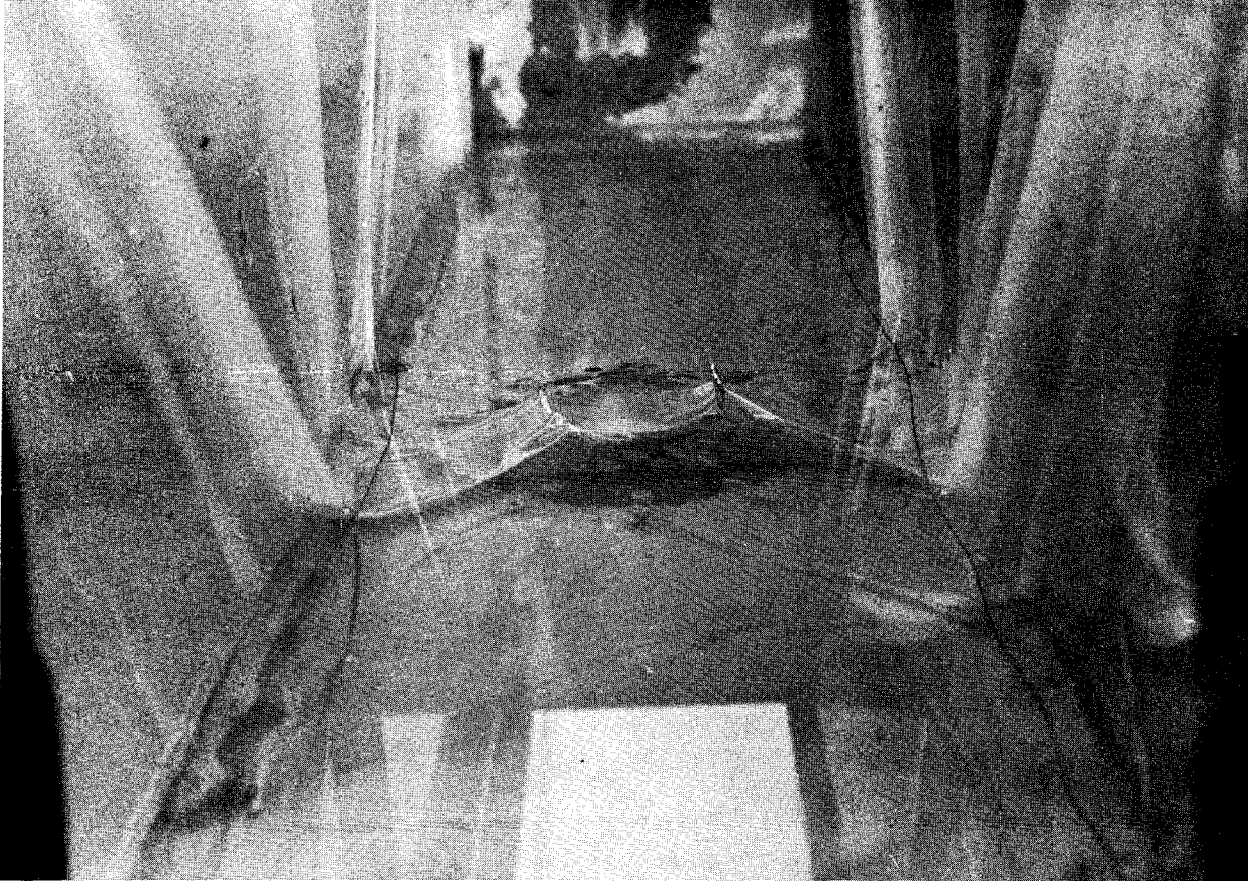
FIGURE 15 FUEL FLOW TEST SHOWING CURTAIN IN POSITION
OVER WOUND

A second 0.002-inch thick polyethylene film was installed as before and the curtain positioned so as to lay relatively close to the front, bottom, and top surface of the structure. Position was maintained by securing the top and bottom leading edges with piano wire across the full width of the tank. Upon release of the quick disconnect there was full flow for approximately 2 minutes and 30 percent flow for an additional 2 minutes. Figure 15 shows the curtain in position over the wound, also shown are the piano wires used to maintain curtain position prior to test.

As a result of the above tests it was felt that curtain position within the structure would have to be maintained in close proximity to the wound to insure any degree of success. Subsequent tests were conducted with curtain position maintained through use of piano wire as was done for Test No. 2 of Curtain Concept No. 1.
