FULL-SCALE AIRCRAFT CRASH TESTS OF MODIFIED JET FUEL

FINAL REPORT

1. Report No. FAA-RD-77-13		2. Government Accession No.		3. Recipient's Catalog No.	
4. Title and Subtitle FULL-SCALE AIRCRAFT CRASH TESTS OF MODIFIED JET FUEL				5. Report Date July 1977

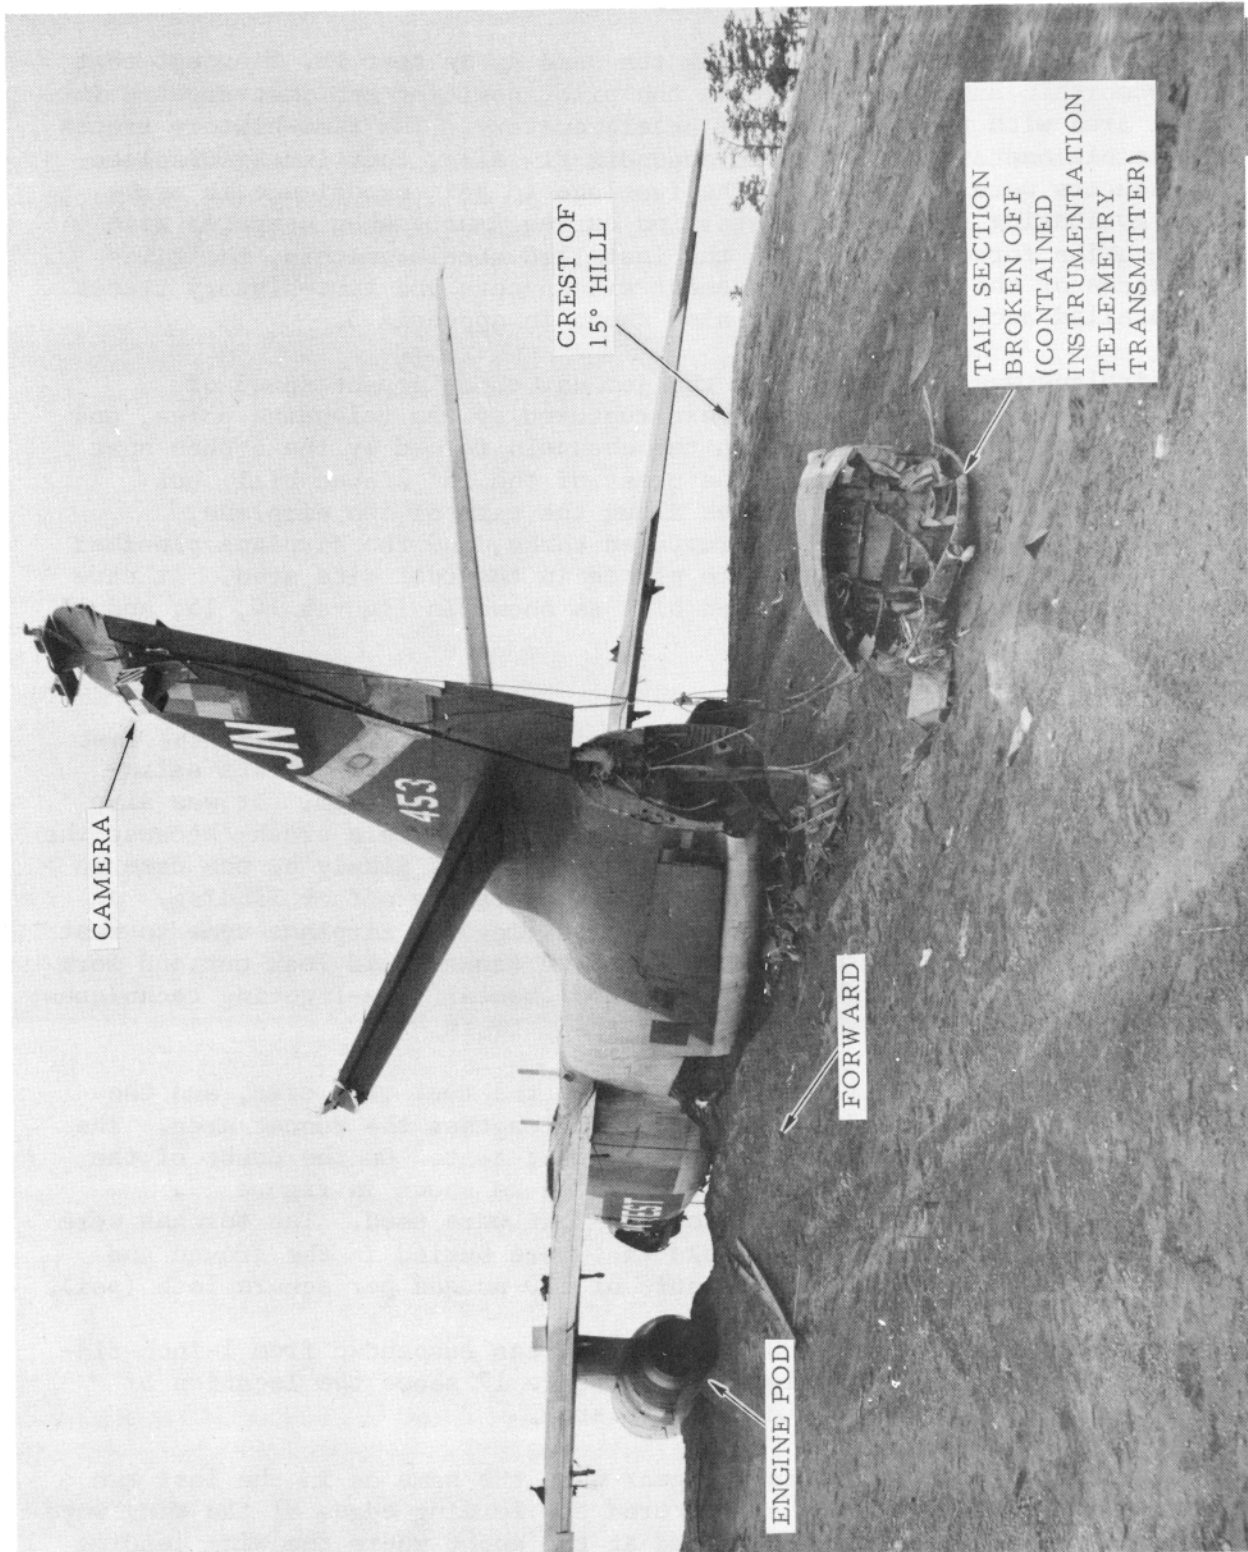
74-38-16

The RB66 airplane was accelerated by the jet car to an impact speed of 105 knots. The integral wing tanks were ruptured by the telephone poles, and the modified fuel spilled out through the channels formed by the broken spar web. The airplane came to rest on the crest of the 15° sloped hill, but did not burn; nor were there any fires along the path of the airplane, even though fuel spilled out of the ruptured tanks, and the airplane ploughed through the ignition sources that were placed in the test site area. It came to rest on the crest of the 15° sloped hill as shown in figures 14, 15, and 16.

FIGURE 14. RB66 AIRPLANE OF TEST NO. 3 (LEFT REAR VIEW)

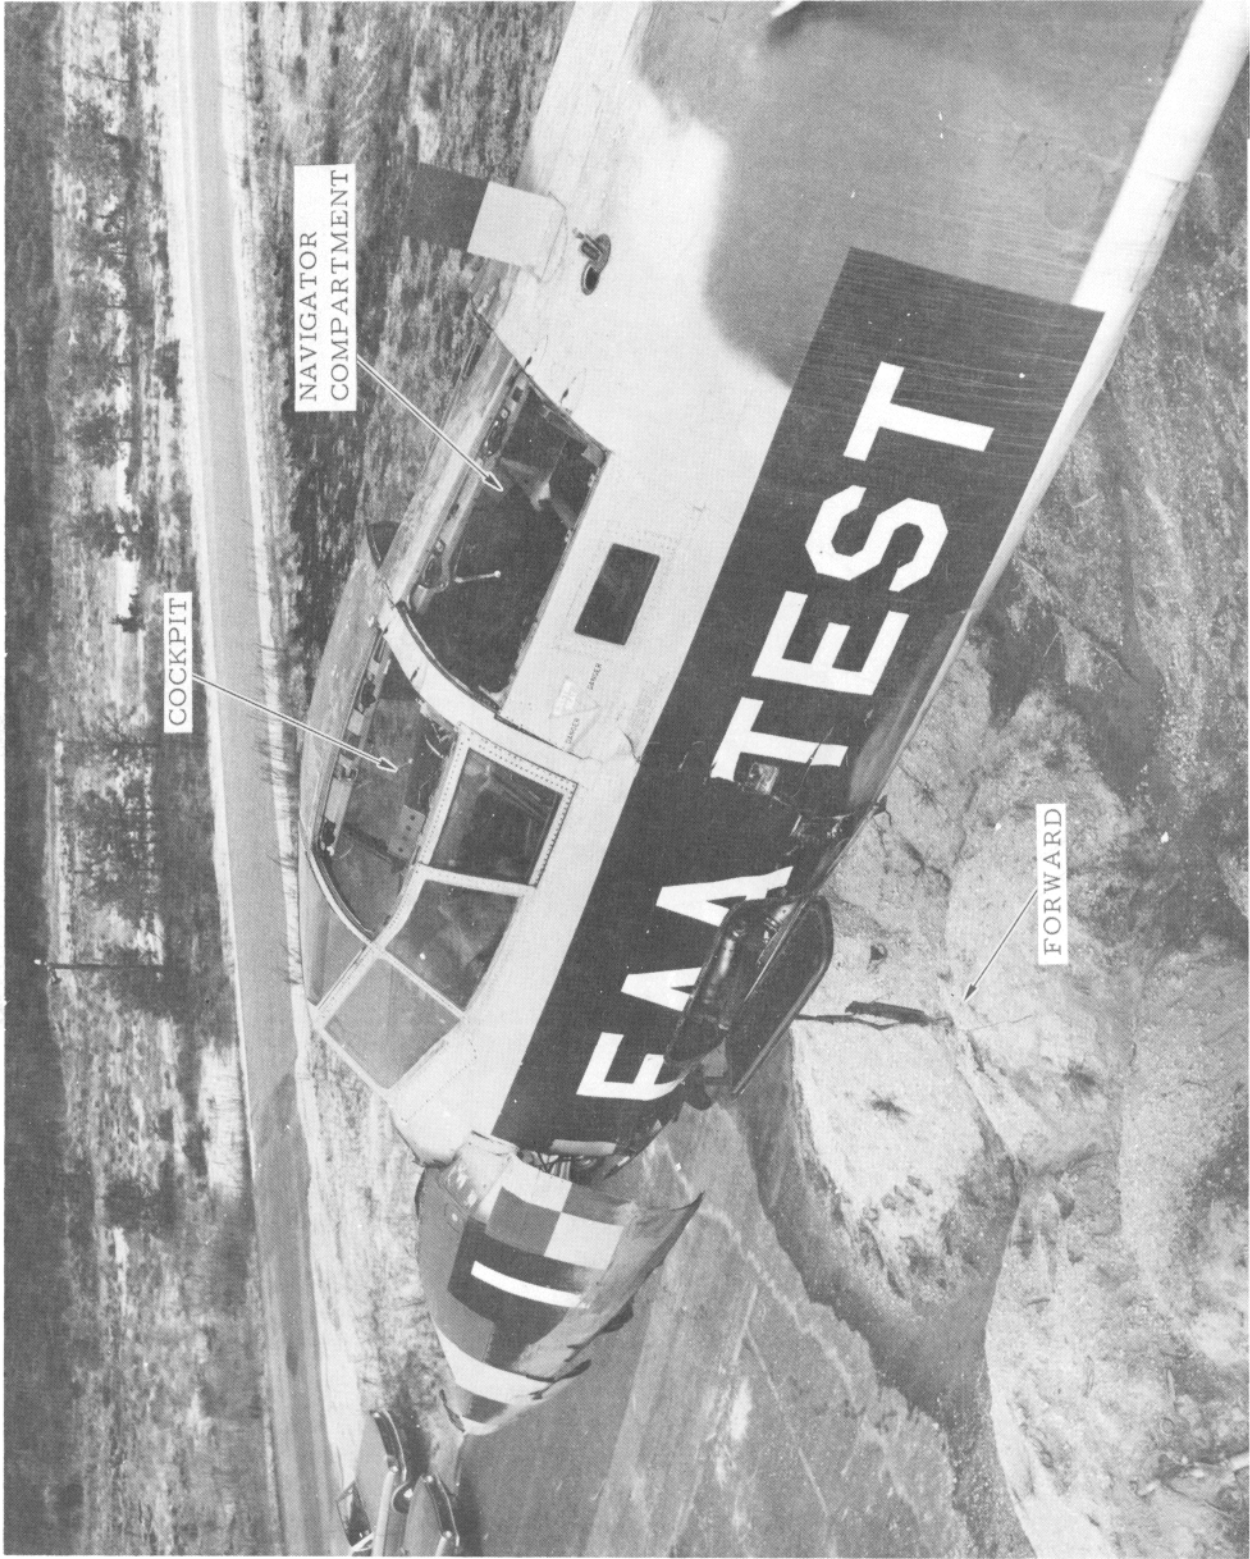
74-38-17

FIGURE 15. RB66 AIRPLANE OF TEST NO. 3 (LEFT SIDE VIEW)

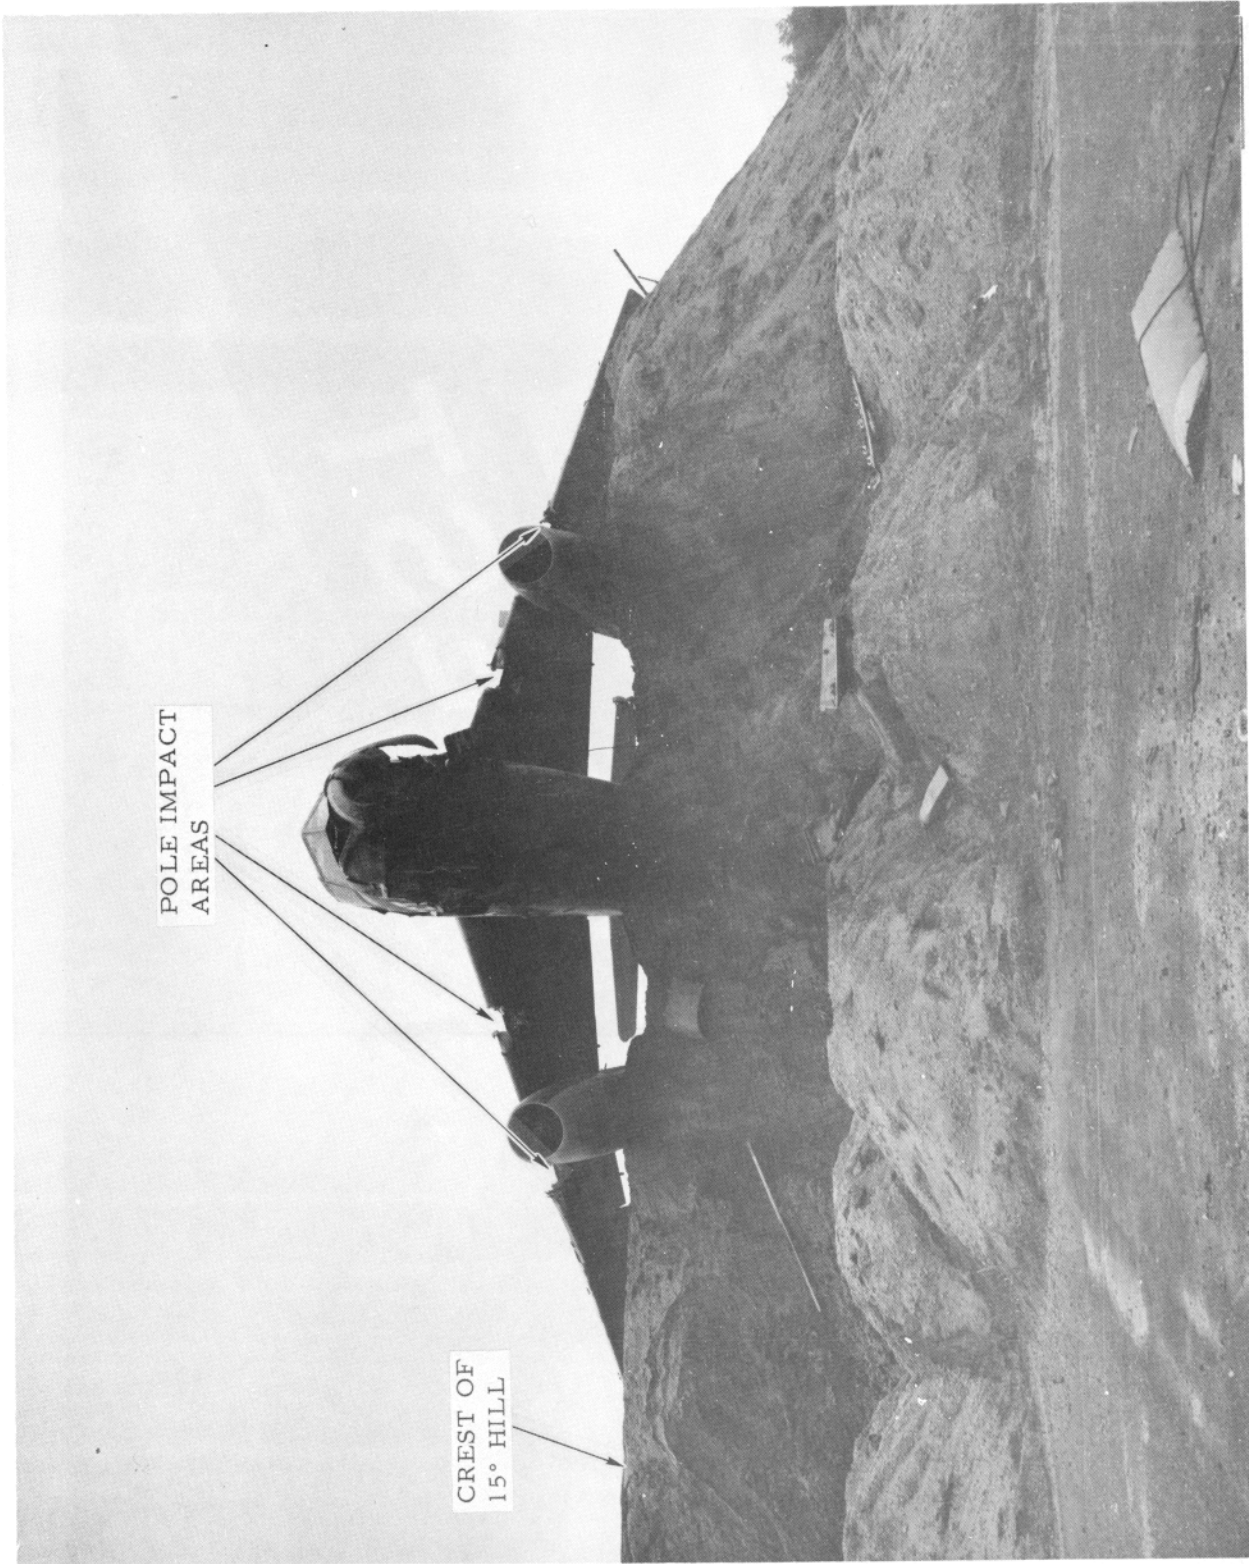
74-38-18

FIGURE 16. RB66 AIRPLANE OF TEST NO. 3 (GROUND FRONTAL VIEW)

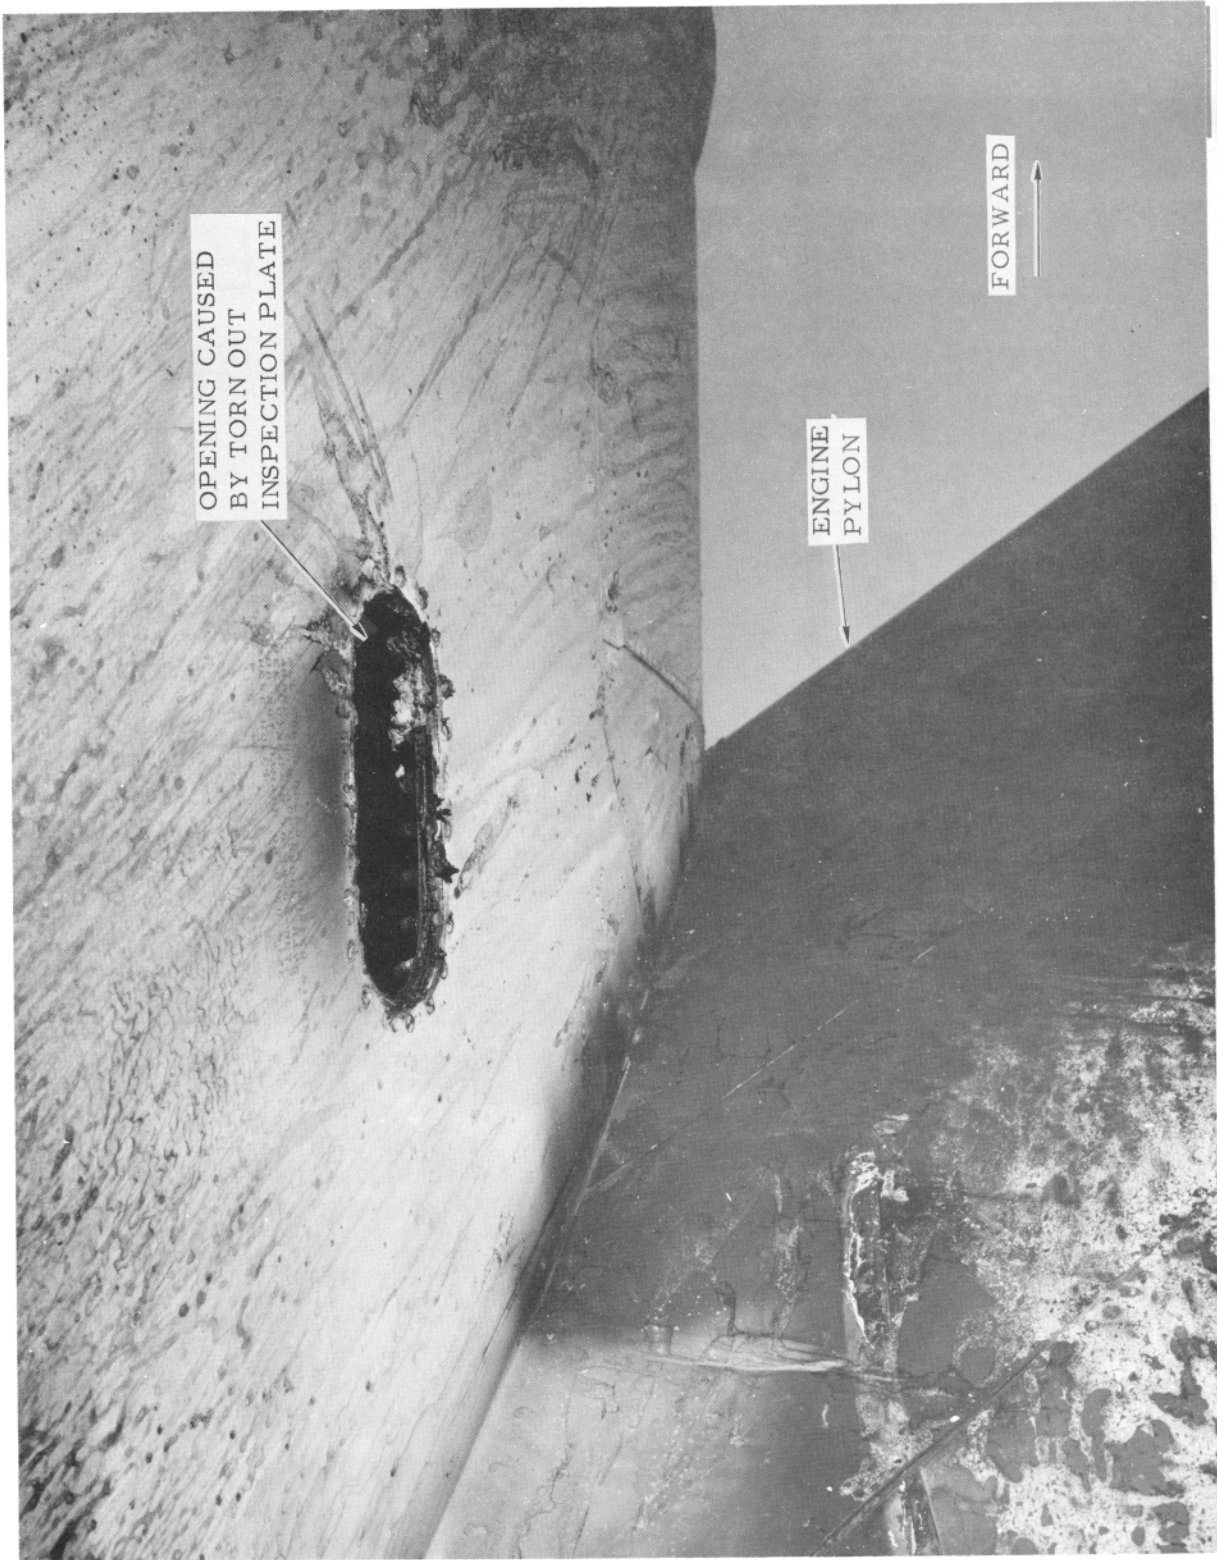
74-38-24

FIGURE 22. EXISTING OPENING IN FUEL TANK AFTER INSPECTION
PLATE HAD BEEN PULLED OUT

The four inspection plate plugs that were attached to the landing gear by stainless steel cable lanyards were pulled out successfully and produced openings in the bottom of the wing tanks, as shown in figure 22. The four telephone poles caused large gaping openings in the leading edge of the wings, as shown in figure 24. The combination of these openings allowed copious quantities of fuel to pour out of the wing tanks as the airplane ploughed into the 3° sloped hill (figure 37). From the high-speed motion pictures taken during the test, it was determined that the fuel spewing from the ruptured tanks was ignited between the fuselage and the starboard engine which was running at the time. A fire developed at ground level in line with and aft of the starboard engine as the airplane slid along the 3° sloped hill and reached the crest of the hill. The propane torches burning at the top of the 3° sloped hill ignited the spilling fuel on the left side of the airplane. From that point on, the airplane was enveloped in flame as it passed down the test site area, and it continued to burn after it came to rest until the flames were extinguished by the fire fighters on the scene.

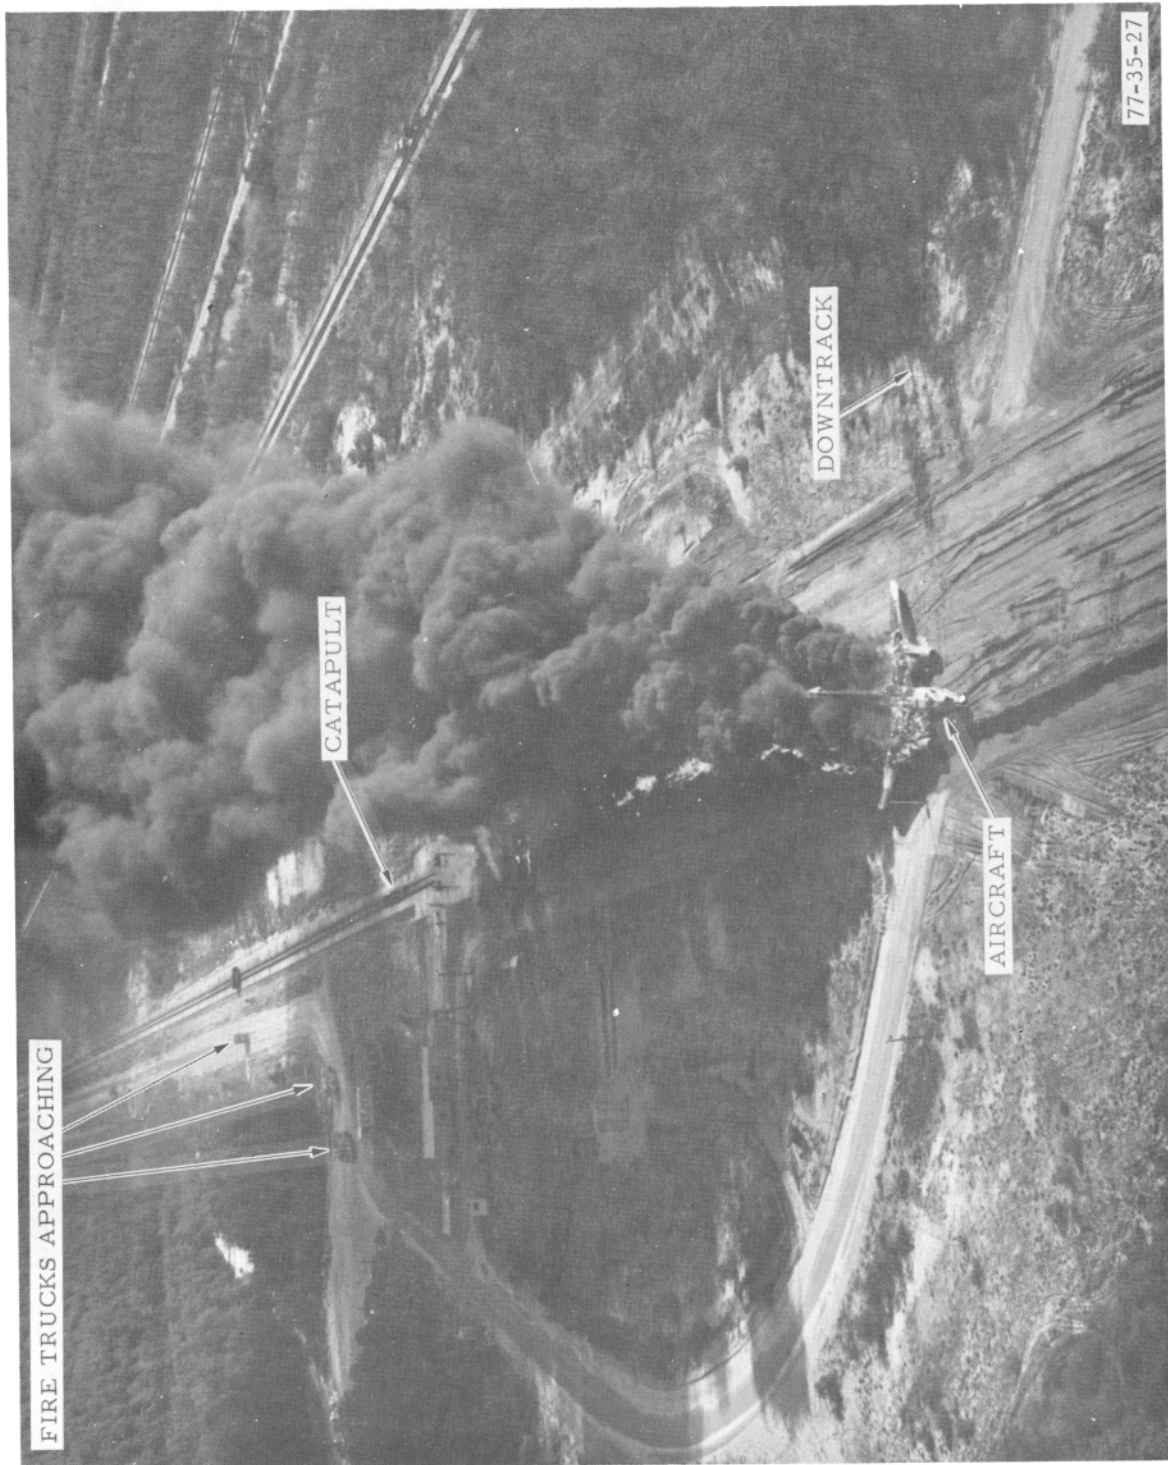
The engines on the airplane were started on JP-4-type fuel and switched over to run on the modified fuel in the wing tanks. The airplane was accelerated to an impact speed of 102.4 knots by the jet car, and the airplane came to rest 600 feet downtrack. There was considerable fire in the test site area, and the airplane itself was on fire from the forward wing roots aft, to the tail (figure 27).

FIGURE 27. RESULTING FIRES FROM SPILLED FUEL DURING TEST NO. 4

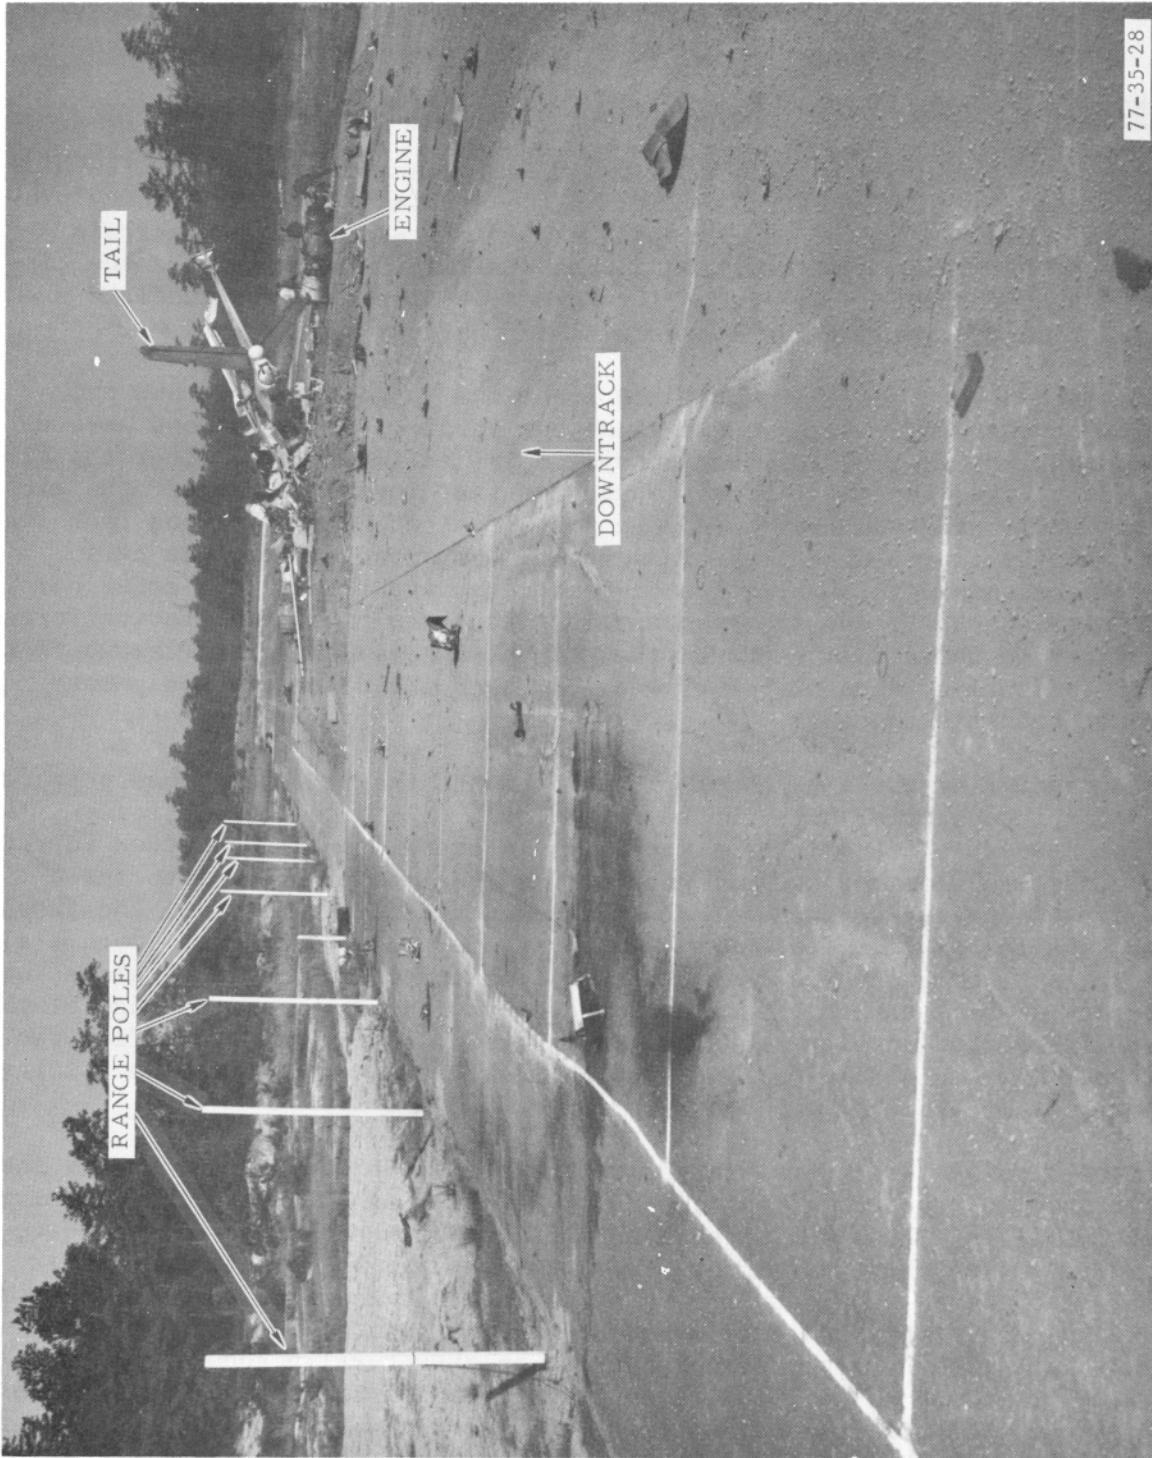
After encountering the landing gear obstacles and the four telephone poles, the A3 airplane settled onto the 6° sloped hill in a nose-down attitude. The vertical descent of the airplane was abruptly changed as it proceeded forward, and the nose section and cockpit area of the fuselage ploughed into the 6° slope. Both engines contacted the 6° slope as the forward part of the fuselage failed, and the port engine was torn from its mount. The airplane became airborne for approximately 190 feet after it left the crest of the 6° slope, and as it settled back toward the ground, the port wing contacted the edge of the 2-foot-high earthen pillow that was constructed 200 feet downtrack from the 6° slope. The whole airplane folded upon itself and came to rest in a large compact pile of wreckage, as shown in figures 28 and 29.

Since the airplane structural integrity had been completely destroyed by the time it came to rest, this test could not be considered to be within the limits of survivability. From the high-speed motion picture coverage of the test, it was determined that the impact forces encountered by the airplane as it settled onto the 6° sloped hill were so severe that they caused vital structures, such as the wing roots and engine-pod attachment points, to fail. As the airplane left the 6° slope, it appeared to be structurally sound, but more than likely, it was not. The movement of all the parts, wings, fuselage, and tail, through the air at the same velocity made it appear intact, but when the airplane settled back to ground level, there was not enough structural strength left to hold the various parts in their relative positions, and the airplane came to rest in a heap.

FIGURE 28. WRECKAGE OF A3 AIRPLANE OF TEST NO. 1 (LEFT REAR VIEW)

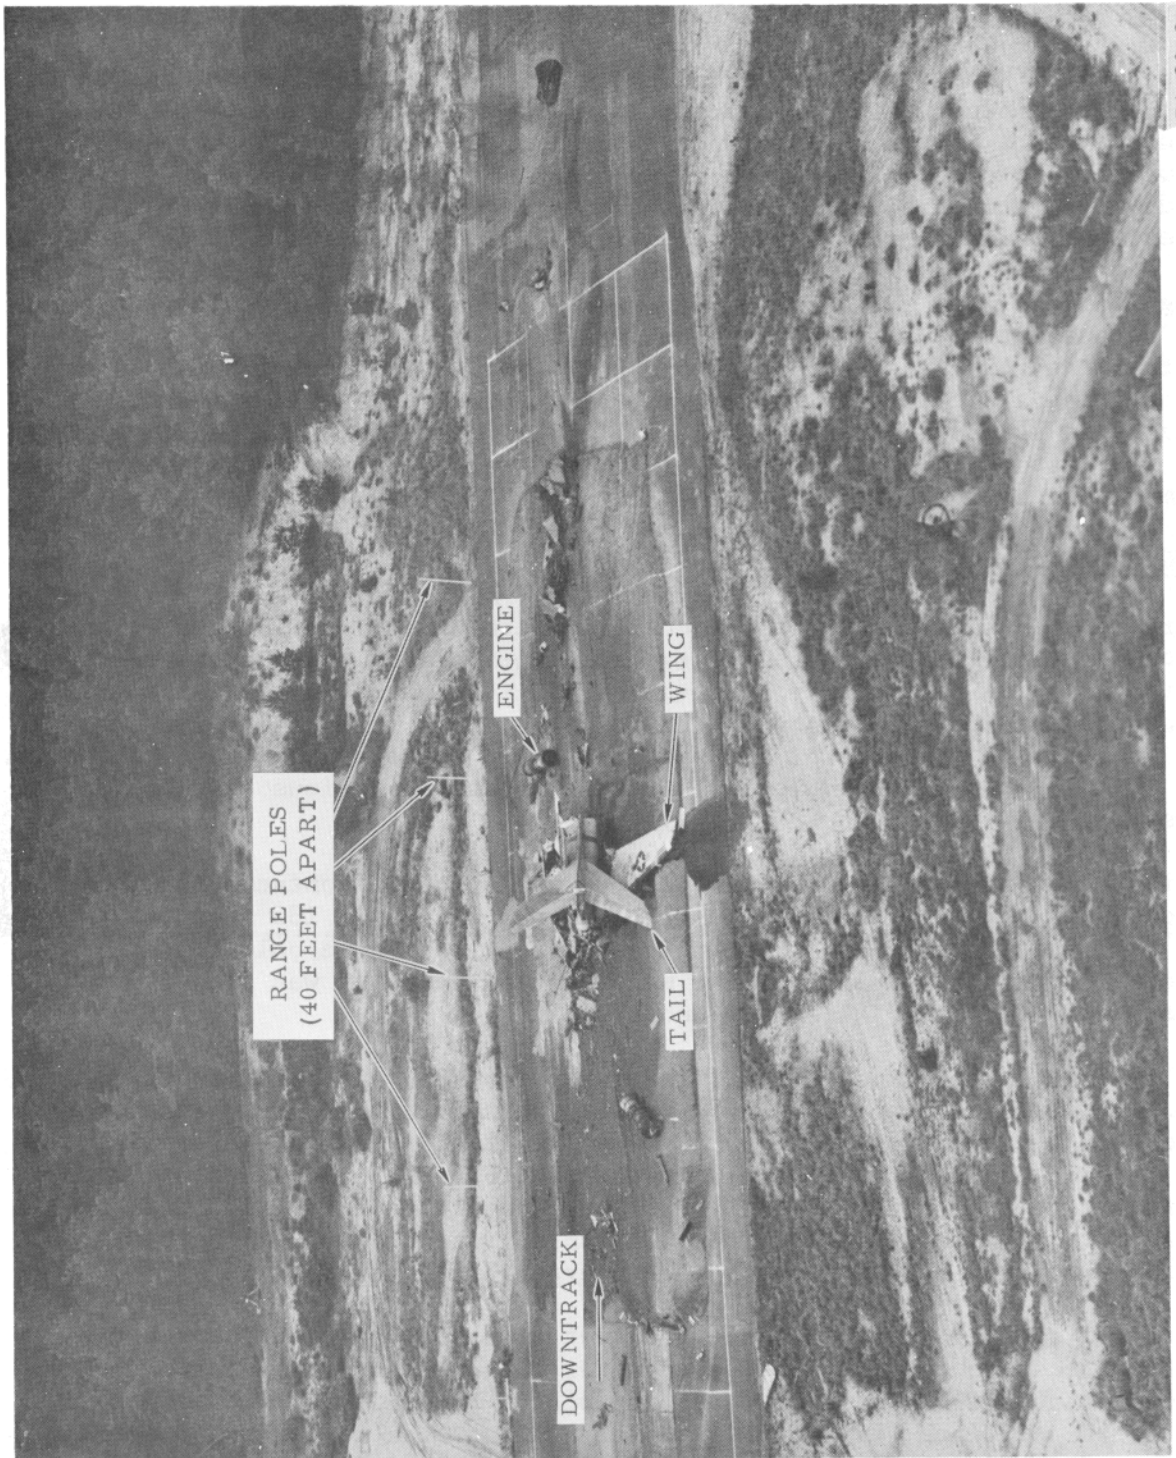
74-38-8

FIGURE 29. WRECKAGE OF A3 AIRPLANE OF TEST NO. 1 (OVERHEAD RIGHT SIDE VIEW)

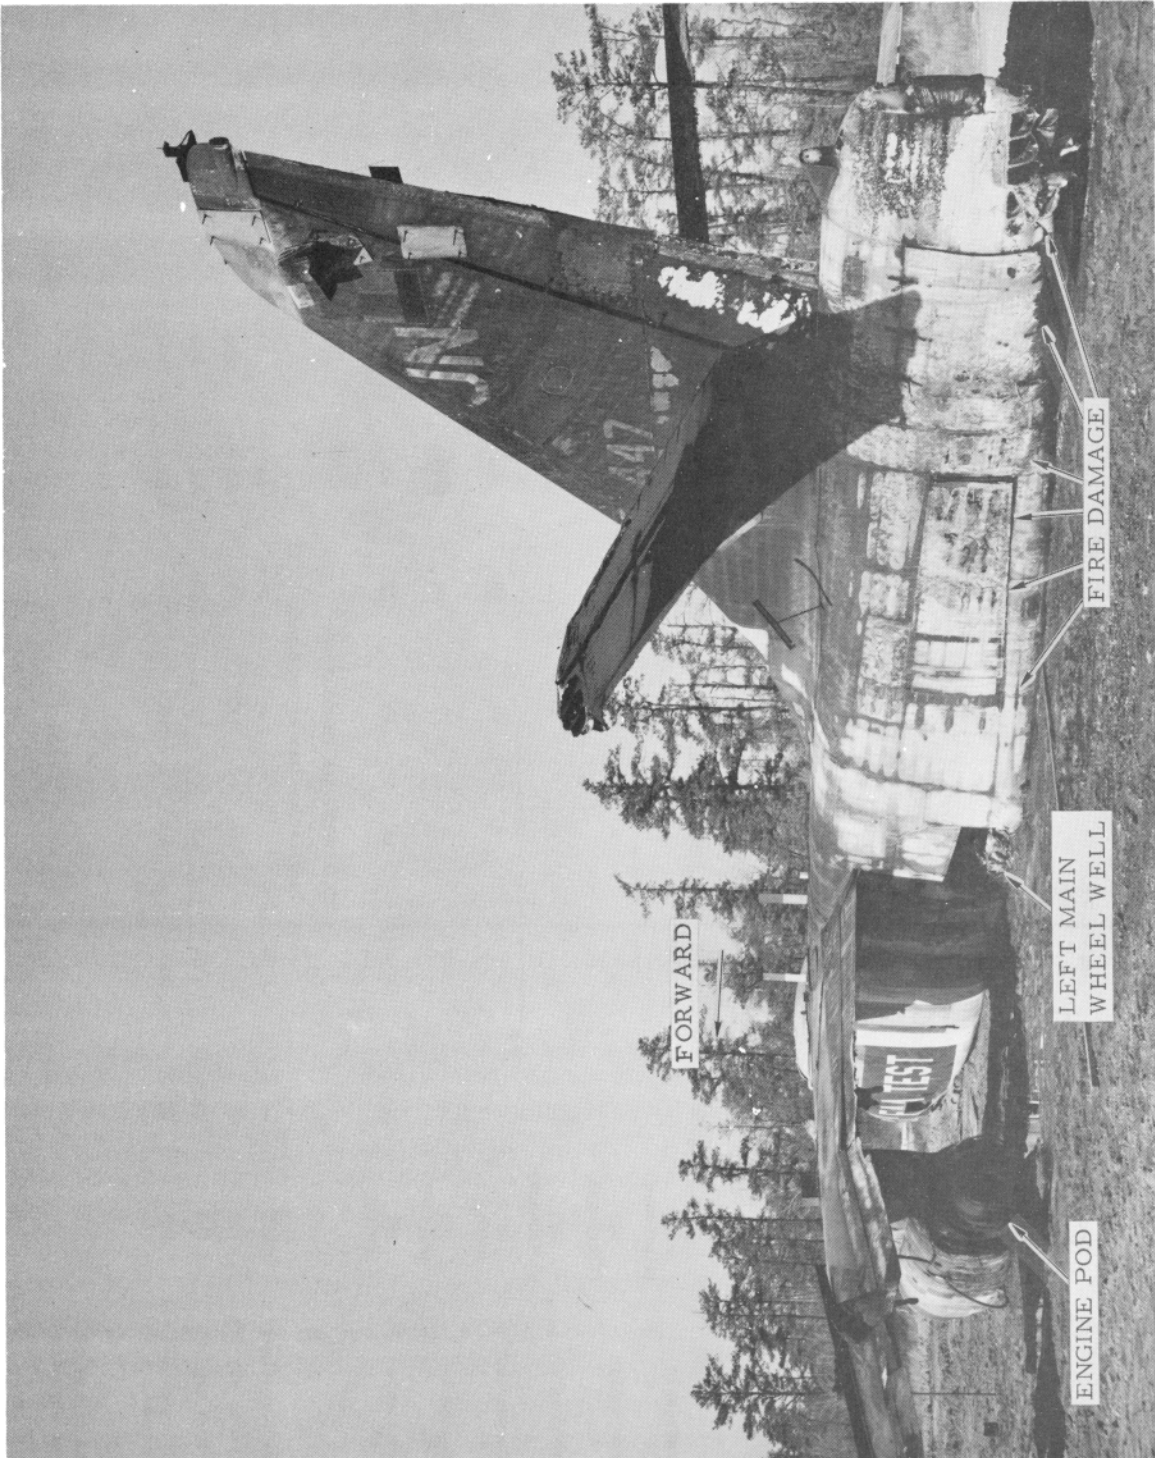
74-38-37

The fire had to be extinguished by the fire-fighting crew that was standing by at the crash site area. Figures 38 and 39 show the hulk of the airplane after the fires were extinguished. The fires were confined to that part of the airplane aft of the wing leading edge mainly because the forward velocity of the airplane caused the spilled fuel and flames to propagate aft, and also because the airplane came to rest with its nose pointed into the prevailing wind. Therefore, the cockpit area of the fuselage was relatively free of fire and heat.

FIGURE 38. LEFT-SIDE VIEW OF RB66 AIRPLANE USED IN TEST NO. 4

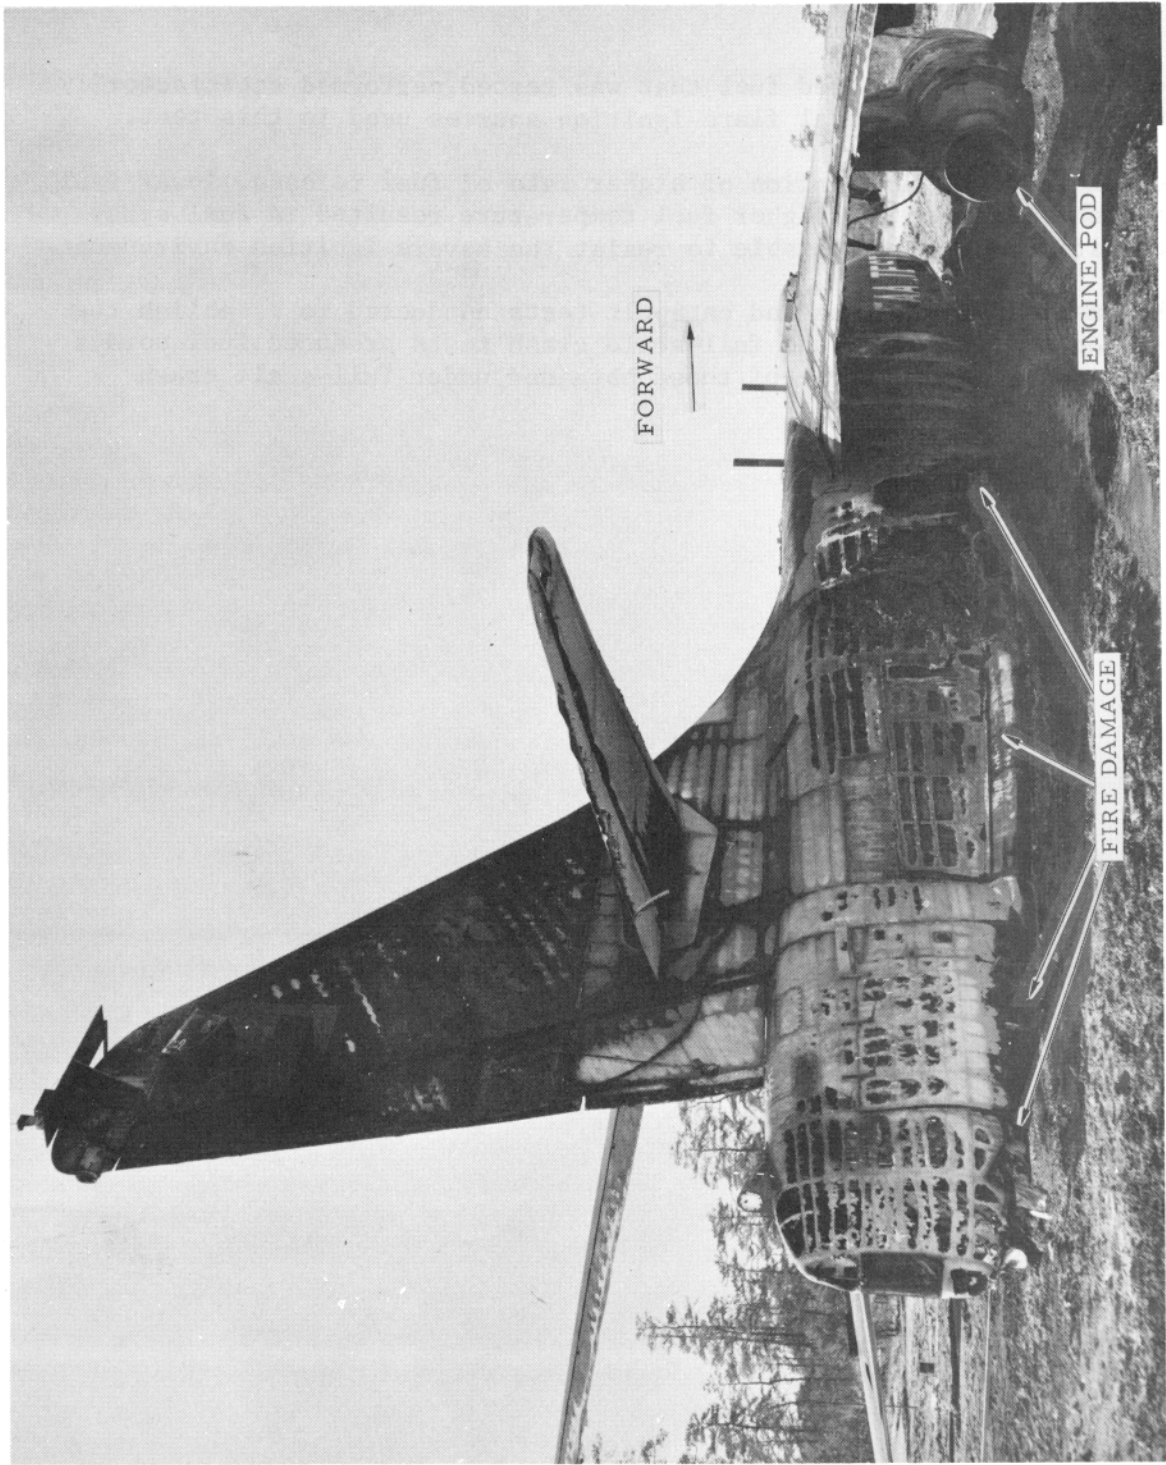
74-38-38

FIGURE 39. RIGHT-SIDE VIEW OF RB66 AIRPLANE USED IN TEST NO. 4
