FLIGHT TEST OF A SELF-GENERATING OVERHEAT DETECTION SYSTEM

JANUARY 1976

TECHNICAL REPORT AFAPL-TR-76-1
REPORT FOR PERIOD OCTOBER 1972 TO JULY 1975

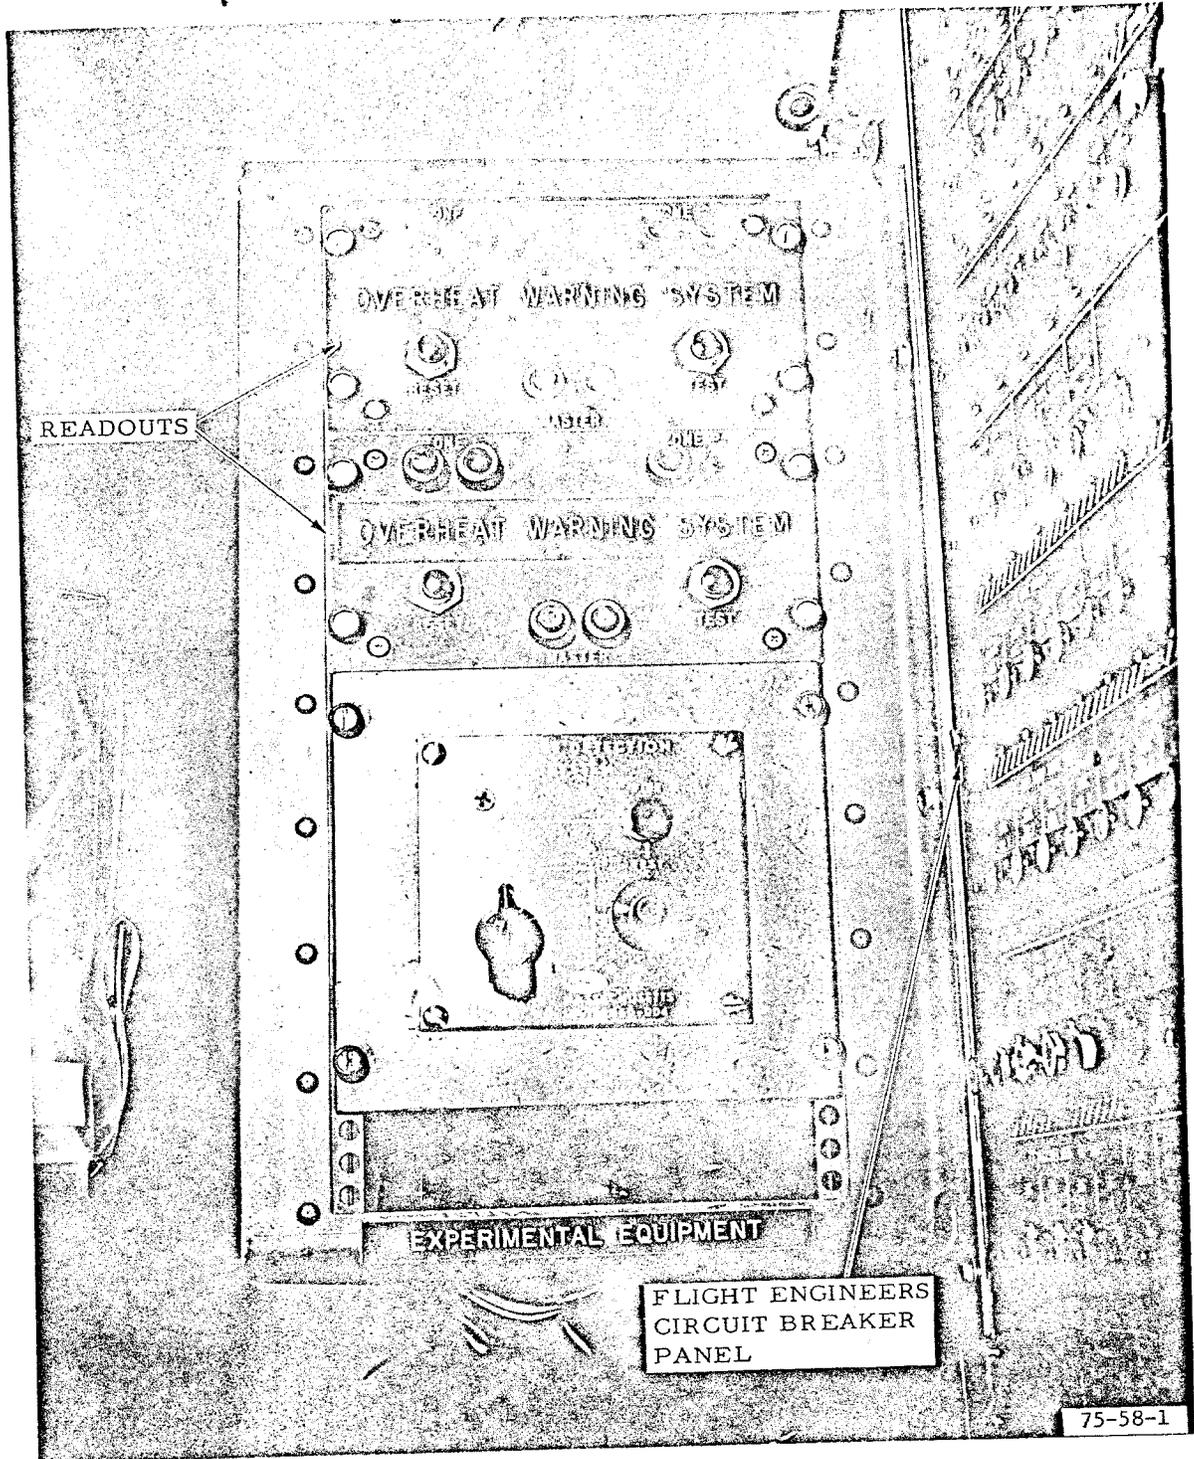
FIGURE 1: READOUT UNITS IN COCKPIT OF CV880 AIRCRAFT

In order to alleviate any problems that might have resulted from a false alarm, the readout boxes for the two systems were mounted (figure 1) so as to be seen only by the flight engineer. Instructions were given the flight crew to record all alarms, but take no action unless the aircraft system alarmed. A simple pre- and postflight continuity check was performed by the flight crew using a push-to-test circuit in each system. The results were to be reported only in the event of a discrepancy.

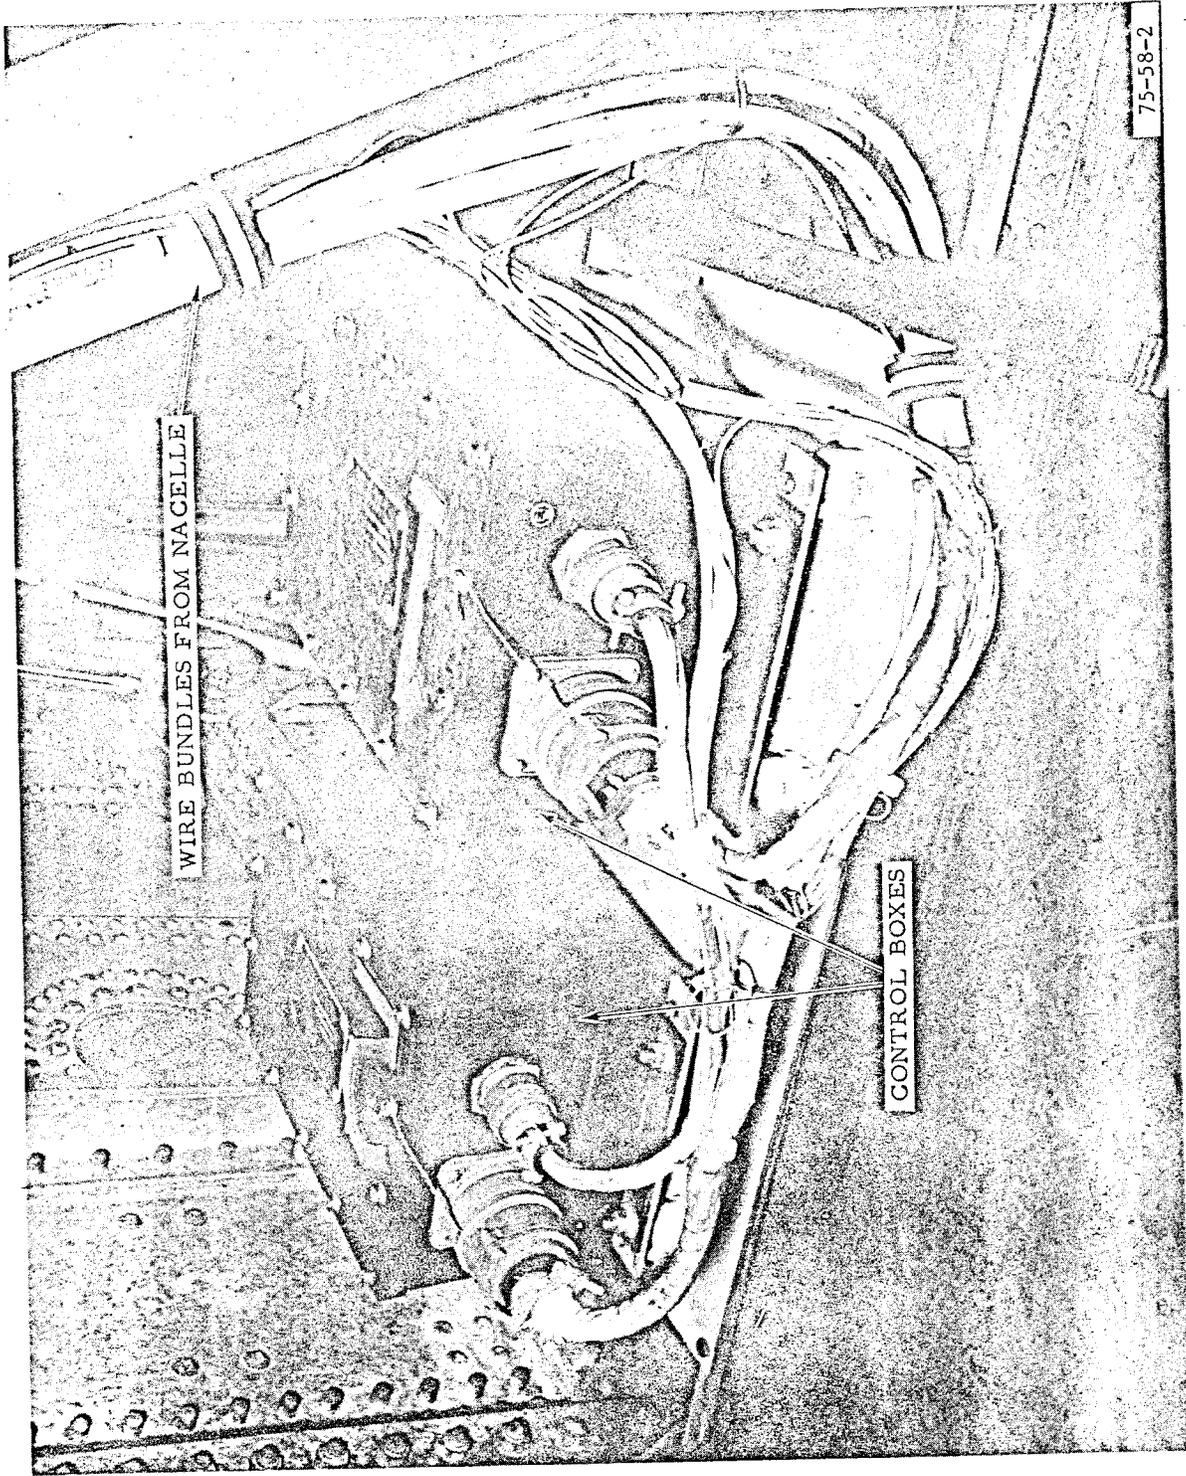
FIGURE 2: CONTROL BOXES LOCATED IN WHEEL WELL

The original plan for installing the two self-generating systems called for mounting the two control boxes in the pylon. Due to limited space in the pylon and the size of the control boxes (6 1/8 by 6 3/4 by 8 13/16 inches), the control boxes had to be repositioned to the closest area to the number two engine nacelle with available space. The left wheel well was chosen for mounting the control boxes (figure 2). The control boxes were larger for these prototype systems by a factor of three than for production systems. The boxes were fabricated to allow easy modification and change. They were not hermetically sealed, so repairs and modifications could be made easily if required. Since a wire bundle consisting of two iron conductors, two constantan conductors, and one copper conductor for each of the four overheat cables had to connect the junction boxes in the nacelle and the control boxes in the wheel wells, existing aircraft wiring in the wing between the nacelle and the wheel well could not be used. The wire bundles supplied with the system were made up of fire-zone cables (as shown in figure 3) which proved very poor in abrasion resistance in the 40- to 50-foot run from the nacelle through the pylon along the trailing edge of the wing and into the wheel well.

- (1) Decrease the size of the control box so that installation in an aircraft pylon would be possible.
- (2) Supply bulkhead firewall fittings with iron-constantan pins.
- (3) Use iron constantan extension wire with improved abrasive quality for runs outside the nacelle.

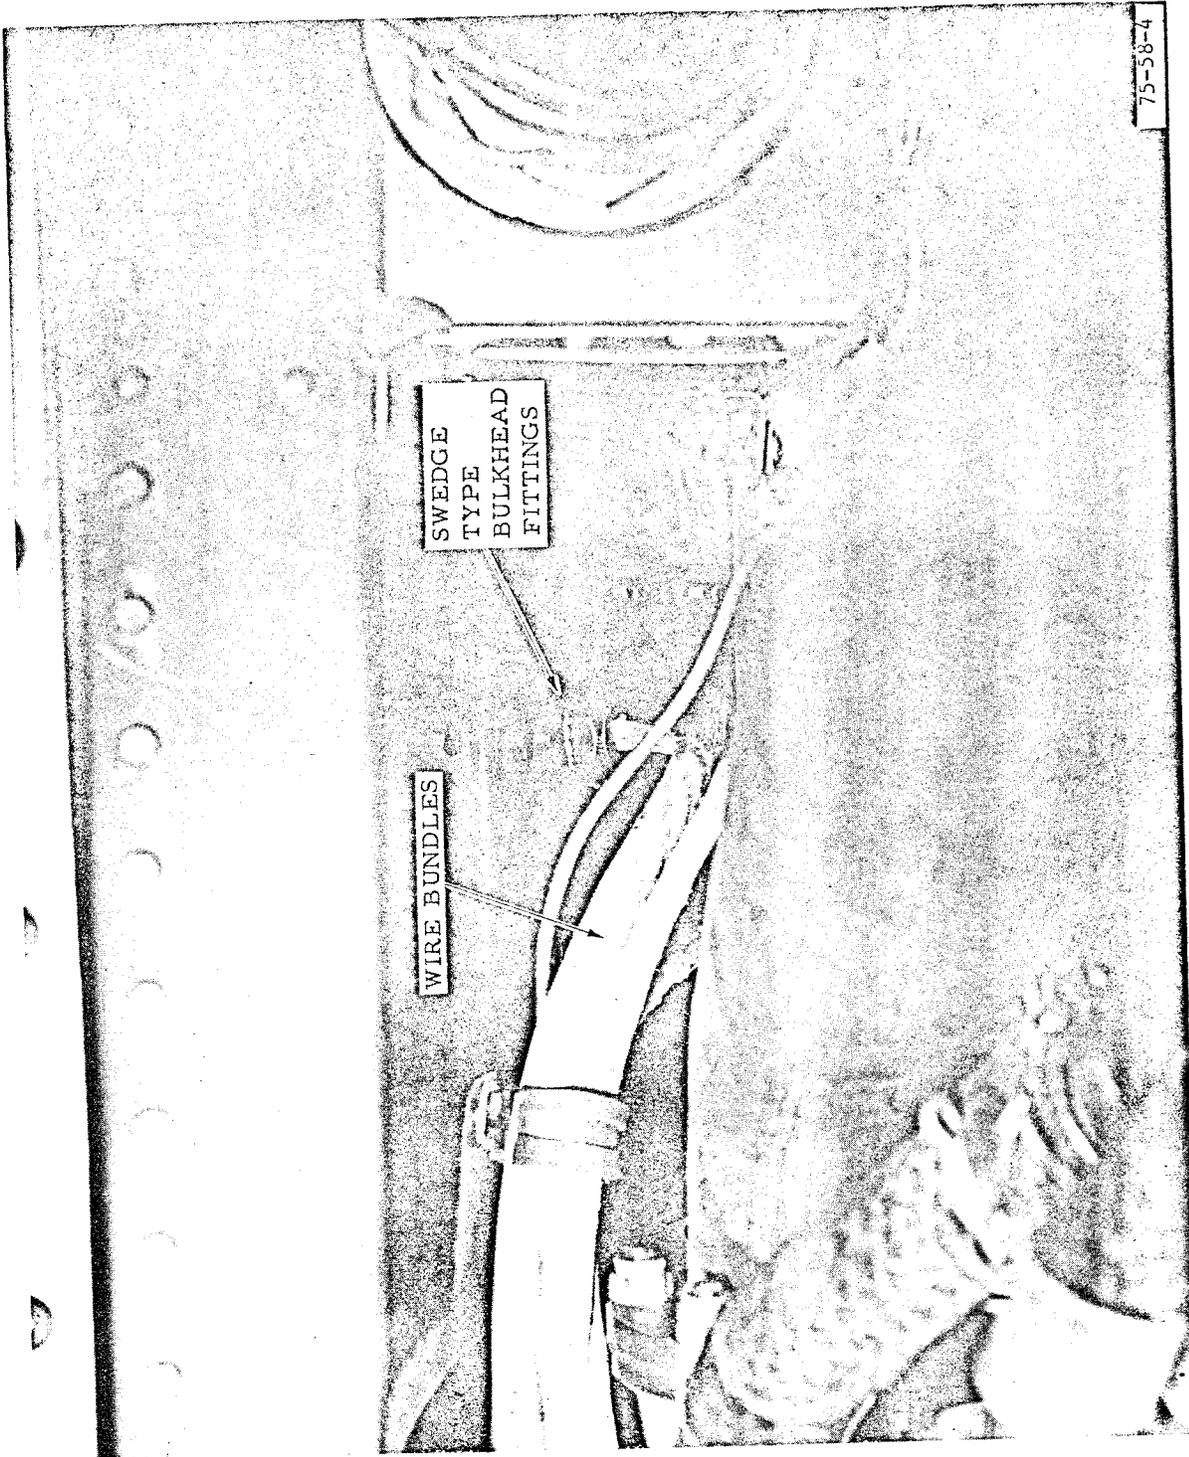
FIGURE 4: FIREWALL FEED-THROUGH FROM NACELLE TO PYLON

were copper, not iron or constantan). Because no iron-constantan connectors were available for the installation, each of the four wire bundles were put through swedge-type connectors and sealed with high-temperature sealant (figure 4).

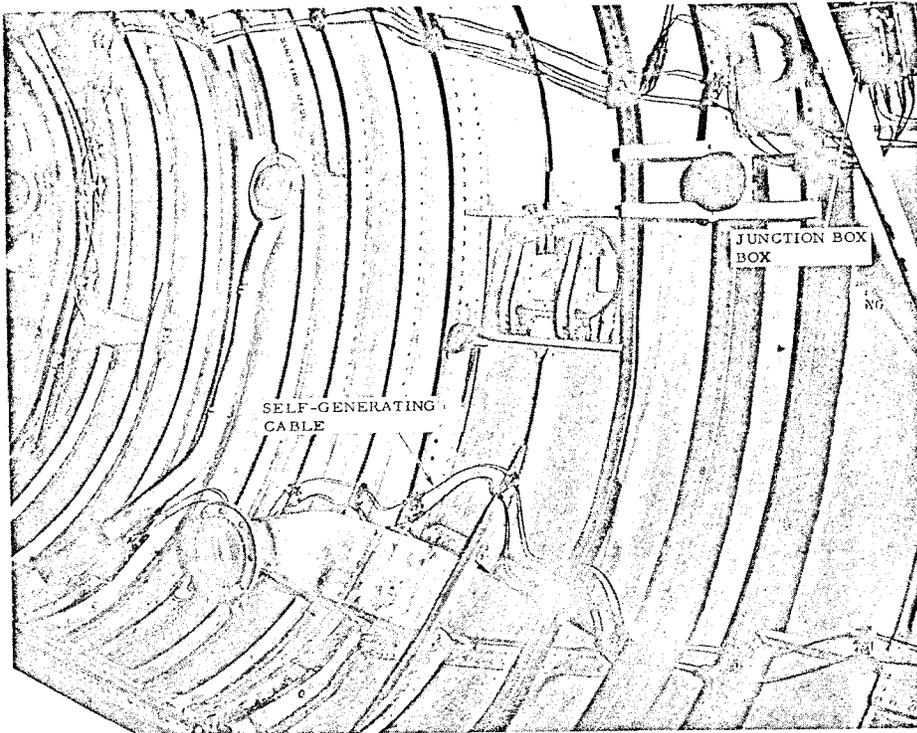
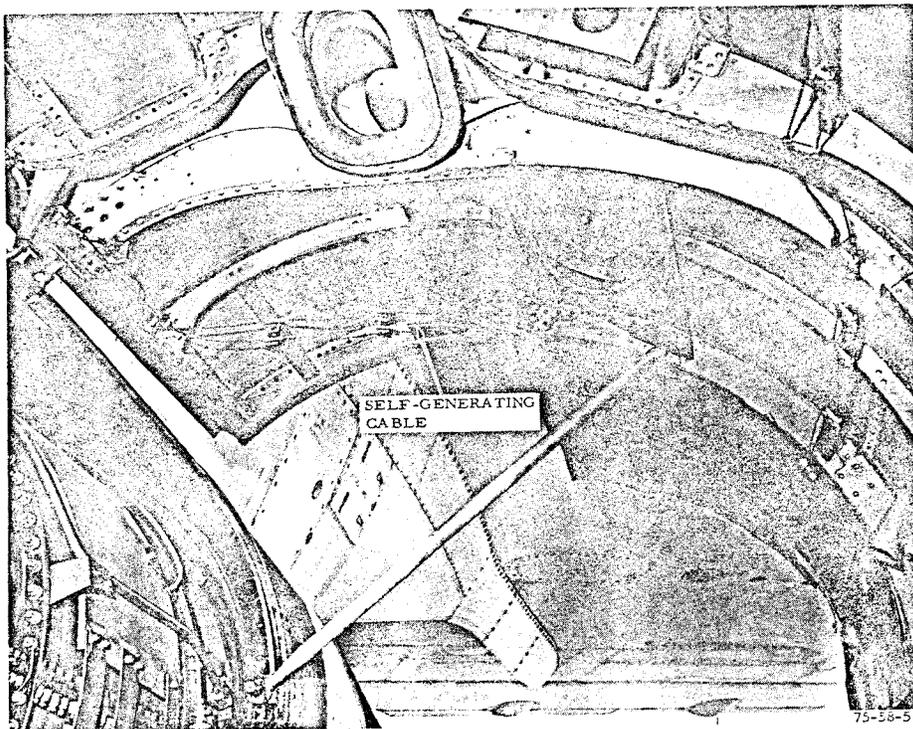
FIGURE 5: OUTBOARD CABLE INSTALLATION

The installation in the nacelle consisted of a junction box for each of the two systems, located on the inboard and outboard nacelle doors (figure 5). The location of the junction boxes on the doors was necessary, since the self-generating cables were mounted on the nacelle doors, and the cables could not be repeatedly flexed. The wire bundles between the junction boxes and the swedge fitting in the pylon were positioned so as to allow minimum flexing of the wire bundles when the nacelle doors were opened and closed.

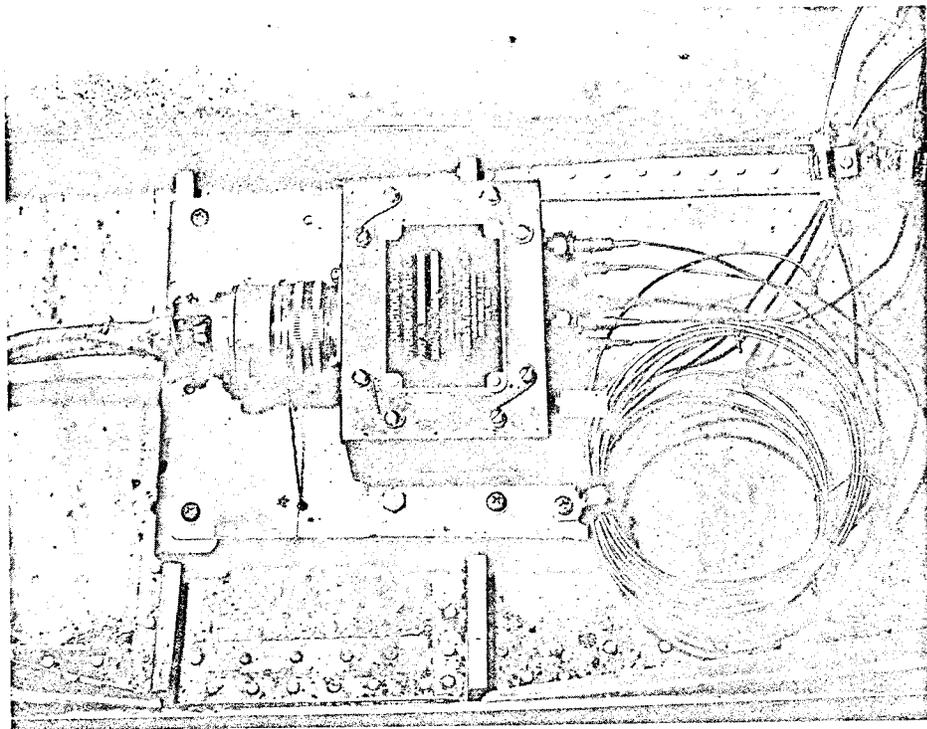
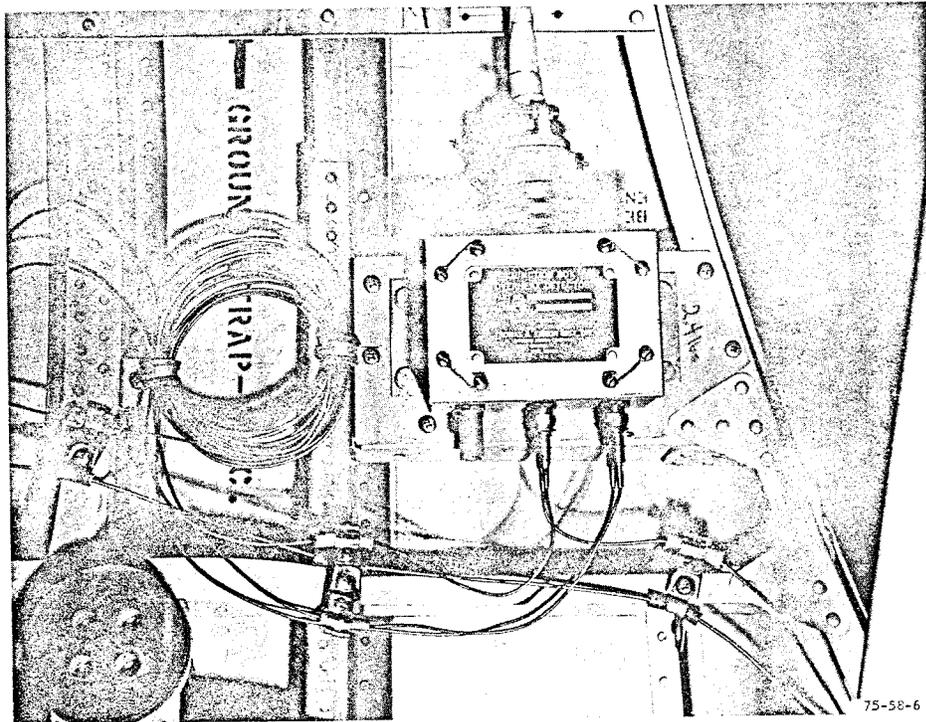
FIGURE 6: LOCATION OF JUNCTION BOXES IN NACELLE

The self-generating cables were located on the nacelle doors parallel with the existing aircraft fire and overheat system (figure 6 and 7). The forward zone cable, for each system, was 32 feet in length, with both ends connected to the junction box. The forward zone systems were factory set to alarm at 575° F when the entire cable was heated to that temperature. The aft zone cable consisted of an 18-foot cable for each system set to alarm when the entire cable was heated to 765° F. In addition, two inert cables for each system were used as a thermocouple extension wire to connect both ends of the aft cable with the junction boxes located in the forward zone.
