AIRCRAFT CARGO COMPARTMENT FIRE TEST  
SIMULATION PROGRAM

R. E. Blumke  
McDonnell Douglas Corporation  
Douglas Aircraft Company  
3855 Lakewood Blvd.  
Long Beach, California 90846

NAS2-8699  
CR151951-NASA Report Number  
January 1977

Final Report for Period October 1974 - January 1977

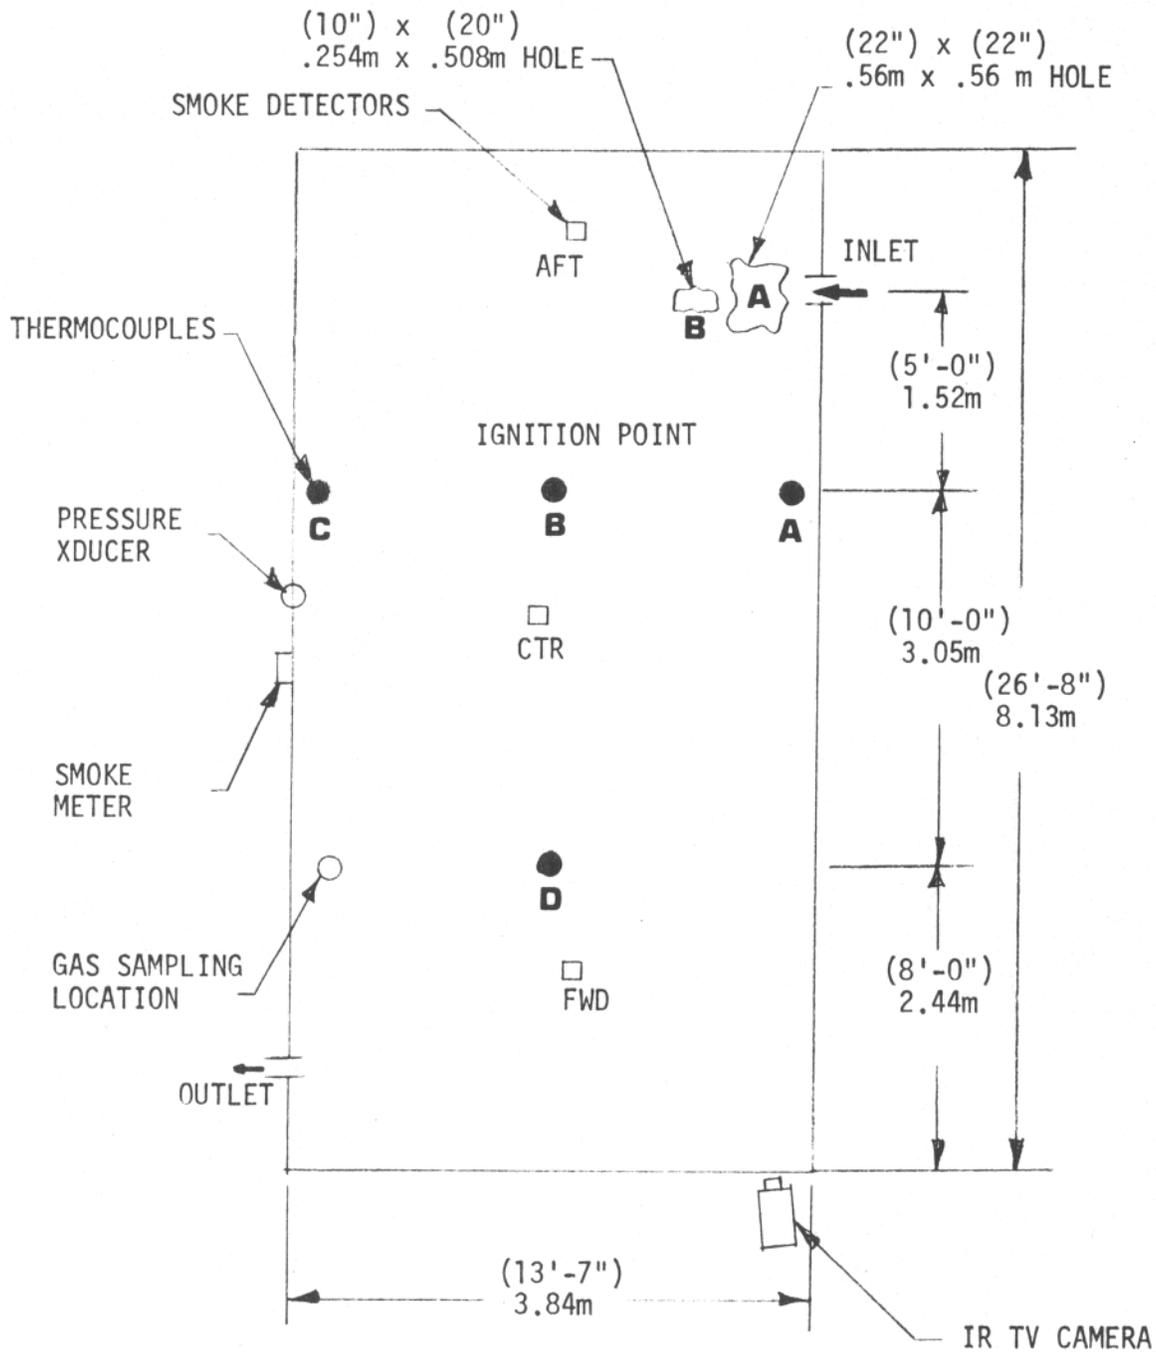
FIGURE 4. SCHEMATIC OF COMPARTMENT INSTRUMENTATION SHOWING RELATIVE LOCATIONS, AND DAMAGED CEILING AREAS - TEST NO. 1

Post-test examination revealed two holes burned through the ceiling liner adjacent to the vent inlet. The holes were approximately 55.88cm x 55.88cm (22 x 22 inches) and 25.4cm x 50.8cm (10 x 20 inches) as shown in Figures 4, 28 and 29. Though extensive areas of the ceiling and sidewall liner were delaminated and baked free of resin, no other burnthroughs existed.

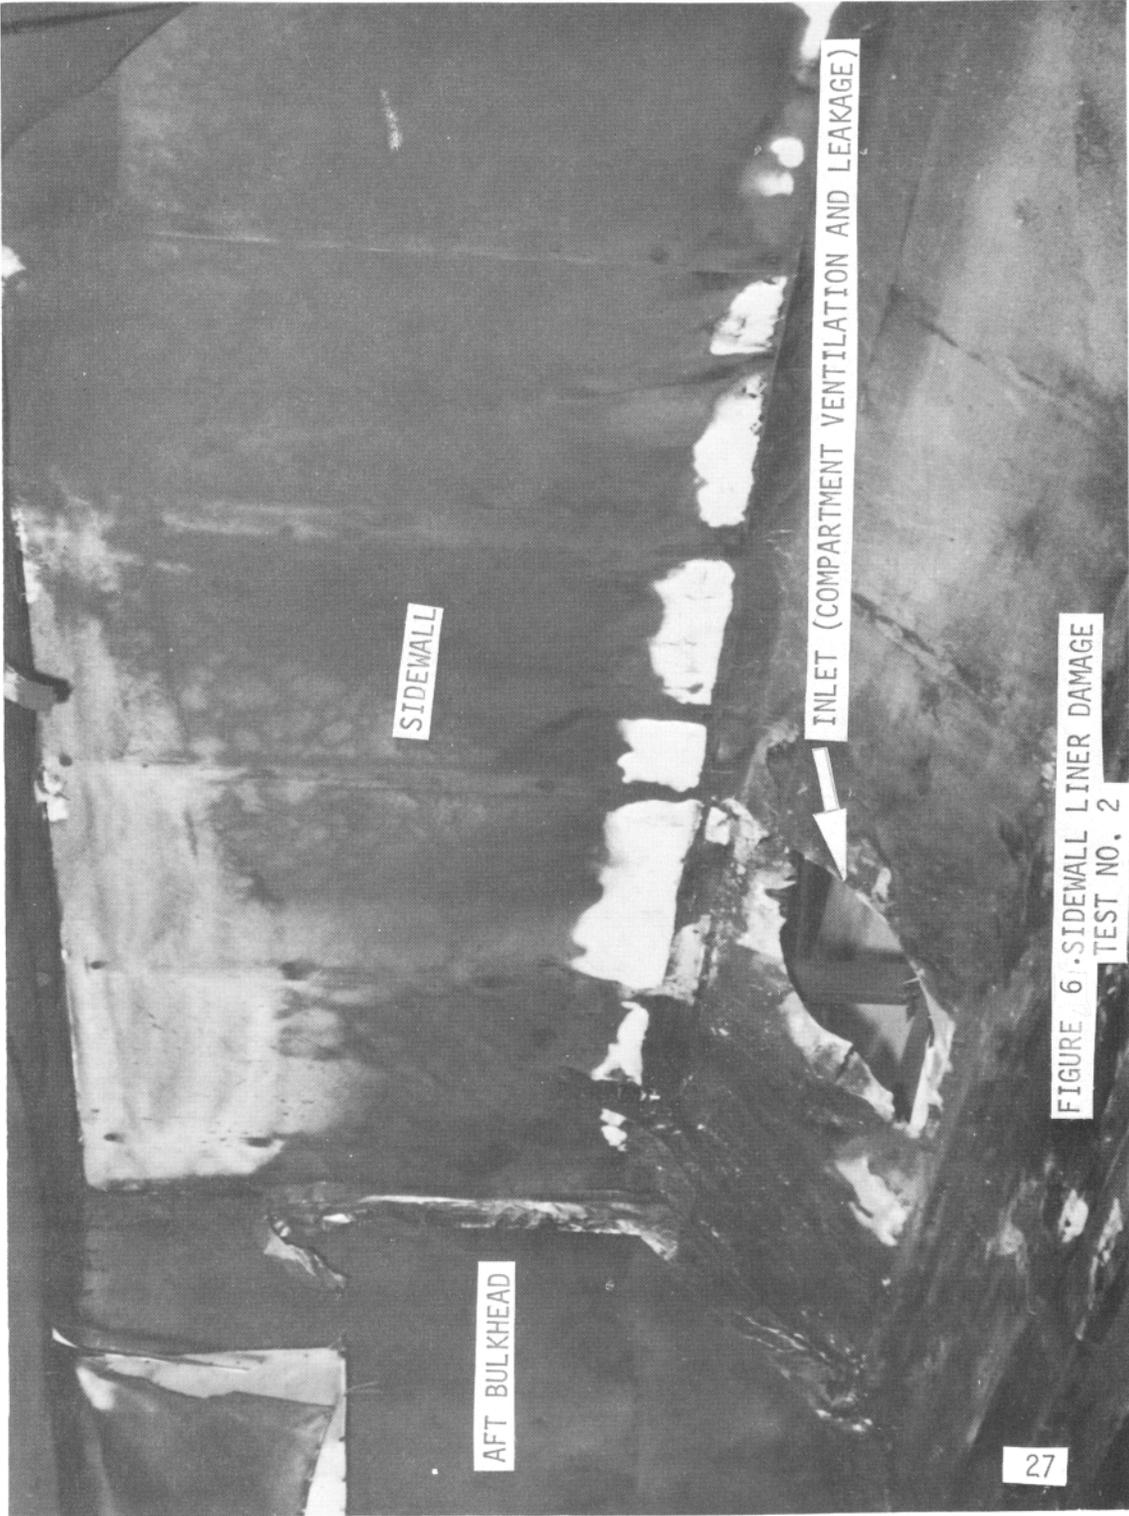
FIGURE 6 . SIDEWALL LINER DAMAGE  
TEST NO. 2

Extensive areas of the ceiling were delaminated and baked free of resin but no other burnthroughs existed. The sidewall liner above the inlet also showed delamination and was baked free of resin but no burnthroughs; see Figure 6. Although the resin bakes free from the fiberglass the mat remains and provides an effective barrier against flame penetration.

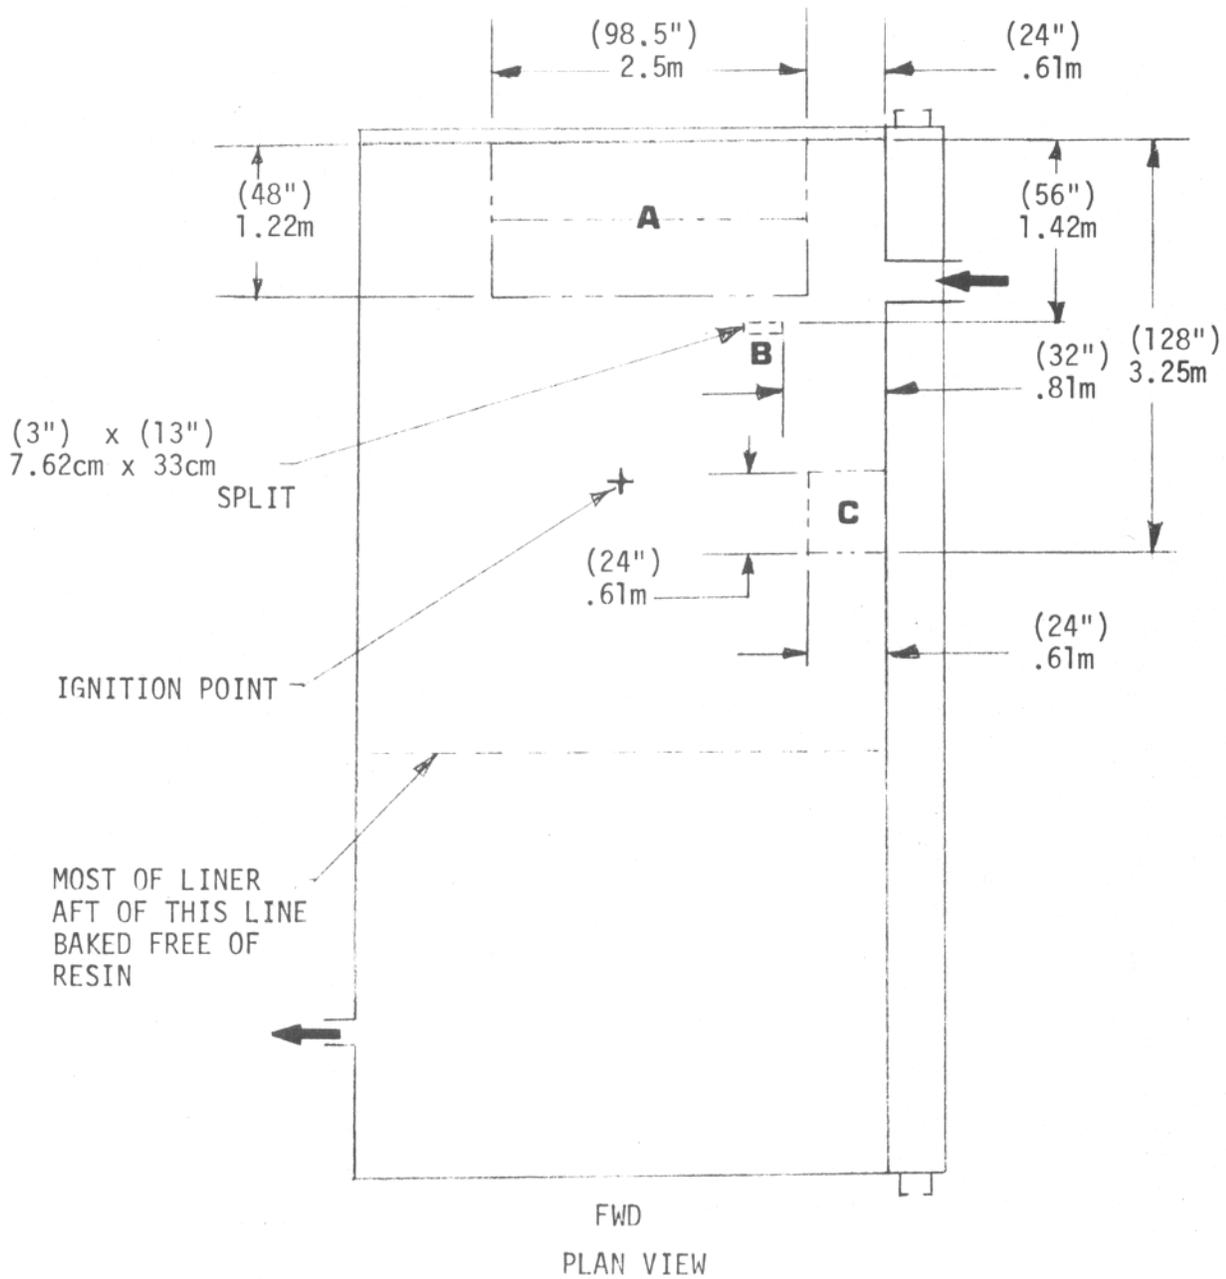
FIGURE 52. SCHEMATIC DAMAGED AREAS OF CEILING LINER RELATIVE TO IGNITION POINT - TEST NO. 2

Figures 52 through 56 show the ceiling liner damage. The greatest damage occurred adjacent to and in front of the airflow inlet where the fire was centered. The ceiling area over the ignition source did not burn through. When the resin in the fiberglass bakes free only the fiberglass mat remains. This mat without the resin has little strength. The weight of the fiberglass panel causes the structural attachments to shear through the mat and the panel falls and hangs into the compartment, see Figure 53. New design techniques for attachment should be considered and tested in future programs. A split 7.62cm x 33cm (3 in. x 13 in.) occurred in the ceiling

- o The ceiling still appears to have the least margin for burnthrough.
- o Sidewall integrity remains adequate against burnthrough.
- o The fire spread generally, localizing towards the source of air during the test, then moved from the fire source region to involve the entire length of the cargo.
- o Temperatures throughout the compartment reached their highest values during the first 60 minutes then either stabilized or began to decrease.
- o Structure temperatures climbed steadily for the first 60 minutes then stabilized.
