Airborne fires from damaged electrical wiring - Recent investigations and recommendations

Rob Carter & Anne Evans

Air Accidents Investigation Branch, Farnborough, UK

**The Fourth Triennial
International Aircraft Fire and Cabin Safety
Research Conference**

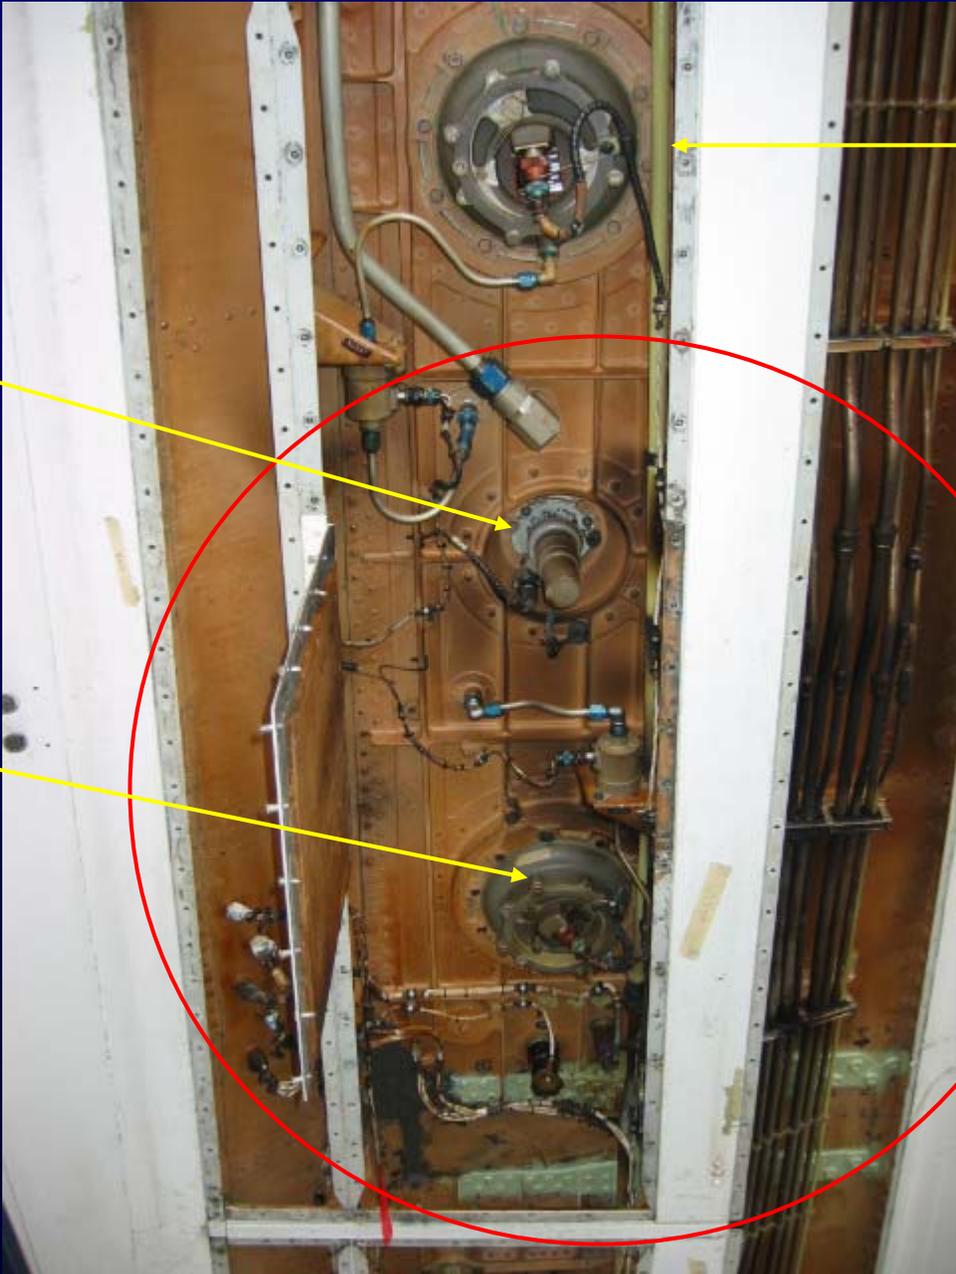
1st Standby
Fuel
Pump
Tank 3

Tank 3
Refuel valve

2nd Standby
Fuel
Pump
Tank 3

Area of
fire damage

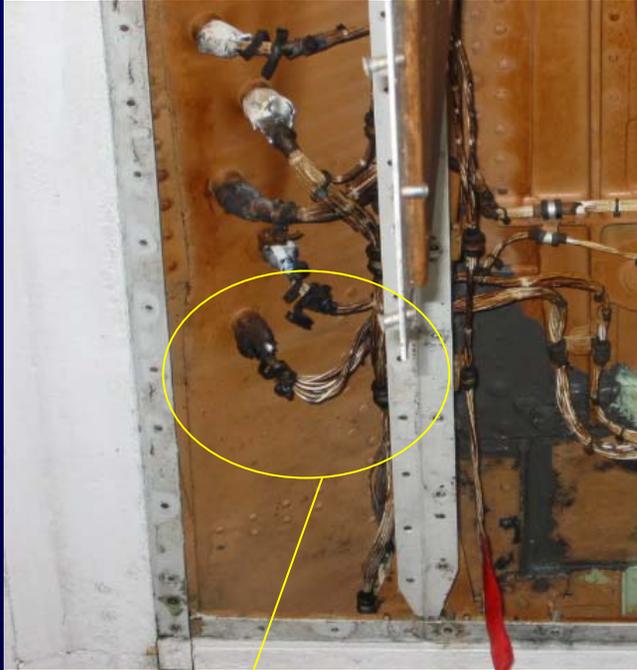
Chafed Wire

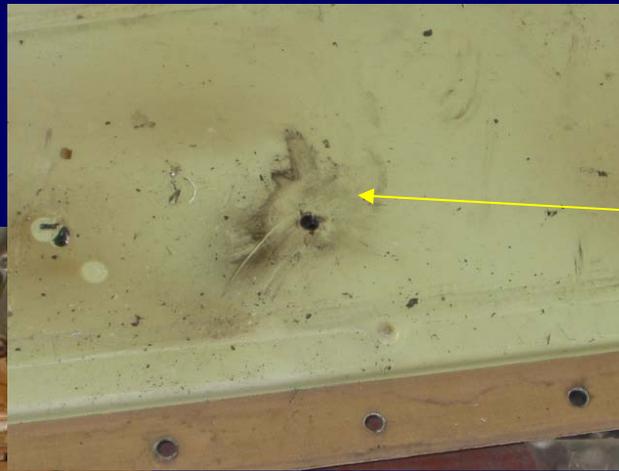
'Spark Erosion' hole in aluminium honeycomb panel

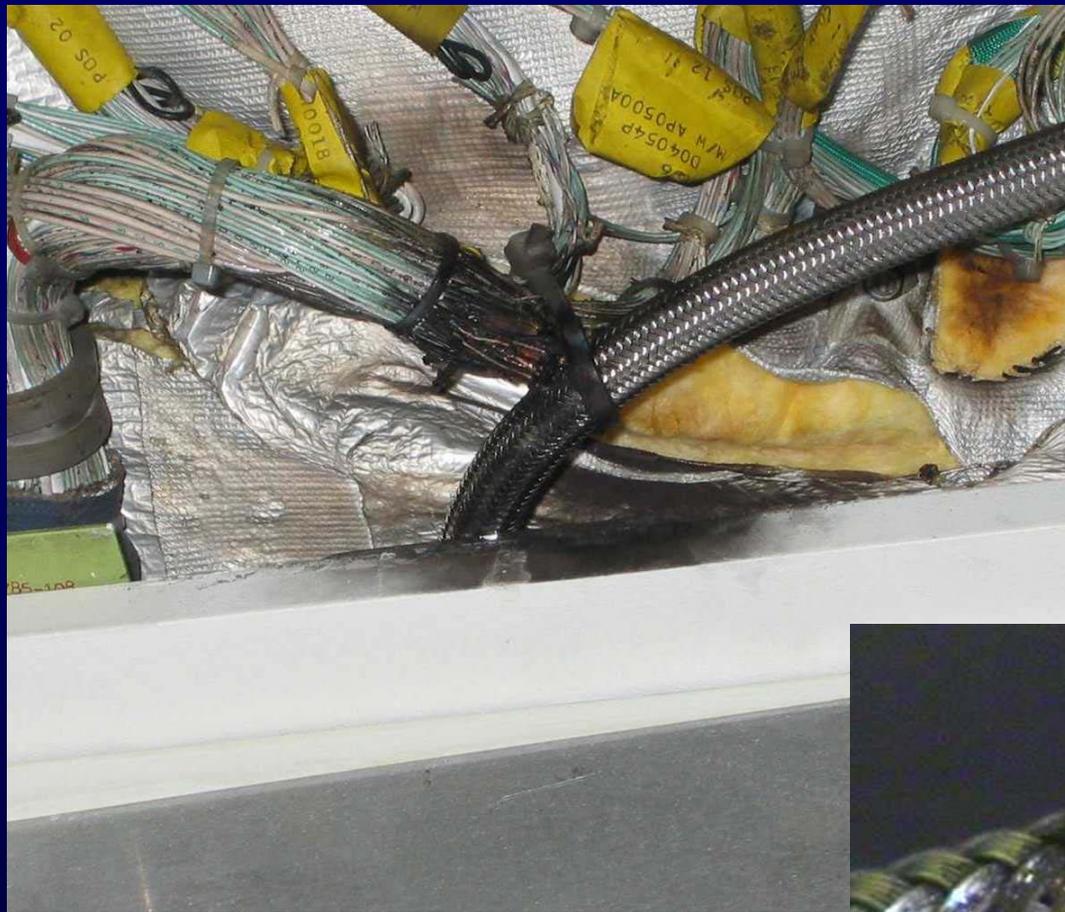
An investigation revealed that an engineer had tied a water hose to a bundle of wires. These had rubbed together, exposing the wires and causing sparks. The Air Accidents Investigation Branch (AAIB) identified a series of problems with maintenance and also with emergency procedures used by pilots when detecting smoke.

Water hose, Ty-Wraps/
'Zip' straps & wiring looms

Braided water hose detail
