# **Lessons Learned: Case Studies of Recent In-flight Battery-related Incidents**

Nancy McAtee

NTSB-Office of Research and Engineering

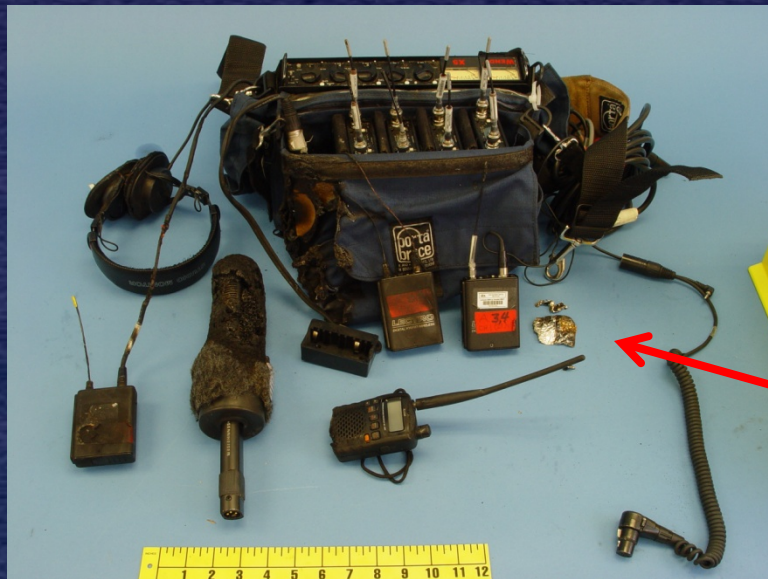
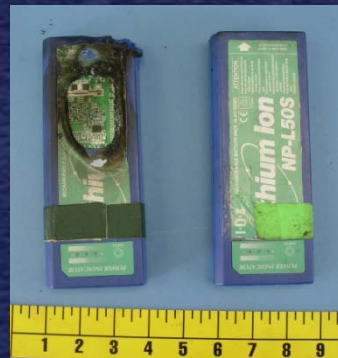
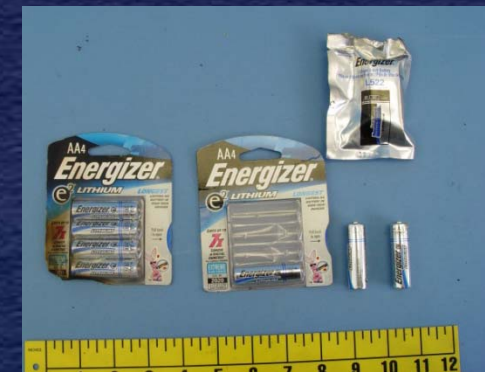
- Contents of the bag
  - Two 14-volt rechargeable batteries with unprotected contacts
  - Various Li-metal batteries-AA and 9-volt

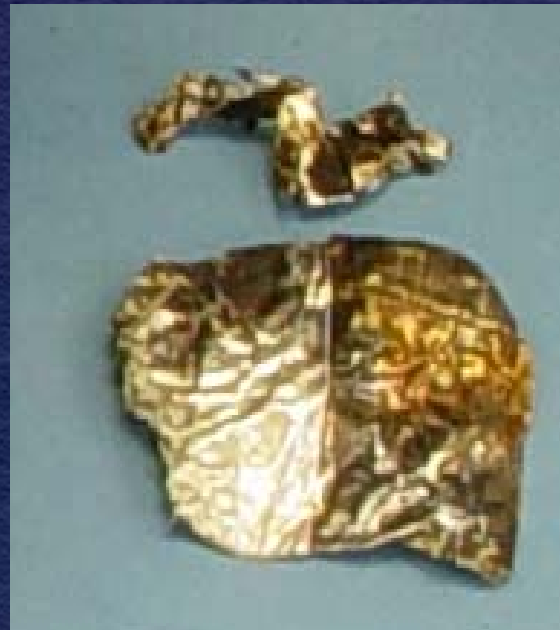
- Debris found inside bag determined to be remains of Li-metal 9-volt battery
- Cause determined to be thermal runaway and failure of 9-volt battery
