# FAA Office of Accident Investigation & Prevention

## Air India Express Limited Accident Examination

**October 2022**

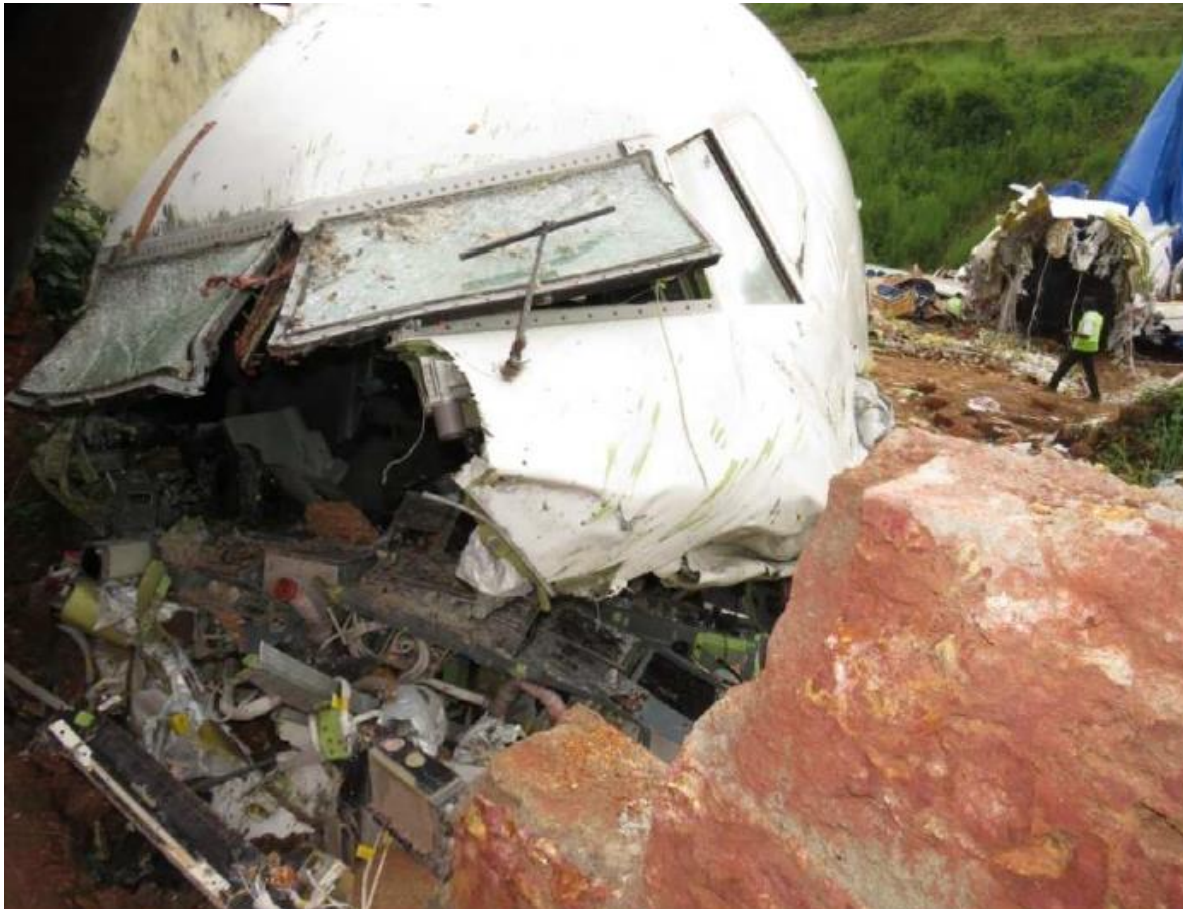
# Cockpit/Flight Deck

Crew Fatal

CPT & FO seats were subject to high decel g. Seat structures were deformed and cracked. Seat mounting tracks cracked and a few seat mounting bogies were disconnected.

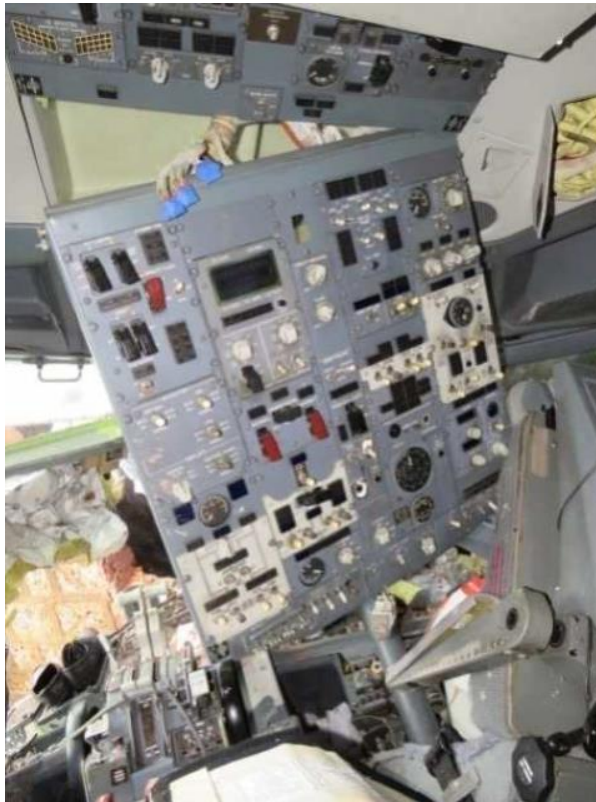
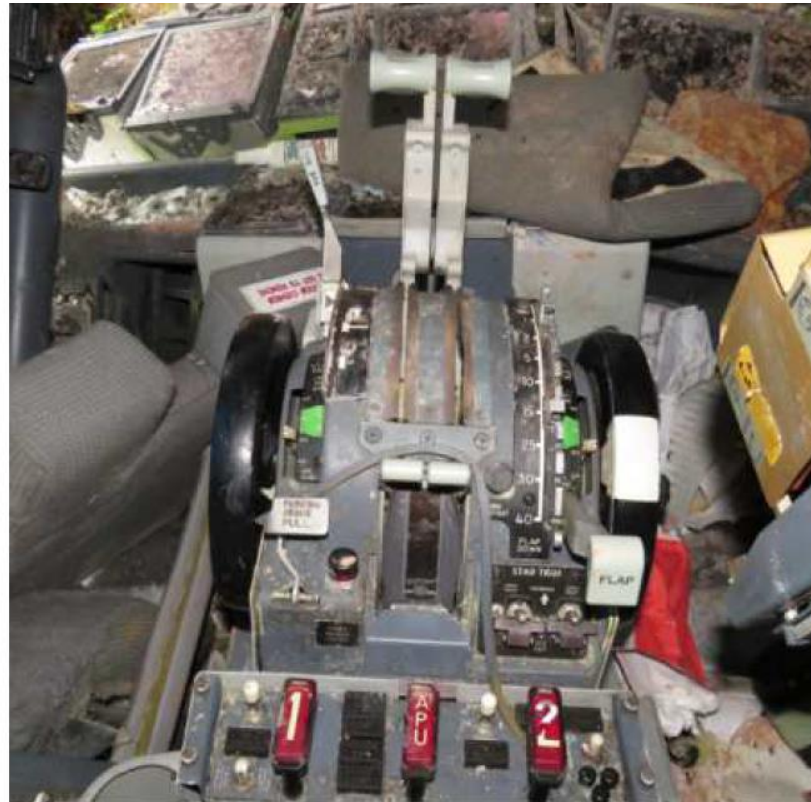
# Flight Deck

Control wheel and column on both sides were severely damaged. The rudder pedals were raised up and had jammed in the adjoining structure

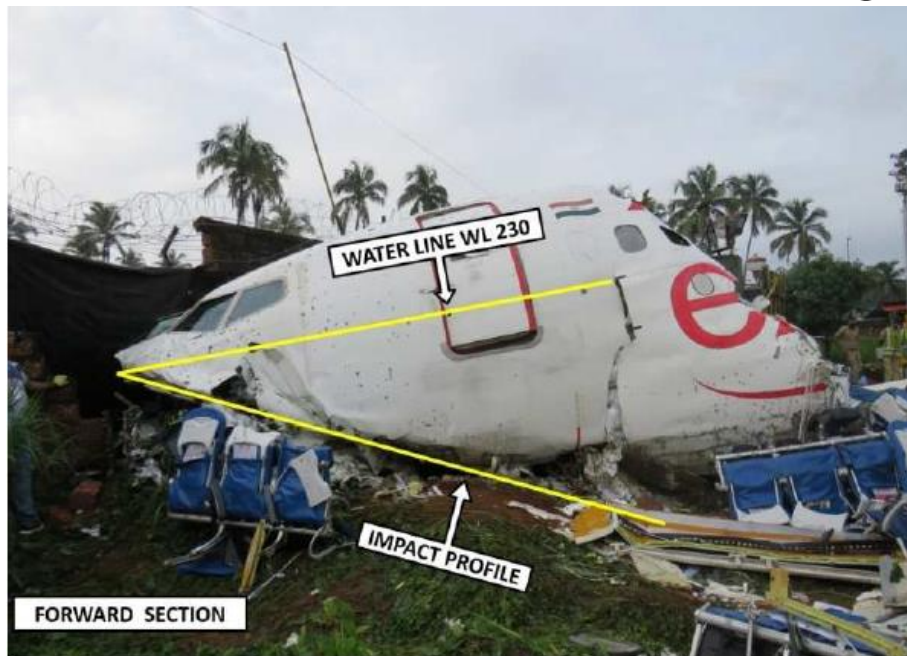
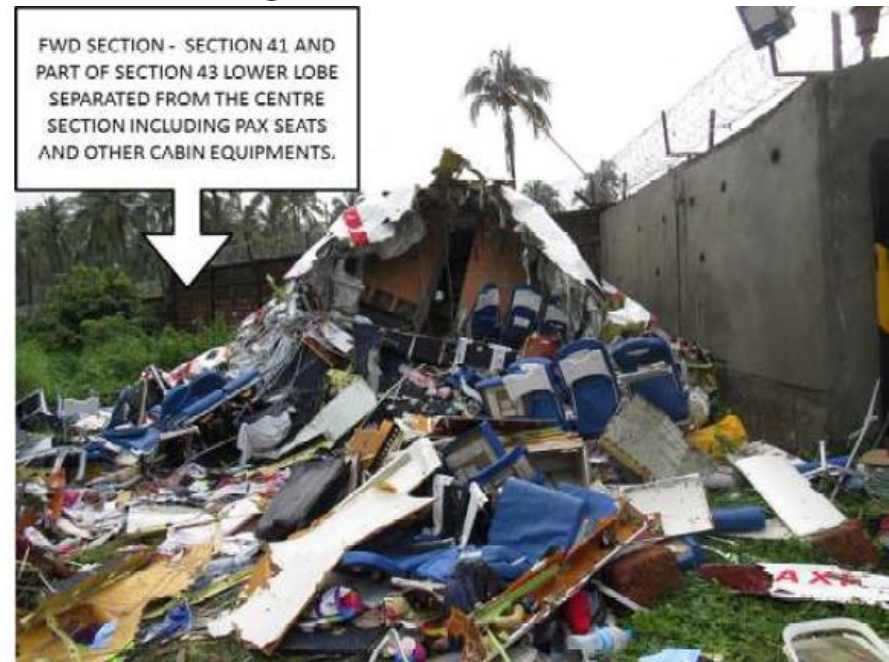
# Forward Section

Initial impact separated the forward section from the center section, it moved forward in the direction of the perimeter wall. Impact and separation dissipated a part of the total energy and the rest was friction with road/soft ground and impact with the perimeter wall. Impact angle of 30 deg to water line.

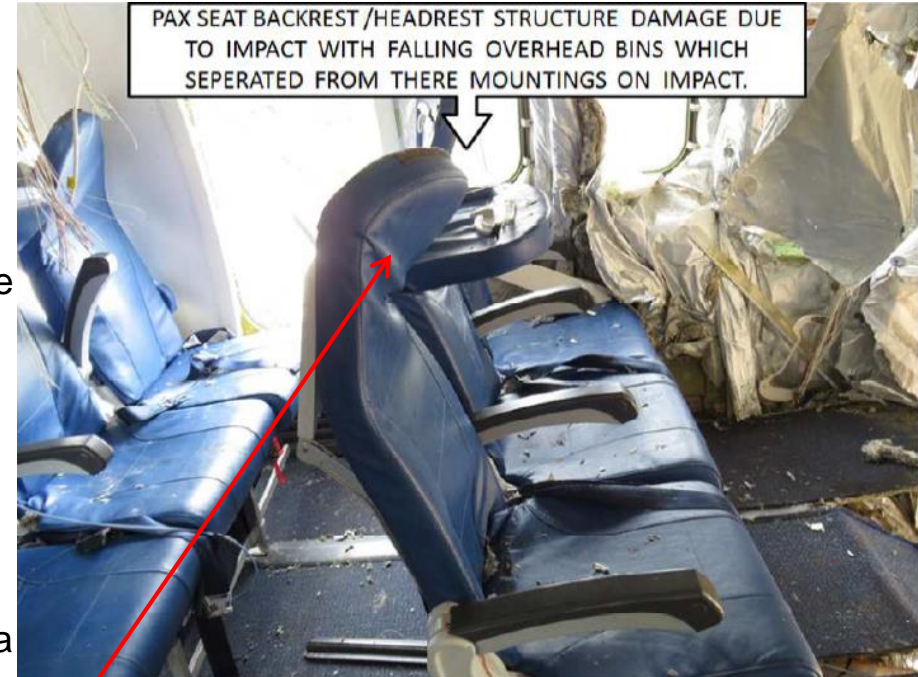
# Center Section

- After separating from the forward section continued plunging into the road at about 30 degree angle.
- Structural members in section absorbed brunt of impact with the ground
- Floor beams were shattered, the lower lobe skin, cargo and cabin floor crumpled and separated.
- Center wing box including the center tank structure was severely damaged.
- Air conditioning damaged.
- Section of the fuselage skin, cargo floor panel, generator system tubing showed signs of gear folded back and separated on impact.
- Attached cabin equipment including seats, overhead bins, passenger service units and side wall panels fragmented and scattered over an area of approximately 300 square yards forward of the center section.
- Passenger seat headrests were bent forward due to impact with the loaded overhead bins that separated and fell down with a forward momentum.

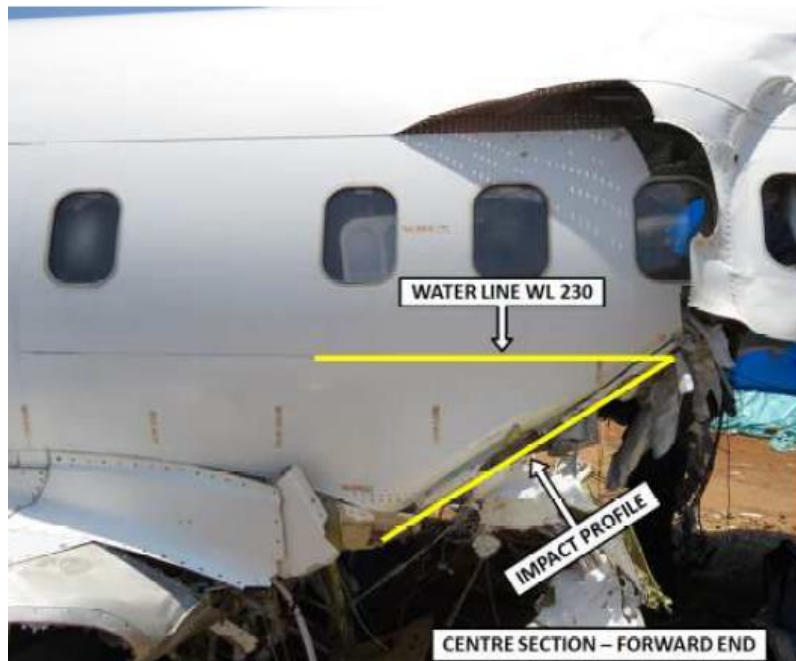
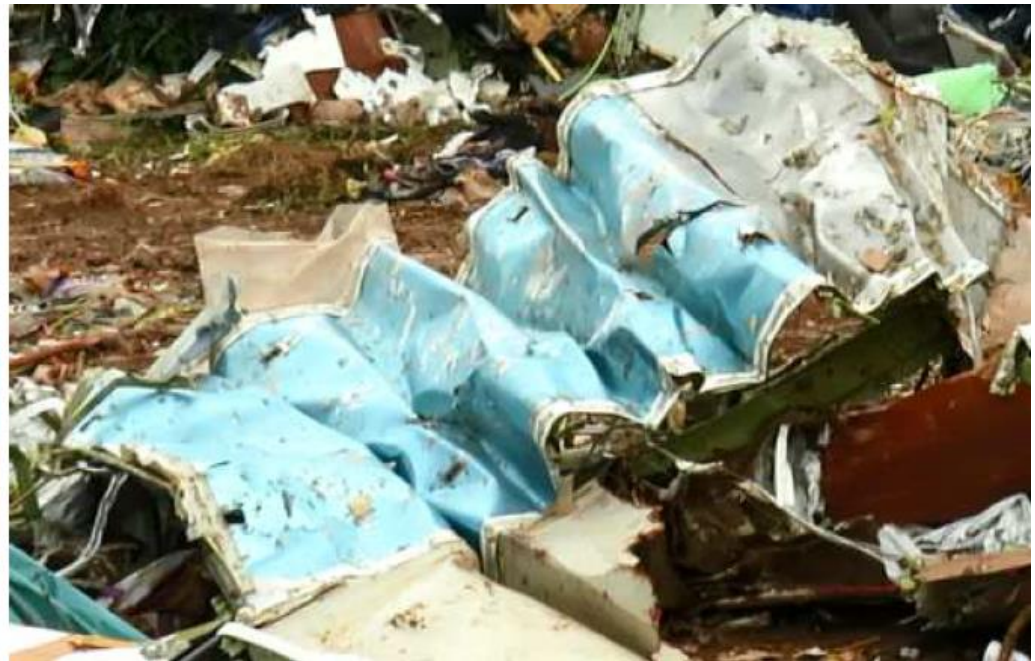
# Center Section

Center wing box including the center tank structure was exposed and severely damaged. Section of the fuselage skin, cargo floor panel, generator cables and system tubing showed signs of a rippled pattern resembling corrugated sheet metal

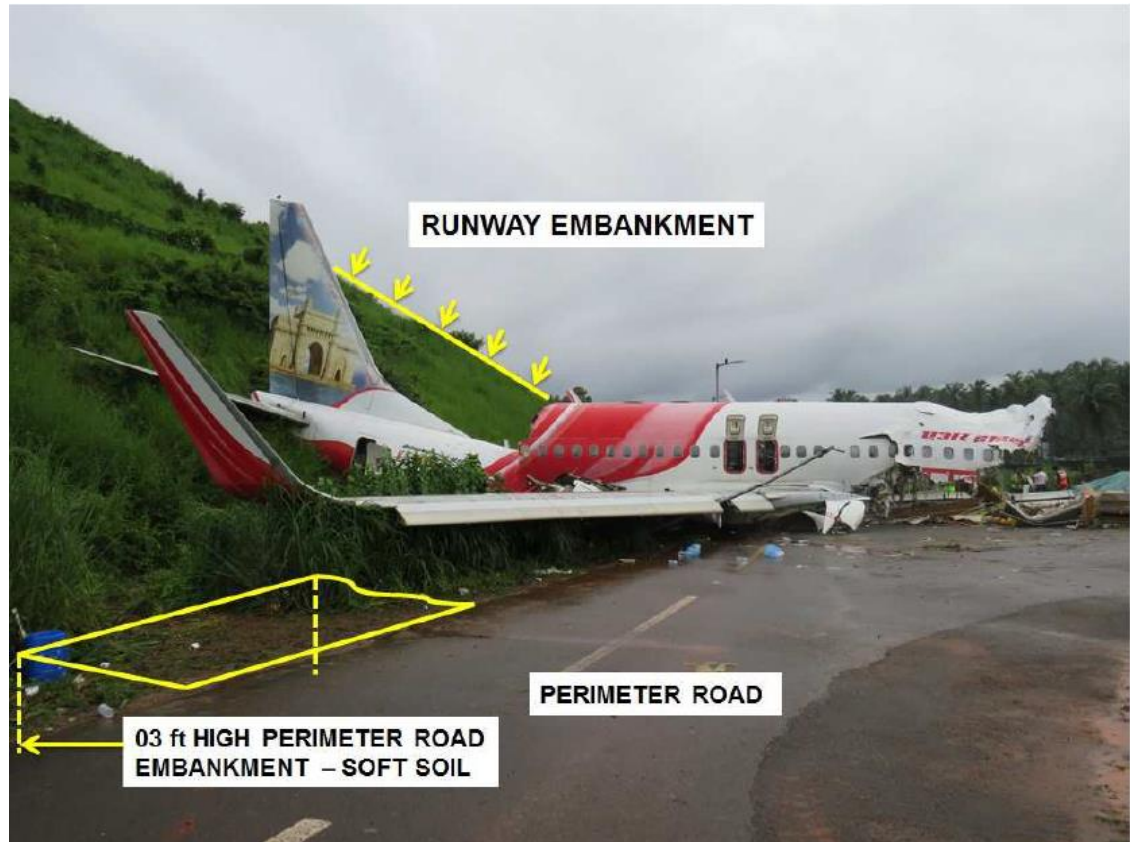
# Aft Section

- Aft section separated from the center section
- Center section was supported on the belly by the edge of the perimeter road embankment.
- Due to momentum, the aft section continued moving down and separated from the center section.
- It was supported at the forward end by the base of a storm drain and at the aft end by the runway embankment.
- Due to this orientation it was at a relative angle of 10-12 degrees with the center section.

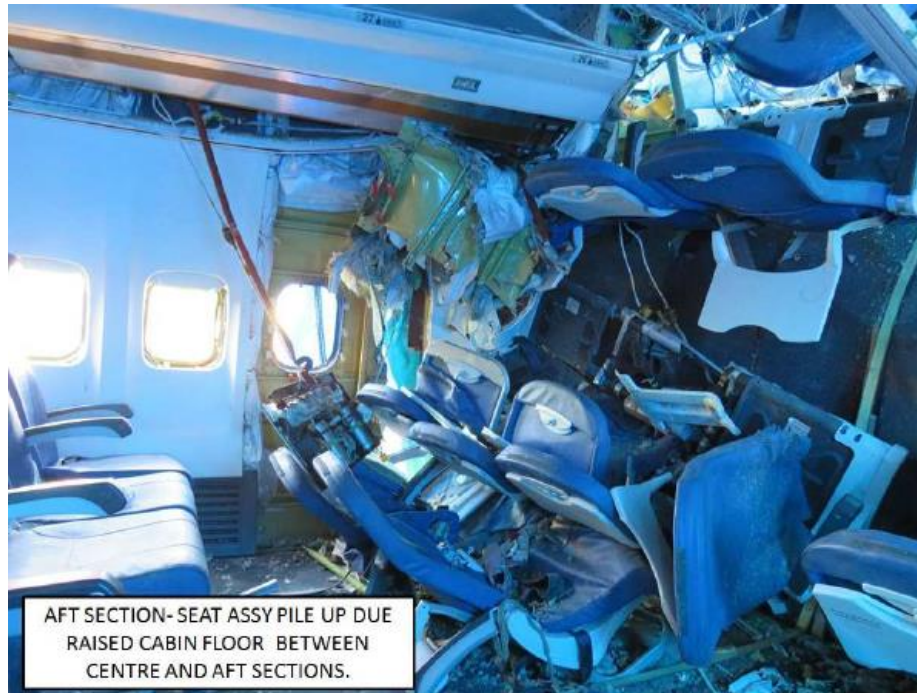
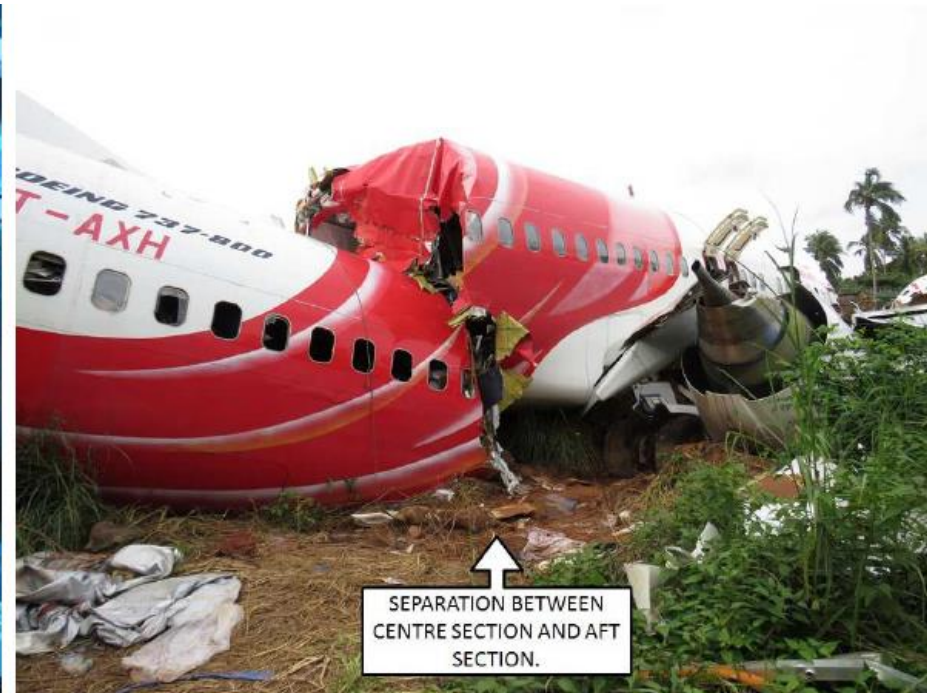
# Aft Cabin

Cabin floor structure was damaged but did not separate cleanly. Due to the height difference between the cabin floor levels of the two sections, the cabin floor rotated from horizontal to near vertical position between seat rows 23 to 26 with the seats still attached causing the passenger seats to pile up at this location. The empennage was relatively intact other than a few post impact damages.

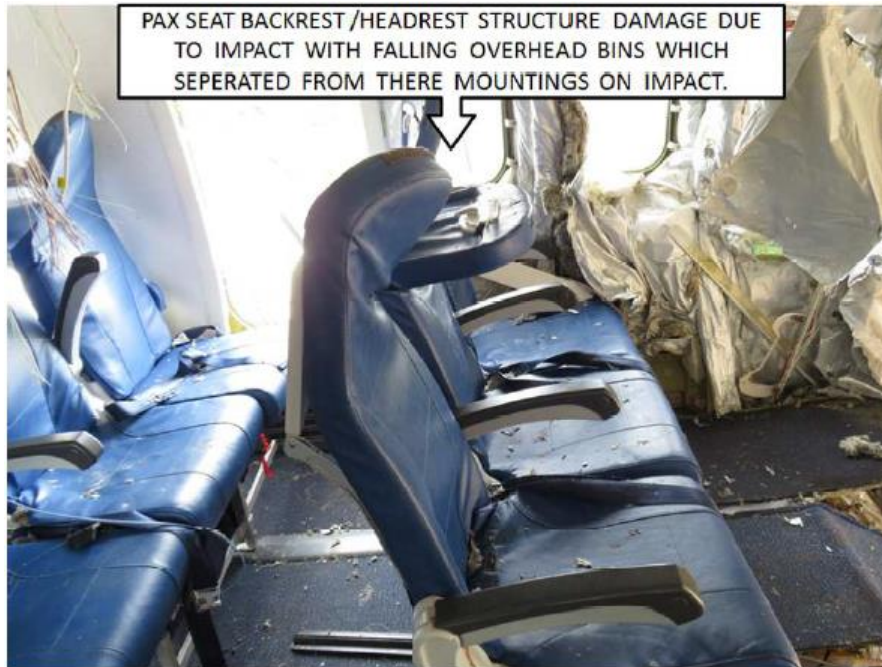
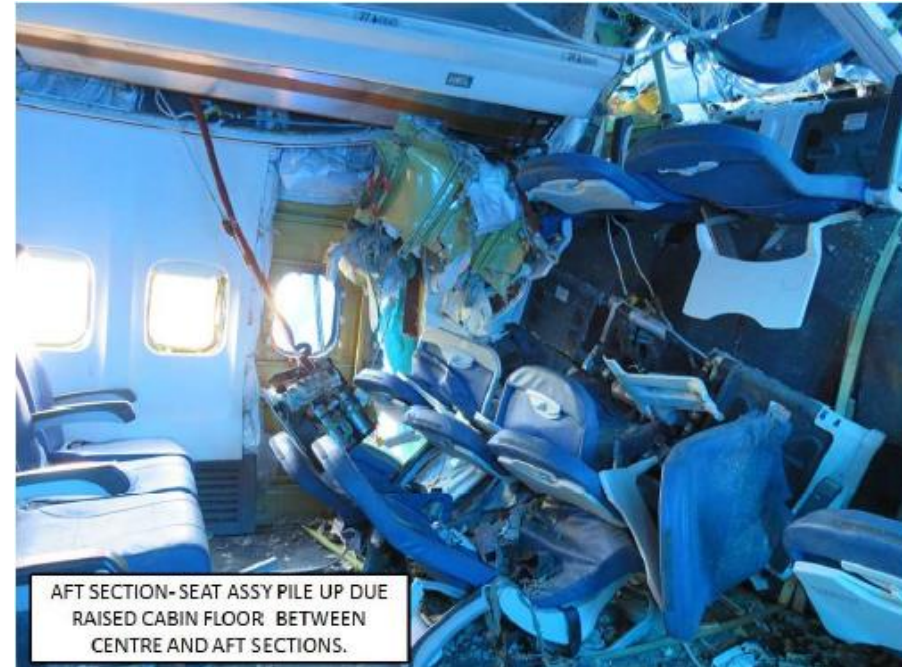
Rows 23-26

- 3E 5A, 8F and 9E (six passengers) sustained minor injuries
- Rows 22 to 26 suffered extensive damage due to the fact that the aircraft split up around this location. 05 out of 30 passengers seated in the area suffered fatal injuries and one suffered serious injuries. Remaining 24 passengers suffered minor injuries.
