AIRCRAFT ACCIDENT REPORT

TRANS WORLD AIRLINES, INC.

B-707, N742TW

NOVEMBER 6, 1967

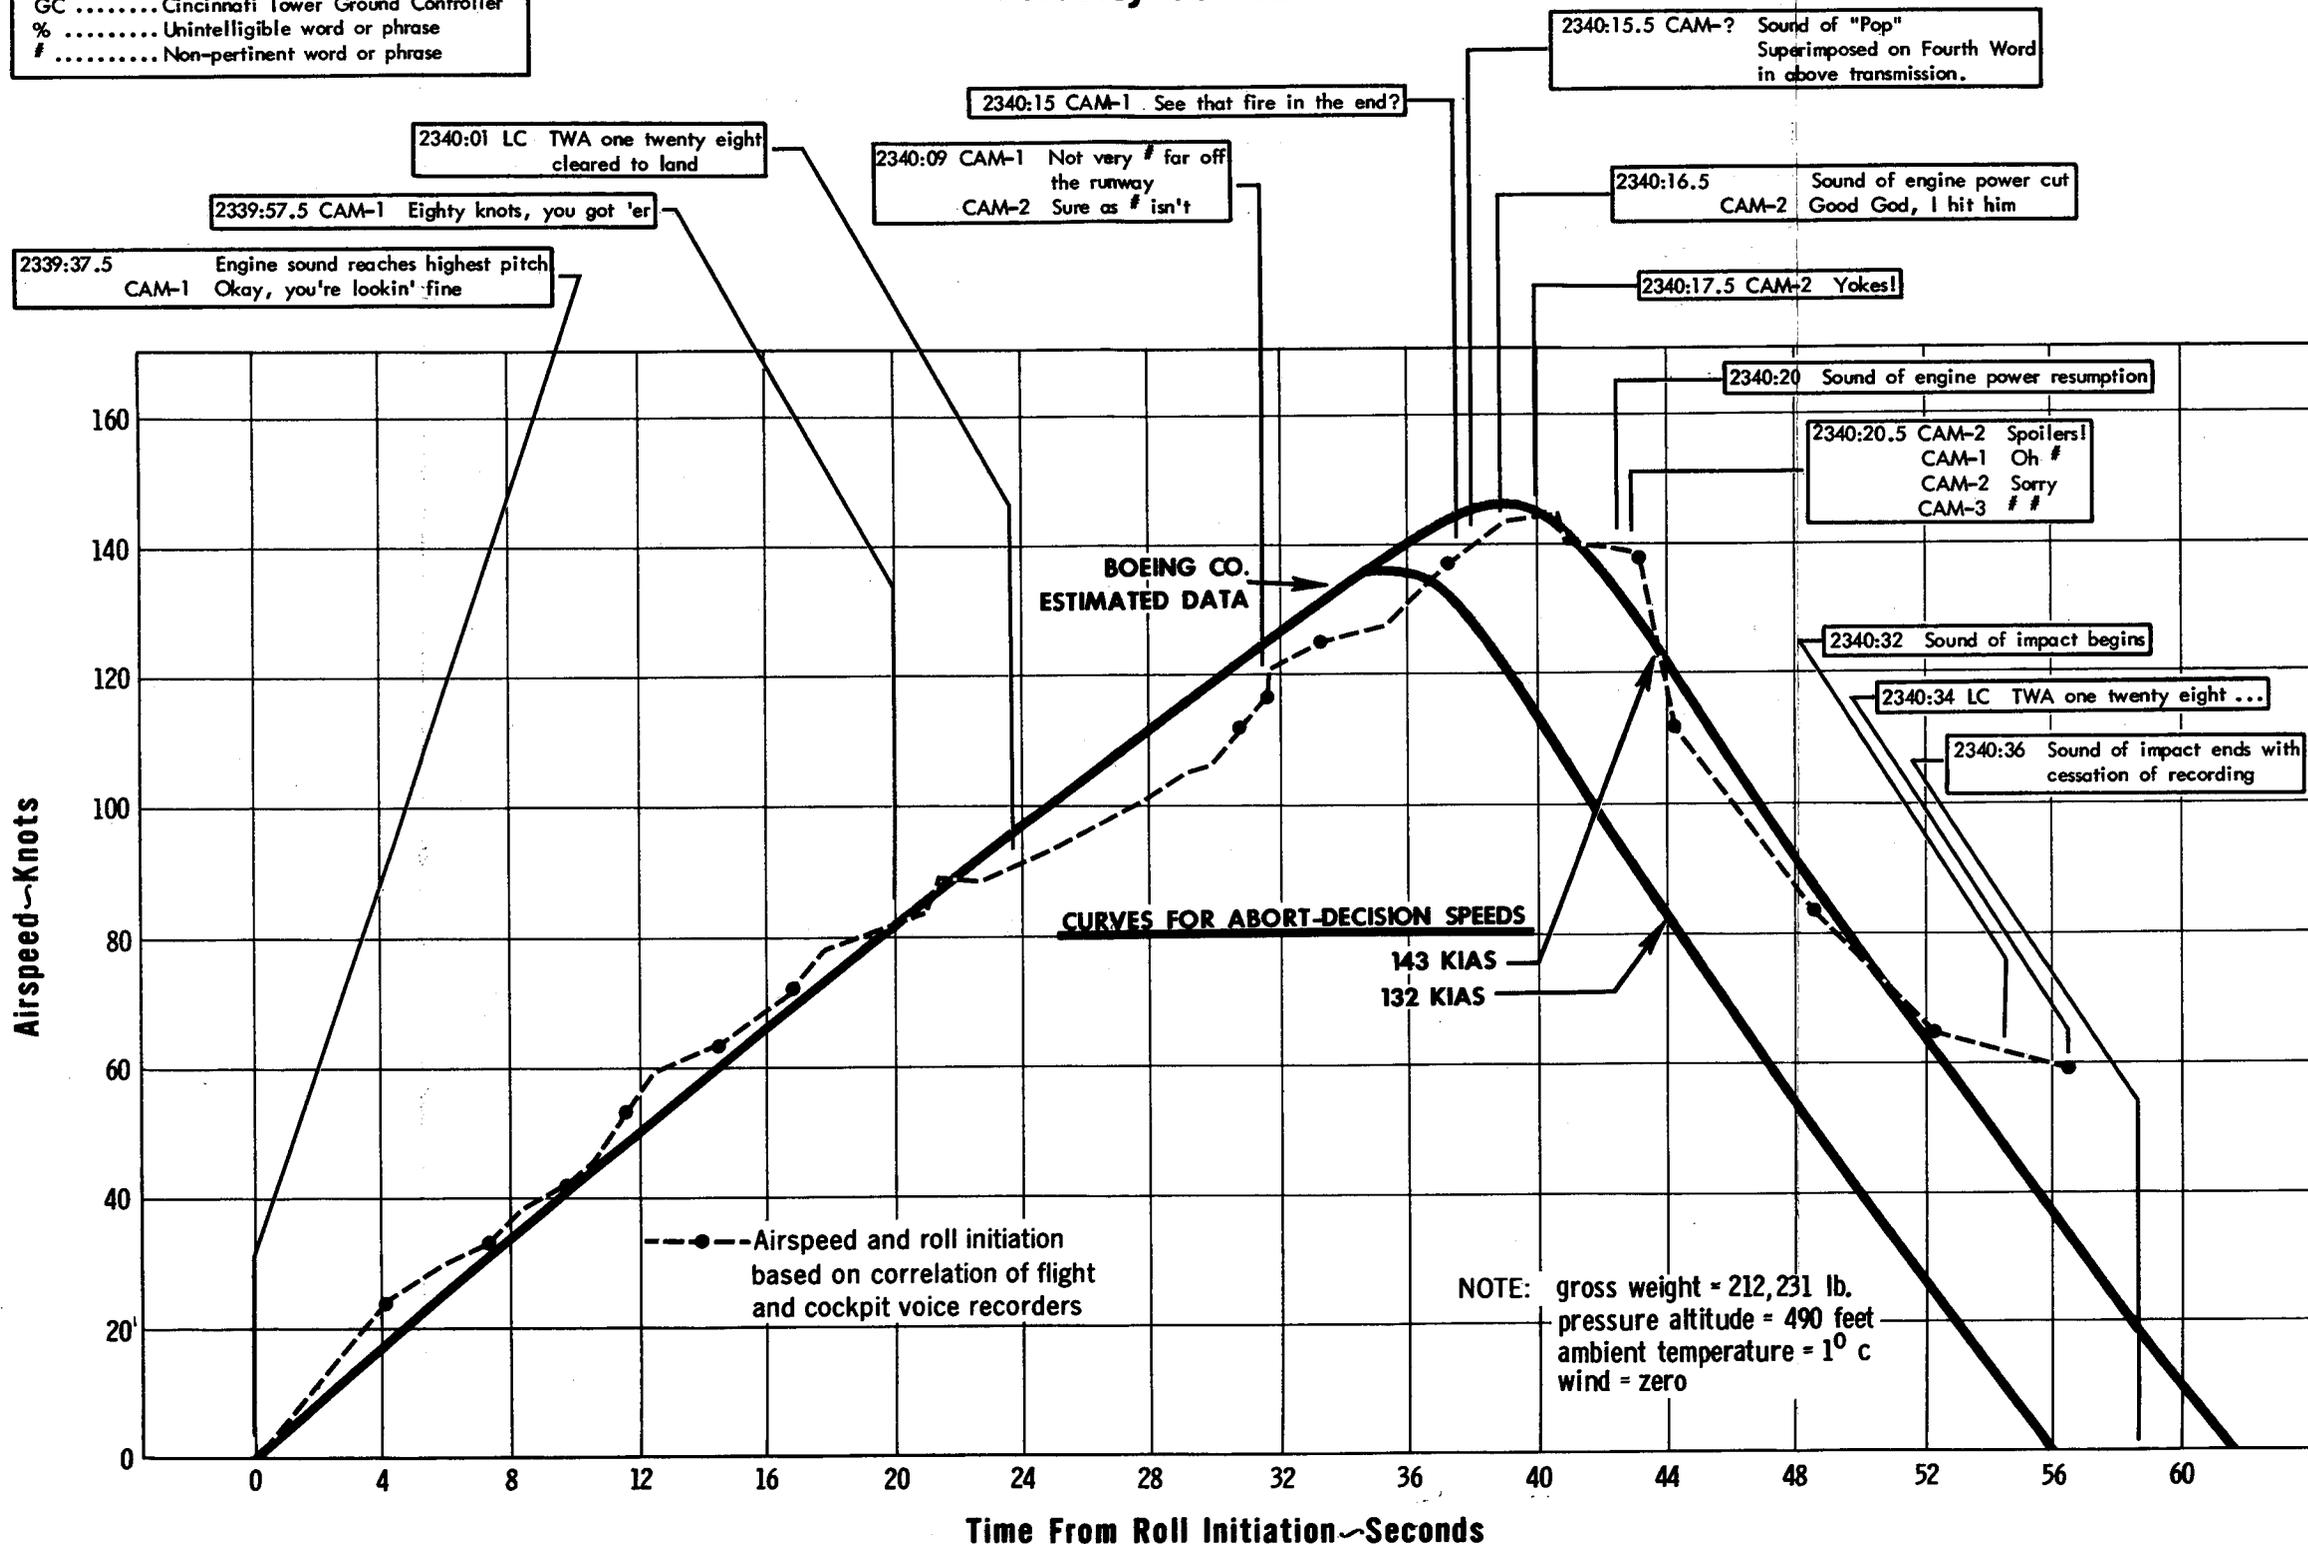
Velocity vs Time

The CVR-flight recorder airspeed curve was then compared with a predicted performance curve provided by Boeing. (See Attachments 1 and 2). This comparison, utilizing the takeoff clearance as a time reference, revealed an apparent disparity between the predicted and recorded performance of the aircraft in both the acceleration and deceleration phases of the takeoff. Further study of the evidence prompted selection of the engine noise reaching its highest peak as the time reference for the takeoff roll initiation point. This resulted in closer comparison of the two airspeed traces at the higher, more accurately recorded values, and still provided exceptional correlation with the physical evidence. In addition to the time base reference point, there were three other factors affecting the compatibility of the predicted and recorded performance. First, the airspeed values during deceleration are apparently depressed due to static

The final CVR-flight recorder correlation indicates that the first reference of the crew to the position of DAL 379 occurred at approximately 115 knots. At this point, TWA 159 had progressed about 3,350 feet along the runway in 31.5 seconds. Five seconds later, at 4,400 feet (200 feet prior to passing DAL 379), the flight reached V_1 . Acceleration continued as TWA 159 passed DAL 379 at approximately 135 knots, the sound of a "pop" was recorded at 139 knots, the sound of the engine power cut was at 143 knots, and finally the airspeed peaked at 145 knots. During this time interval, between 36.5 seconds and 40.5 seconds, the flight traveled approximately 950 feet to 5,350 feet from the takeoff roll initiation point. The airspeed then dropped in the next second to 140 knots. At 42.5 seconds the sound of engine power resumed, followed at 43 seconds by the command of the first officer for spoilers. At this point, the aircraft was approximately 5,900 feet down the runway and a marked increase in the deceleration began. The sound of impact began at 7,575 feet.
