AIRCRAFT ACCIDENT REPORT

NORTH CENTRAL AIRLINES, INC.

CONVAIR 580, N46345

MIDAIR COLLISION NEAR

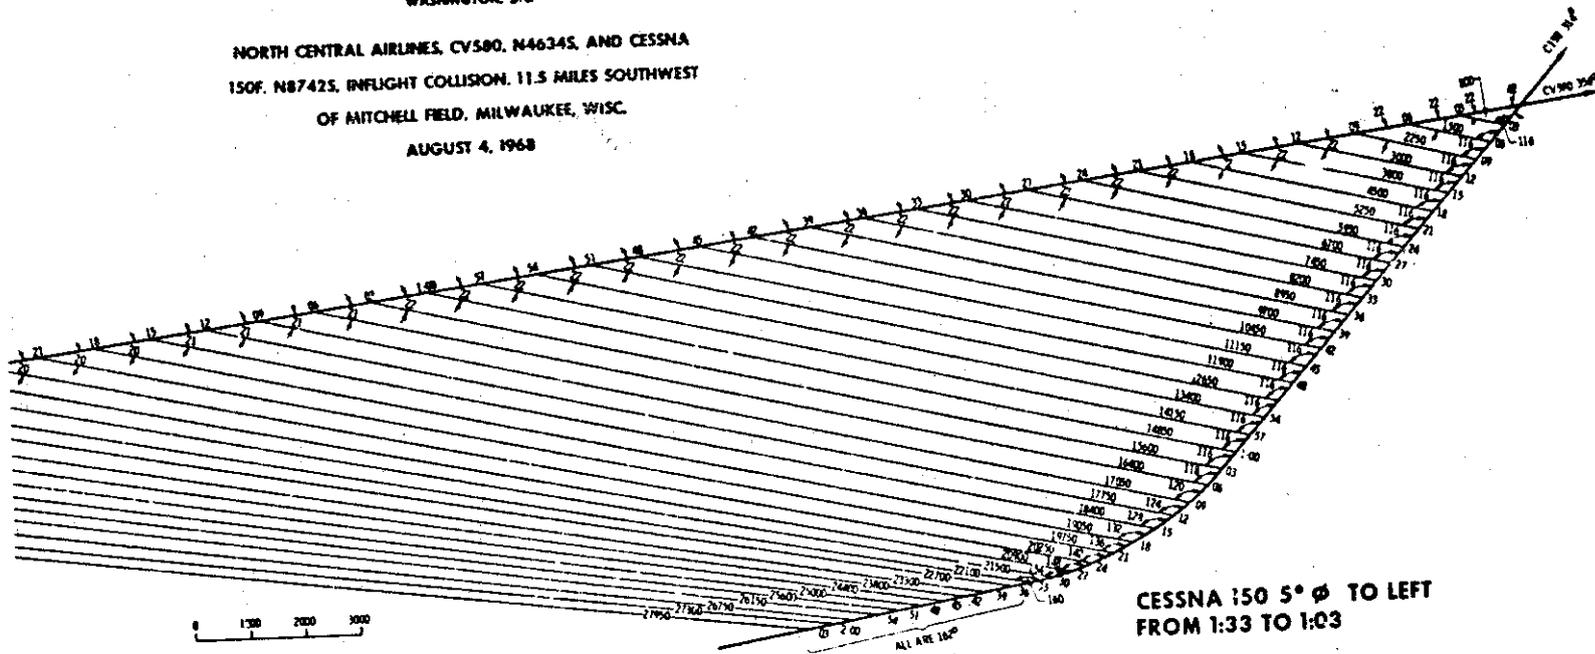
ATTACHMENT 2

NORTH CENTRAL AIRLINES, CV580, N46345, AND CESSNA
150F, N87425, INFLIGHT COLLISION, 11.5 MILES SOUTHWEST
OF MITCHELL FIELD, MILWAUKEE, WISC.
AUGUST 4, 1968

CESSNA 150 5° ϕ TO LEFT
FROM 1:33 TO 1:03
