AIRCRAFT ACCIDENT REPORT

UNITED AIR LINES, INC.

Boeing 737-222, N9005U

PHILADELPHIA INTERNATIONAL AIRPORT

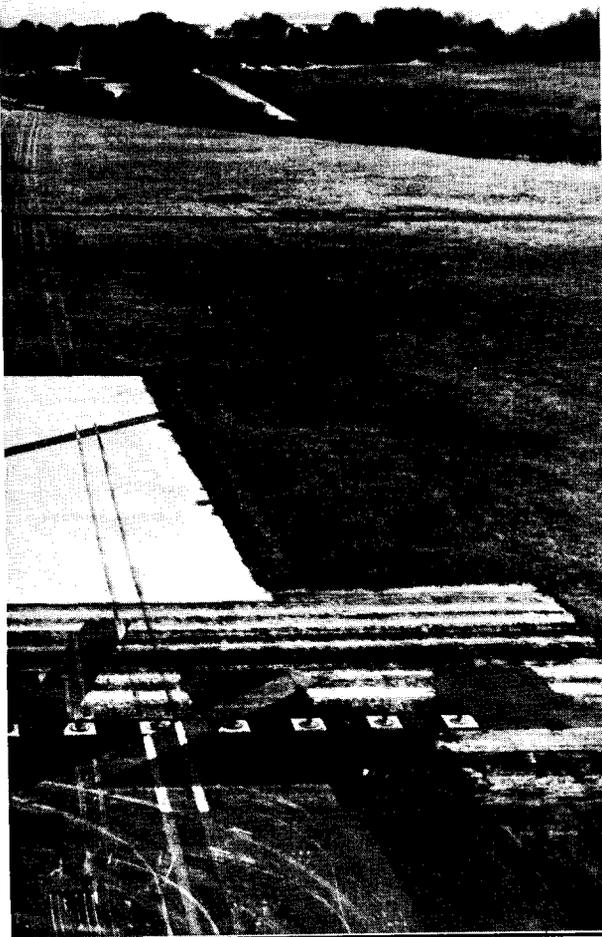
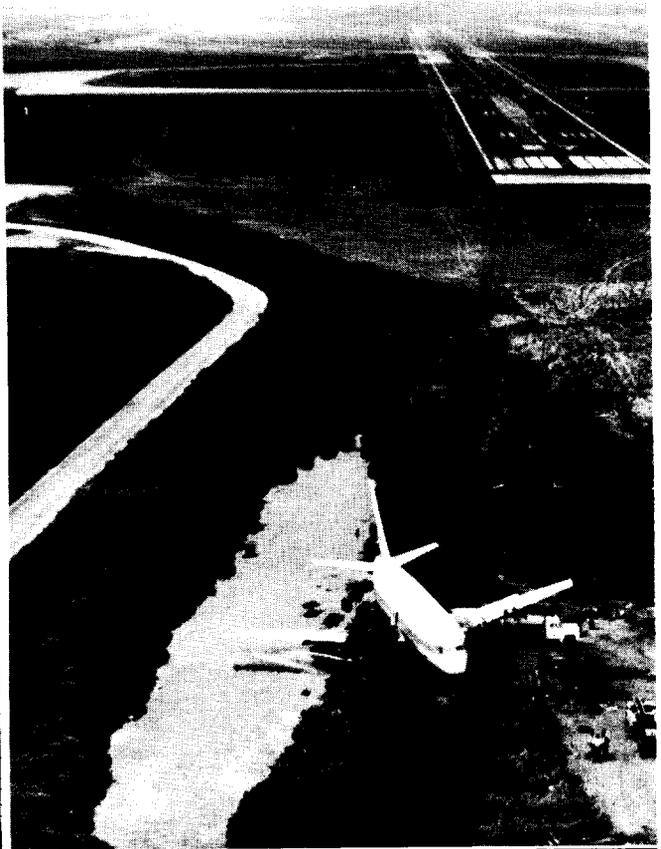
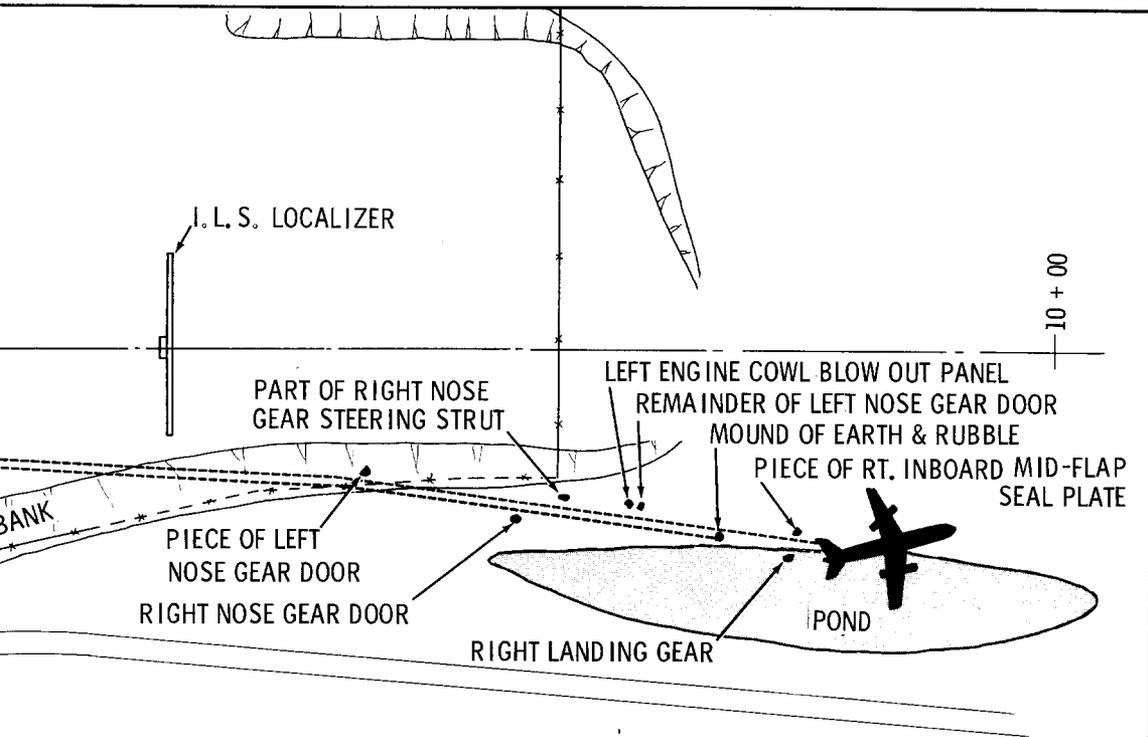
WRECKAGE DISTRIBUTION

The aircraft's right main landing gear touched down approximately 1,075 feet from the end of the runway and approximately 46 feet to the right of the centerline. The nose landing gear touched down approximately 776 feet from the end of the runway and 44 feet to the right of the centerline. The blackened condition of the runway prevented the determination of the touchdown point of the left main landing gear. However, the track of the left main landing gear was visible after it came out of the blackened area. It was also evident that the nose gear wheels tracked toward the right main gearwheel tracks throughout the landing and overrun. The aircraft came to rest 1,634 feet beyond the end of the runway beside a pond on a heading of 070° magnetic. During the overrun, the aircraft had passed over three runway threshold lights, through a chain link fence topped with barbed wire, and then impacted two mounds of earth and rubble before it came to rest. (See Appendix C.)

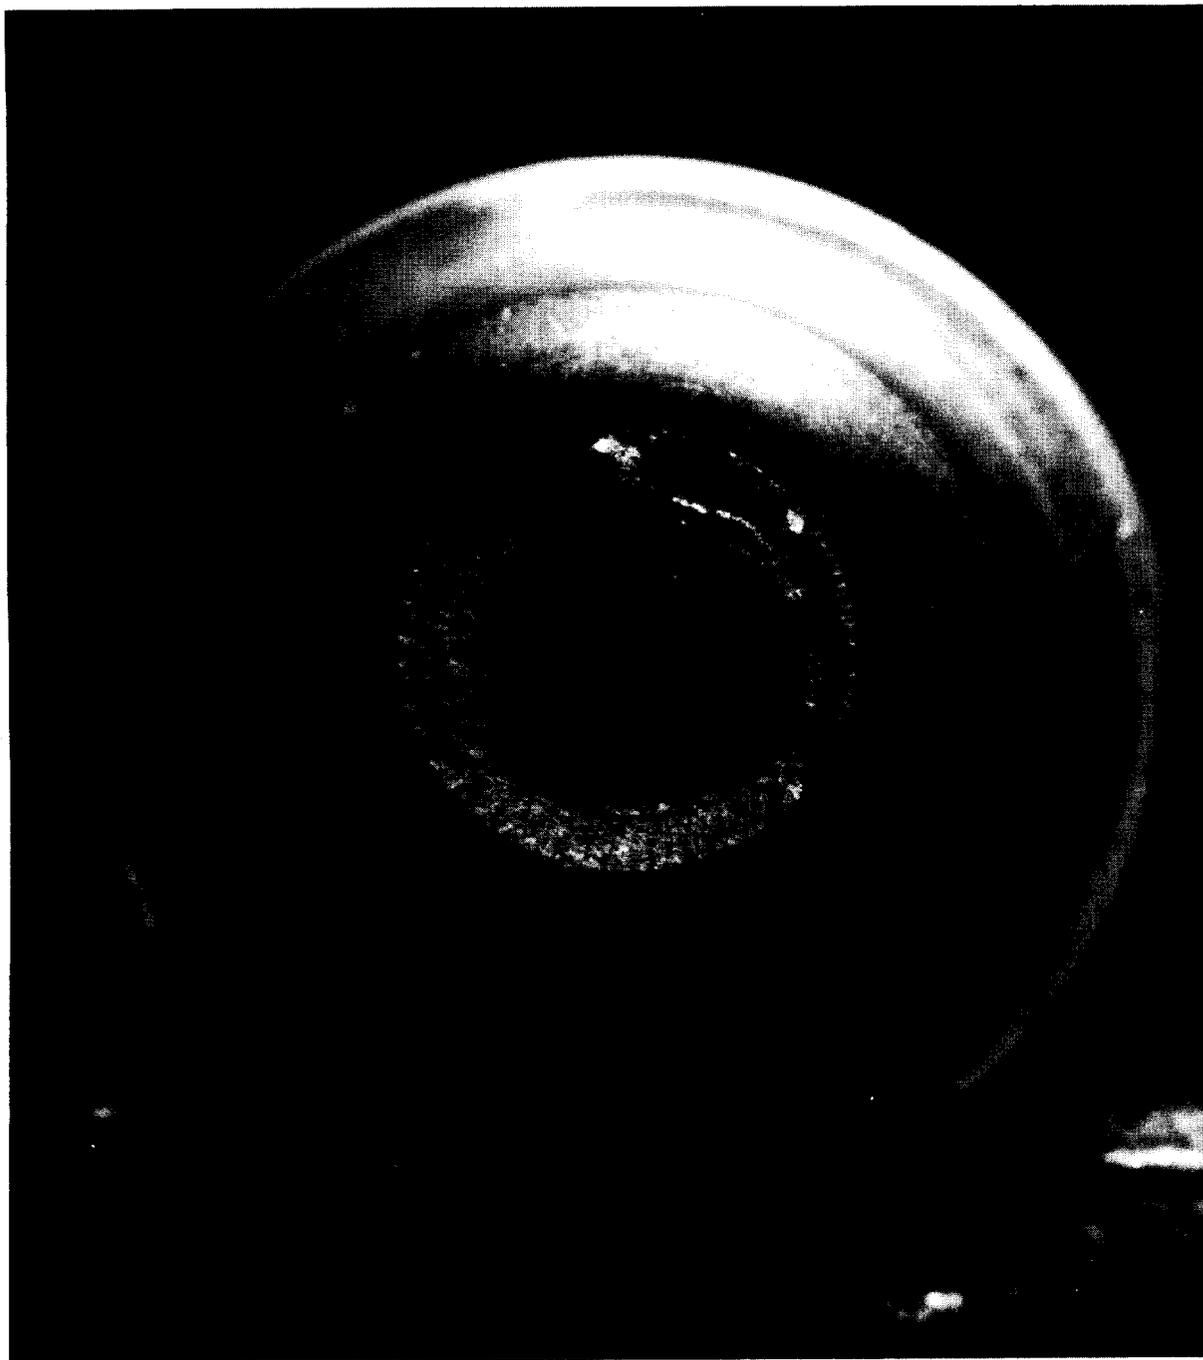
The fuel pump drive shaft splines bore evidence of normal as well as abnormal wear. The normal wear was obvious, due to its pattern and axial location, on the driven side of the spline. The abnormal wear was particularly evidenced by the wear on the nondriven side. This degree of abnormal wear further substantiated a high

Results of examination and testing of the fuel pump drive shaft showed that the fracture was caused by fatigue resulting from a rotating beam type loading.

The loading induced on this shaft was due to an extreme misalignment between the fuel pump and the spur gear drive shaft. It was estimated that the misalignment created a bending stress in excess of 180,000 p.s.i. in the fuel pump drive shaft. Such a high bending stress results in ratchet marks, indicating multiple fatigue origins, which increase in number with the degree of stress concentration and stress level. The number of cycles to failure is primarily dependent on the level of this bending stress. In this case, the number of cycles is assumed to have been low. Inspection of the fuel pump drive shaft fracture surfaces revealed an extremely high number (at least 50) of fatigue origins.

Failed Fuel Pump Drive Shaft P/N 208235 from UAL Engine 656059 Involved in Philadelphia Incident. . . Boeing 737 N900 5U, Flight 611, No. 2 Position, *Accident* 7/19/70. Viewed Toward Gearbox.

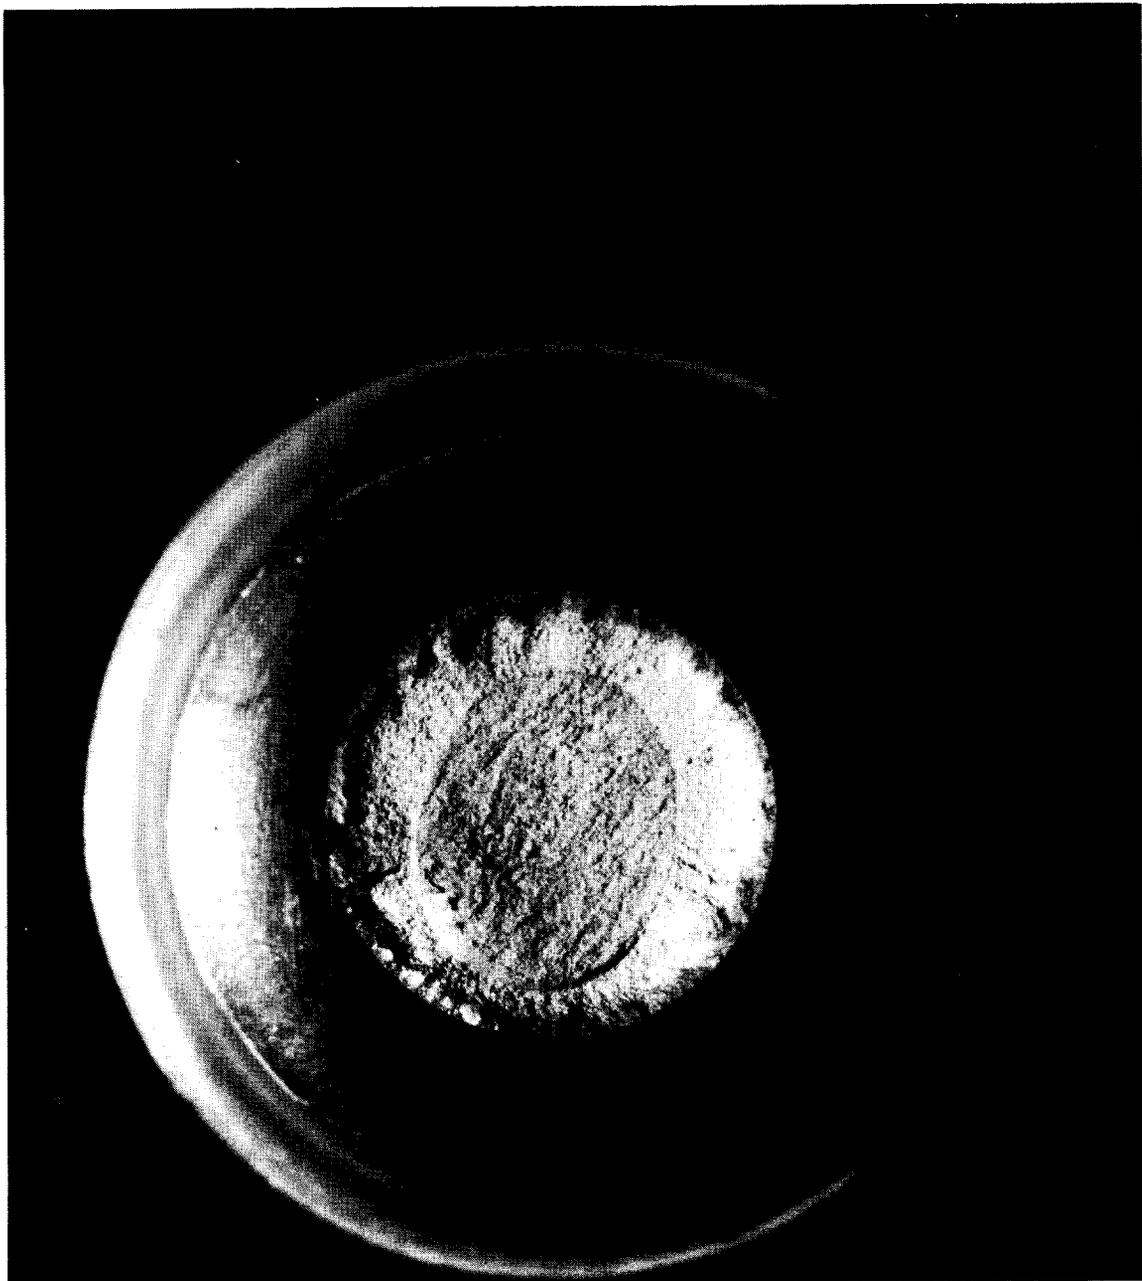
An extrapolation of the above cited rig test and fatigue origin data, coupled with a comparison of the similarity between the fracture surface of the broken fuel pump drive shaft (Appendix G) and the test specimen that was subjected to a stress range of 160,000 to 165,000 p.s.i. (Appendix H), led to the estimation by Pratt & Whitney that a stress in excess of 180,000 p.s.i. was required to fail the broken fuel pump drive shaft.

Fuel Pump Shaft Test Simulation – Bending Stress 160,000-165,000 PSI – 3500 Cycles
