AIRCRAFT ACCIDENT REPORT

MISSISSIPPI VALLEY AIRWAYS, INC.

JEANVILLAND BHC-6, N956SM

LA CROSSE, WISCONSIN

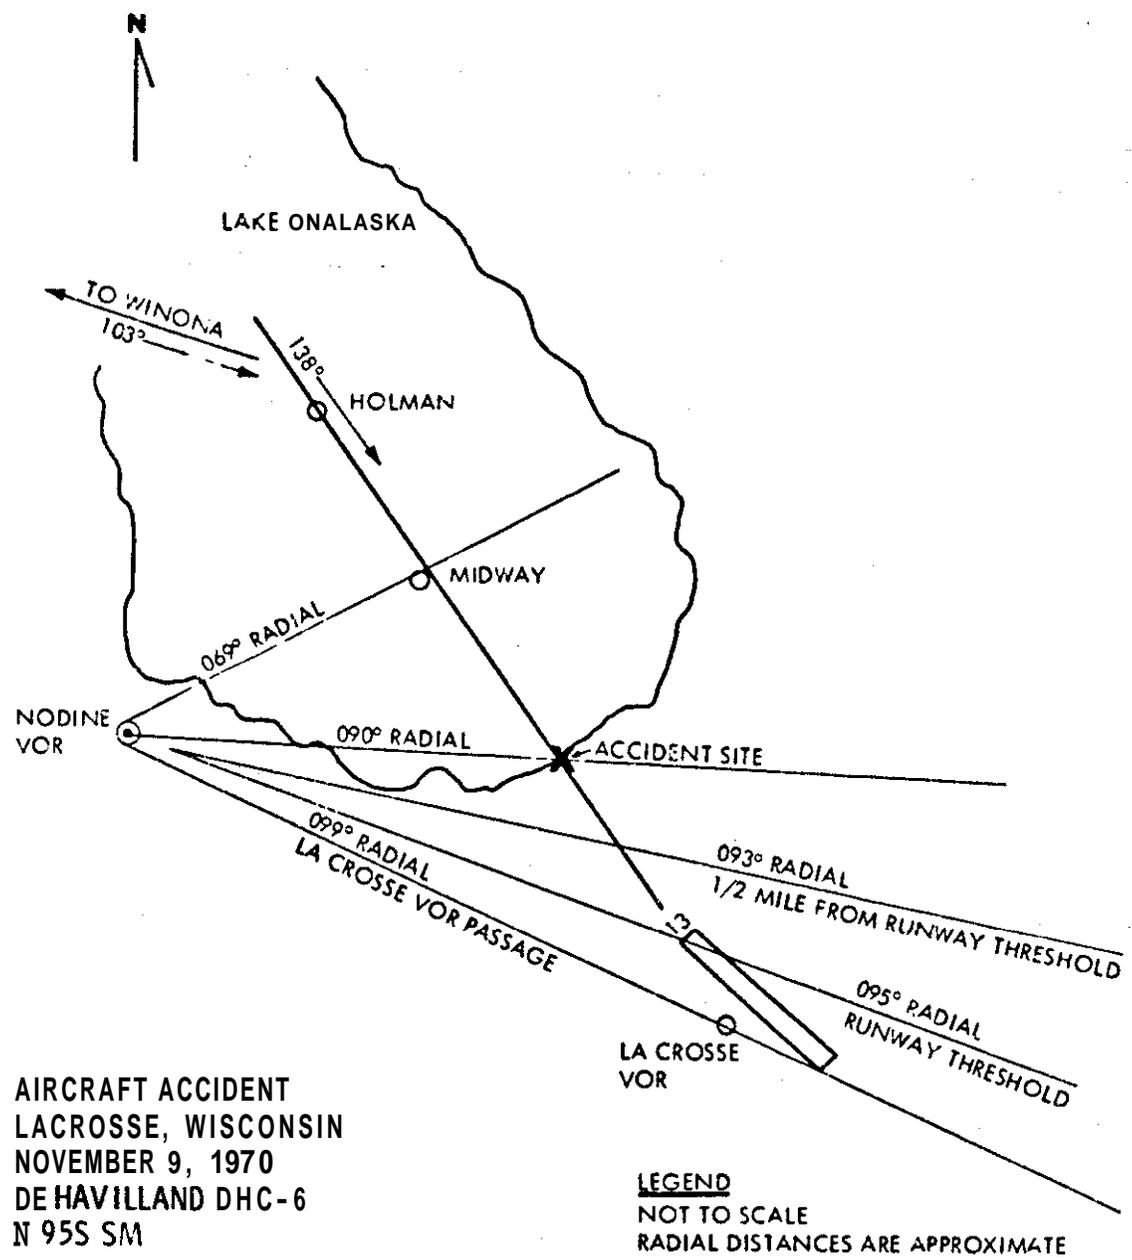
The Midway Intersection, the final descent fix for Runway 13, is positioned 5.1 nautical miles from the touchdown zone of that runway. This fix is shown as the intersection of the 069° radial of the Nodine VOR and the 138° inbound radial, to the La Crosse VOR. ^{1/} Pilots are authorized to descend to the minimum descent altitude of 1,040 feet m.s.l., or 388 feet above the touchdown zone elevation of Runway 13, for a straight-in approach, after they cross the VOR at La Crosse.
