NATIONAL
TRANSPORTATION
SAFETY
BOARD

AIRCRAFT ACCIDENT REPORT

NORTHWEST AIRLINES, INC.,
BOEING 747-151, N606US
OVER THE NORTH PACIFIC OCEAN
105 NAUTICAL MILES WEST OF 150° EAST
LONGITUDE AT 36° NORTH LATITUDE
APRIL 12, 1972

REPORT NUMBER: NTSB-AAR-72-27

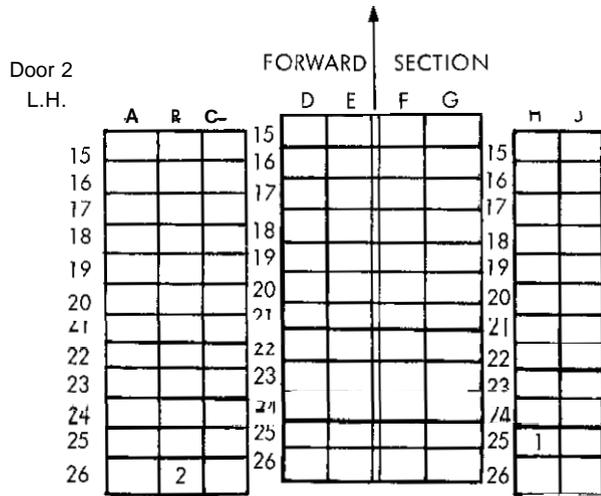
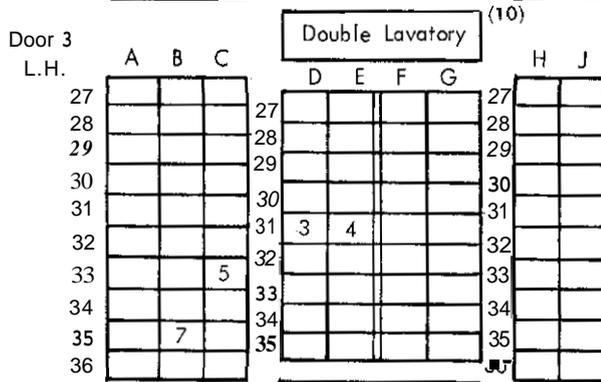
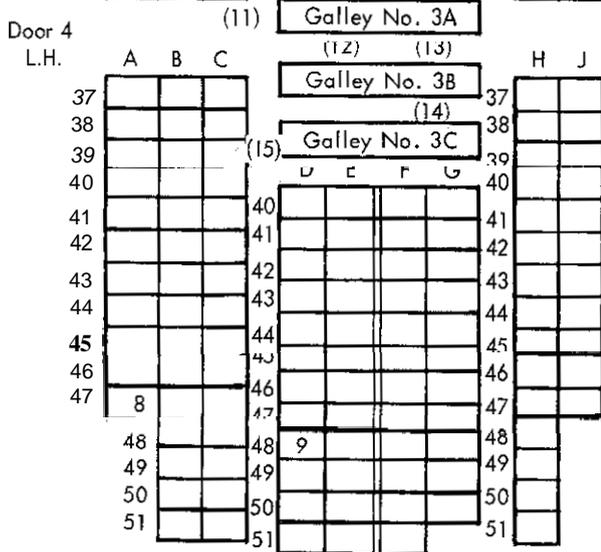
INJURY LOCATION CHART
NORTHWEST ORIENT AIRLINES, INC.
BOEING 747-151, N606US
OVER THE NORTH PACIFIC OCEAN
105 NAUTICAL MILES WEST OF 150°
EAST LONGITUDE AT 36° NORTH LATITUDE

Despite the purser's advisory announcement, none of the injured passengers had their seatbelts fastened, although the majority of them were in their seats. The five stewardesses were standing. All those injured were located in rear cabin areas.

^{2/} Attachment 2 depicts the positions and degree of injury of the personnel injured at the time of the turbulence encounter.
