AIRCRAFT ACCIDENT REPORT

EASTERN AIR LINES INC.

DC-9-31, N8961E

May 18, 1972

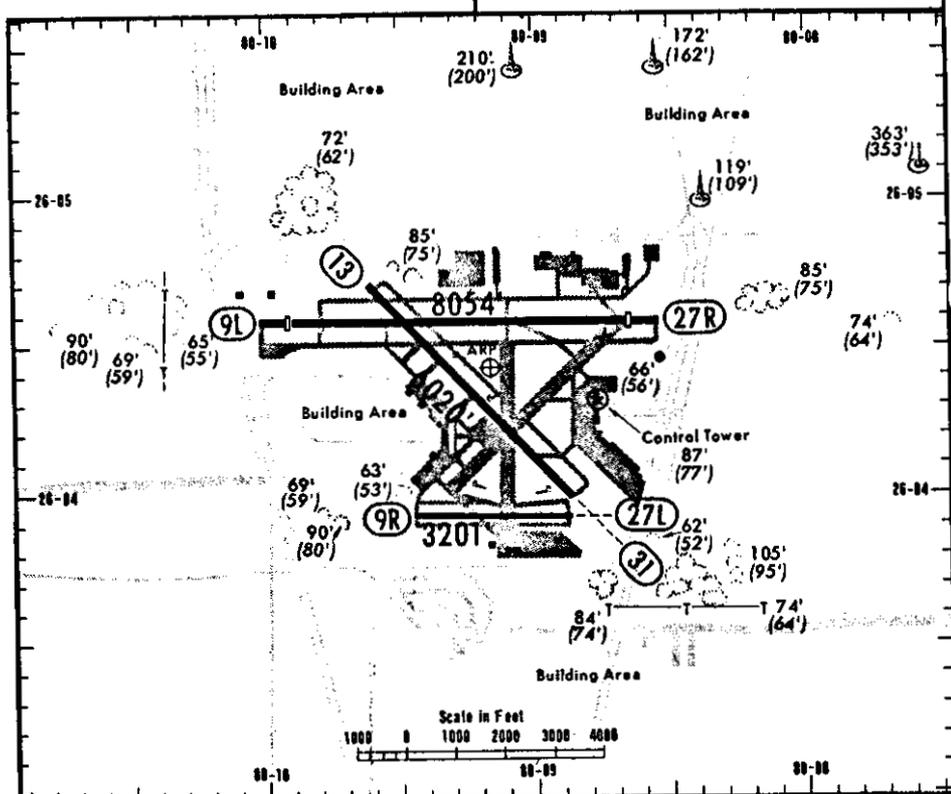
The Jeppesen Approach Chart showed that the straight-in landing minima for Runway **9L** with the glide slope inoperative were: MDA, **460** feet; visibility, **1** mile. With all components of the ILS in service, the minima listed were: decision height (DH), **257** feet; visibility, three-quarters of a mile.

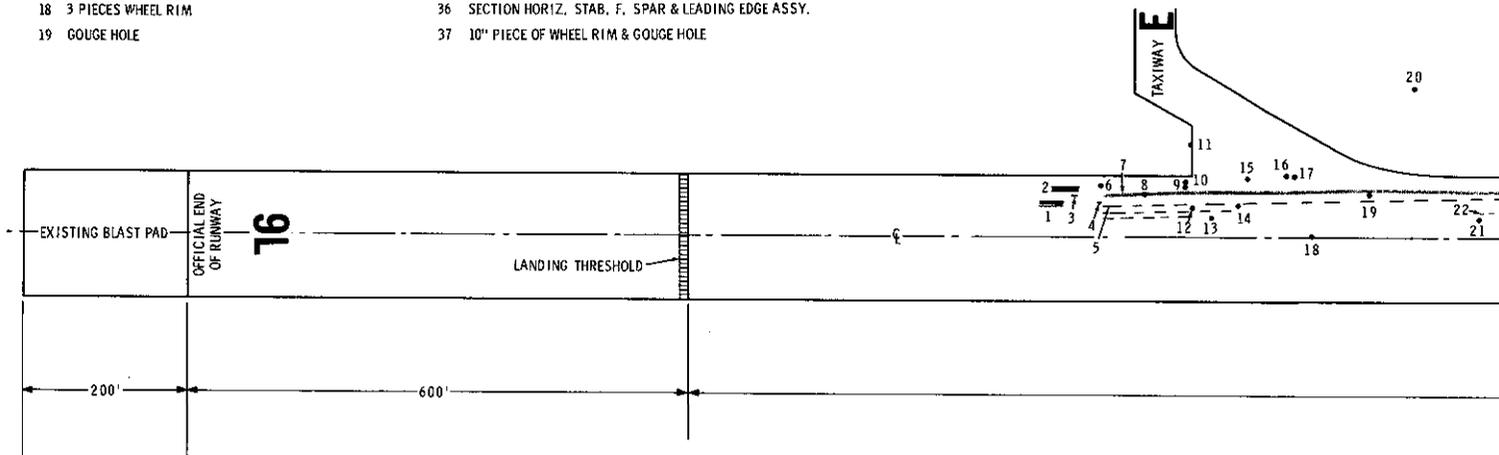
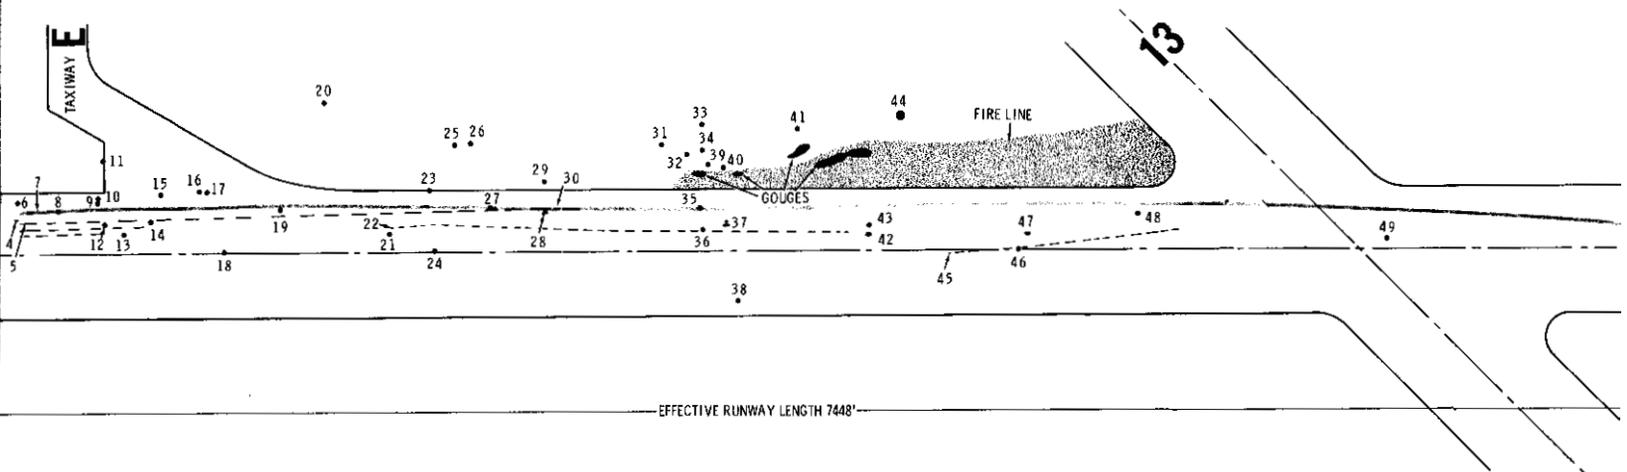
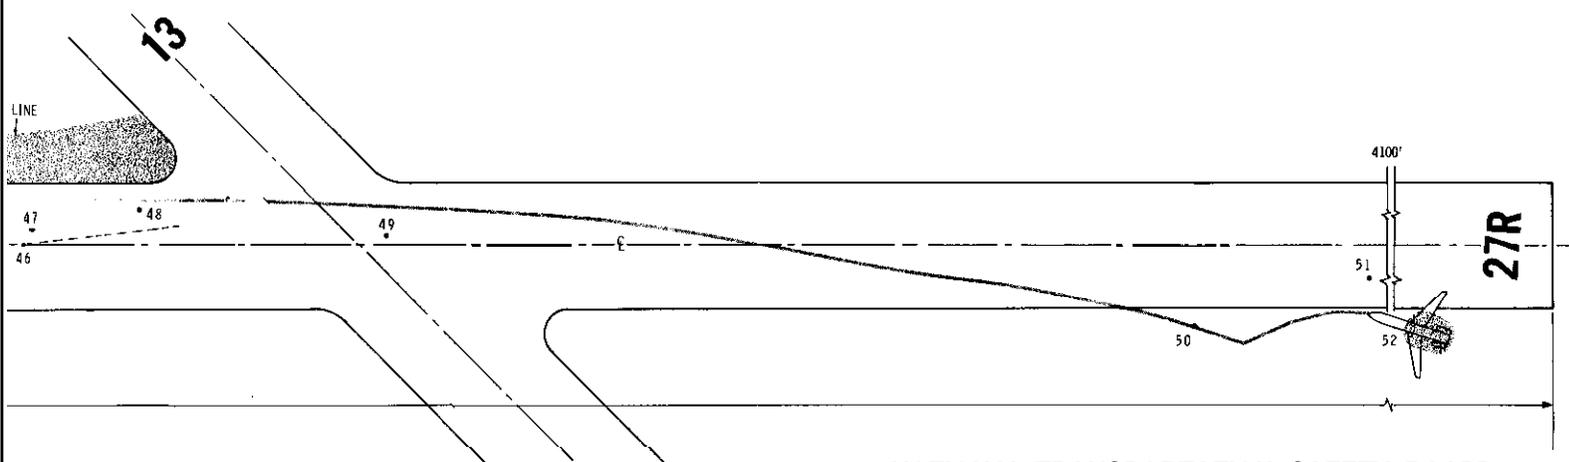
WRECKAGE DISTRIBUTION CHART
EASTERN AIRLINES, INC. DOUGLAS DC-9-31, N8961E
 FORT LAUDERDALE - HOLLYWOOD INTERNATIONAL AIRPORT
 Fort Lauderdale, Florida
 May 18, 1972

The right main landing gear with a section of the rear spar web separated from the aircraft at impact. The left main landing gear was pushed up and to the rear but remained attached to the left wing. The nose gear was found in the down and locked position. The wing-leading edge slats were fully extended. The exact position of the trailing edge flaps could not be determined because of the damage caused by the collapse of the main landing gear. All spoiler panels were found in the retracted position. All flight control surfaces were accounted for, and no discrepancies were found in any flight control system. The stabilizer was positioned at 2.5°, aircraft nose up.

NO.	DESCRIPTION
1	R. M. GEAR TOUCHDOWN POINT & TIRE SCRUB MARKS
2	L. M. GEAR TOUCHDOWN POINT & TIRE SCRUB MARKS
3	GOUGE IN RUNWAY
4	GOUGE IN RUNWAY
5	R. WING FLAP HINGE BRACKET GOUGES & SCRAPE MARKS
6	AREA OF SMALL PIECES OF RED GLASS
7	NOSE GEAR TIRES SCRUB MARK TRACKS
8	SHIM - EMPENNAGE TO FUSELAGE JOINING SECTION
9	PIN 2419184
10	PIN - 7619-510 ALUM. & FIBERGLASS
11	STATIC WICK & PIECE OF FIBERGLASS
12	8" SECTION WHEEL RIM
13	OUTB'D. FLAP HINGE FAIRING
14	STATIC WICK
15	RIB - TRAILING EDGE WING x TE 135.619
16	4' SECTION HYD. LINE
17	DOOR. R. M. GEAR - WING
18	3 PIECES WHEEL RIM
19	GOUGE HOLE
20	8" SECTION WHEEL RIM & SECTION WING T. EDGE
21	FLAP VANE - T.E. FLAPS & P/N 5023142-5601
22	SCRAPE MARKS
23	FLAP VANE - T.E. FLAPS
24	PIECE OF AUX. WING SPAR
25	STRIP - INB'D. WING - UPPER T.E. - INB'D.
26	DOOR - L. M. GEAR - WING
27	LARGE ROLLER BEARING & BRACKET
28	GOUGE HOLE
29	ACCESS DOOR - STARTER VALVE
30	R. INB'D. FLAP HINGE SCRAPE MARKS CROSSED NOSE GEAR TIRES SCRUB MARKS

31	PANEL - INB'D WING - UPPER T.E. - INB'D.
32	SECTION OF HORIZ. STAB. TIP
33	ALUM. RING & FLEXIBLE DUCT CONNECTOR
34	2 SECTIONS HYD. LINES - 5' - ELEV. RETURN
35	PIECE OF BHD. & CAP WING STA. x 111.500
36	SECTION HORIZ. STAB. F. SPAR & LEADING EDGE ASSY.
37	10" PIECE OF WHEEL RIM & GOUGE HOLE
38	RESTRICTER ASSY. - M.L.G. SHOCK STRUT - FLUID FLOW
39	LARGE ROLLER BEARING
40	CONE-VERT. STAB. ACTUATOR ACCESS
41	SECTION - L. ELN.
42	GOUGE HOLE
43	SECTION ELEV. T.E.
44	EMPENNAGE
45	GOUGE AND SCRAPE MARKS
46	SECTION OF ELEV. L. E. WITH BZ
46	SECTION OF ELEV. L. E. WITH BALANCE WEIGHT
47	GOUGE HOLE
48	R. M. GEAR STRUT PISTON & WHEEL ASSYS.
49	R.M. GEAR ASSEM. & ATTACHING STRUCTURE
50	NOSE GEAR TIRE
51	NOSE GEAR TIRE
52	AIRCRAFT CAME TO REST
