1. Report No. NTSB-AAR-78-4		2. Government Accession No.		3. Recipient's Catalog No.	
4. Title and Subtitle Aircraft Accident Report - Johnson and Johnson, Inc., Grumman Gulfstream II, N500J, Hot Springs, Virginia, September 26, 1976				5. Report Date February 9, 1978

AIRCRAFT ACCIDENT REPORT

JOHNSON & JOHNSON, INC.
GRUMMAN GULFSTREAM 11, N500J
HOT SPRINGS, VIRGINIA
SEPTEMBER 26, 1976

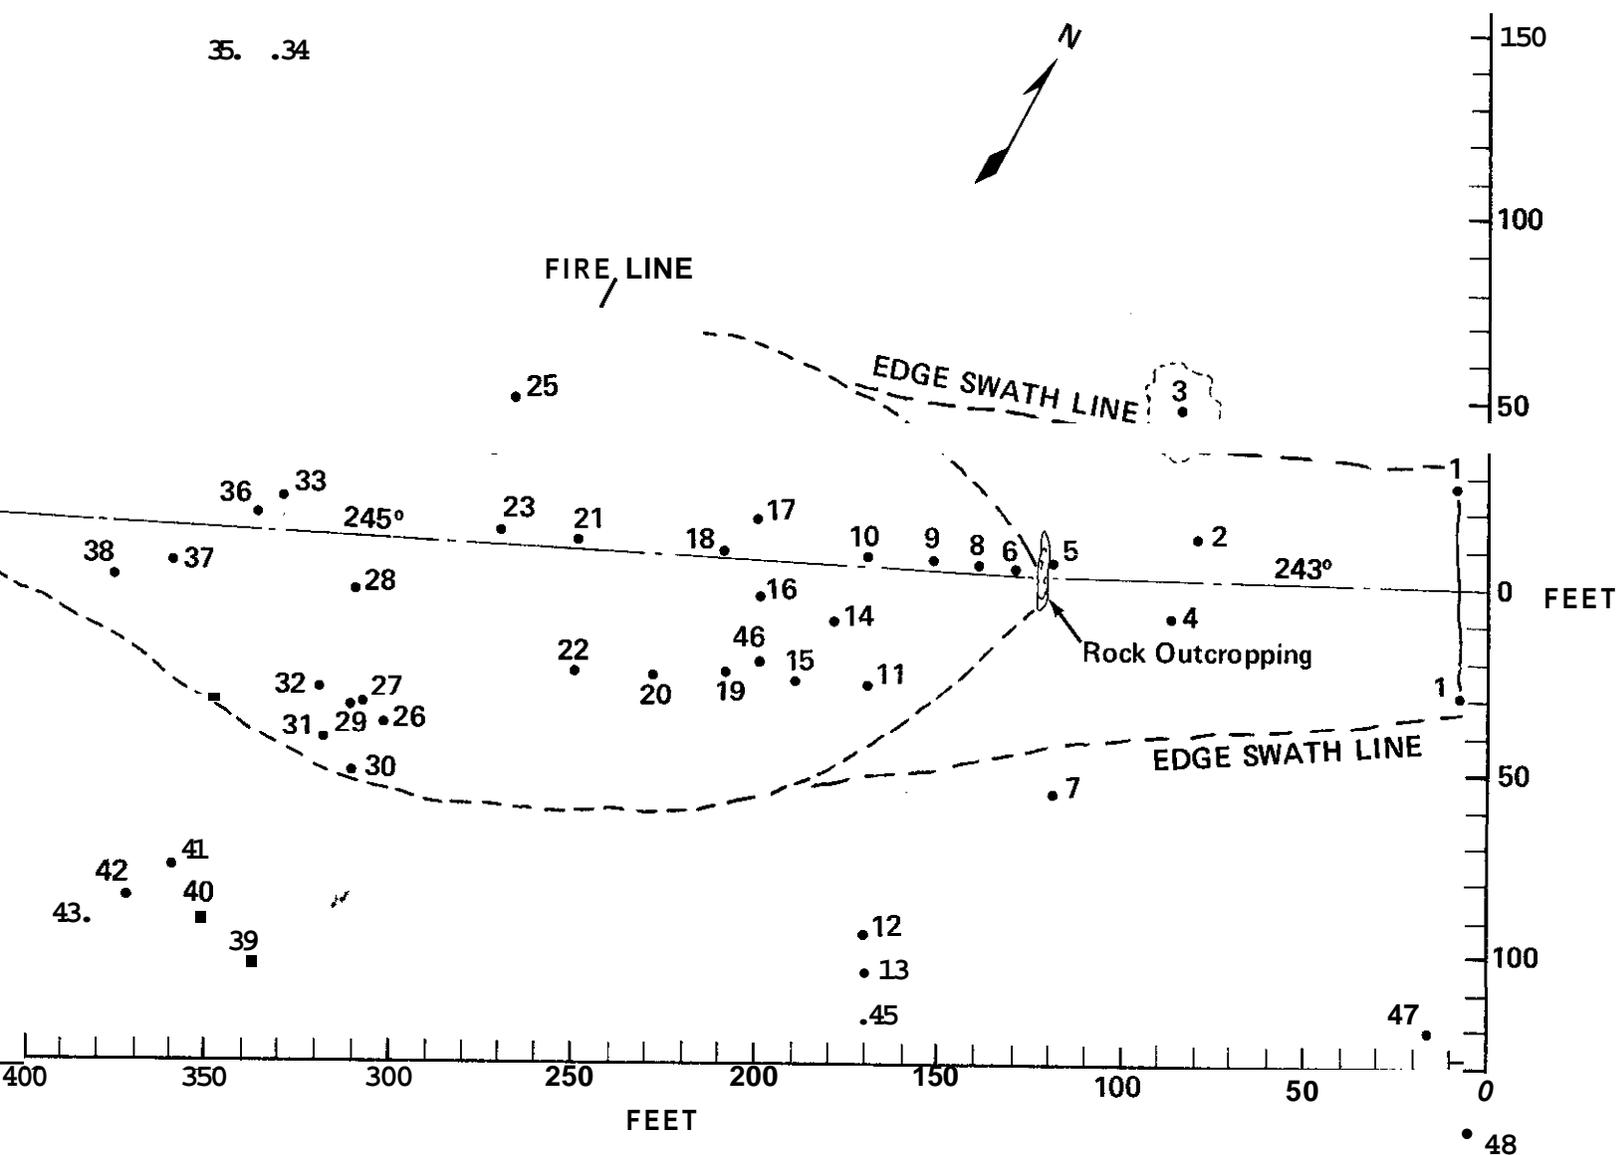
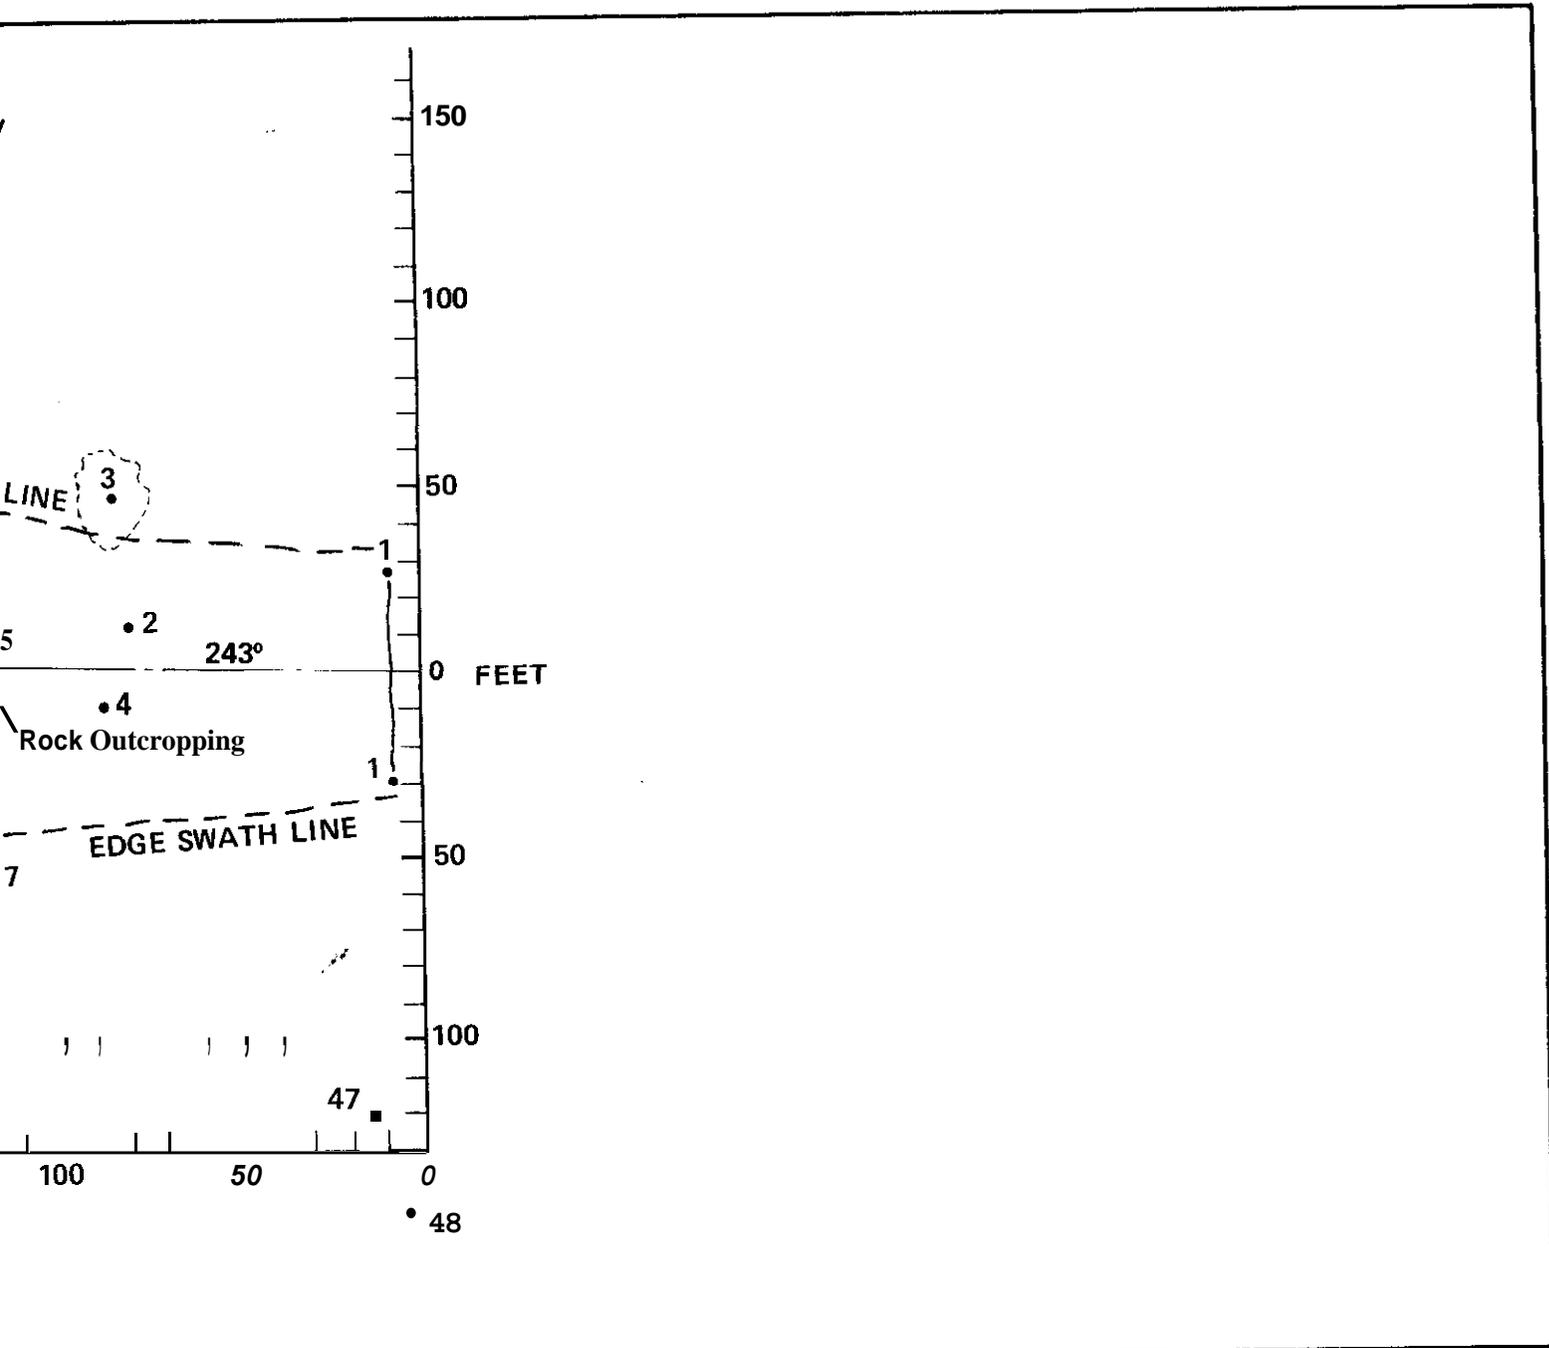
WRECKAGE DISTRIBUTION CHART
 JOHNSON BJOHNSON
 GRUMMAN GULFSTREAM II , N500J
 INGALLS FIELDS AIRPORT, HOT SPRINGS, VIRGINIA
 SEPTEMBER 26, 1976

The aircraft was certificated, maintained, and equipped according to FAA regulations. There was no evidence of structural failure. Although some components of the aircraft were outside the postcrash fire area and were damaged by fire, it is believed that these components were propelled from the main wreckage by the postcrash explosion. The left main landing gear outboard tire probably exploded and broke the wheel rim because of the intense ground fire and the remains were propelled to the locations shown on the wreckage distribution diagram. (See Appendix F.) Since

the main landing gear wheel wells adjoin and are open, any fire or smoke generated in one of those areas should leave evidence of that kind of damage in the other area. Since there was evidence of an explosion and since the right main landing gear and wing flap structure were not damaged by fire or, smoke, the Safety Board concludes that an in-flight fire did not occur in the wheel wells. There was no evidence of an in-flight fire on any other structure or component of the wreckage.
