1. Report No. NTSB-AAR-78-5		2. Government Accession No.		3. Recipient's Catalog No.	
4. Title and Subtitle Aircraft Accident Report - Alaska Aeronautical Industries, Inc., DeHavilland DHC-6-200, N563MA, Near Iliamna, Alaska, September 6, 1977.		5. Report Date May 4, 1978		6. Performing Organization Code

AIRCRAFT ACCIDENT REPORT

ALASKA AERONAUTICAL INDUSTRIES, INC.
DEHAVILLAND DHC-6-200, N563MA
NEAR ILIAMNA, ALASKA
SEPTEMBER 6, 1977

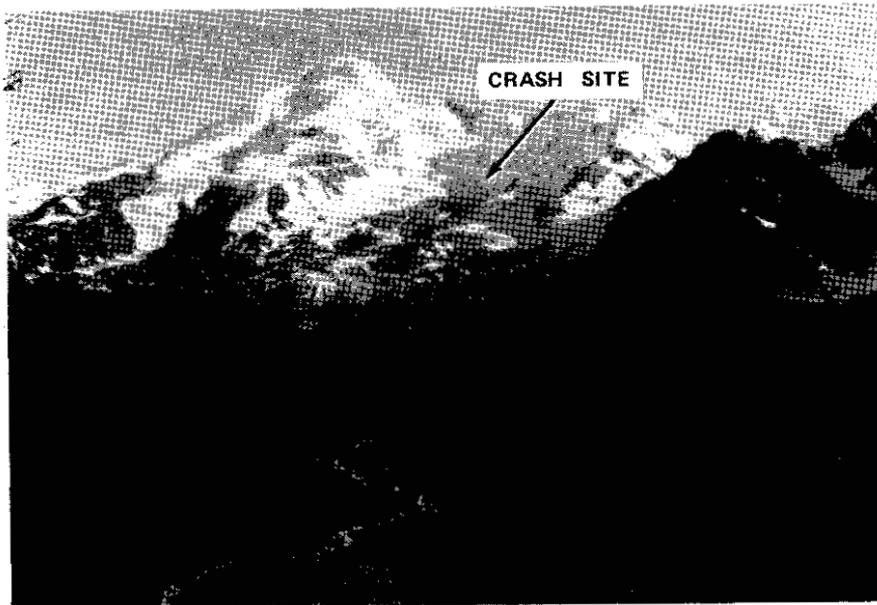
There were no survivors. Because of the rapidly changing environmental conditions on the glacier face of Mt. Iliamna, recovery of bodies and wreckage was not possible. (See figures 1A, 1B, 1C and 1D.)

Figure 1A. Mt. Iliamna.

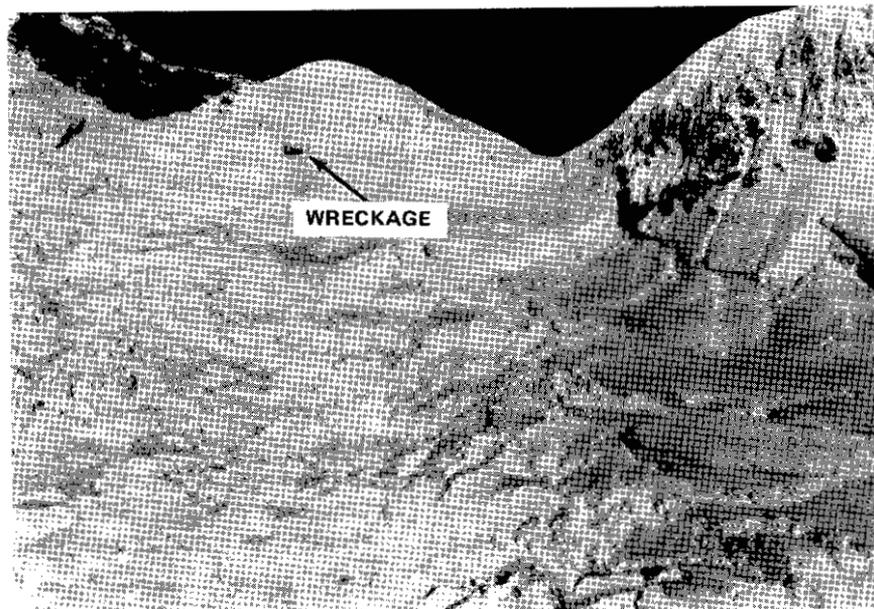
Figure 1B. Glacial field.

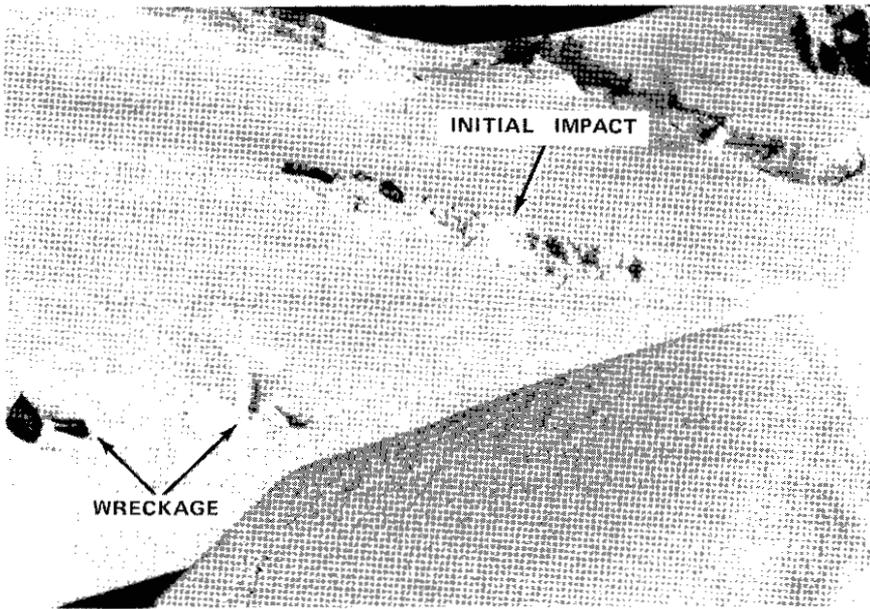
Figure 1C. Impact point on ice cliff.

The aircraft wreckage site was located about 56 nmi east-northeast of Iliamna Airport on September 7, 1977, by U.S. Air Force search and rescue aircraft. The wreckage was oriented along a heading of about 012°. A rescue team was landed at the site and they determined that there were no survivors. Because of the extremely hazardous environmental conditions, the team was forced to leave the area shortly after their arrival.

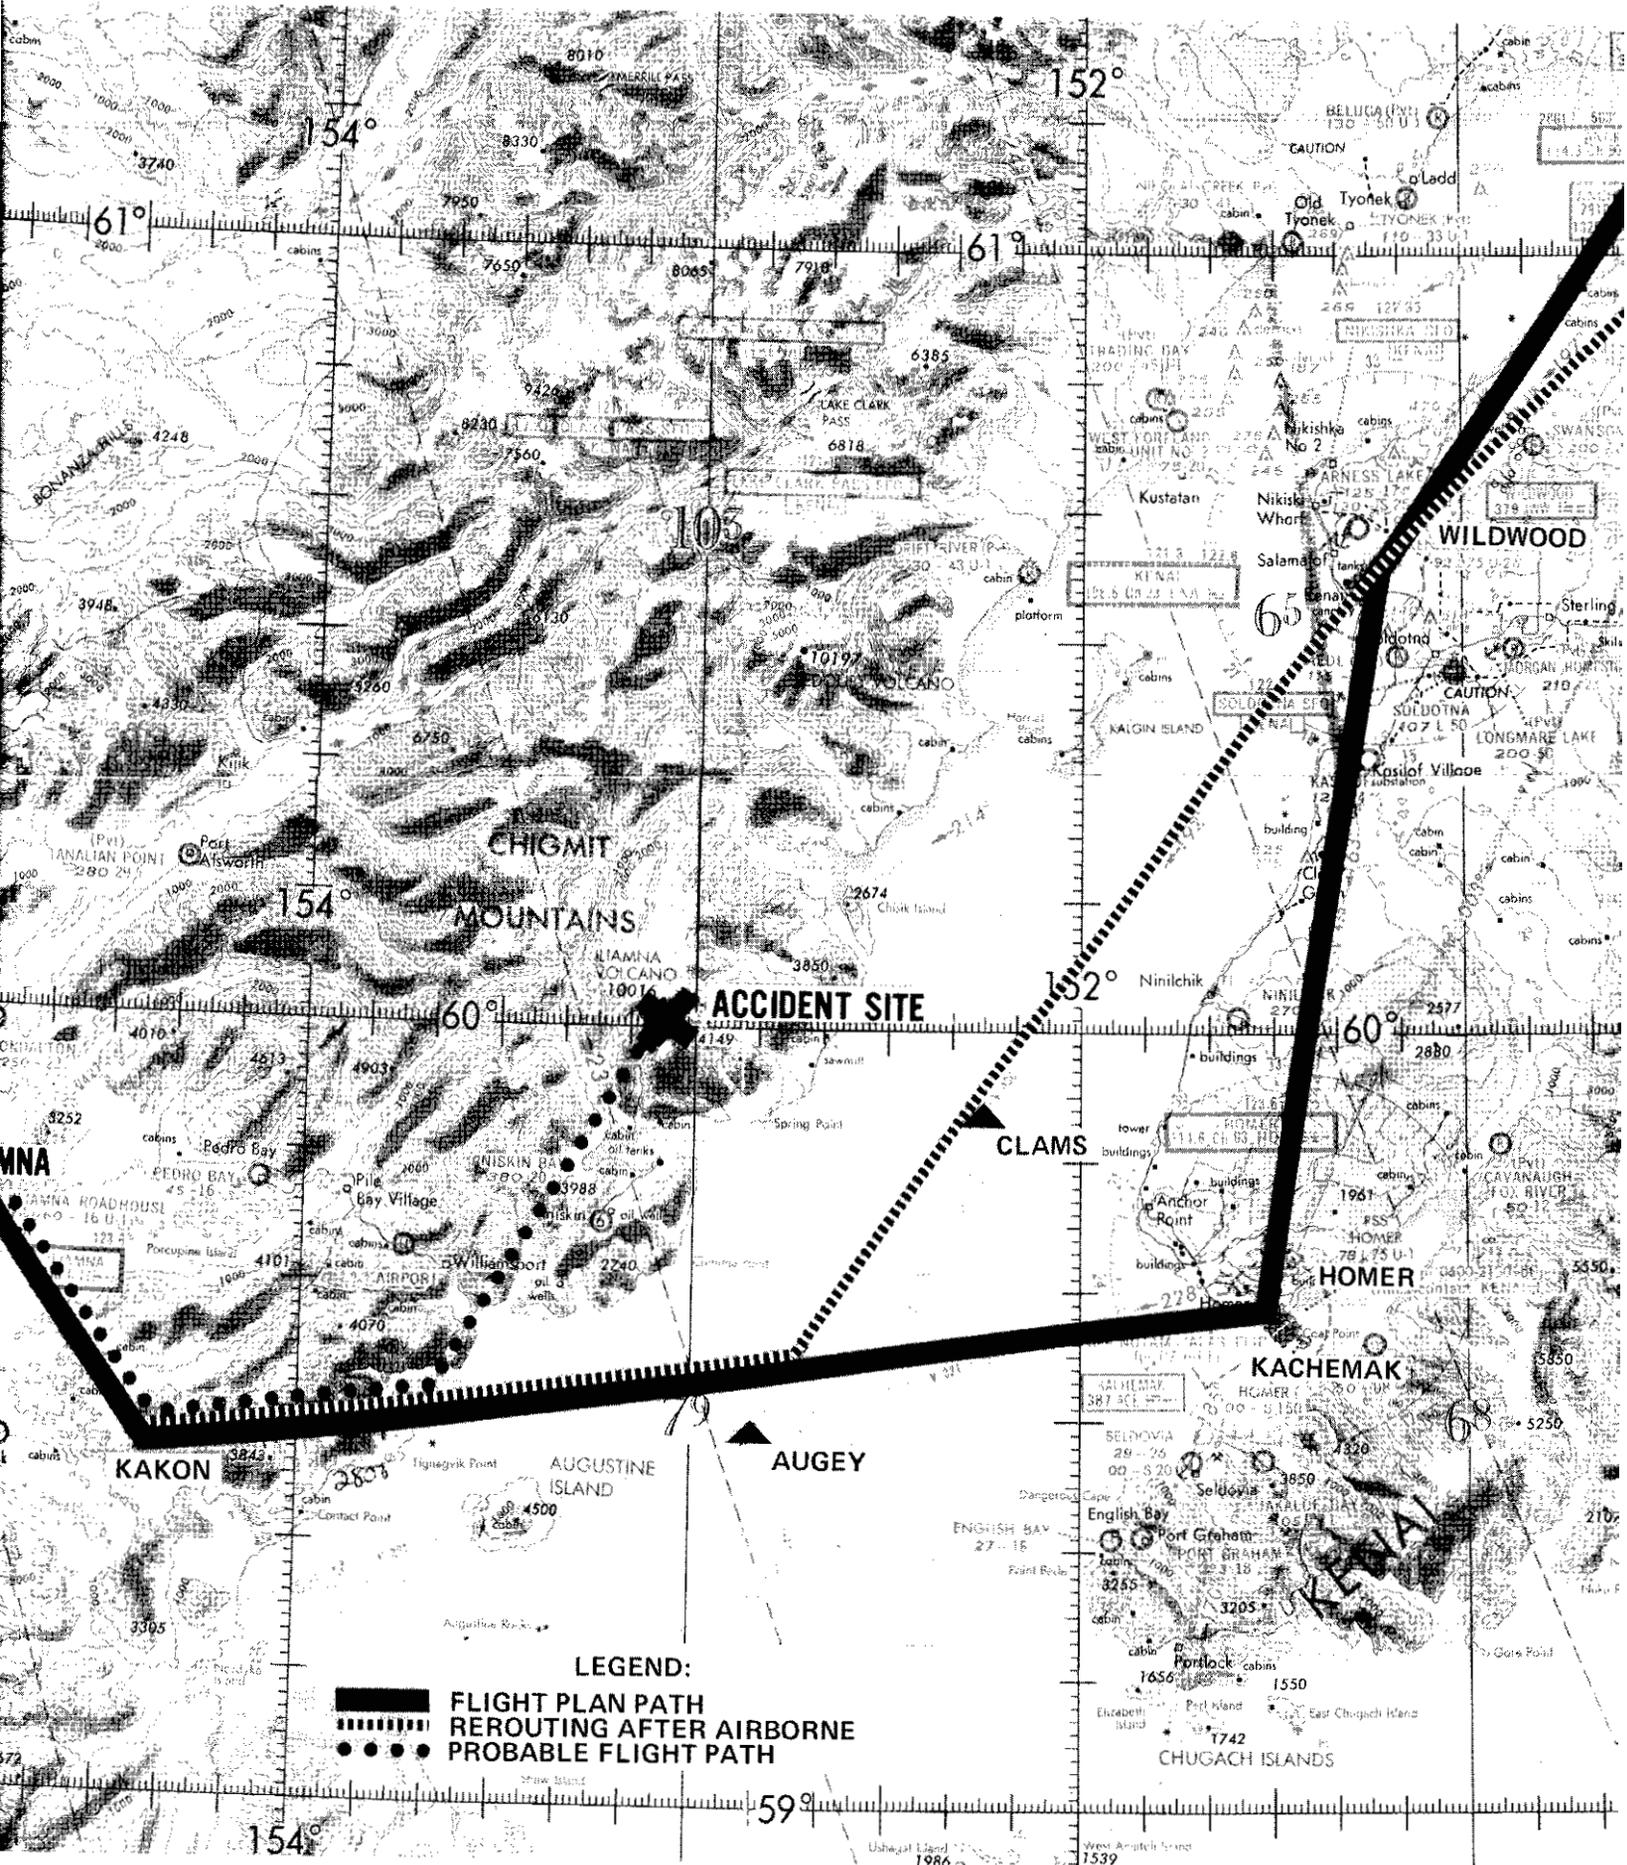
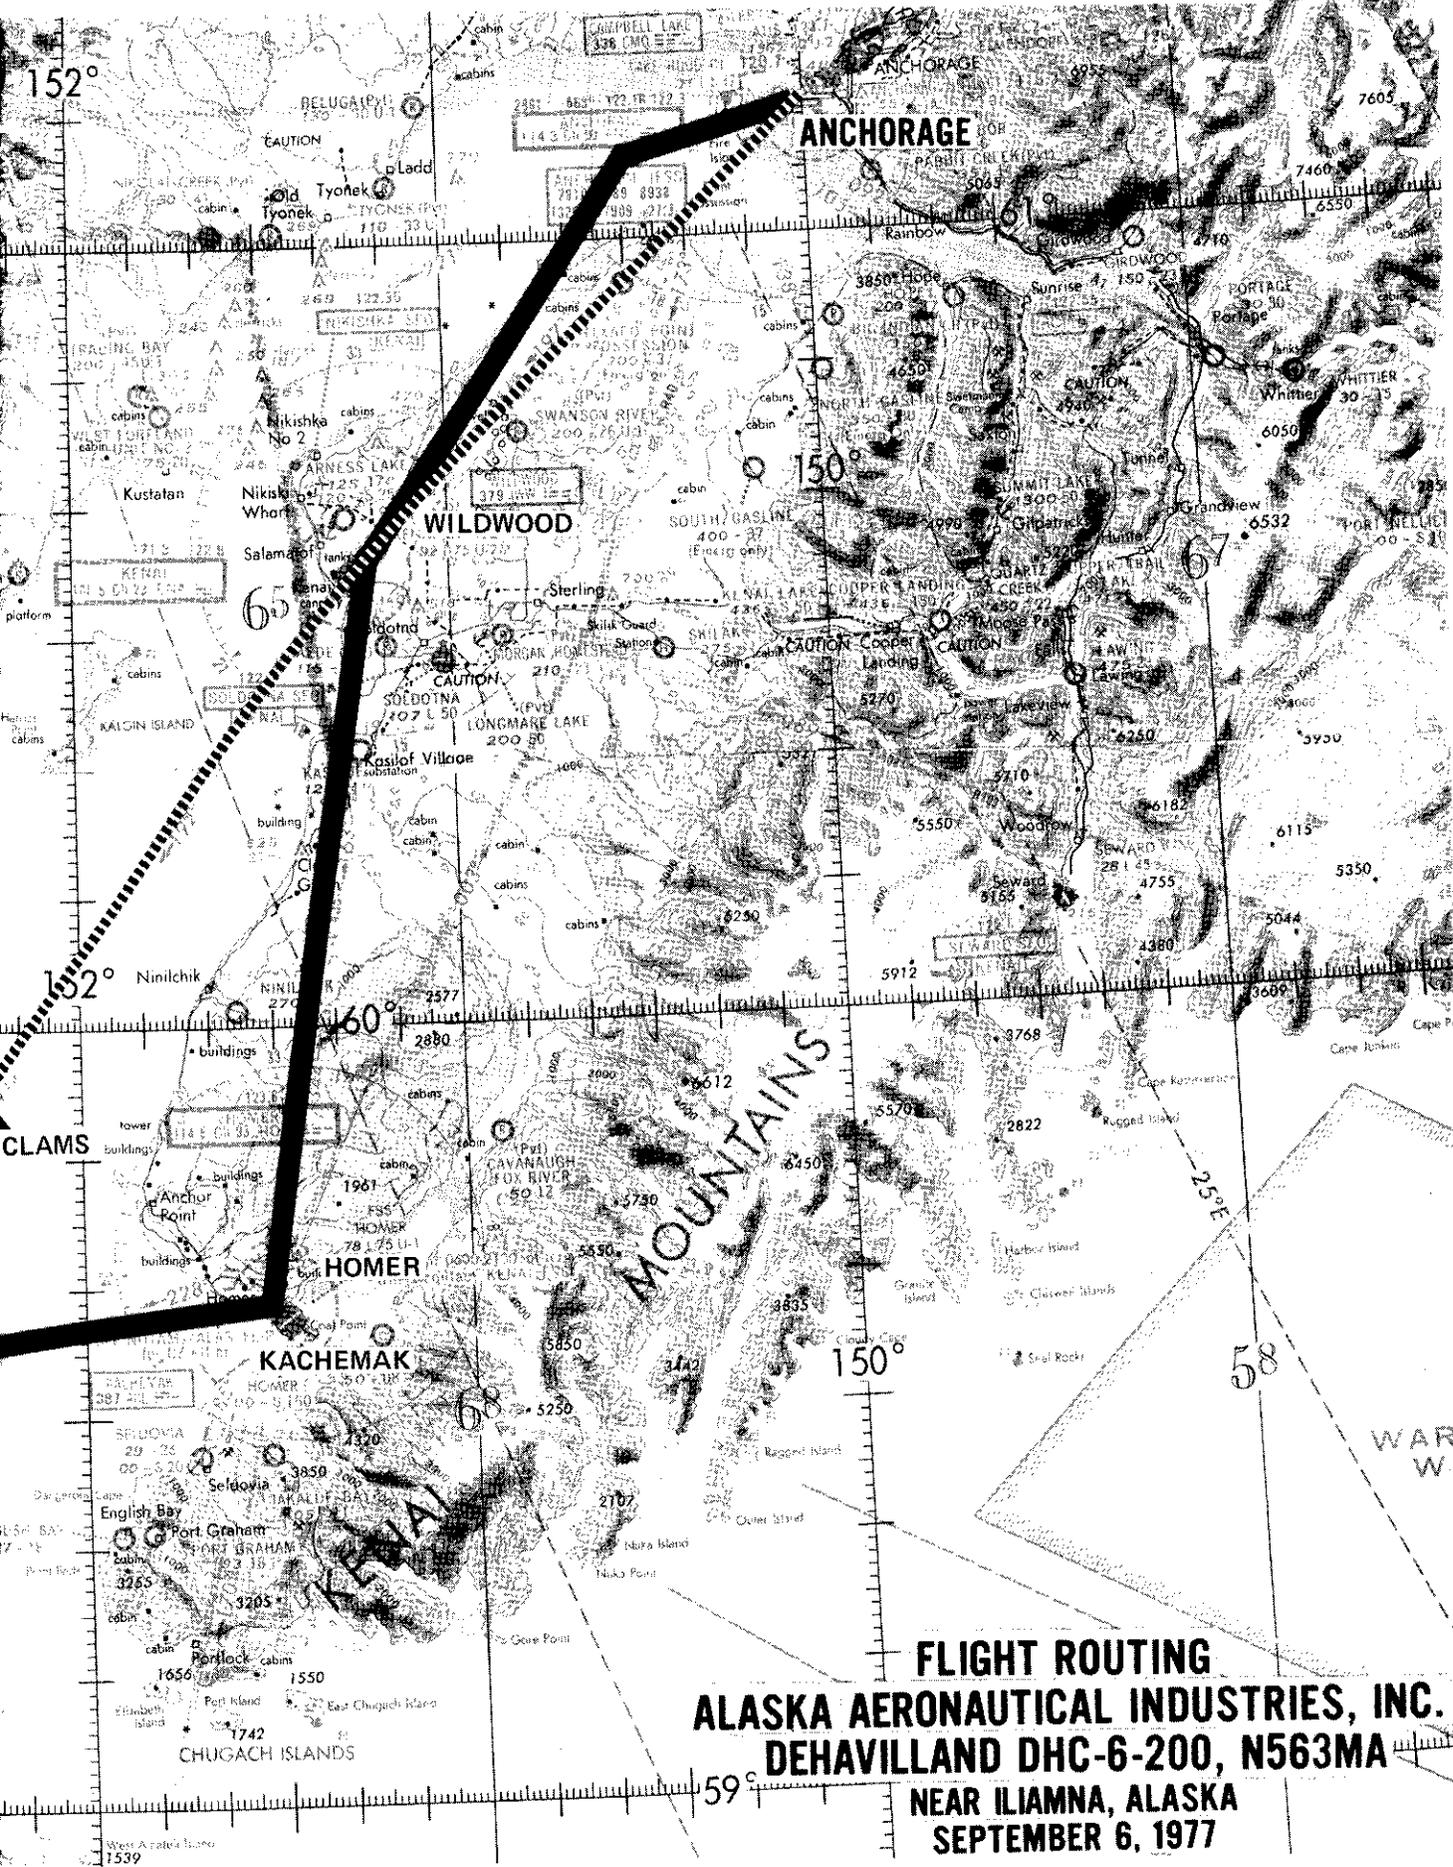
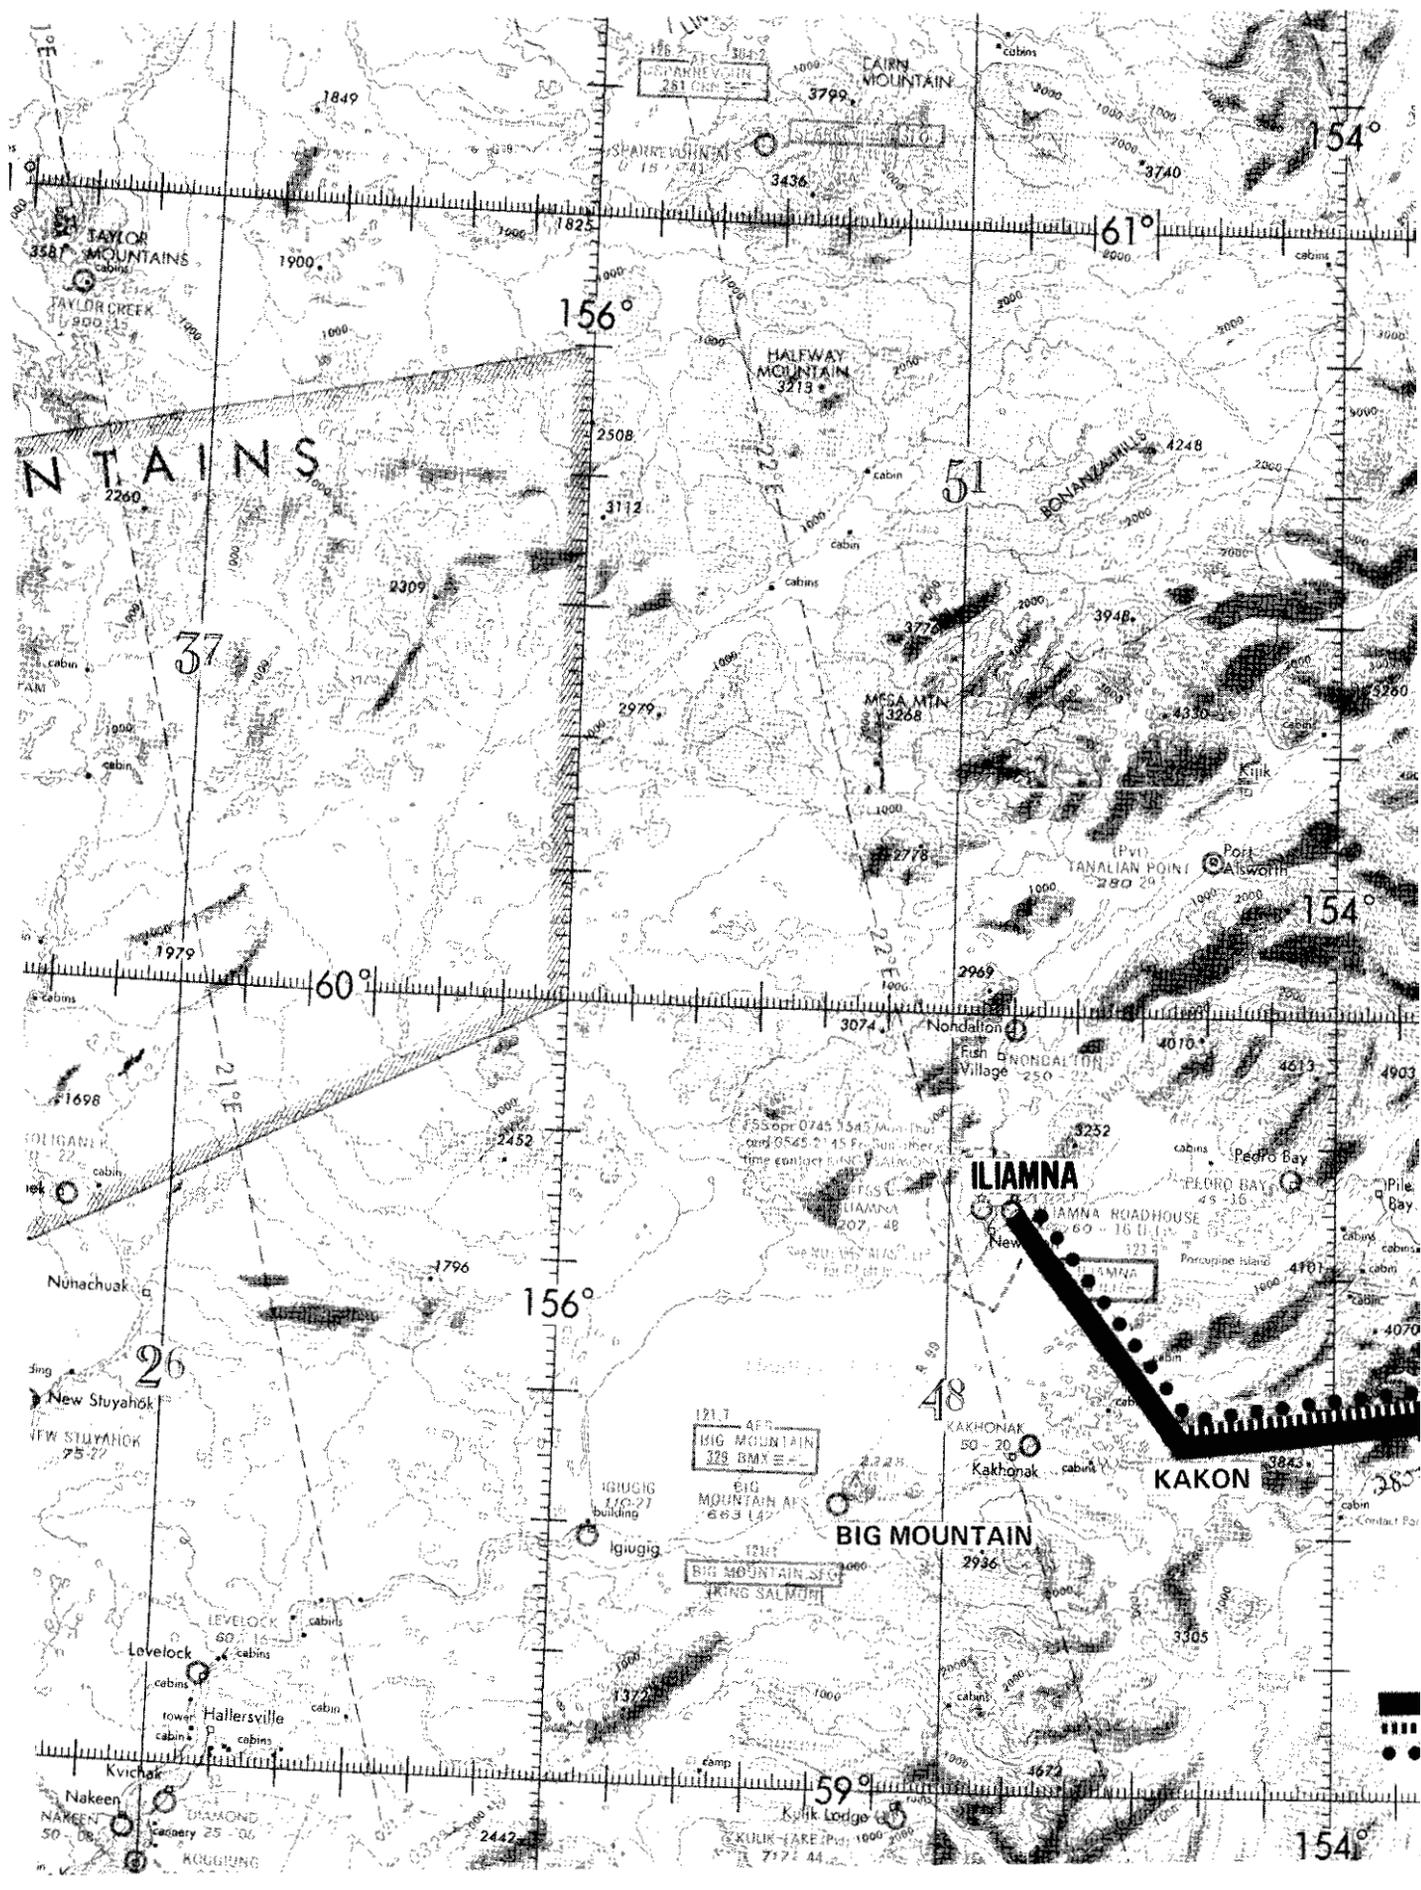
FLIGHT ROUTING
ALASKA AERONAUTICAL INDUSTRIES, INC.
DEHAVILLAND DHC-6-200, N563MA
NEAR ILIAMNA, ALASKA
SEPTEMBER 6, 1977

Assuming that the aircraft was established on Green 8 after passing Kakon at 1434, the next call to Anchorage Center at 1439:40 would be logical since the crew did want to take the shortest route back -- the 192° bearing from Wildwood NDB -- and they would have had more than 5 mins to establish the aircraft on Green 8 and to discuss the proposed route. From 1434 at Kakon to 1439:40 on Green 8, the following conditions would have existed: Wind 210° at 37 kns, heading 070°, groundspeed 161 kns, and distance traveled about 14 nmi. This would have placed the aircraft on Green 8, 14 nmi east of Kakon, and about 40 nmi to 43 nmi from the accident site. Once the flight was cleared via the 192° bearing, the crew could have, and logically would have, checked their position on Green 8 by tuning in the Wildwood NDB. At this point, if the ADF indicated that the aircraft was already on the 192° bearing and the error was not discovered, the aircraft would be turned to track to the Wildwood NDB. Using winds of 210° at 37 kns and a groundspeed of 170 kns, it would have taken 14 or 15 mins to arrive at the accident site. This would place the aircraft at the impact site within seconds of 1452 -- within seconds of the sounds similar to the carrier frequency of the aircraft heard on the Anchorage Center tape at 1452:08 and the seismographic recording of a small tremor which started at 1451:59.

The most reasonable explanation is that Kachemak ADF was used to establish the aircraft on Green 8. Once on course, the amended routing was requested via the 192° bearing from Wildwood. At 1440:15, when this request was granted, Wildwood NDB was tuned. The aircraft would have been about 14 nmi east of Kakon. The crew should have expected arrival at the 192° bearing about 1453. However, they did not report their arrival at Kakon at the estimated time of 1434, and they may not have noted what time they actually did pass it. It is apparent that they did not note or pay attention to the time when Kakon was passed or they would not have turned toward the Wildwood NDB at 1440 to 1442 instead of an estimated time of 1453. The Safety Board believes that the indications of the ADF needle, and not actual time-distance planning or DME distance from Homer VOR, were the primary means the crew used to identify the 192° bearing.
