1. Report No. NTSB-AAR-79-2		2. Government Accession No.		3. Recipient's Catalog No.	
4. Title and Subtitle Aircraft Accident Report - Allegheny Airlines, Inc., BAC 1-11, N1550, Rochester, New York, July 9, 1978				5. Report Date February 8, 1979

AIRCRAFT ACCIDENT REPORT

ALLEGHENY AIRLINES, INC.
BAC 1-11, N1550
ROCHESTER, NEW YORK
JULY 9, 1978

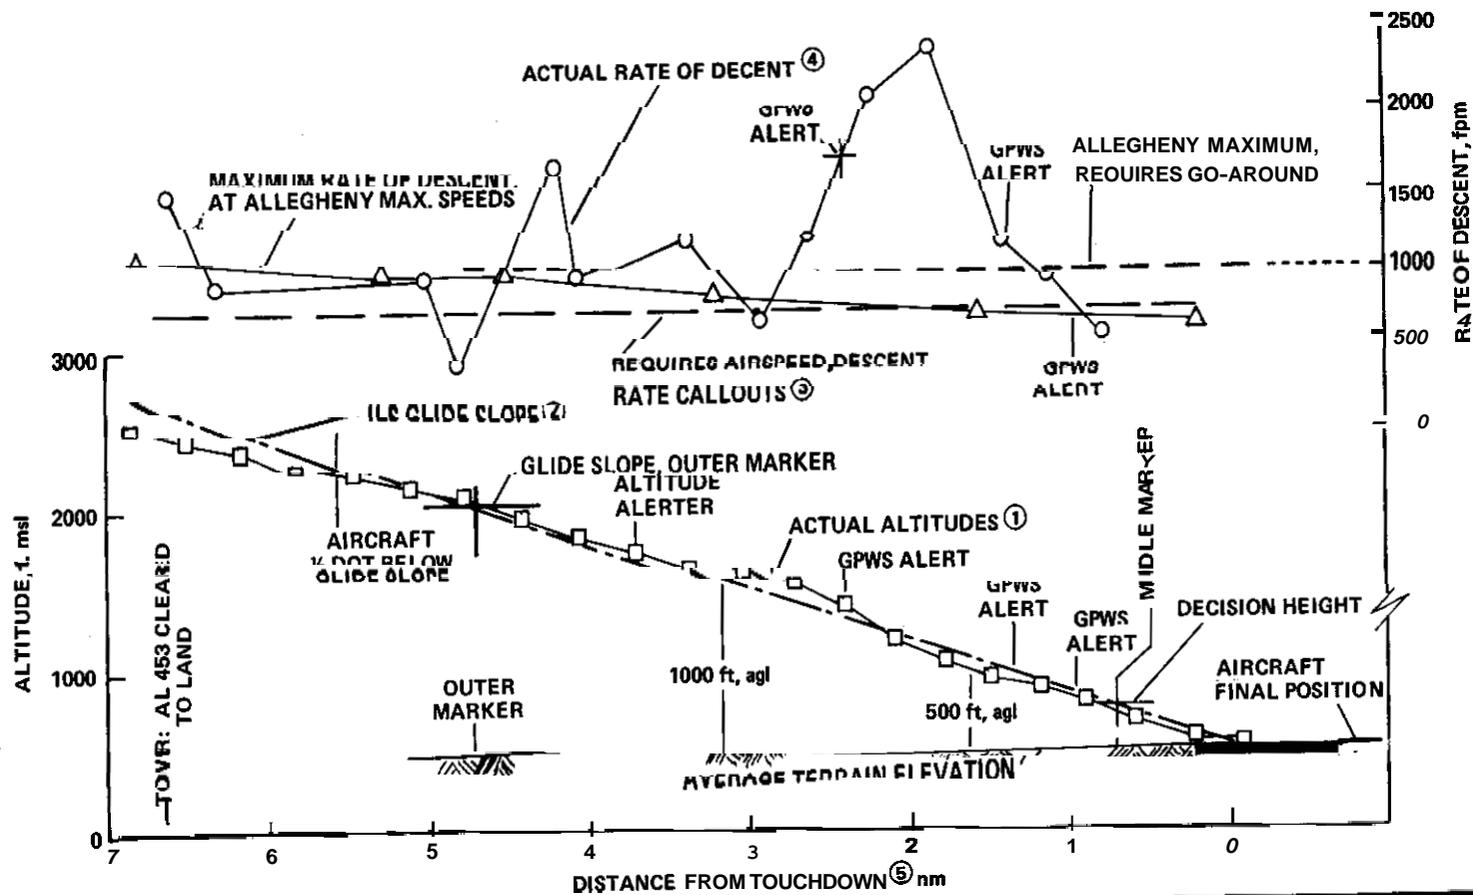
COMPARISON OF AL-453 AIRSPEEDS WITH
ALLEGHENY MAXIMUM SPEEDS
ALLEGHENY AIRLINES, BAC 1-11, N1550
ROCHESTER, NEW YORK
JULY 9, 1978

8. The crew failed to comply with recommended approach and landing airspeeds.
9. The approach was not made according to prescribed procedures and was not stabilized.

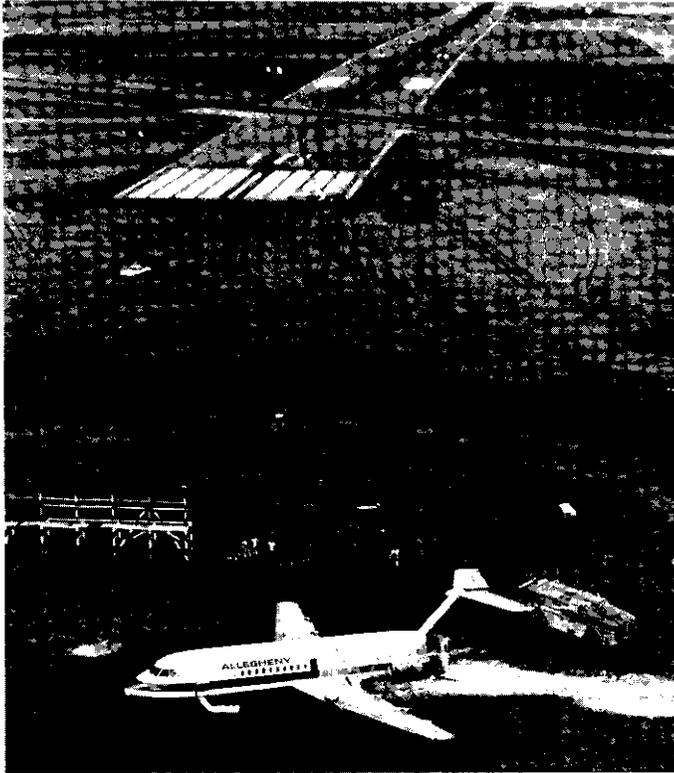
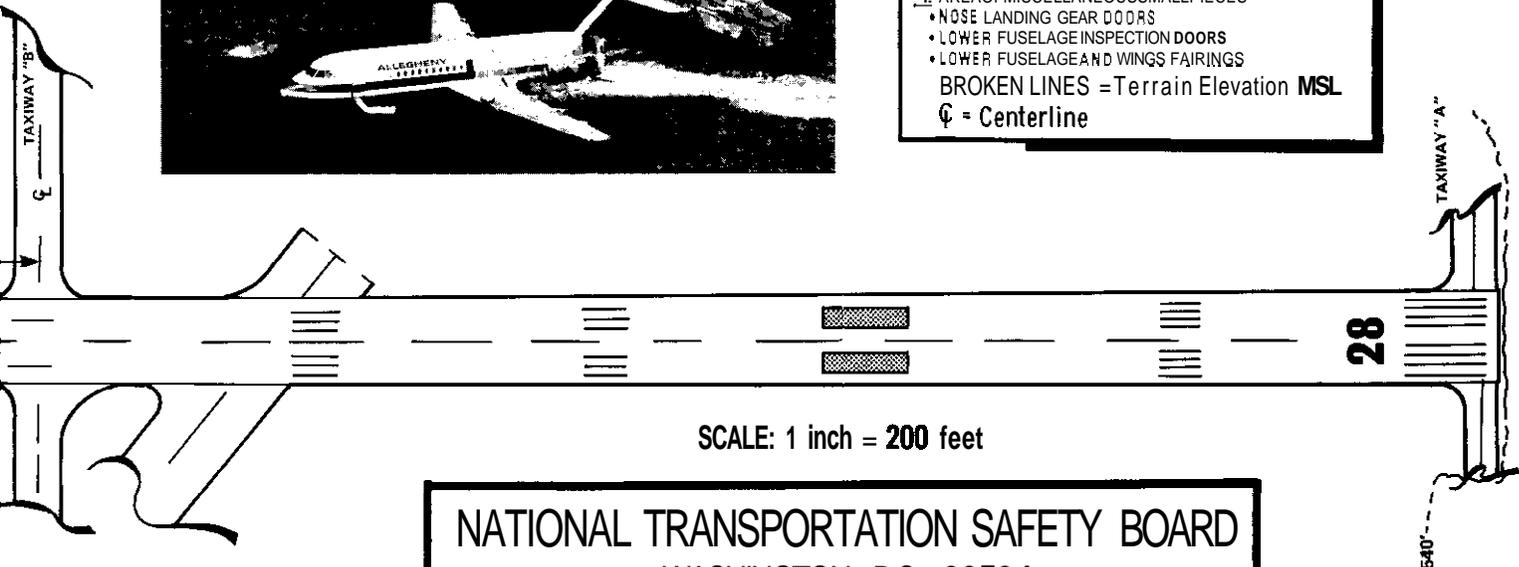
WRECKAGE DISTRIBUTION CHART
 ALLEGHENY AIRLINES, INC.
 BRITISH AEROSPACE, INC.,
 BAC-1-11 **TYPE-203AE**, N1550
 ROCHESTER-MONROE COUNTY AIRPORT, NEW YORK
 July 9, 1978

Before the aircraft came to rest, the left main landing gear was propelled over the fuselage. It impacted the top fuselage skin and came to rest adjacent to the left side of the aircraft. (See Appendix I.) The fuselage was creased and buckled in several areas. However, the empennage was not damaged.

1. POSITION WHERE AIRCRAFT CAME TO REST.
728 FEET PAST DEPARTURE END OF RUNWAY 28
143 FEET TO LEFT OF RUNWAY EXTENDED CENTER
MAGNETIC HEADING 334 DEGREES.
 2. LEFT INBOARD FLAP
 3. RIGHT INBOARD FLAP
 4. LEFT MAIN LANDING GEAR ASSEMBLY
 5. RIGHT MAIN LANDING GEAR ASSEMBLY
 8. LEFT MAIN LANDING GEAR DEPARTED SIDE OF RUNWAY
24 FEET FROM END.
 1. AREA OF MISCELLANEOUS SMALL PIECES
 - NOSE LANDING GEAR DOORS
 - LOWER FUSELAGE INSPECTION DOORS
 - LOWER FUSELAGE AND WINGS FAIRINGS
- BROKEN LINES = Terrain Elevation MSL
 ☉ = Centerline
