NATIONAL TRANSPORTATION SAFETY BOARD

AIRCRAFT ACCIDENT REPORT

**AIR CALIFORNIA FLIGHT 336
BOEING 737-293, N468AC
JOHN WAYNE ORANGE COUNTY AIRPORT
SANTA ANA, CALIFORNIA
FEBRUARY 17, 1981**

NTSB-AAR-81-12

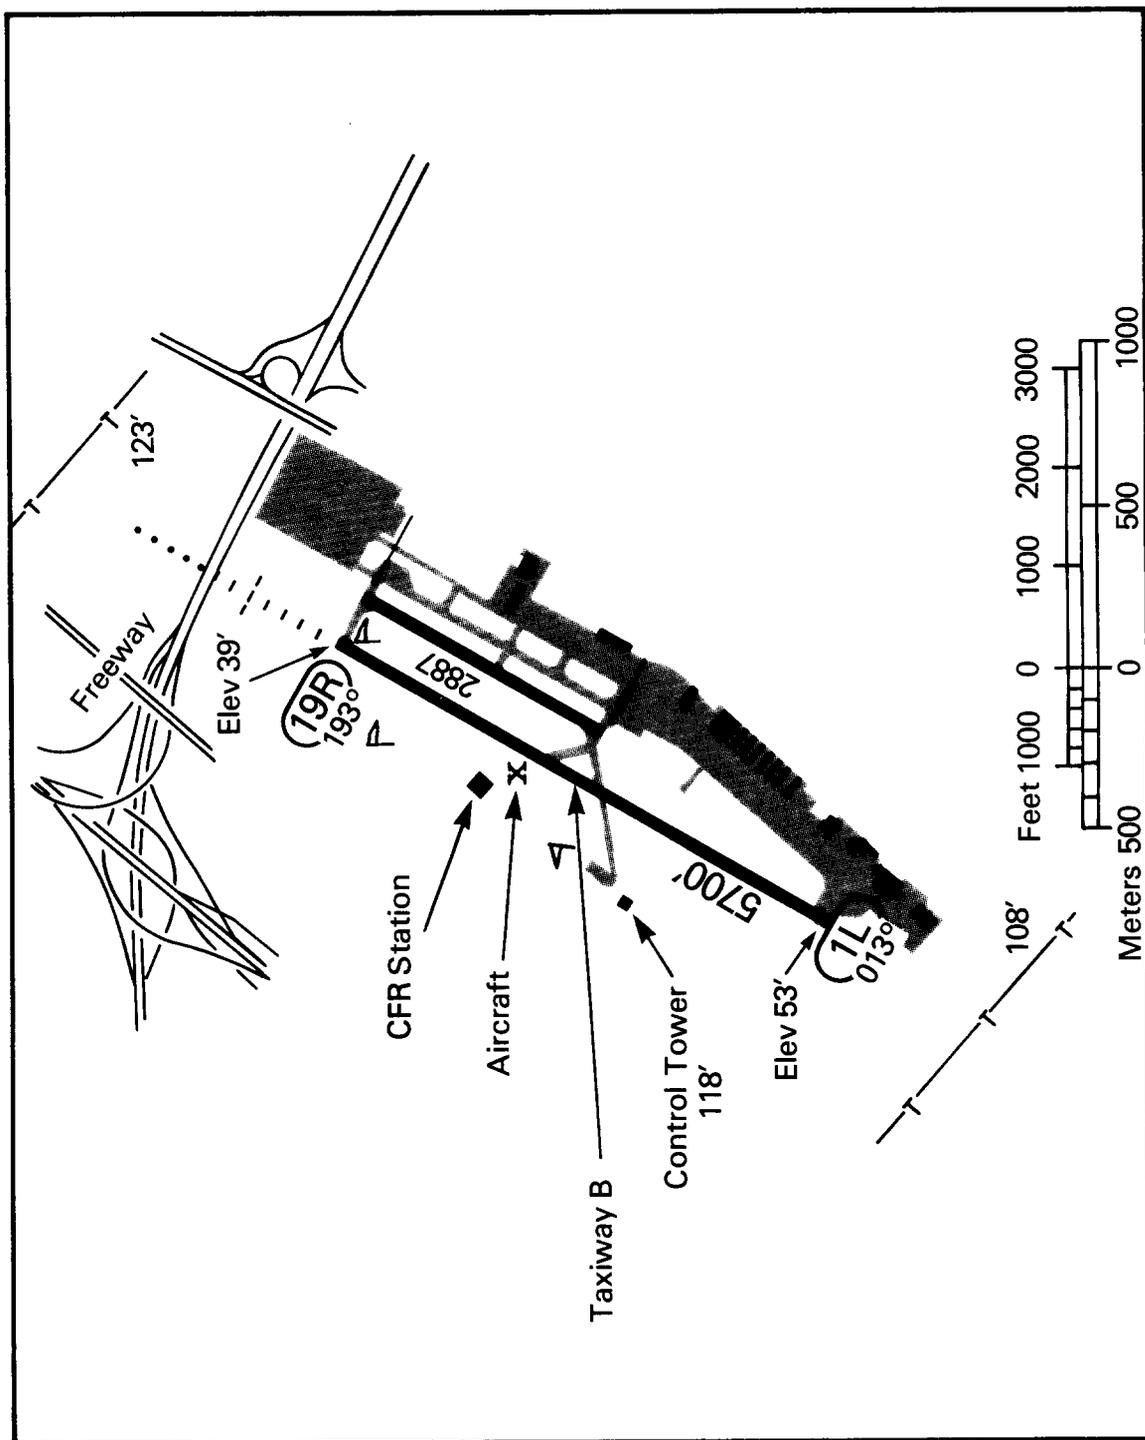
Figure 1.—Diagram of the John Wayne Orange County Airport at Santa Ana, California.

point, he observed that ACL336 appeared to have a high pitch attitude, was still in a descent, and was inside the freeway just approaching the end of runway 19R. (See figure 1.) The controller noted that ACL336 touched down on the right side of the runway, close to the approach end with gear down. As ACL336 touched down, the controller noted that ACL931 had aborted the takeoff and was almost abeam taxiway Bravo, taxiing slowly. He observed the right main gear of ACL336 go off the pavement, the right wing drop, and the aircraft slide and then pivot to the right. He stated that he saw a flash of fire under the left wing, which lasted for about 15 seconds and then "died down." The fire department arrived in less than a minute. He stated that all of the visible aircraft exits were opened 5 to 10 seconds after the aircraft stopped and that the passengers departed soon thereafter.

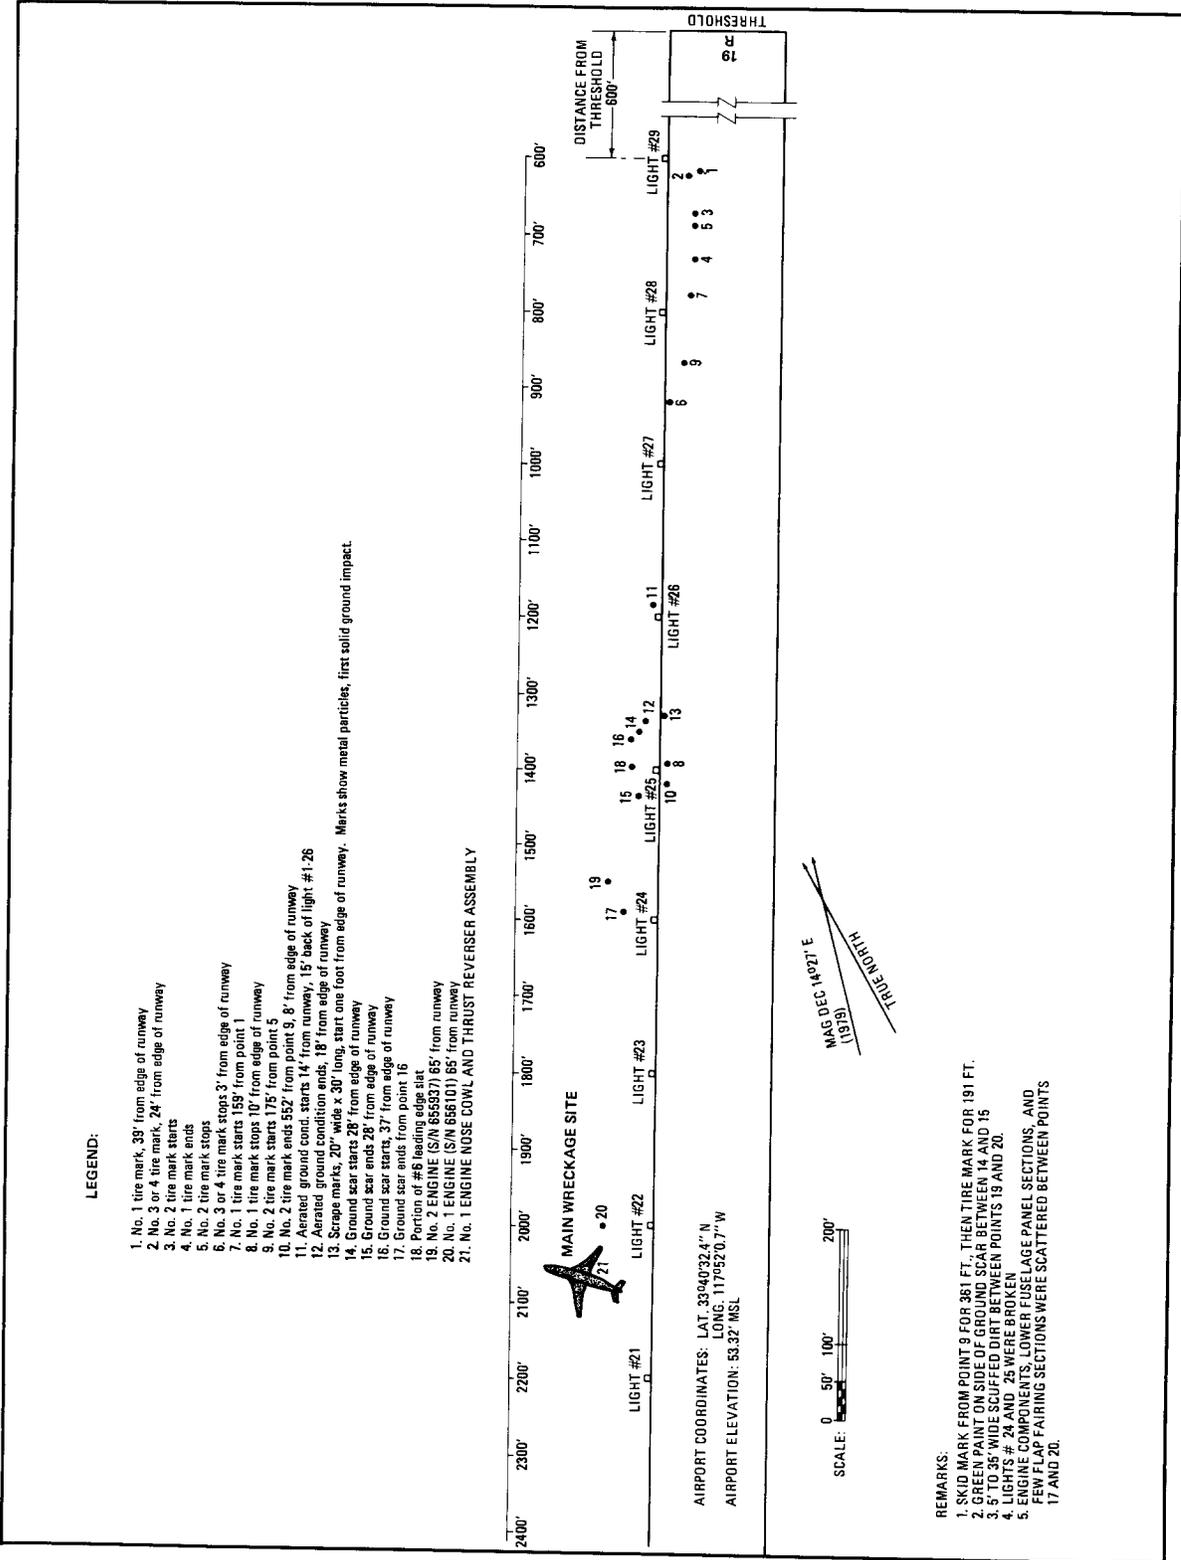
WRECKAGE DISTRIBUTION PATTERN OF AIR CALIFORNIA 336

The aircraft wreckage distribution pattern was confined to the right side and the area adjacent to the right side of runway 19R. (See appendix E.)

The Boeing 737 maintenance manual states that the main gear tread width is 206 inches and that the main gear tires are numbered from left to right, Nos. 1 through 4. Tire marks on the runway indicated that at least three main gear tires contacted the runway (tires Nos. 1 and 2 and No. 3 or 4) about 620 to 624 feet from the threshold with about a normal tread width. Intermittent tire mark patterns on the runway continued for about 800 feet, trending toward the right side of the runway with the distance between the sets of marks decreasing. No nose gear tire marks were found on the runway. A deep scrape mark, 30 inches long by 20 inches wide, 1,330 feet from the runway threshold and 1 foot from the edge of the runway, was imbedded with metal particles. The No. 6 leading edge slat from the right wing was located in a 90-foot-long ground scar, which was about 1,350 feet from the runway threshold and about 28 feet outside of and parallel to the runway.

The right engine (No. 2), with nose cowl and thrust reverser attached, was found 1,550 feet from the runway threshold, 65 feet to the right of the runway edge. The left engine was found near the right wing tip of the aircraft and was located 2,000 feet from the threshold and 65 feet to the right of the runway edge. Engine components, lower fuselage panels, and flap fairing sections were scattered along the wreckage distribution pattern from about 1,550 feet from the threshold to the aircraft wreckage.

The aircraft came to rest about 2,070 feet from the runway threshold with the tail about 40 feet from the runway edge. The aircraft's centerline was oriented on a magnetic heading of 305°. The aircraft was intact, except for the loss of both engines and those lower body parts noted in the wreckage distribution pattern. Both wings were attached to the fuselage, although both had sustained substantial damage during the accident sequence. The fuselage was intact, except for a fracture at the top and side aft of the wings. There was fire damage and sooting of the left side of the fuselage in the area where the wing joins the fuselage and of the left wing from the engine pylon to the wing root. The empennage and aft fuselage received minor damage. The horizontal stabilizer was at 11 degrees nose up according to the stabilizer markings on the aft fuselage. At idle thrust, stabilizer trim should be between 6 and 14 degrees nose up. Neither the rudder nor the auxiliary power unit was damaged.
