NATIONAL TRANSPORTATION SAFETY BOARD

AIRCRAFT ACCIDENT REPORT

**RYAN AIR SERVICE, INC.,
FLIGHT 103, BEECH AIRCRAFT CORPORATION
1900C, N401RA,
HOMER, ALASKA,
NOVEMBER 23, 1987**

NTSB/AAR-88/11

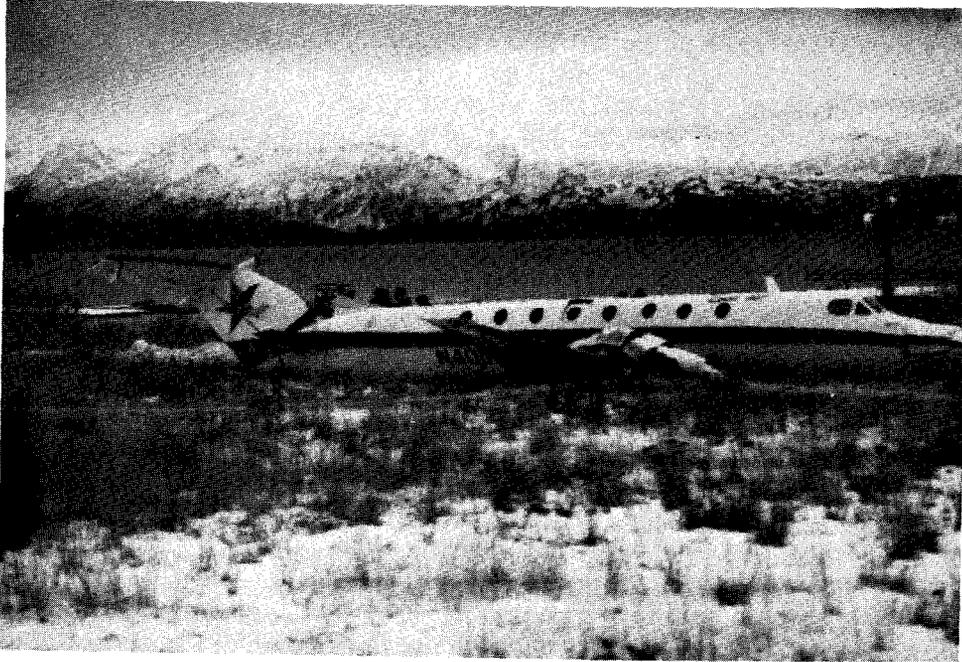
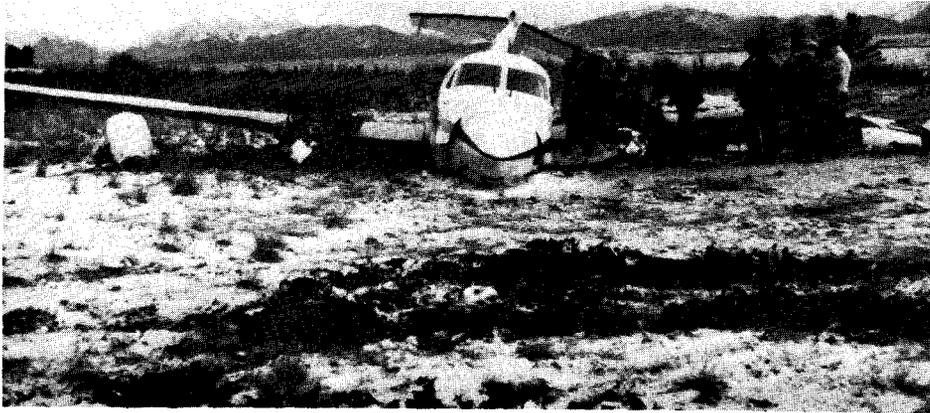
Figure 2.--Wreckage of RYA 103.

The airplane wreckage, located west of runway 3, was distributed along a distance of 159 feet, on a heading of approximately 355°. A video tape taken 4 hours after the accident revealed a rime ice accumulation up to 3/8 inch on the leading edges of the wings, horizontal stabilizers, stabilons, tailsets, vertical stabilizer, and nose cone. No other ice accumulation was observed on the airplane. The gear actuators indicated that the gear was down and locked at impact. (See figure 2.) The propeller blades of both engines, which were composed of composite material, were broken away at their hubs and were scattered along the wreckage path.

The lower wing surfaces were heavily damaged from their root end to outboard of the landing gear well. Numerous ribs were broken and/or crushed. The flap handle was in the up position. The left flap actuator attachment brackets were broken. The right flap actuator was found in an intermediate position, between 7" and 12". Company procedure was to select full (35") flaps when landing was assured.
