DOT/FAA/AR-09/19

A Study of the Effects of Engine Configuration, Fuselage Breaks and Ruptures in Aircraft Accidents Involving Ground Pool Fires

June 2009

Final Report

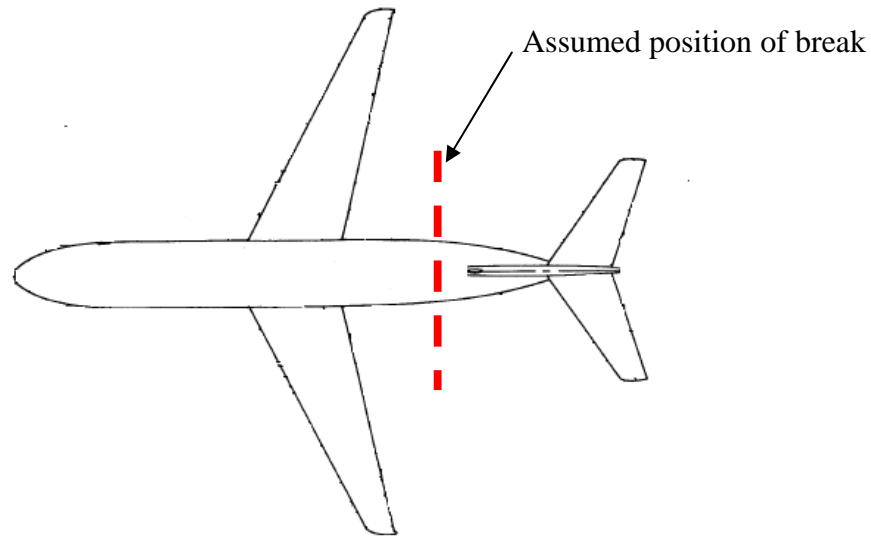
Occupant Egress & Fire Entry

The fuselage sustained a circumferential fracture near Fuselage Station 1320 [seat row 36]. The tail section came to rest about 30 feet from the main fuselage section and rotated 10 deg anti-clockwise from it.

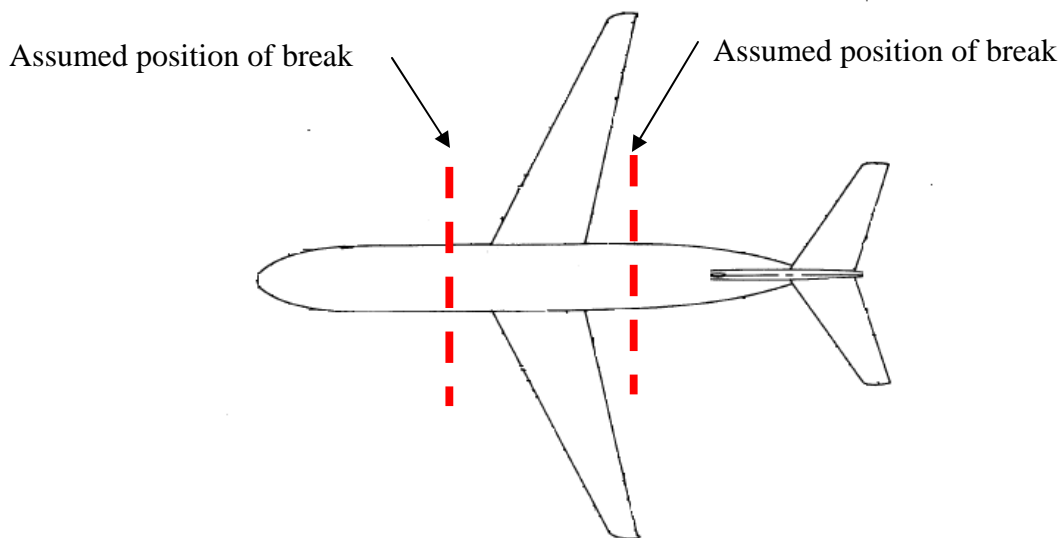
Occupant Egress & Fire Entry

The evacuation was facilitated considerably by the fortuitous fracture of the left forward fuselage, allowing relatively easy egress. Had it not been for this fracture casualties may well have been greater, as the left emergency exits were jammed by impact damage and the right side exits were blocked by fire.

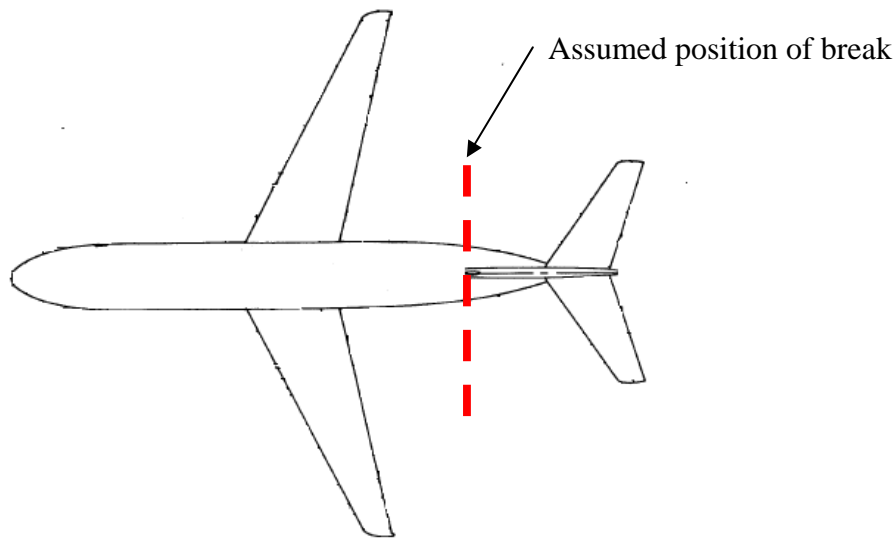
Occupant Egress & Fire Entry

A hard touchdown resulted from the high rate of sink, resulting in the failure of the main landing gear and the separation of the tail section from the aircraft.

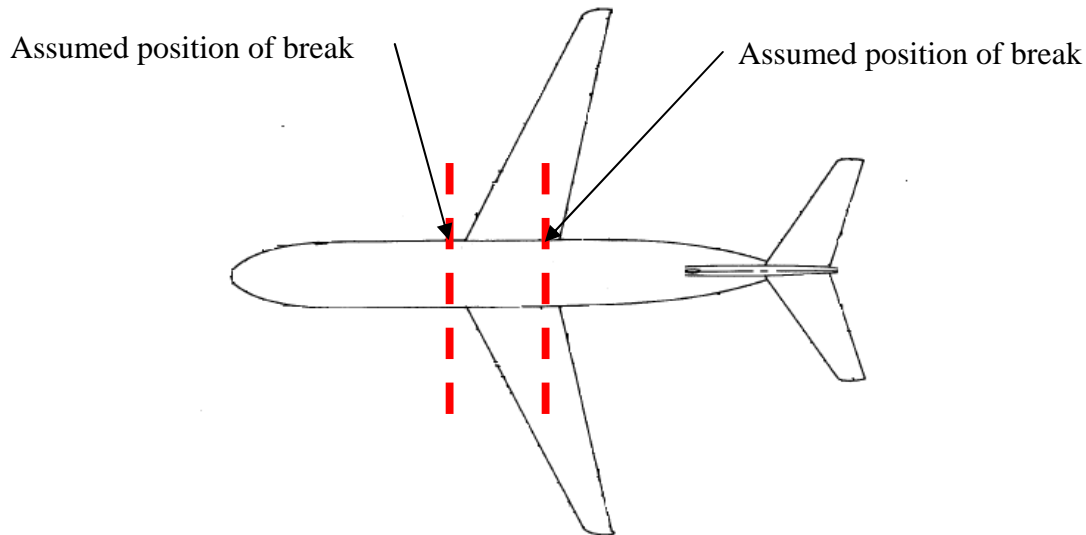
Occupant Egress & Fire Entry

Survivors reported two sizeable breaks in the right side of the fuselage at the cabin partition (forward of row 6) and between seat rows 9 and 10. The breaks in the right side of the fuselage were not noticed until they were illuminated by the fire from outside the aircraft.

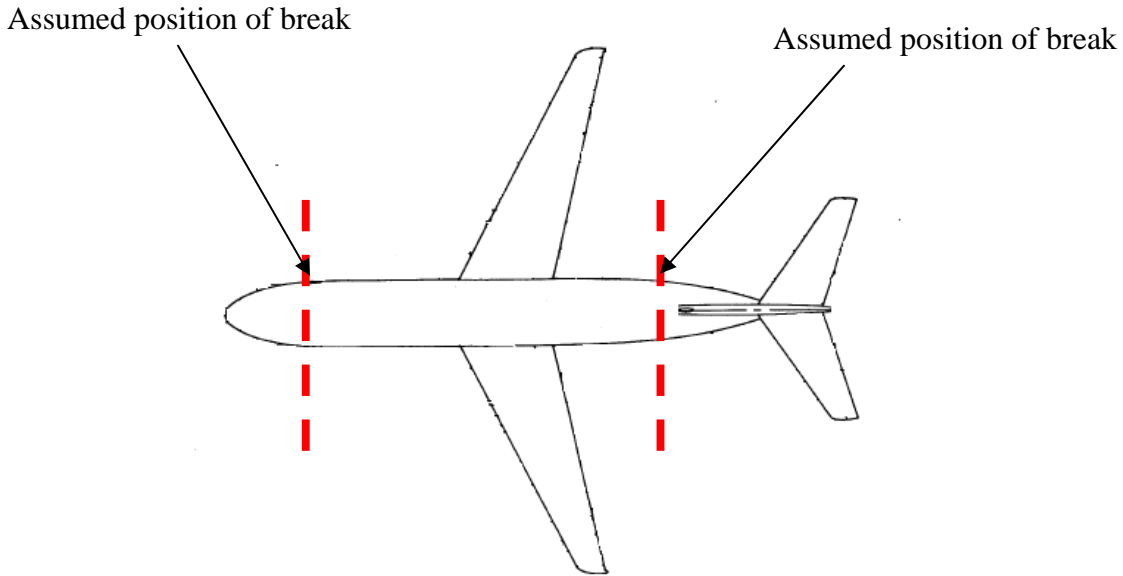
Occupant Egress & Fire Entry

The aircraft was separated into three sections: cockpit section, passenger cabin (containing seat rows 1 to 13), and the tail and engine empennage.

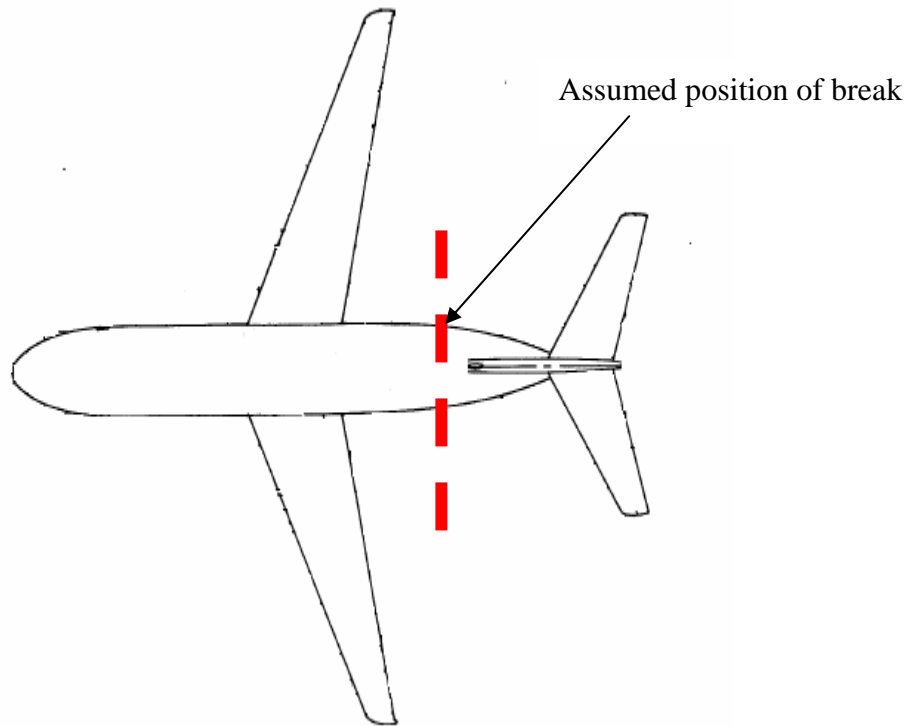
Occupant Egress & Fire Entry

The 14 survivors were seated in the inverted rear portion of the passenger cabin. Although their seat support structures (except the aft flight attendants') also failed, they were less severely injured because the rear portion of the passenger cabin and the empennage section remained relatively intact. The aft flight attendants were able to escape unaided because their restraint systems did not fail, and they were protected from flying debris.

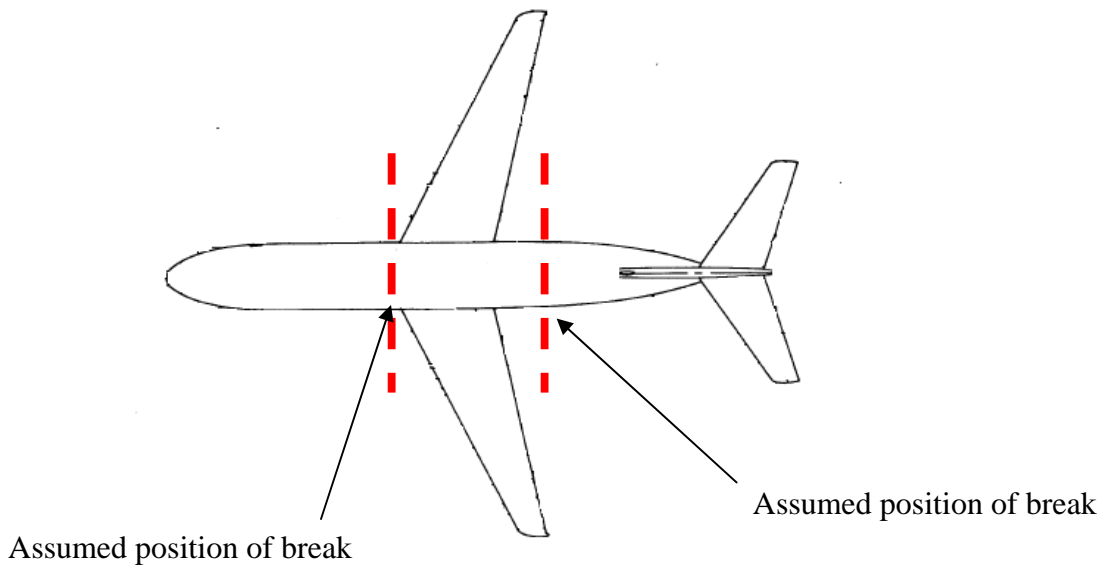
Occupant Egress & Fire Entry

The accident report also states that two flight attendants evacuated through a break near the ventral stairs. However it is considered that this break is the one that occurred near the wing trailing edge (the empennage on this aircraft is relatively close to the wing trailing edge)
