DOT/FAA/CT-90/10

Fuselage Burnthrough from Large Exterior Fuel Fires

Harry Webster

July 1994

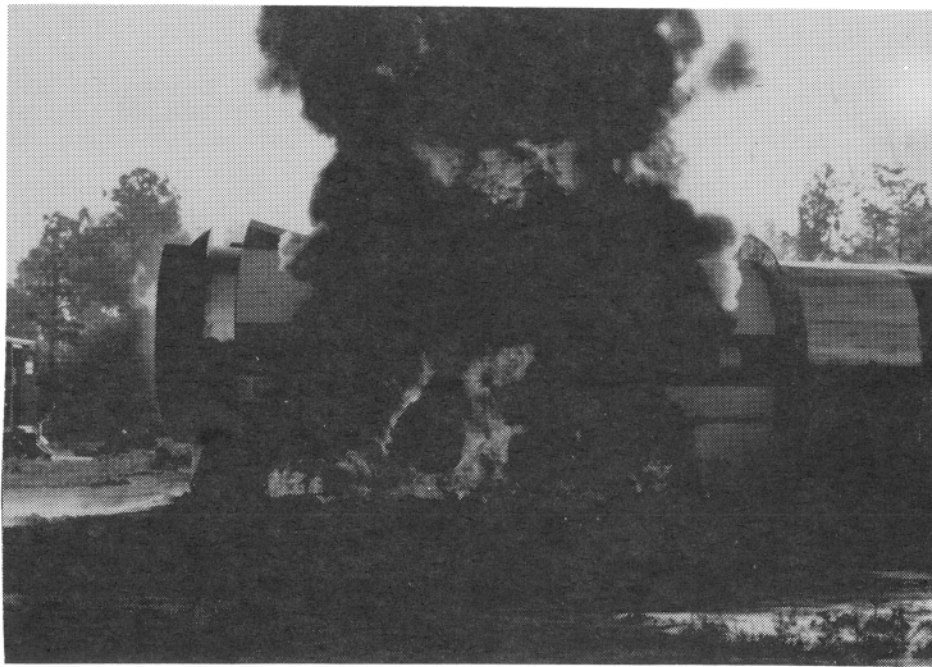
FIGURE 4. TEST 1 DC-8 FLAME EXPOSURE

FLAME IMPINGEMENT. This test was conducted under near zero wind conditions. The pool fire, once fully developed, rose vertically into the air. This exposed the fuselage to a stable flame ranging from station 1200 to station 1450 and extending well above the aircraft (figure 4).

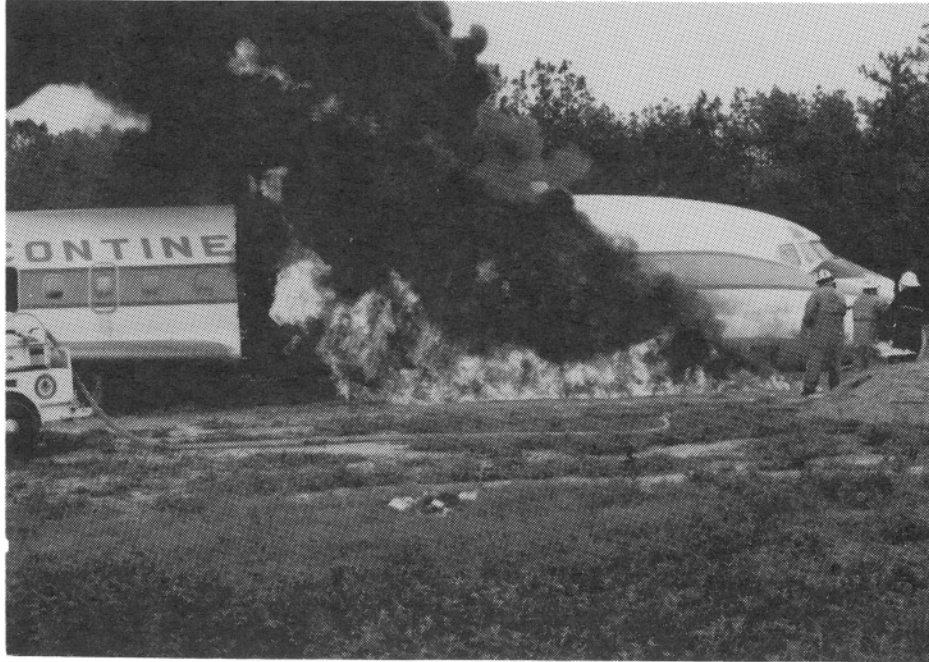
FIGURE 5. TEST 2 DC-8 FLAME EXPOSURE

FLAME IMPINGEMENT. The flame plume was blown against the fuselage and aft by a light wind that measured a steady 3 knots. This shifted the fire towards the rear of the compartment. The exterior baffles prevented the flame from damaging the center compartment. The fuselage was exposed to flame that extended from station 440 forward to station 284 at which point the flame trailed off toward the cockpit (figure 5). Instrumentation locations are shown in figure B-1. The fire temperatures measured at the windows (station 287 and 241) ranged from 1500 to 1800 °F (figures B-2 and B-3). The fire temperature measured at station 226 peaked at 1800 °F, while the fuselage skin at this location only reached 600 °F (figure B-4). The forward calorimeter located at station 228 registered a peak heat flux of 5.8 BTU/FT²-second and the aft calorimeter registered a peak value of 16.8 BTU/FT²-second foot (figures B-5 and B-6).

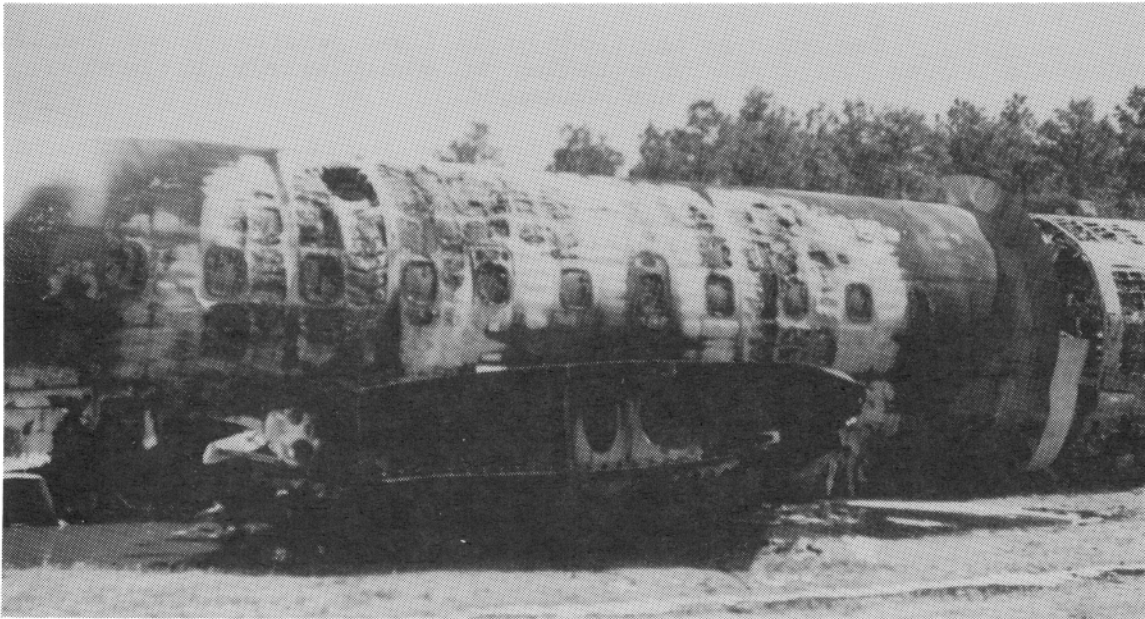
FIGURE 6. TEST 3 DC-8 CENTER SECTION FIRE DAMAGE

Skin Penetration. The skin aft of the wing (enclosing the wheel well) was completely melted away up to the top of the well (figures 6 and C-7). There was a small hole above the wheel well that went through the skin between the top of the wheel well and the cabin floor. Forward of the wing root the skin in the cheek area was melted through and the cargo liner was exposed. The liner was heavily charred but not penetrated. The window located directly above the trailing edge of the wing was completely consumed, allowing flame penetration into the cabin. The other windows exhibited varying degrees of damage but did not allow penetration. The skin both forward and aft of the wing above the melted sections was wrinkled and perforated. Both overwing exits were operable after the test. There was a 2- by 2-foot section above the trailing edge of the wing into the overhead section of the aircraft where the skin completely melted away.

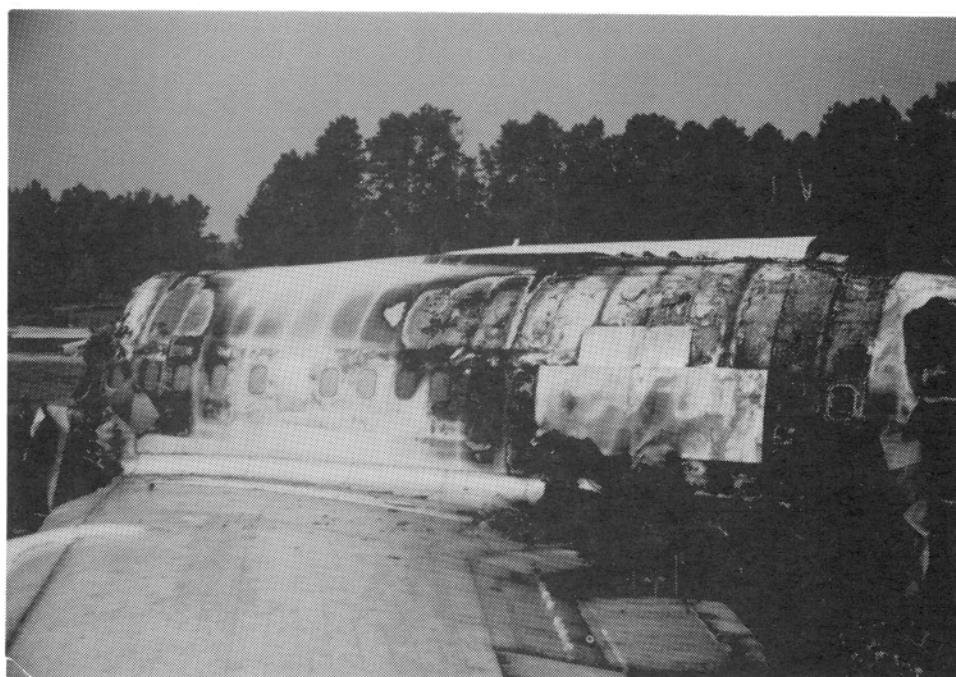
FIGURE 15. CV-880 PORT SIDE FIRE DAMAGE

Skin Penetration. The port side skin that was forward of the leading edge of the wing was completely burned away up to the top of the fuselage (figures 15 and F-7). The windows in this area (station 584) were completely burned through. The windows over the wing were charred but not penetrated. The skin aft of the wing was also burned away with damage extending forward to station 884. The exposed ribs at the aft end were buckled. The windows aft of the wing had their outer pressure panes completely burned away, but the inner fail-safe panes were

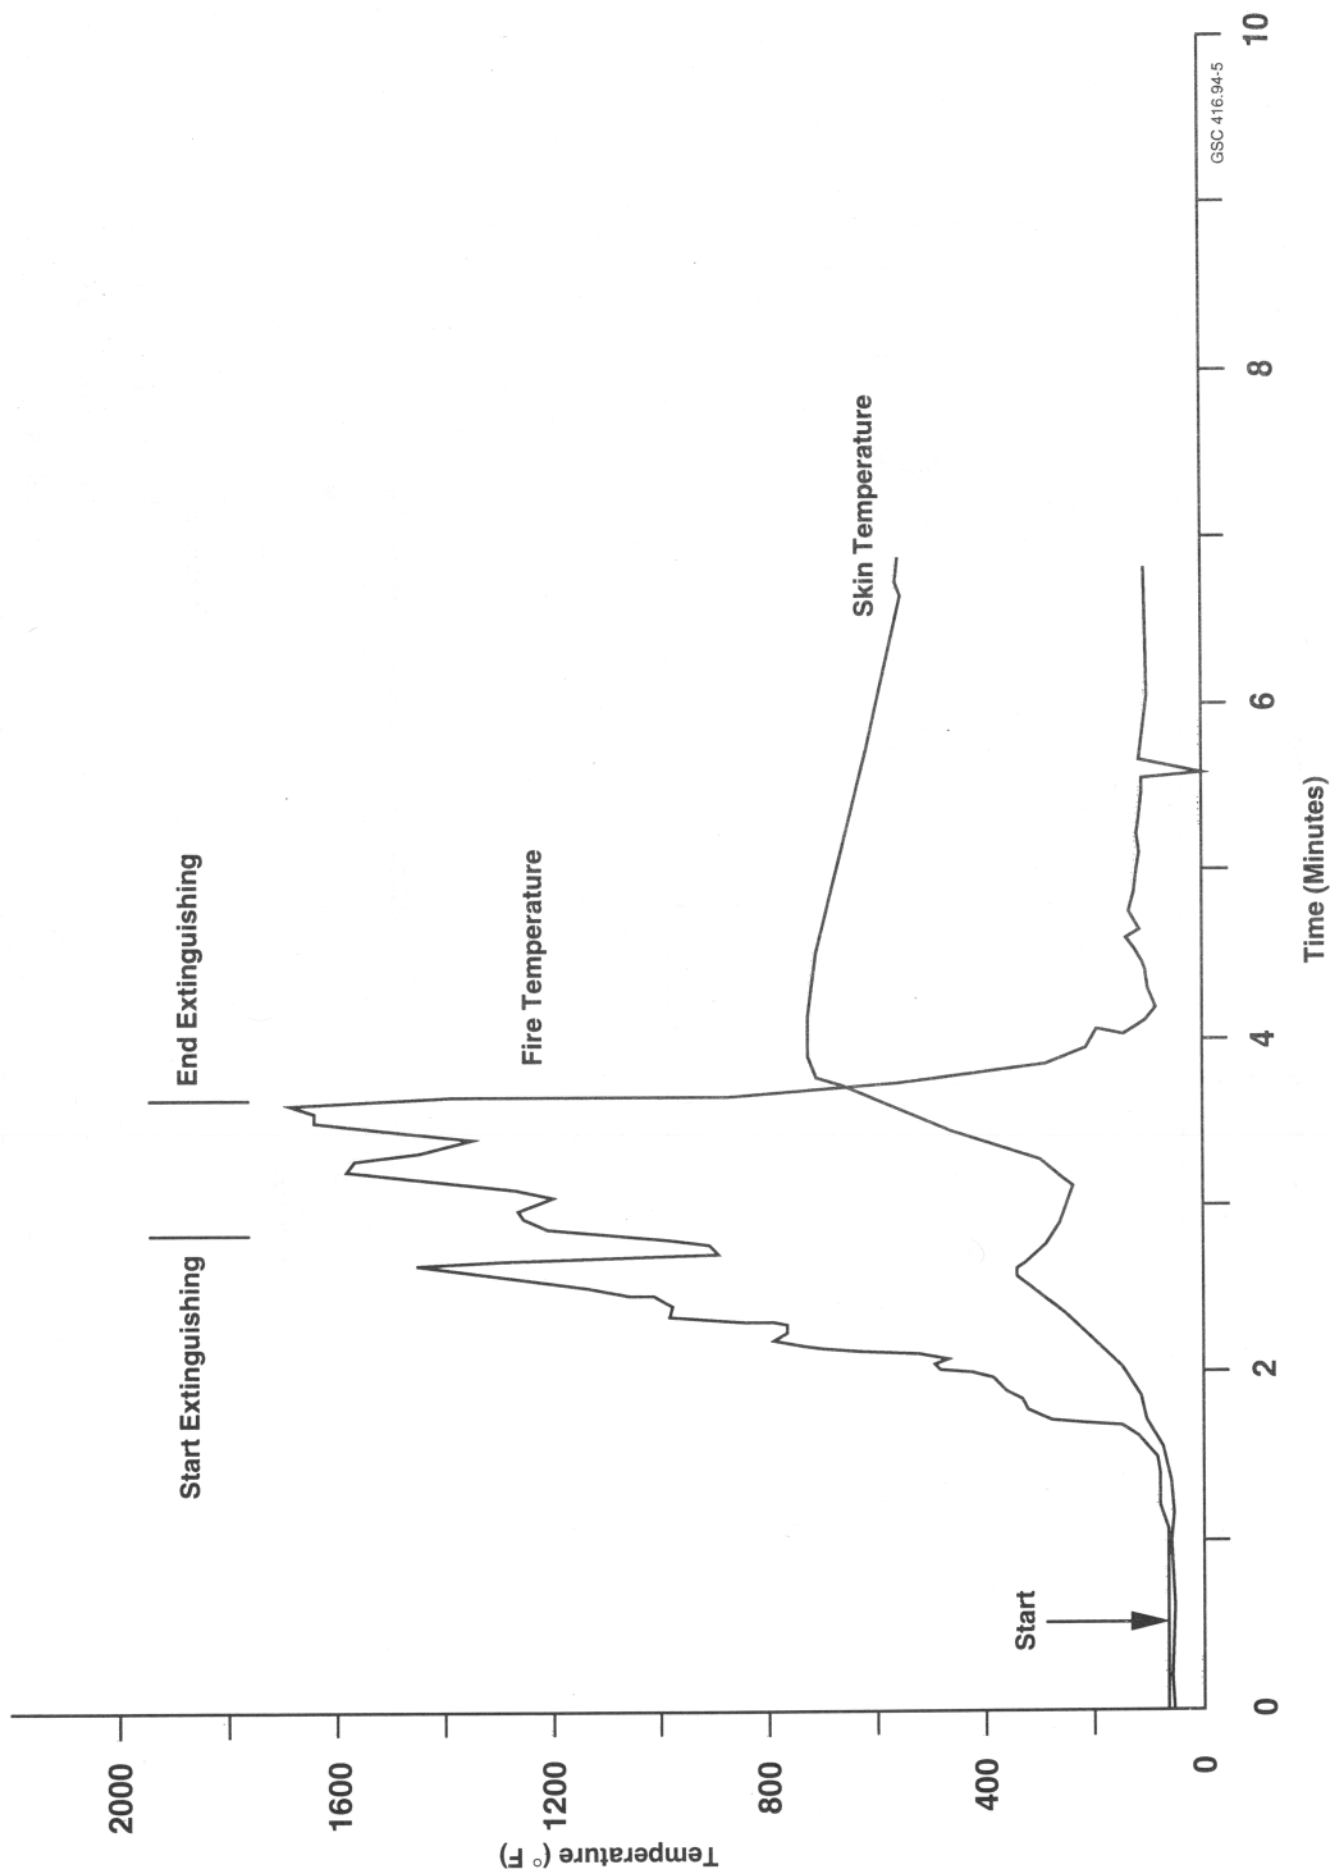
FIGURE A-2. TEST 1 FIRE AND FUSELAGE SKIN TEMPERATURES (UPPER) AT STATION 1286

The indicated fire temperature, measured at the fuselage, ranged from 1600 to 1800 °F. The skin temperatures lagged behind the fire temperatures due to the high heat absorption capability of the aluminum (figures A-2 through A-6).

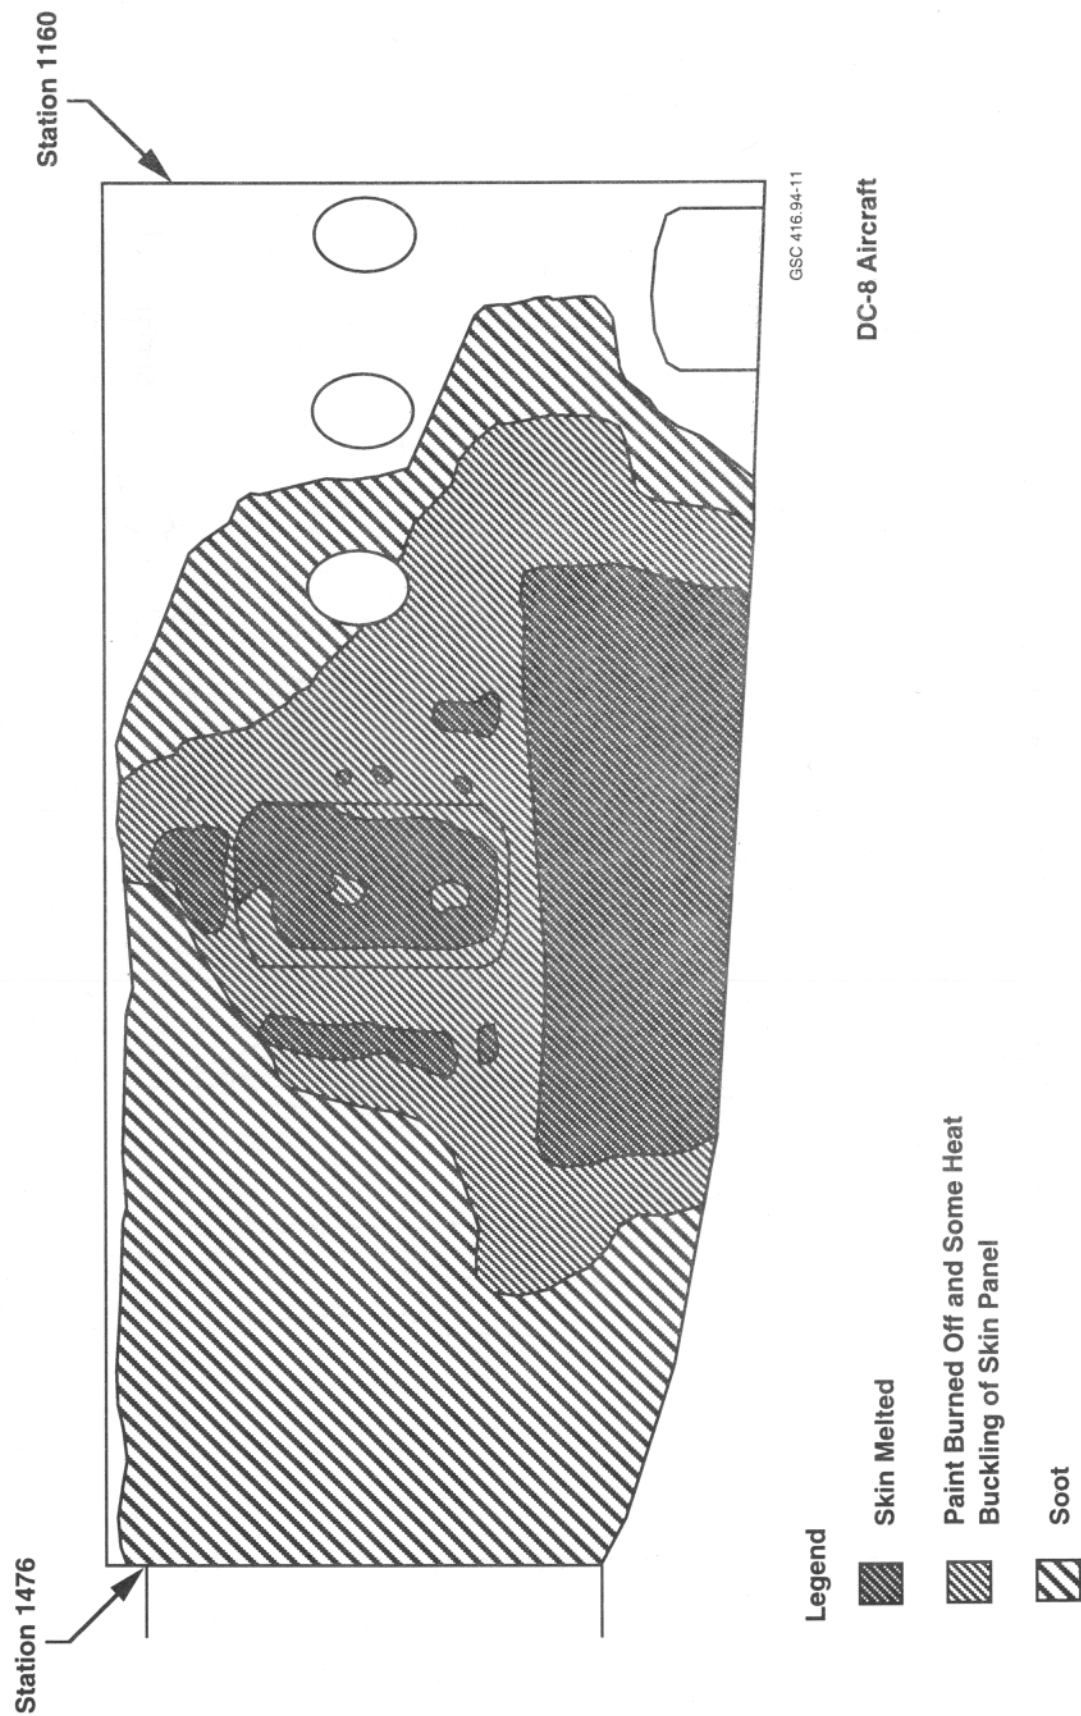
FIGURE A-8. TEST 1 EXTERIOR FIRE DAMAGE, AFT SECTION FUSELAGE STARBOARD SIDE

Skin Penetration. The aluminum skin melted away in an area below the floor and centered about the aft service door (figure A-8). The damage extended approximately 6 feet forward and 5 feet aft of the door. The skin was buckled approximately 30 inches on all sides of the melted area. The titanium doubler strips were undamaged. The skin above the door was melted in a triangular shape extending 12 inches on either side of the doorway and 30 inches above the door.

FIRE PATHS. The smoke and fire that entered the cabin came through the air conditioning return grills located on the sidewall at the floor level. These grills are open into the cheek area on each side of the cargo compartment. This area forms a duct that channels the exhaust air to the outflow valves located in the empennage crawlthrough aft of the cargo compartment. The pool fire melted the skin in the cheek area, opening a path to the grills. The fire in the overhead did not travel up through the sidewalls or through the ventilation ducts. The skin above the door was penetrated directly by the pool fire plume (figure A-8). Here the insulation was dislodged, allowing access to the overhead.

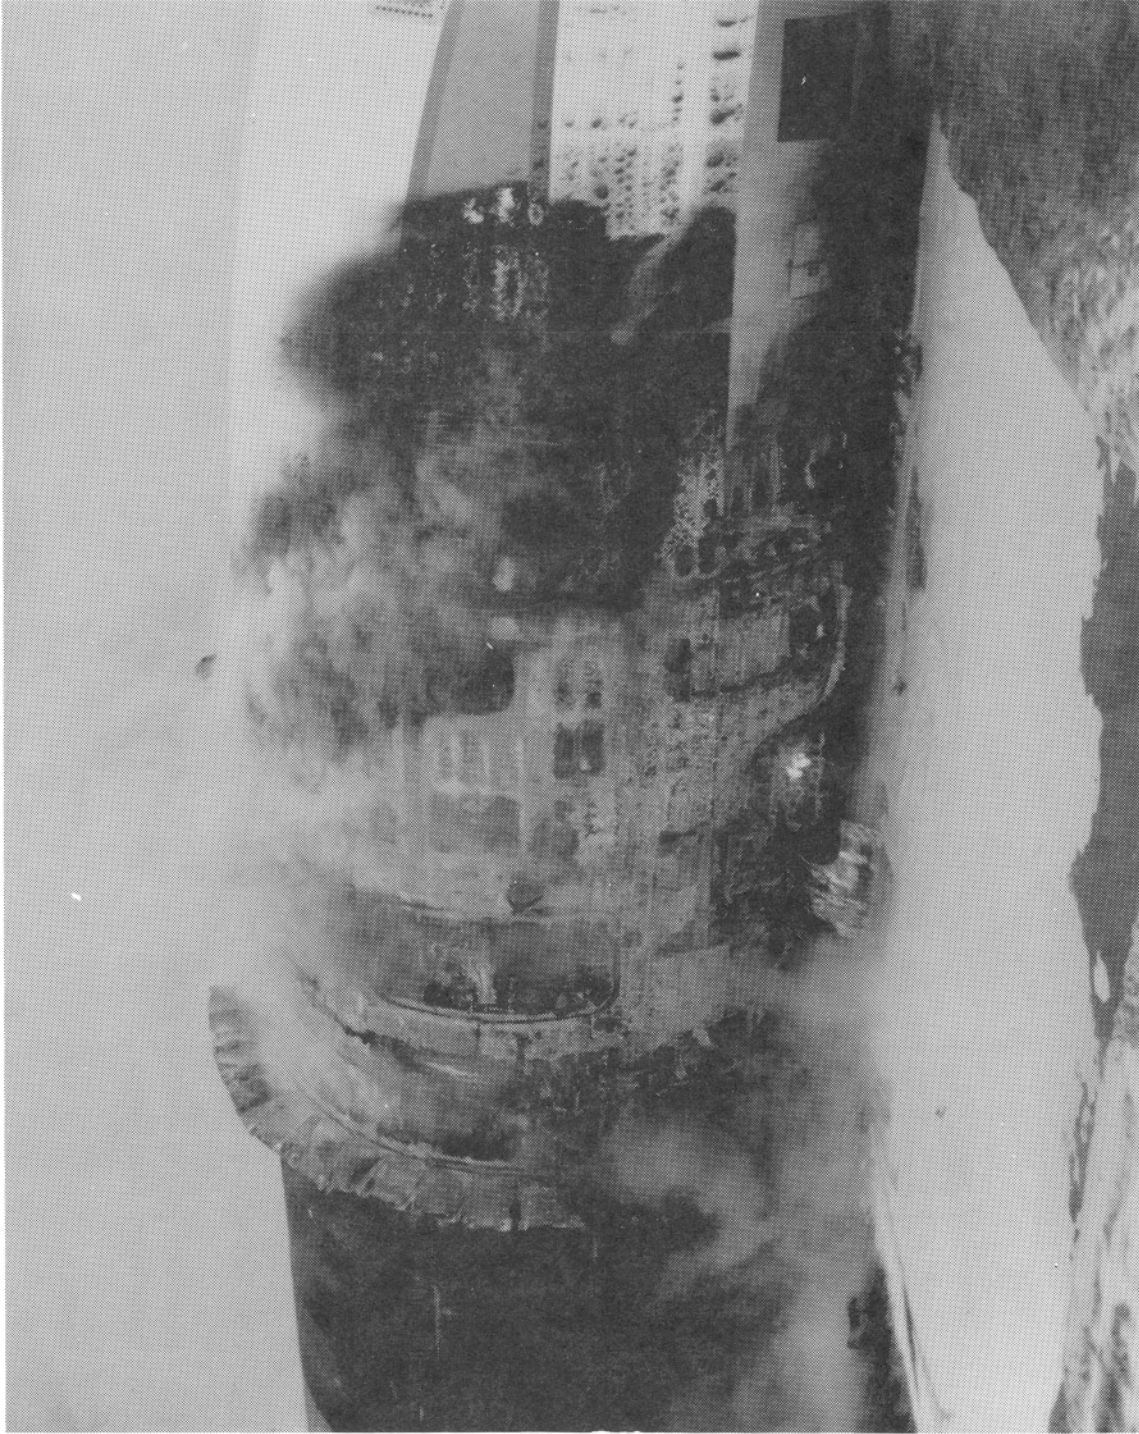
FIGURE B-7. TEST 2 EXTERNAL FIRE DAMAGE, DC-8 FORWARD SECTION

Skin Penetration. The aluminum skin was extensively destroyed from the fire barrier, located at the compartment partition, to approximately 16 feet forward as shown in figure B-7. The damage extended from ground level up to the center or the top of the aircraft (figure B-8). The skin on the service door was completely melted away. The cargo door skin was also melted away. Nearly all of the skin below the floor level was melted. The two windows on the starboard side were checkered but were still in their frames.

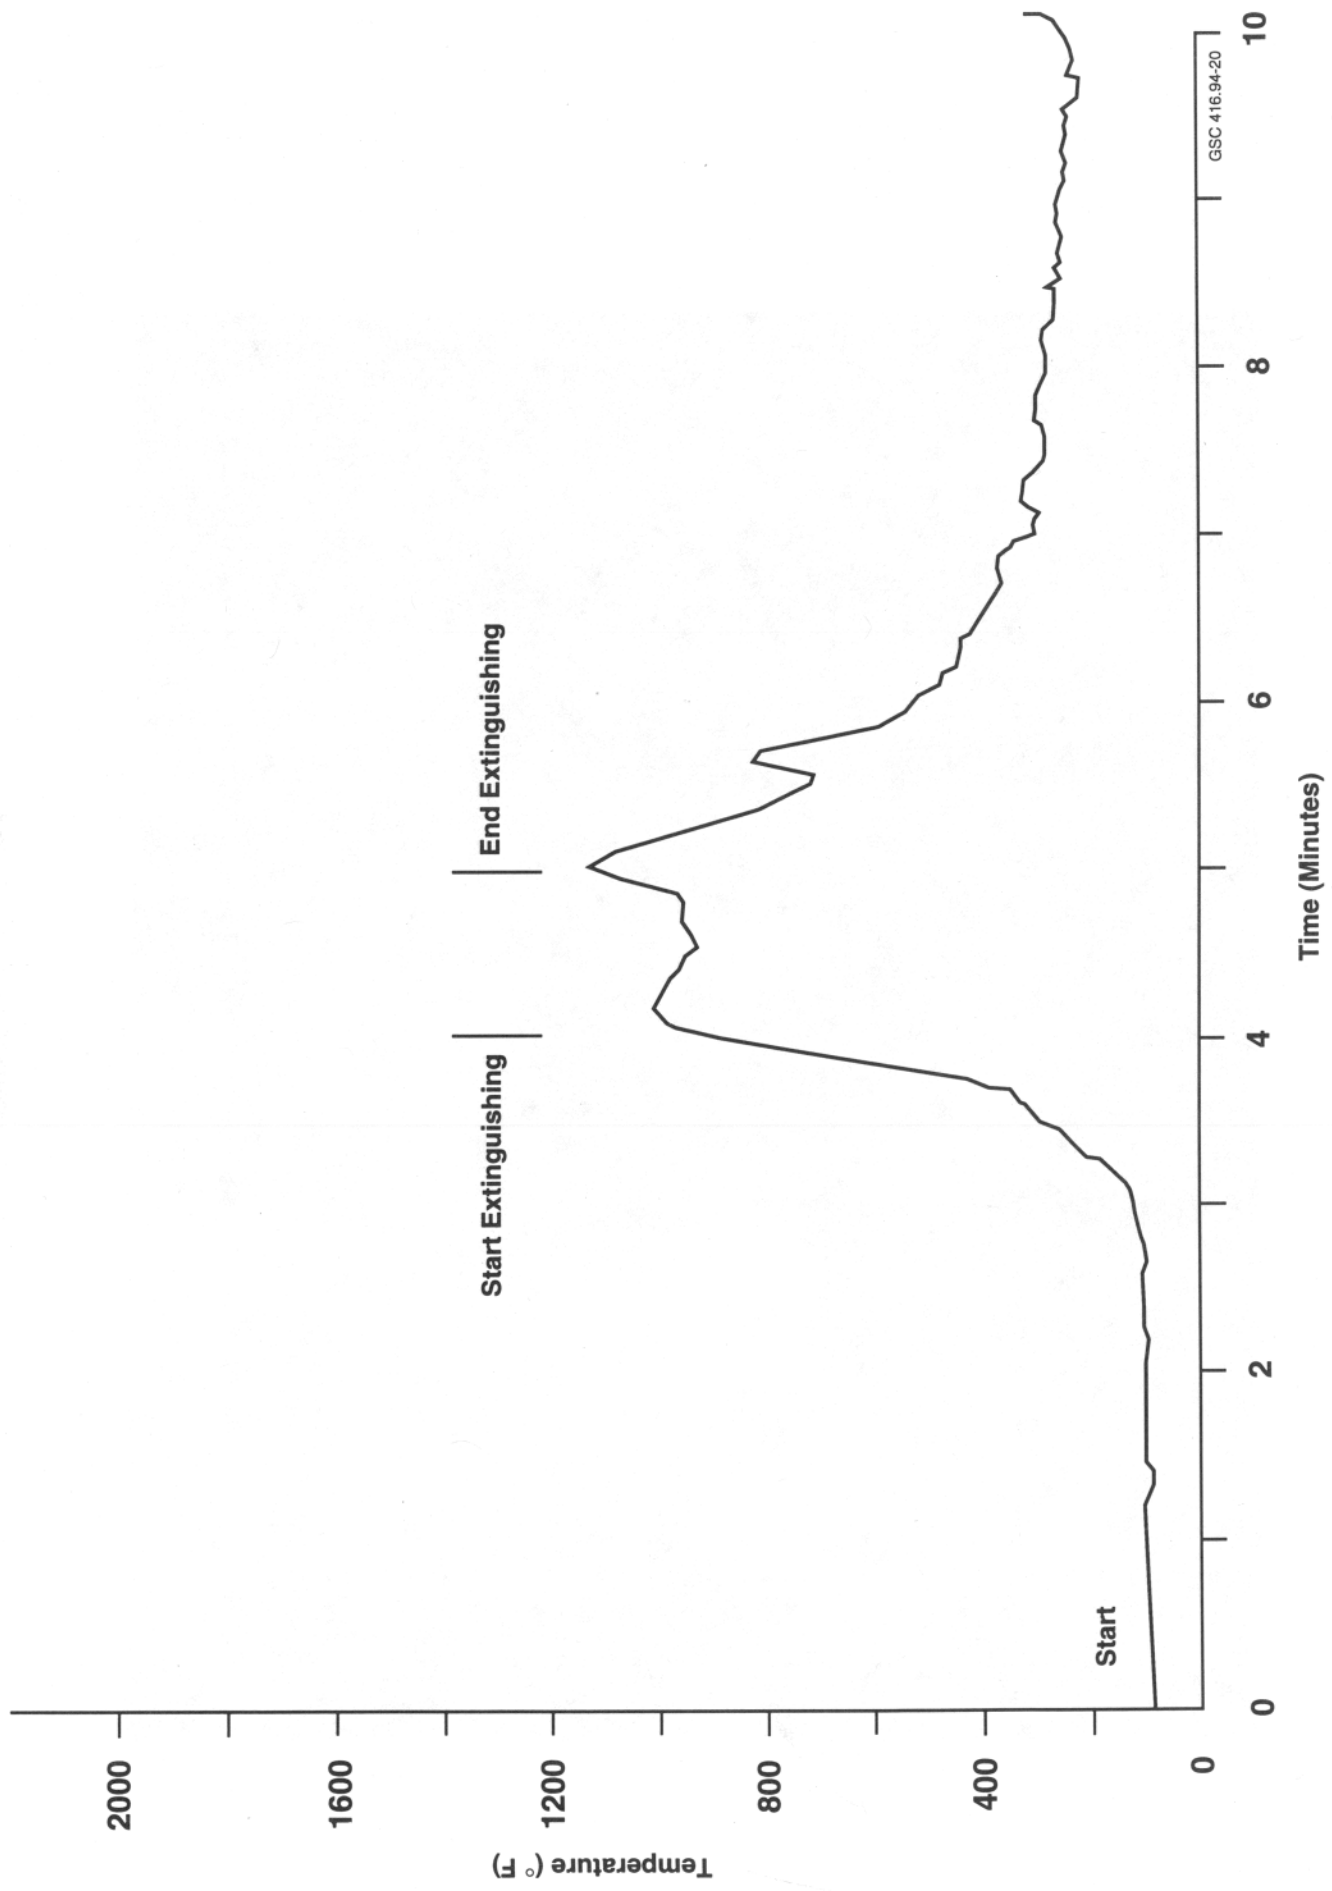
FIGURE B-9. TEST 2 AIR TEMPERATURE BETWEEN CABIN FLOOR AND THE CARGO COMPARTMENT AT STATION 270

Cargo Compartment. The fire breached the cargo compartment through the cargo door. The liner was blackened but not cracked where it was exposed in the cheek area. The interior of the compartment was sooted but undamaged. The area between the upper liner and the cabin floor was heavily sooted and the insulation charred but still intact. The temperature above the upper liner at station 270 reached a peak of 1100 °F (figure B-9). The cargo door was completely destroyed.

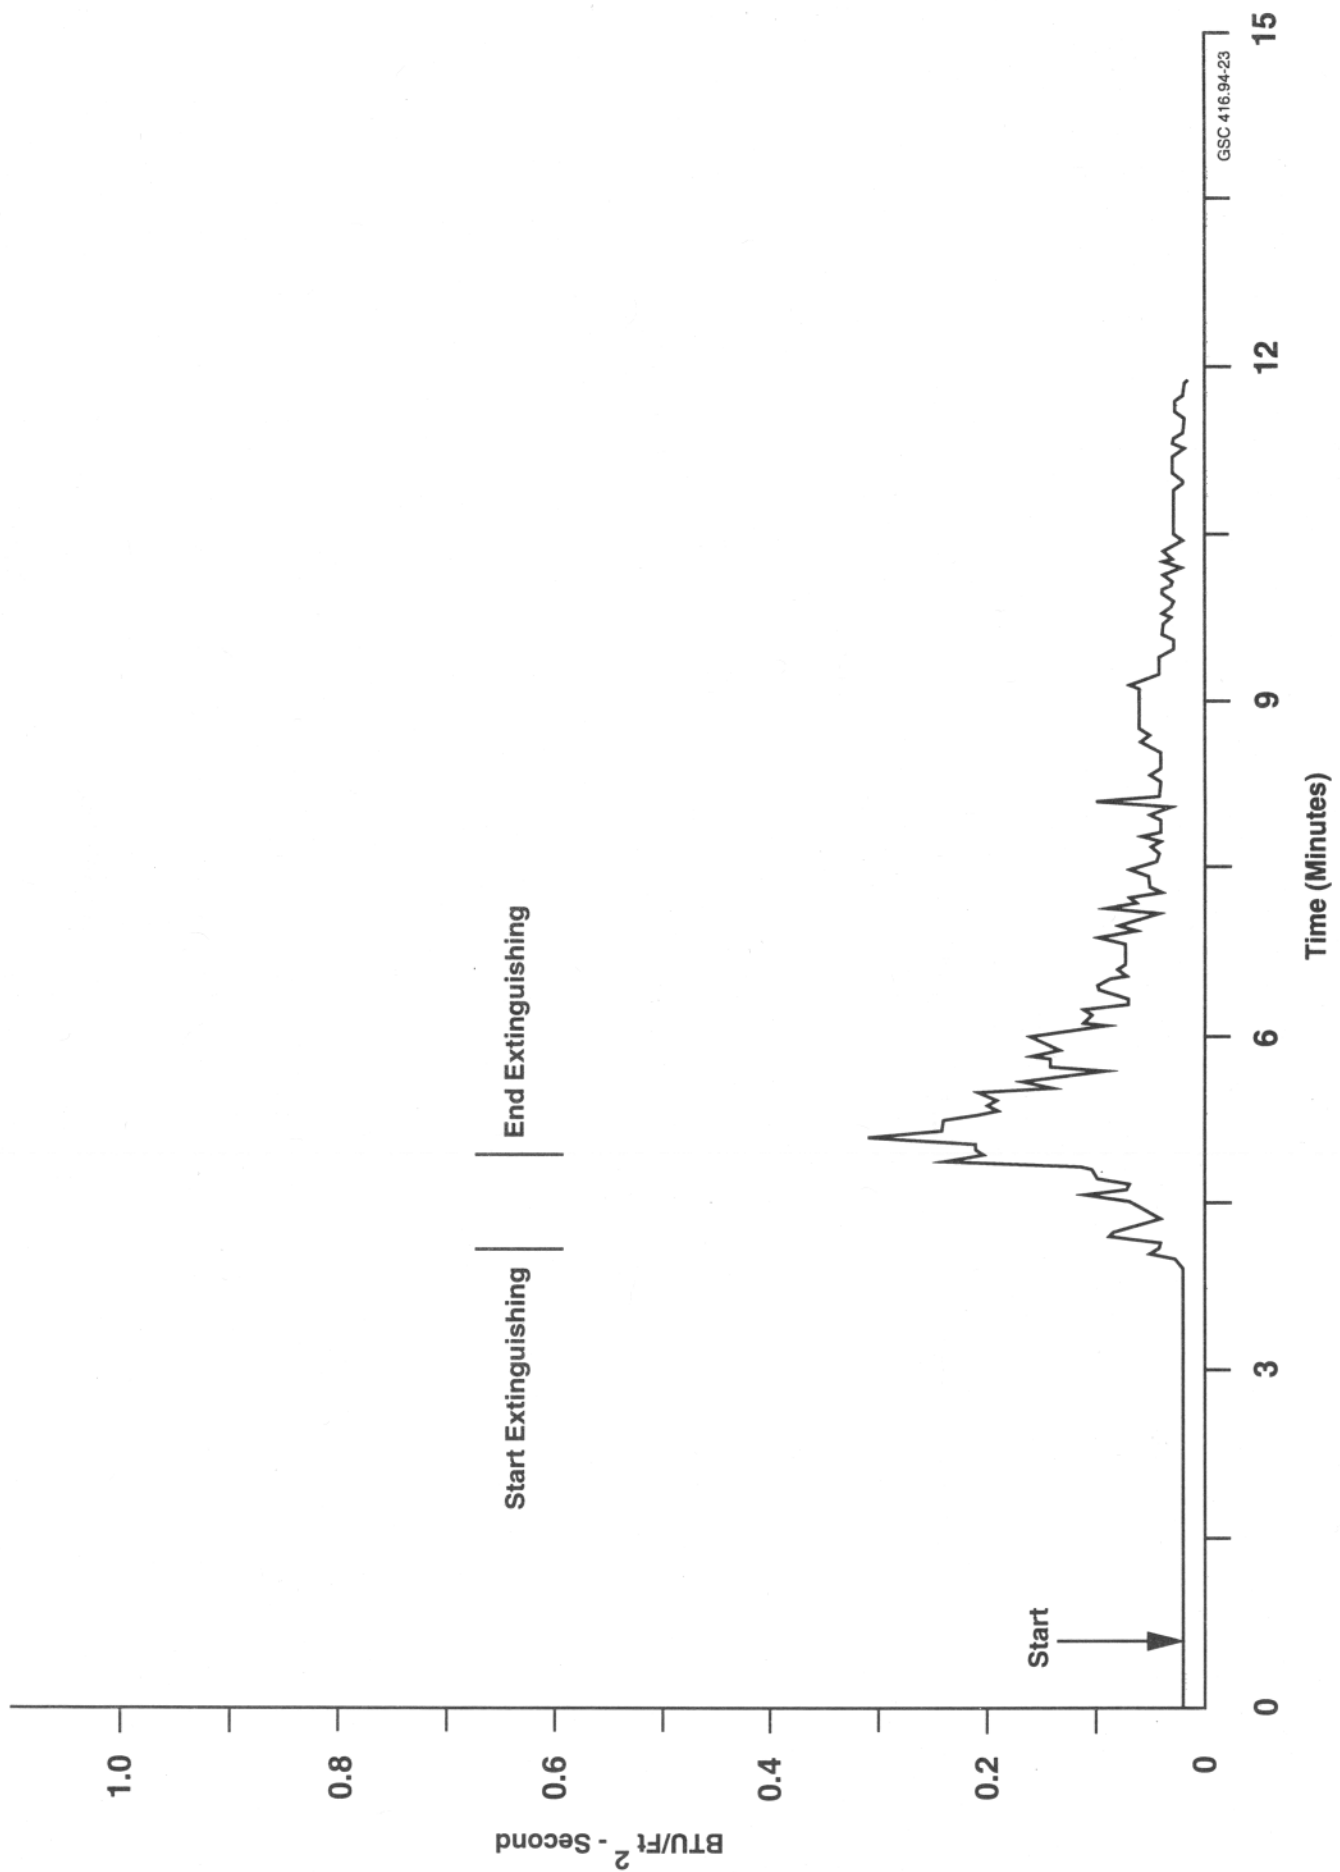
FIGURE B-13. TEST 2 HEAT FLUX TRANSMITTED THROUGH CABIN WINDOW AT STATION 241

Windows. The temperatures of the pressure and fail-safe panes of the windows located at stations 241 and 287 stayed low when exposed to flame temperatures as high as 1800 °F. The pressure pane charred quickly providing an insulating layer that protected the fail-safe pane (figures B-11 and B-12). Calorimeters located inside the cabin and 18 inches from the windows registered heat flux values transmitted through the window panes of only 0.2 to 0.3 BTU/FT²-second. (figures B-13 and B-14).

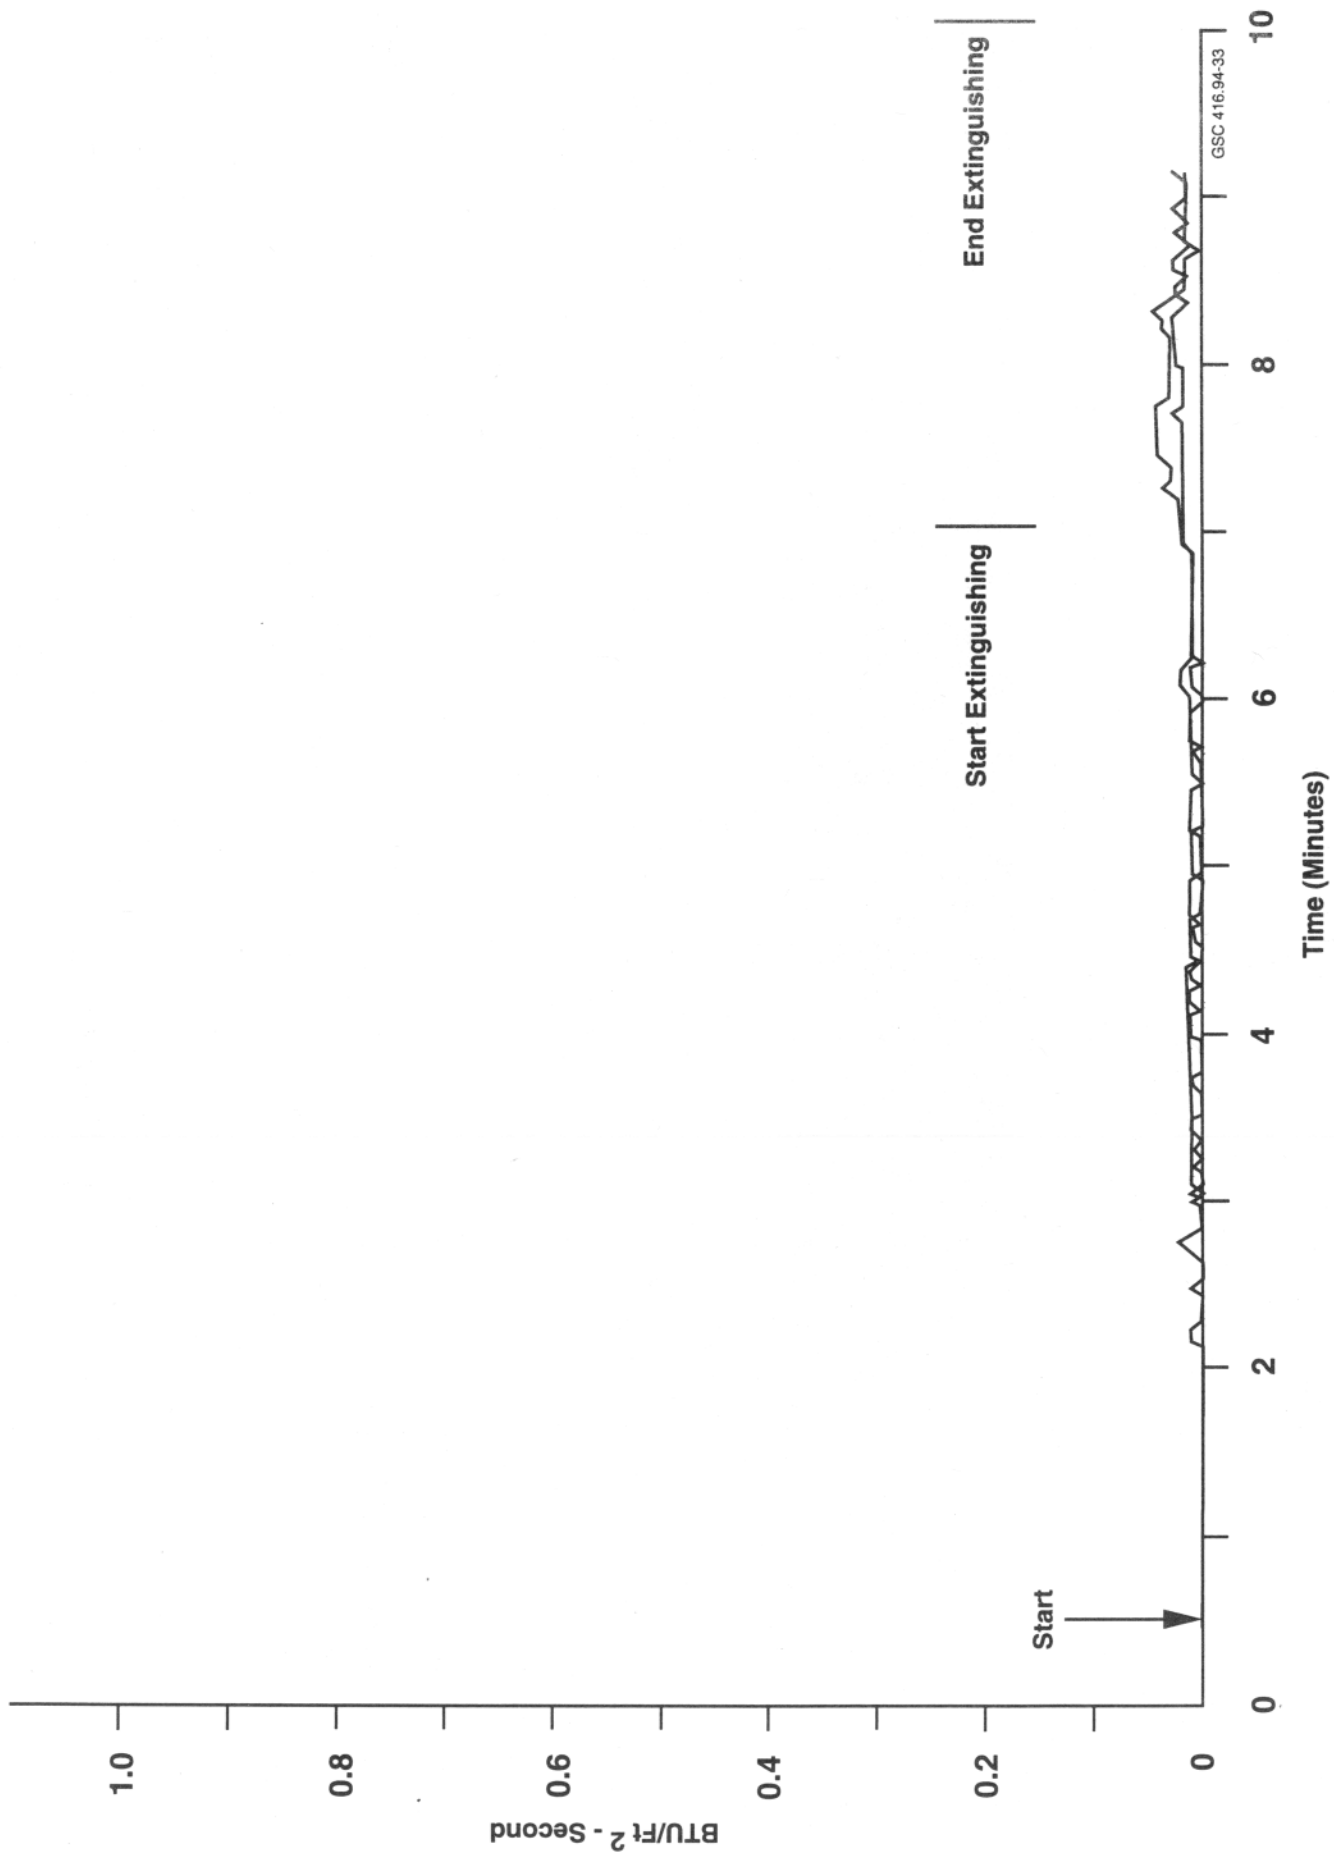
FIGURE C-8. TEST 3 HEAT FLUX TRANSMITTED THROUGH EMERGENCY EXIT WINDOWS AT STATIONS 693 AND 775

cabin and 18 inches from the windows registered heat fluxes transmitted through the window panes of less than 0.1 BTU/ft²-sec (figure C-8). The aluminum skin on the forward hatch was sooted and heat damaged but not melted. Fifty percent of the skin on the aft hatch was melted away.

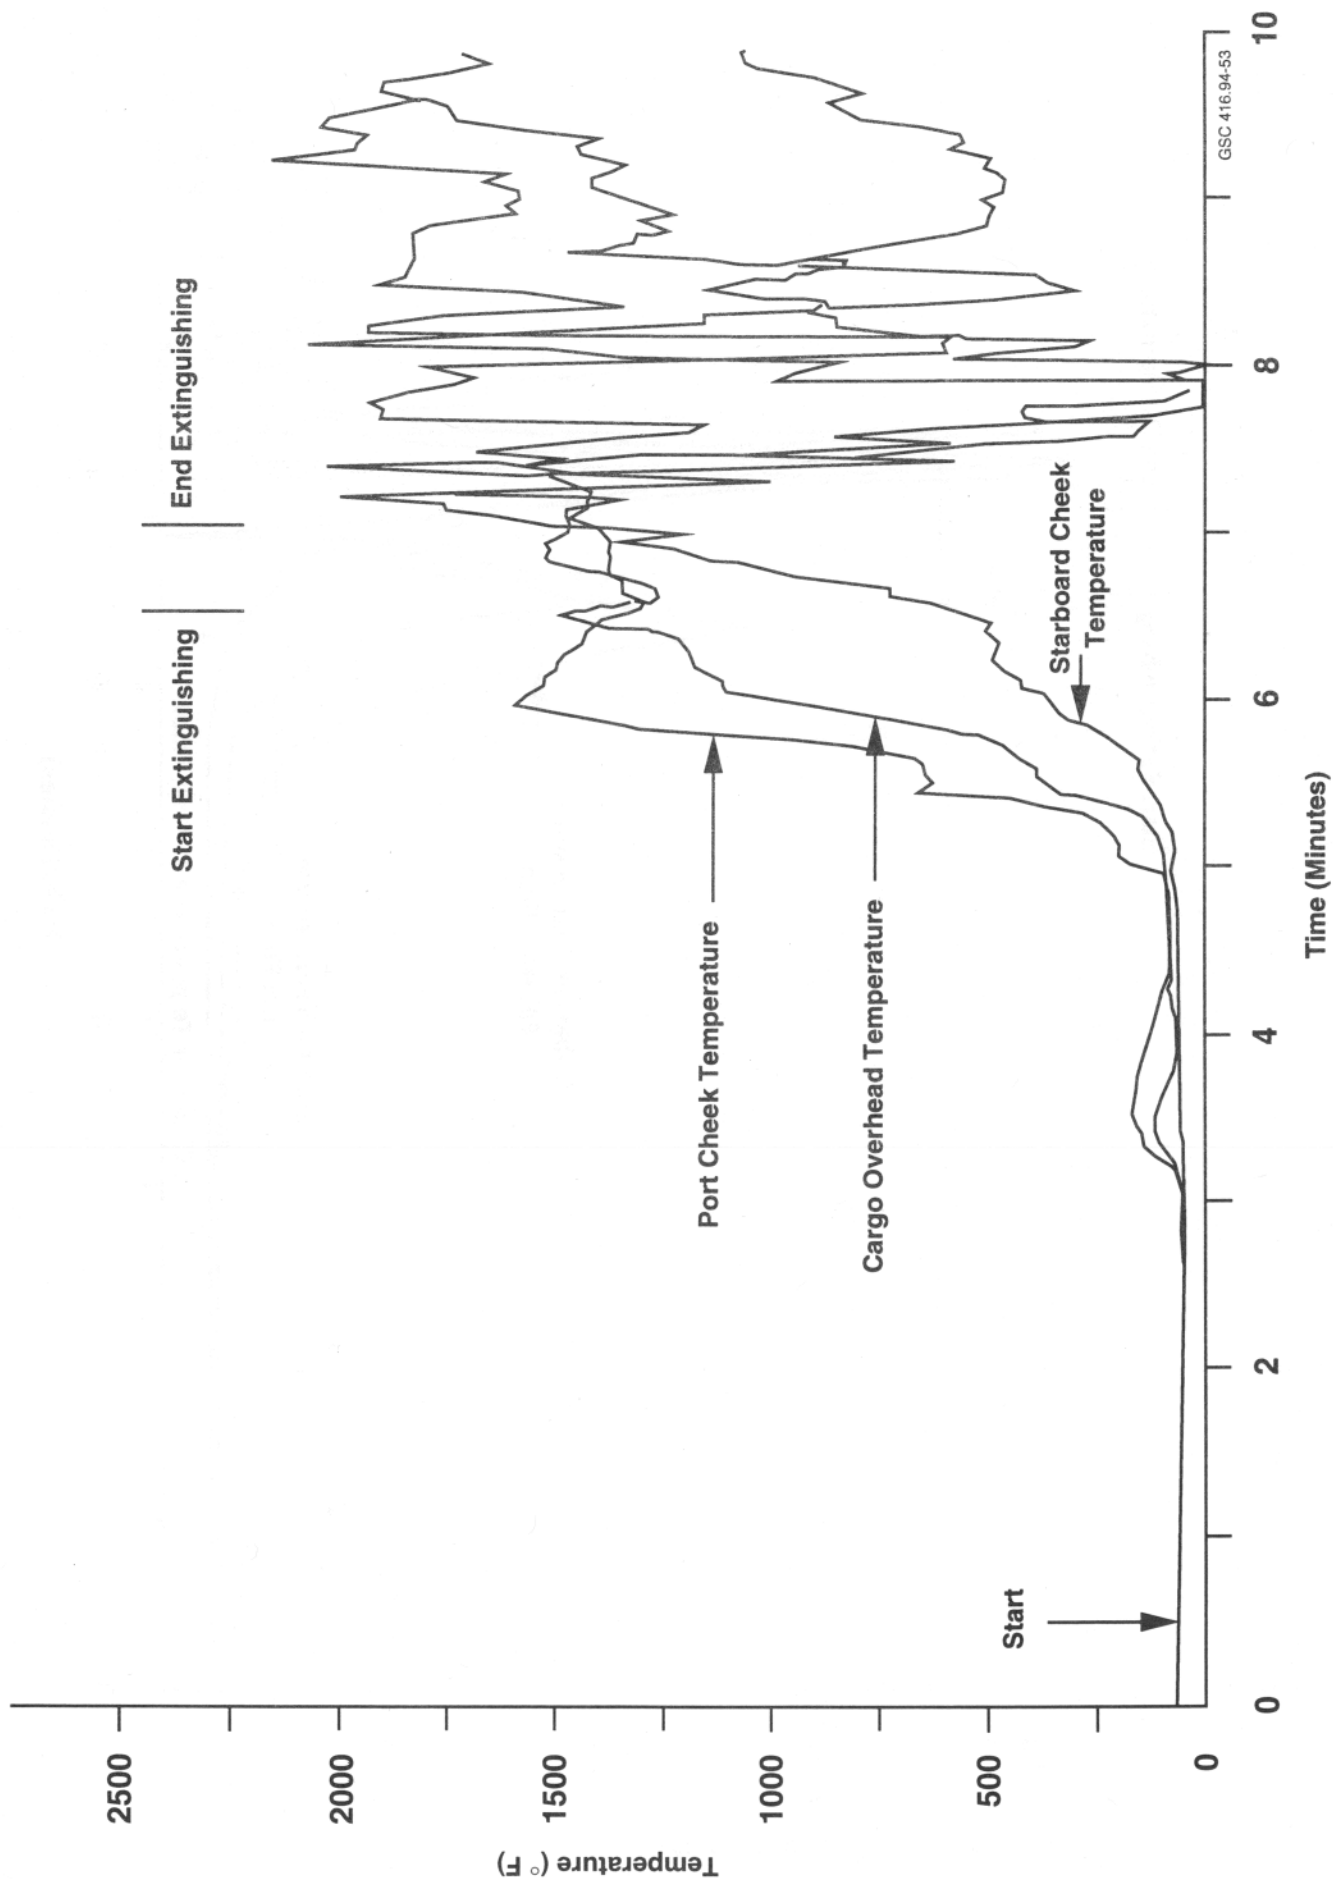
FIGURE D-19. TEST 4 PORT AND STARBOARD CHEEK AND CARGO OVERHEAD TEMPERATURE AT STATION 1182

destroyed as well as 50 percent of the cabin floor above it. The forward bulkhead remained undamaged due to the protective steel partitions. The starboard cargo hatch was scorched on the inside but undamaged on the exterior. The hatch was inoperable after the test. The air temperature in the cargo compartment measured at station 1182 remained ambient for approximately 4 minutes at which time it rapidly rose to 1100 °F, dropped off to 700 °F and then peaked at 1600 °F at the conclusion of the test (figure D-18). The temperature in the cheek areas and between the floor and the top of the cargo compartment measured at station 1182 remained close to ambient for 4.5 minutes and then peaked at 1600 °F near the end of the test (figure D-19).
