DGA Aeronautical Systems

« Fire Safety Department »

**Fire Behaviour of Structural Composite
Materials
Submitted to a Hidden Fire Source**

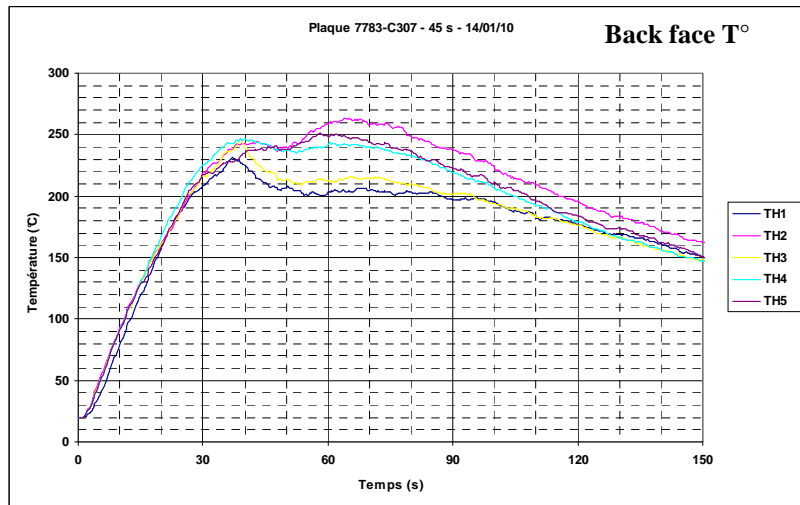
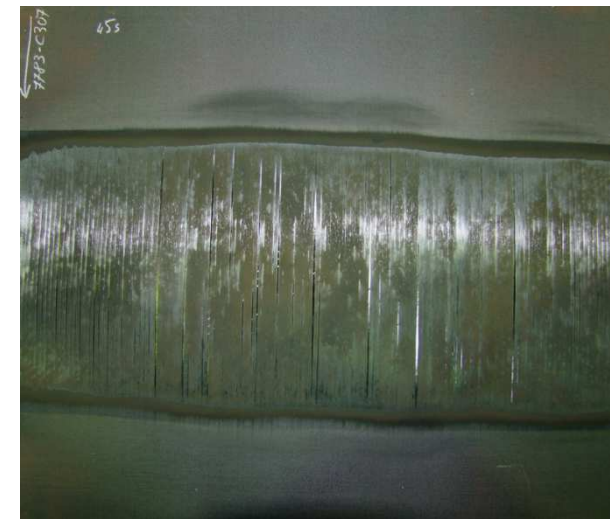
► T300 / 914 Carbon / Epoxy 16 plies / 2.4 mm

2.4 mm Totally delaminated

→ *No mechanical test*

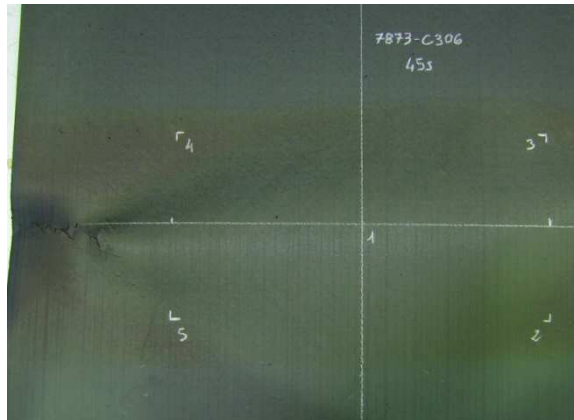
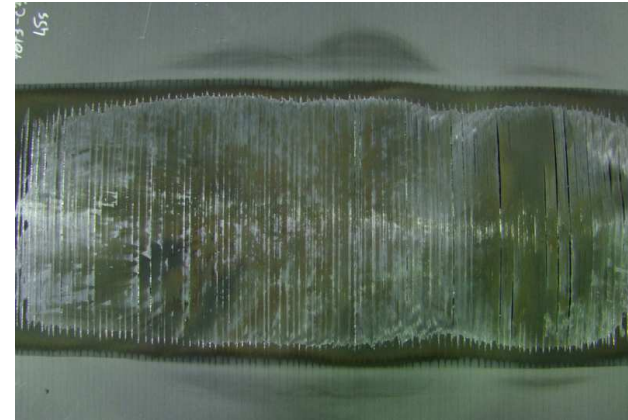
- **T800H / DA508 Carbon / Epoxy 16 plies / 2.4 mm**

2.4mm Totally delaminated

→ *No mechanical test*

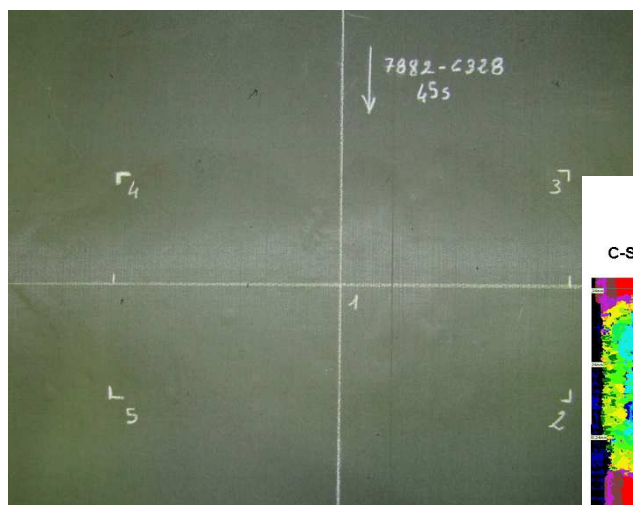
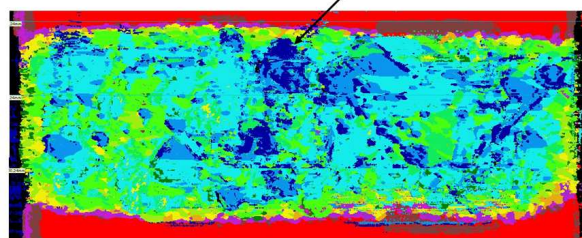
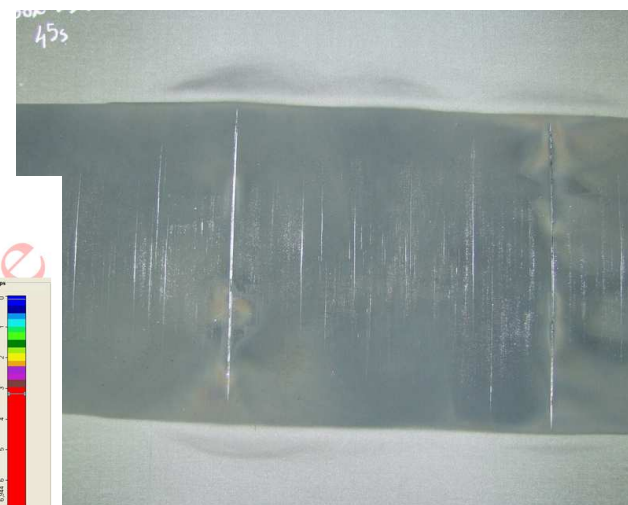
Eprouvette 7882 C328 – 45s

80% delaminated
Better but Thicker

$p = 0,52\text{mm}$

Epaisseur éprouvette = 3,02mm

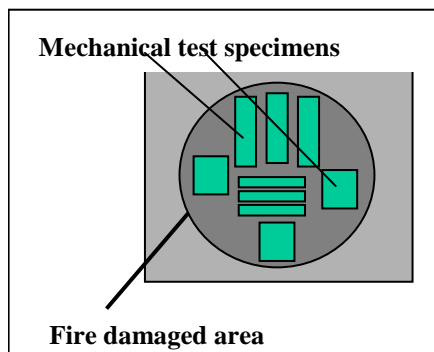
✓ A 16 plies composite material representative to a fuselage skin is at least 80% delaminated

T300 / 914 Carbon / Epoxy	2.4 mm (16 plies)	Totally delaminated
T800H / DA508 Carbon / Epoxy	2.4 mm (16 plies)	Totally delaminated
T800H / 5245 Epoxy-Cyanate-Bismaleimid	3 mm (16 plies)	80% delaminated

➔ These test conditions are too severe to make a study on the mechanical behaviour of the composite materials used for fuselage applications

- The next step will be to determine less severe scenarios which will be able to discriminate and classify the composite materials :
 - ✓ By reducing the gas flow-rate
 - ✓ without reducing the baseline time of exposure which is already very short (45s)

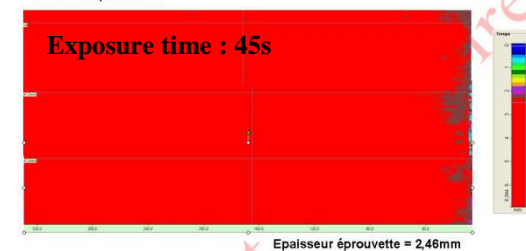
Eprouvette 7628 C319 - 45s

Exposure time : 45s

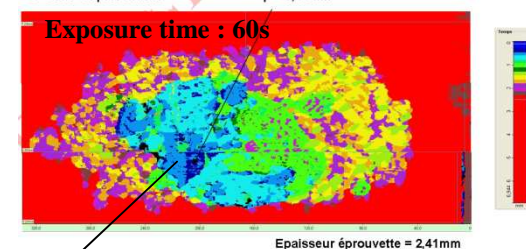
Eprouvette 7629 C319 - 60s

p = 0,40mm

Exposure time : 60s

A maximum of 80% of the thickness is delaminated after 1 mn of exposure

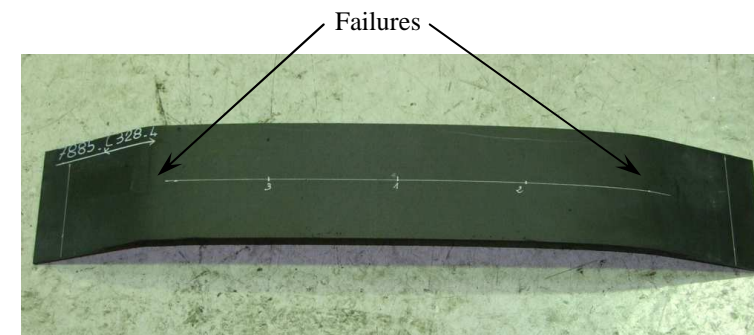
Test sample after test

➤ T300 / 914 Carbon / Epoxy 16 plies / 2.4 mm

Fire source :
Gas fire source (BASELINE setting (representative of the foam block fire scenario)) :
➤ Distance burner / test sample : 6 inches
