FIRE PROTECTION TESTS IN A SMALL FUSELAGE-MOUNTED TURBOJET ENGINE AND NACELLE INSTALLATION

National Aviation Facilities Experimental Center

FINAL REPORT

1. Report No. FAA-RD-70-57		2. Government Accession No.		3. Recipient's Catalog No.	
4. Title and Subtitle FIRE PROTECTION TESTS IN A SMALL FUSELAGE-MOUNTED TURBOJET ENGINE AND NACELLE INSTALLATION				5. Report Date November 1970

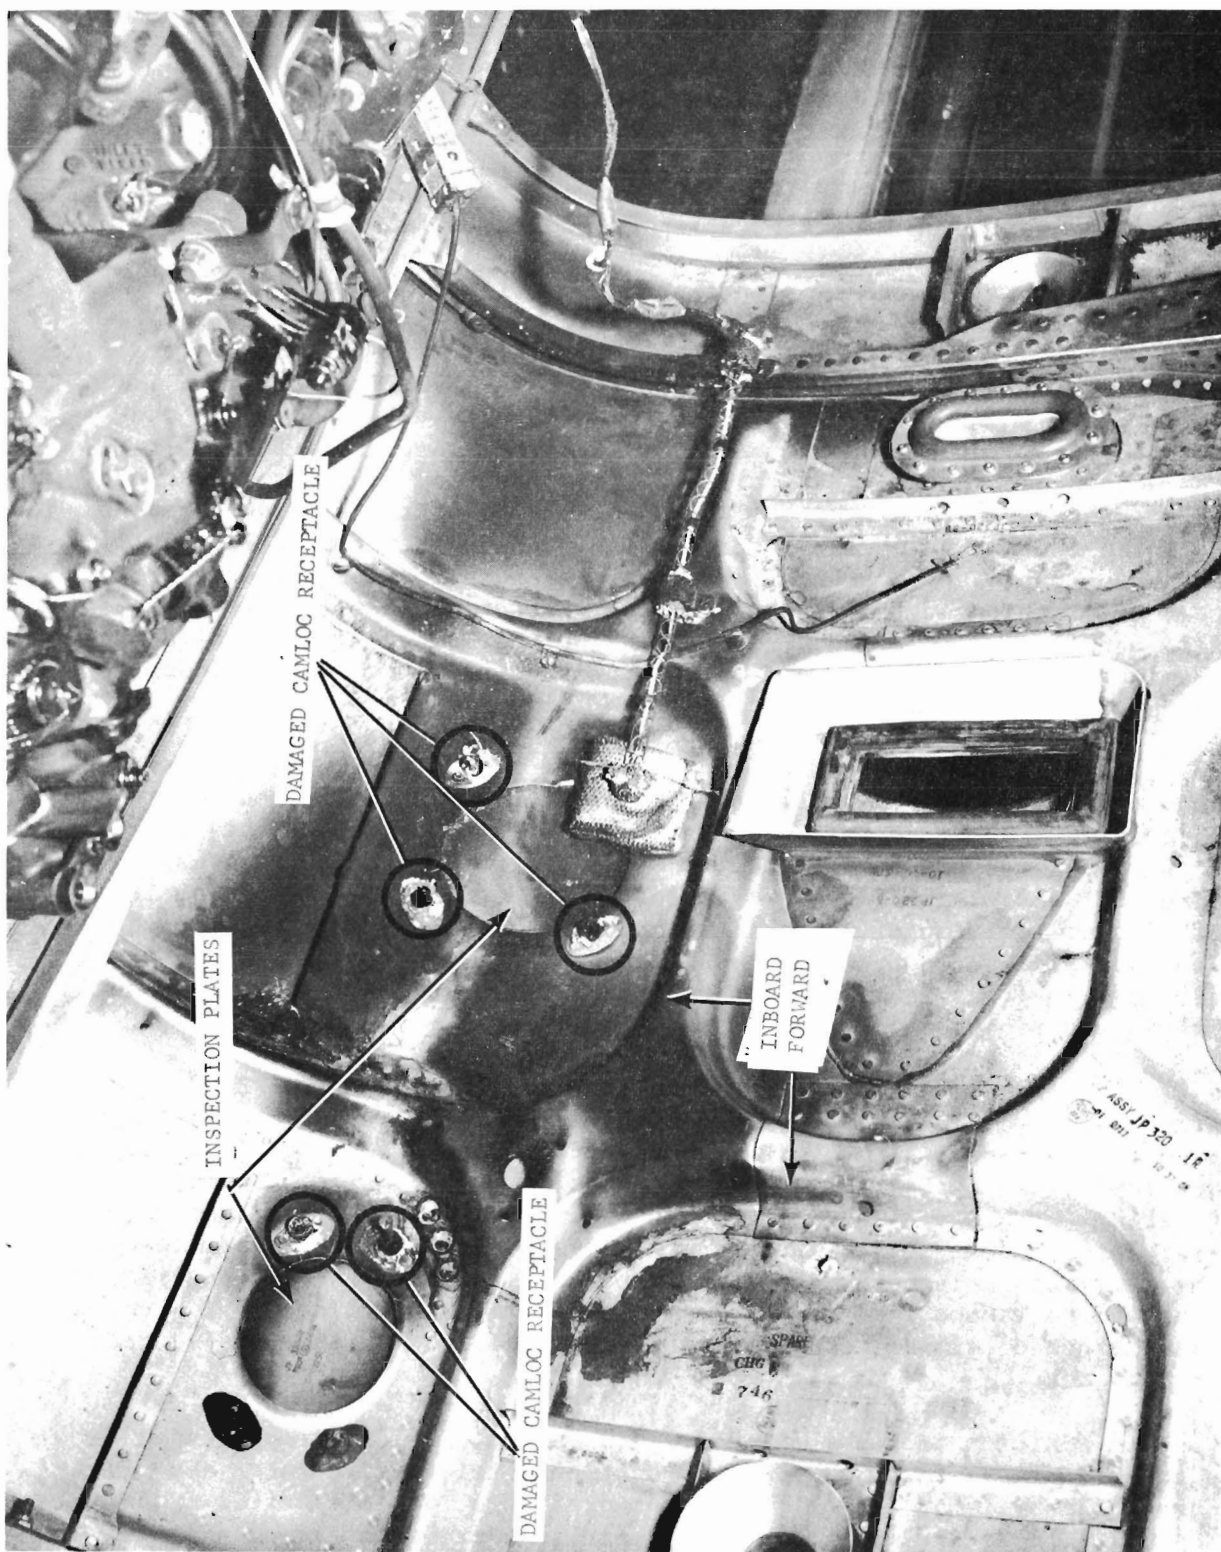
The initial damage of significance was fire penetration of the main Zone II bottom access door at the aft edge of two small inspection plate locations. This was obtained during the initial fire detection test originating at a 4 o'clock forward position in Zone II (Location 5 shown in Figure 6). A 0.07-gpm 10-second duration fire melted aluminum cam-lock fastener receptacle on the aft corner of each plate. This allowed the aft inboard edge of each plate to pop open, and fire egressed from these openings. Fire started to erode the edge of the aluminum doubler to which these panels were secured. This damage is shown in Figures 17 and 18. To prevent continual repair of this area during subsequent fire test originating in the forward inboard portion of Zone II, the inspection panels were replaced by flush aluminum patches. This modification eliminated any further fire damage to this area during the remaining test program.

FIG. 17 DAMAGE TO SMALL INSPECTION PLATE

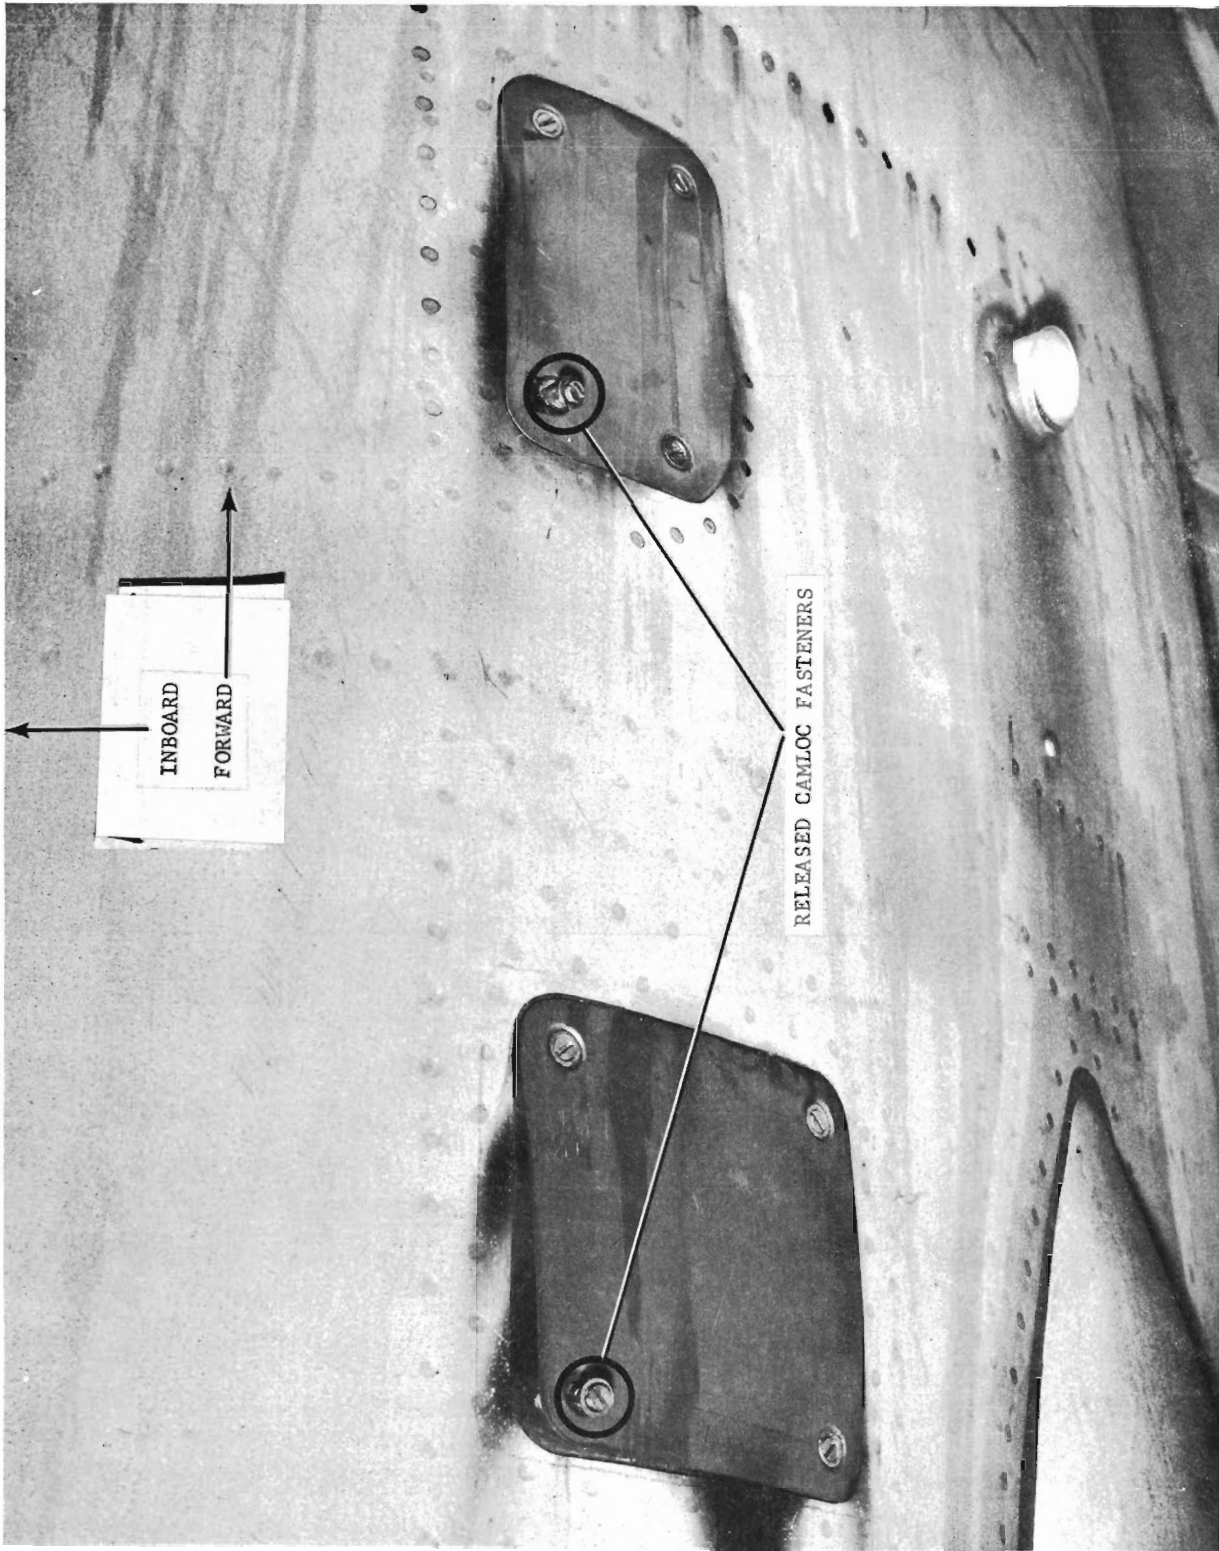
FIG. 18 EXTERNAL VIEW OF DAMAGE IN INSPECTION PLATE AREA

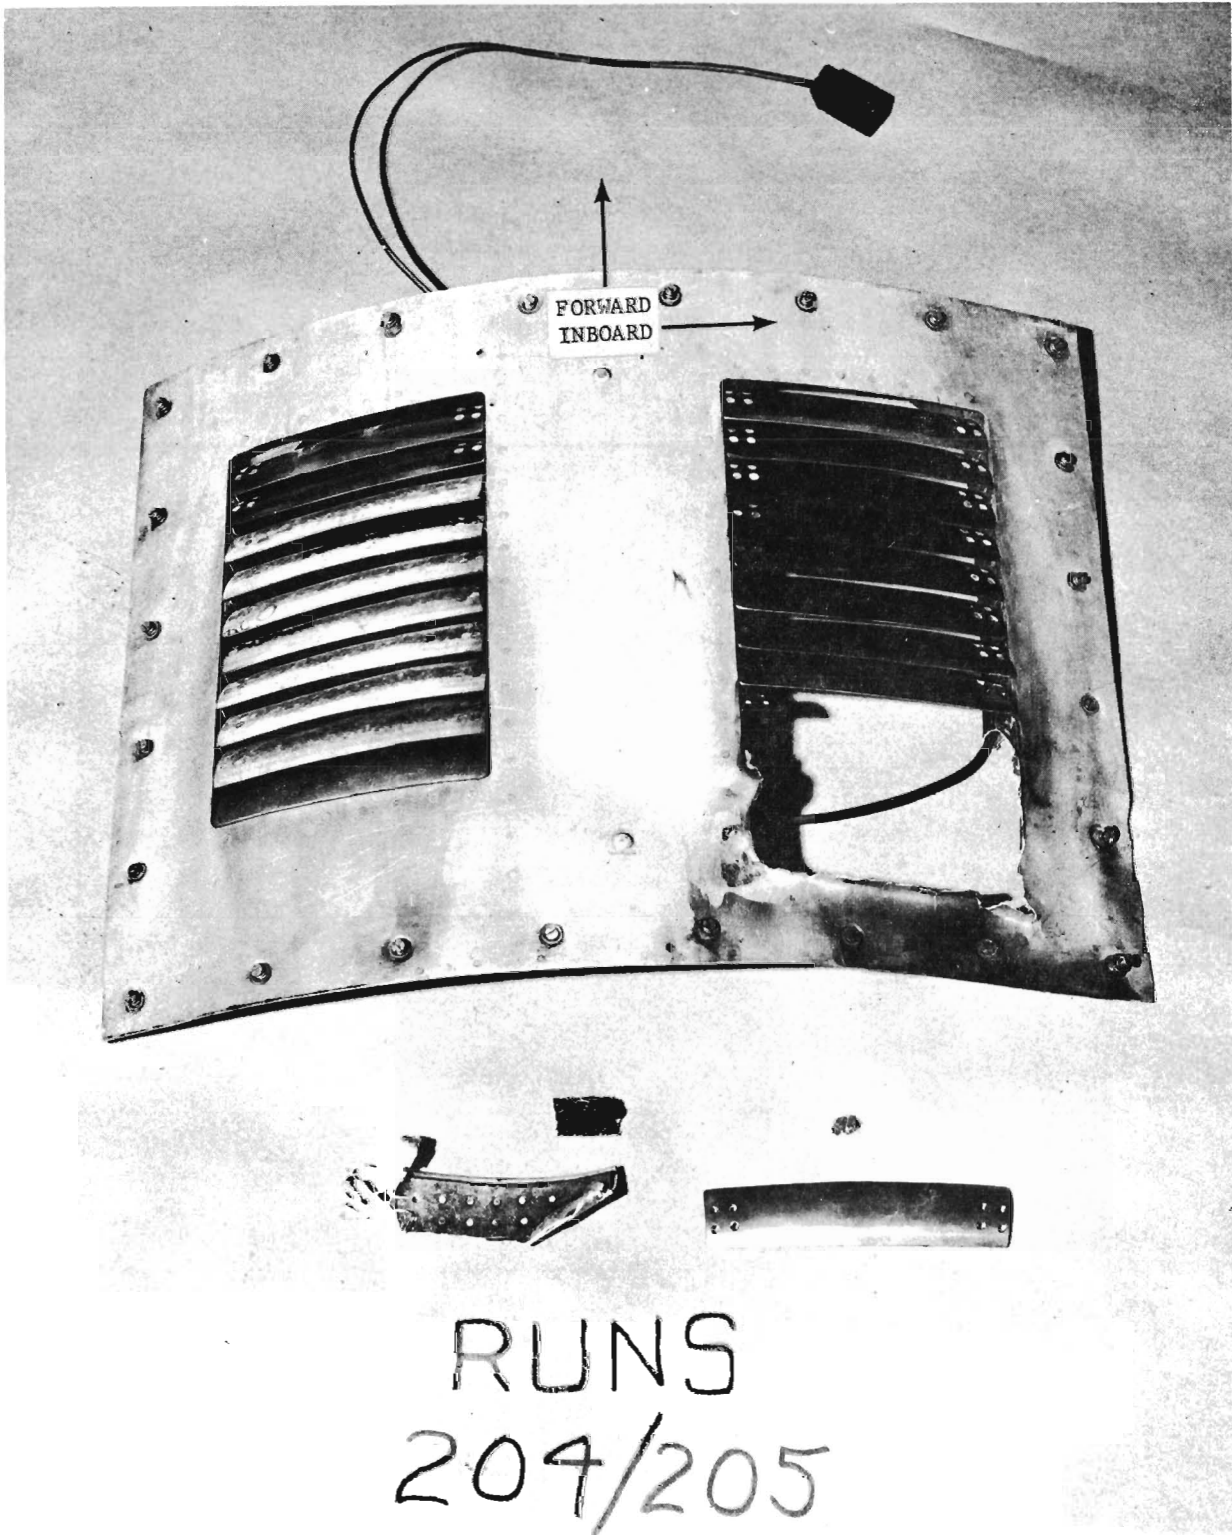
Rapid fire deterioration of the aft section of the Zone II aluminum-louvered panel located at the aft top portion of the zone occurred especially when fires were originated in the aft portion of this zone. Figure 19 shows the damage that occurred after 19 seconds total exposure time to two 0.42-gpm fires originated at the 4:30 o'clock position in the aft inboard portion of Zone II (Location 6 shown in Figure 6). Since the louvered panel was particularly susceptible to damage, a stainless steel slotted panel was fabricated to replace it. This stainless steel panel lasted the remainder of the program.

FIG. 19 DAMAGE TO TOP AFT LOUVERED PANEL IN ZONE II

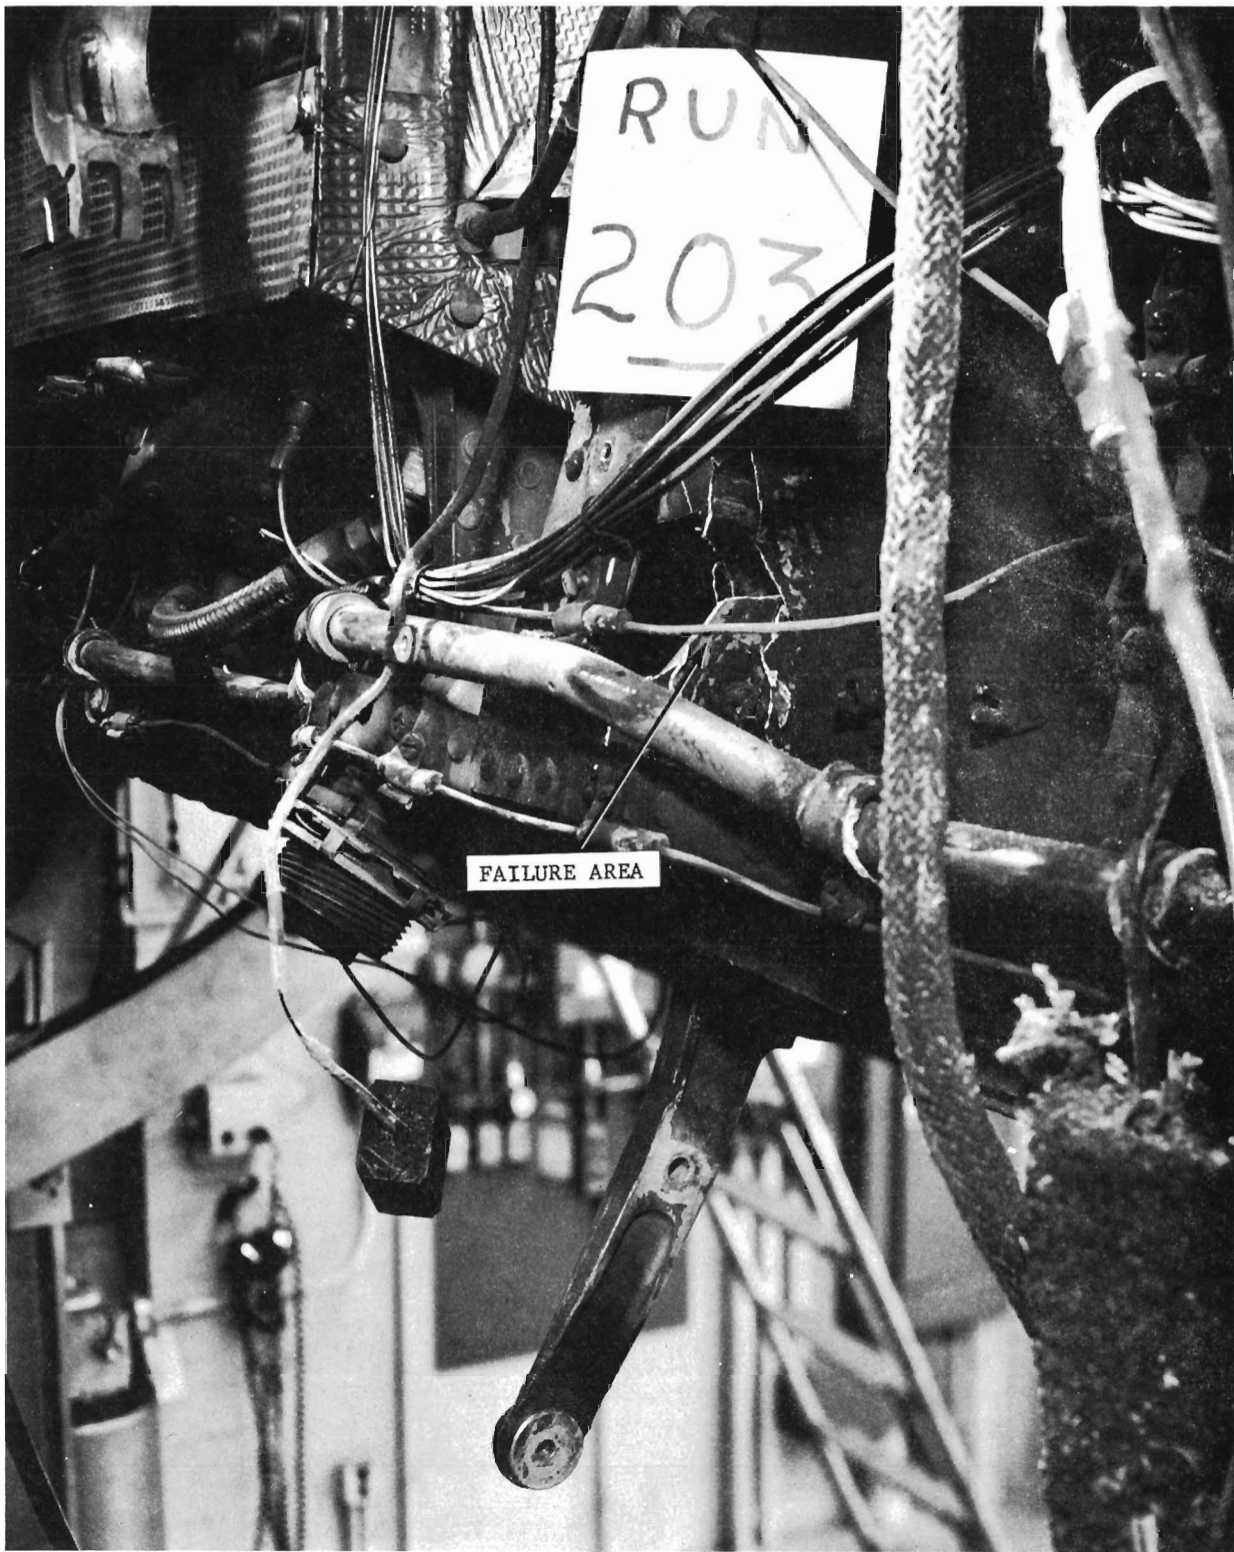
The aft inboard aluminum hinge anchor bracket for the Zone II main access door separated from its attachment point after a total of 99 fire tests in Zone II. The aluminum rib to which the bracket was attached deteriorated and the bracket broke away, allowing the aft inboard portion of the Zone II main access door to drop open. The fire then egressed from Zone II to the outside at this opening. The fires originated in the inboard portion of Zone II and especially those at the 4:30 o'clock aft position in the zone (Location 6 shown in Figure 6) as well as those fires which had fuel flow rates in excess of 0.4 gpm had the most damaging effect on this bracket attachment point. The attachment point failed during a 1.0-gpm JP-4 fire originated at the 4:30 o'clock position in the forward portion of Zone II (Location 5A shown in Figure 6). The duration of this fire was 8.8 seconds. The damage to this area is shown in Figure 20.

FIG. 20 DAMAGE TO ZONE II MAIN ACCESS DOOR AFT HINGE SUPPORT BRACKET

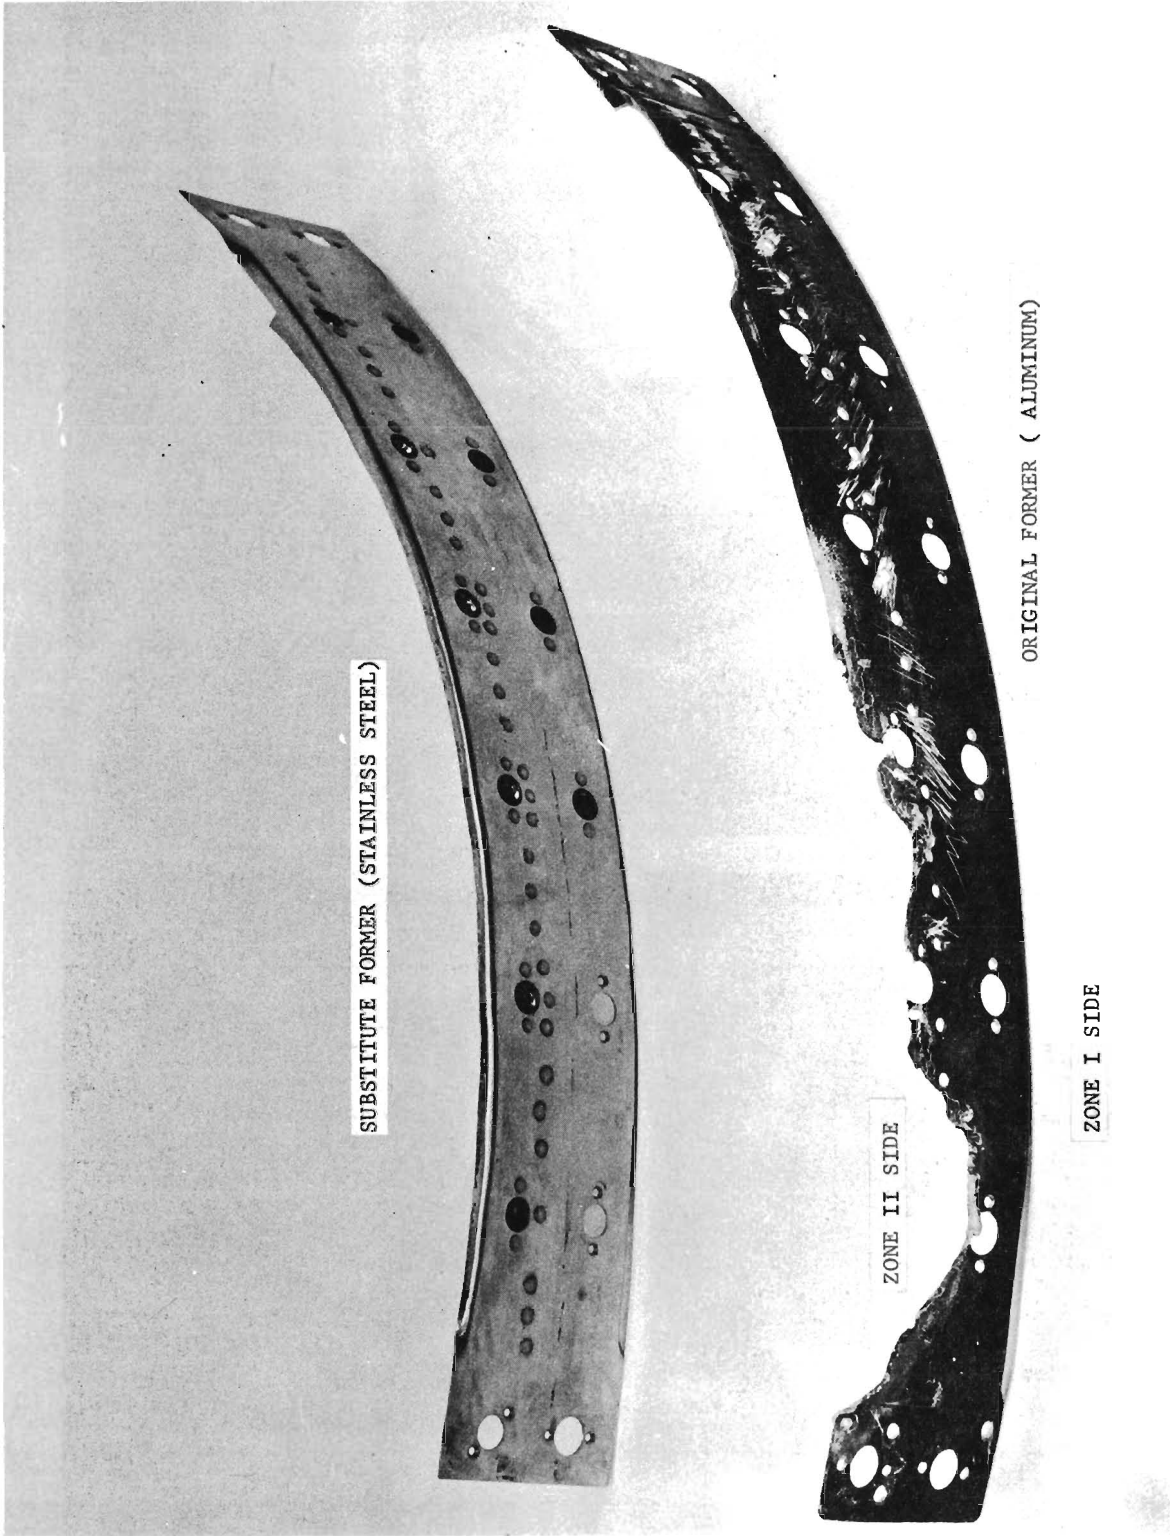
The upper "T" aluminum former attached to the nacelle portion of the Zone I/Zone II separating seal deteriorated to a point that it had to be replaced after 112 fire tests. The Zone II louvered panel as well as the forward top Zone I access panel were attached to this former by camlock-type fasteners. The camlock receptacles riveted to the inside of this former as well as a good portion of the former on the Zone II side of the fire barrier were destroyed. Figure 21 shows the fire damaged aluminum former and the stainless steel former which was used to replace it. Fires which originated in the aft portion of Zone II at the 4 and 8 o'clock positions (Locations 6 and 7 as shown in Figure 6), as well as those fires in the nacelle with fuel flow rates greater than 0.4 gpm, had the most damaging effect on the former. The last fire to which this former was subjected before replacing it was a 0.42-gpm JP-4 fire originated at the 6 o'clock position in the forward portion of Zone II (Location 9A as shown in Figure 6). The duration of this fire was 9.0 seconds.

FIG. 21 DAMAGE TO NACELLE UPPER FORMER AT THE ZONE II/ZONE I SEPARATING FIRE SEAL

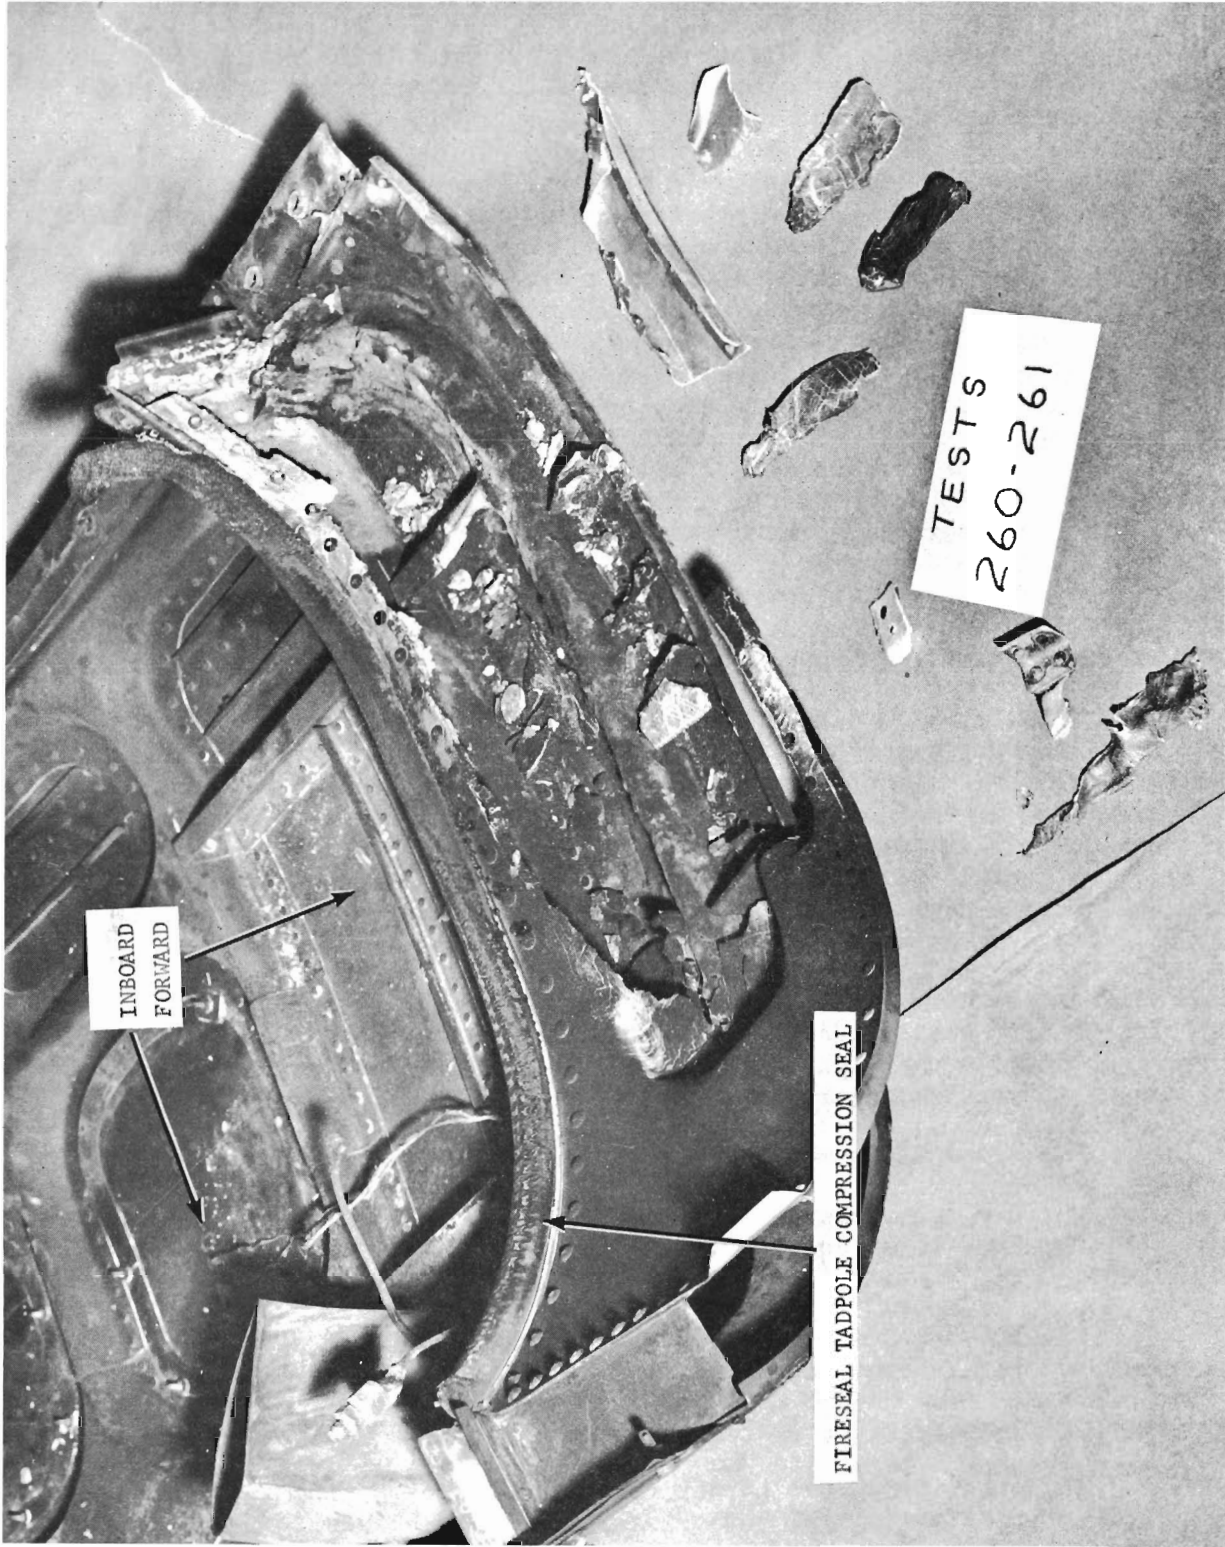
The lower outboard side of the fire barrier was penetrated by fire during Fire Tests Nos. 155 through 157. These were the first three 45-second duration fire tests. Penetration of fire occurred through the tadpole tape compression seal which is located between the engine and nacelle portions of the fire barrier. A considerable portion of the Zone I access door strengthening baffle which extended into Zone II was destroyed during these three fire tests. Figure 22 shows this damage. The fire-barrier seal was replaced for subsequent tests. The fire tests in which this damage occurred were 0.3-gpm JP-4 fire tests. The total fire duration was 2 minutes and 15 seconds; 45 seconds for each test. The fire location in Zone II was at 8 o'clock in the aft portion of the zone (Location 7A shown in Figure 6). However, preceding these 45-second duration fire tests there were 18 fire tests which were originated at Location 7A. These were short-duration fires of 10 to 20 seconds fed by

FIG. 22 DAMAGE TO FIRE SEAL TADPOLE COMPRESSION SEAL AND ZONE I ACCESS DOOR BAFFLE SECTION

JP-4 fuel at flow rates of either 0.3 or 0.42 gpm. These fires most likely contributed to the deterioration of the tadpole tape compression seal prior to the 45-second fires.

During the Fire Tests Nos. 178 and 179, which were the last two conducted in Zone II, fire again penetrated the fire barrier. The tadpole tape compression seal between the engine and nacelle sections of the fire barrier was burned through on the outboard side of the nacelle. Warpage of the engine combustor stainless steel shroud occurred causing the shroud to pull away from the "U"-shaped peripheral collar to which it was riveted. The fire egressed through these openings and into Zone I. Then the fire progressed toward the top of Zone I, burning out the aft outboard edge of the Zone I top aluminum access panel where it mated with the nacelle skin. It burned away a section of the aluminum former to which the aft portion of the panel was attached and burned away a portion of skin directly behind the outboard aft edge of the panel. Figures 23, 24, and 25 show this damage. The two fires during which this damage occurred were 0.46-gpm JP-4 fires conducted at 8 o'clock in the aft portion of Zone II (Location 7A shown in Figure 6). The combined fire duration time for these two tests was 1 minute and 18 seconds.

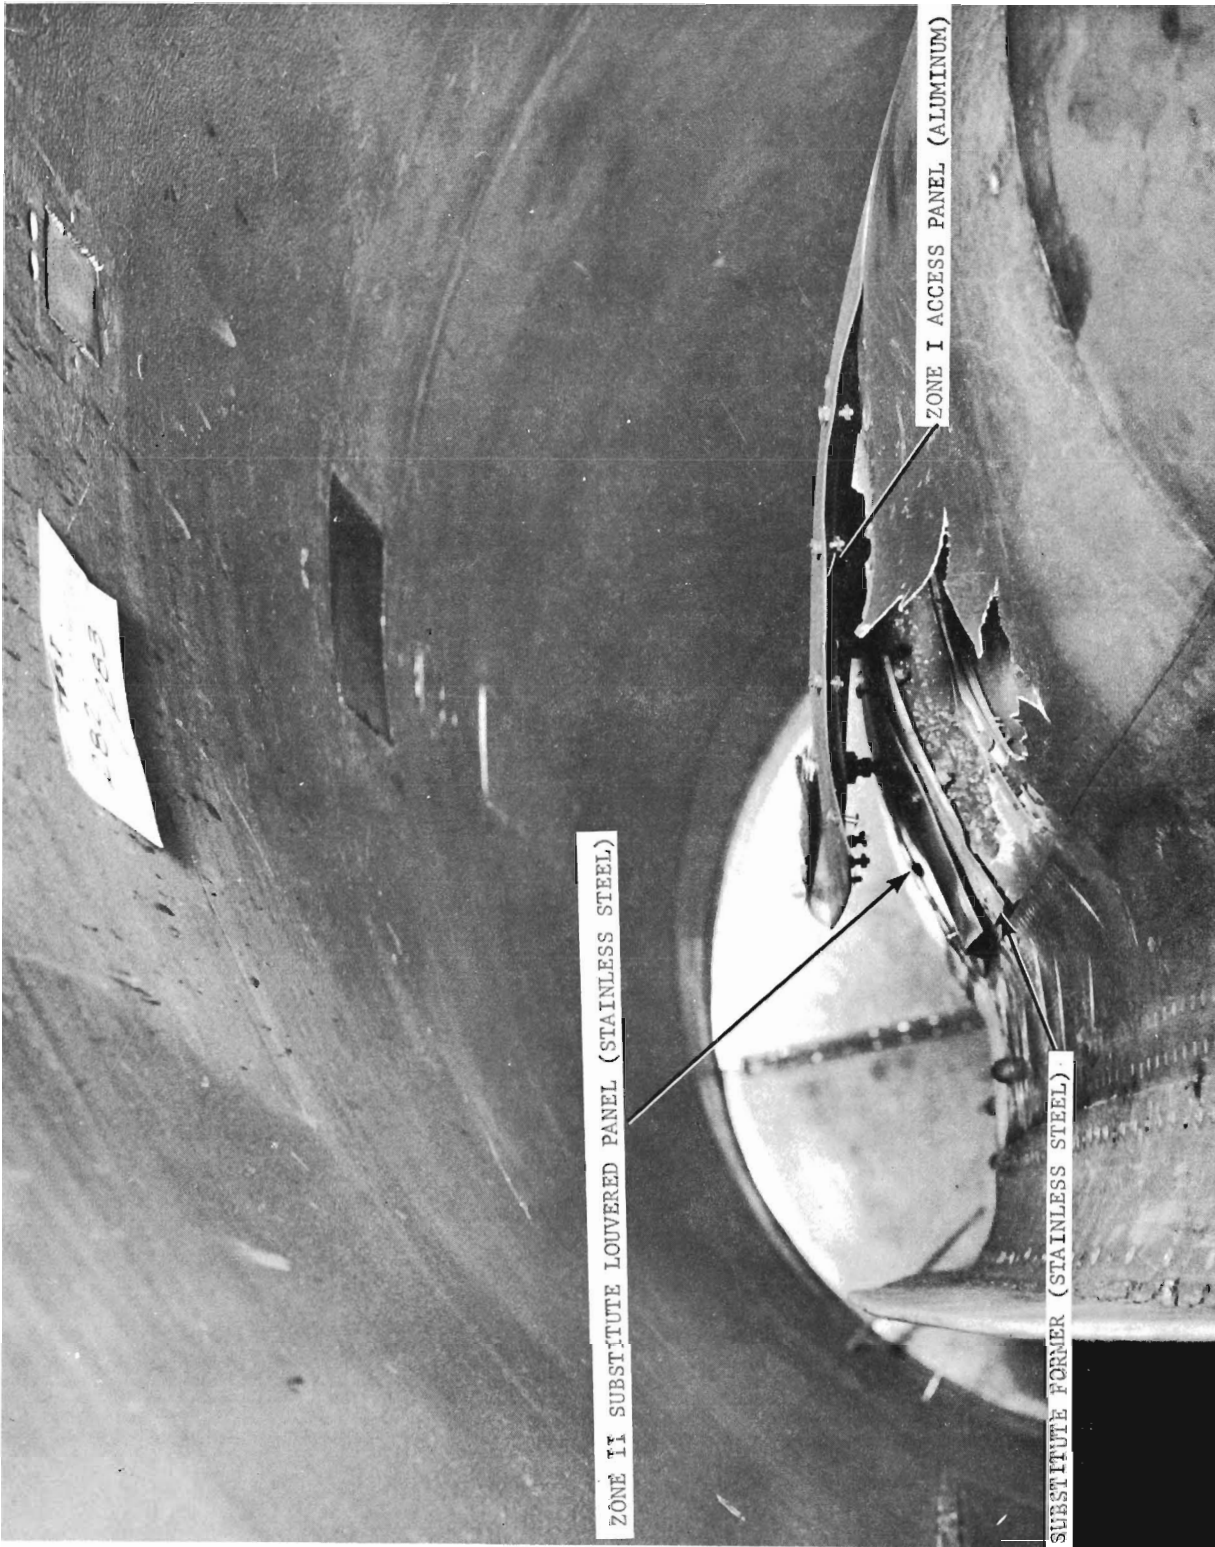
FIG. 23 EXTERNAL VIEW OF DAMAGE TO ZONE I ALUMINUM ACCESS PANEL, NACELLE FORMER, AND SKIN

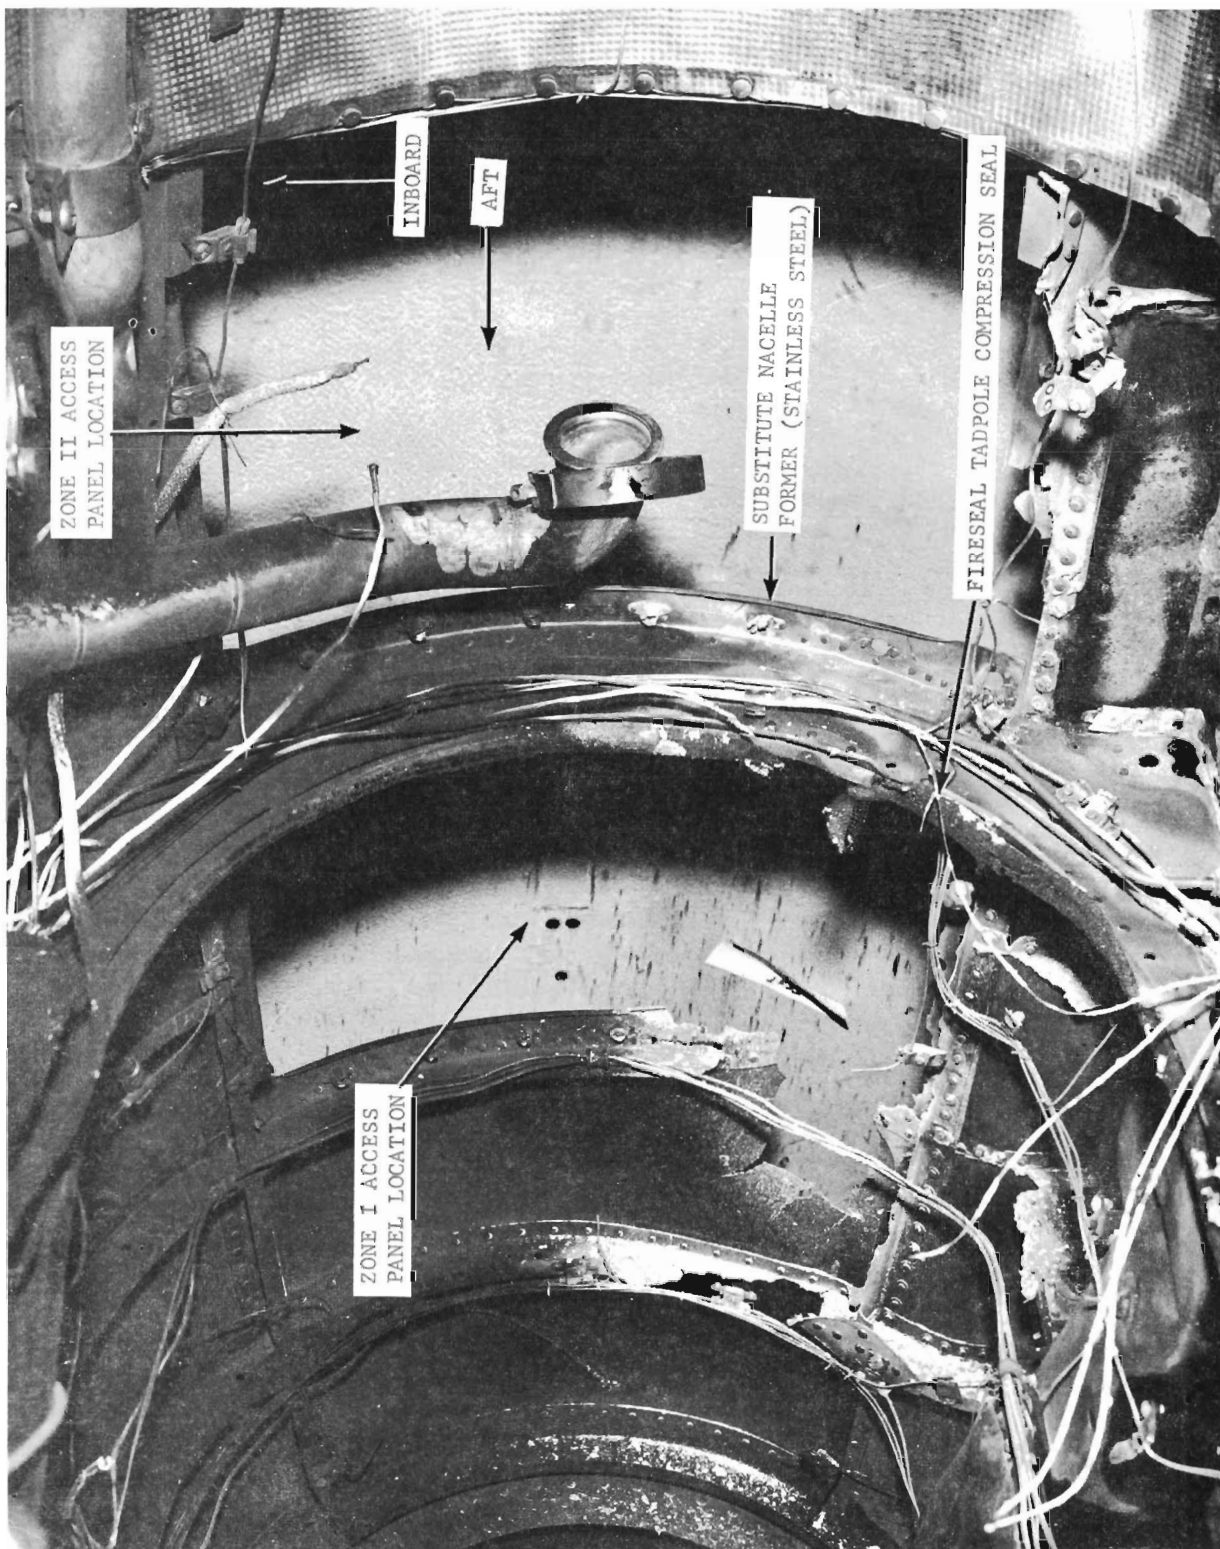
FIG. 24 INTERNAL VIEW OF DAMAGE IN THE TOP OF THE NACELLE FORWARD AND AFT OF THE FIRE SEAL

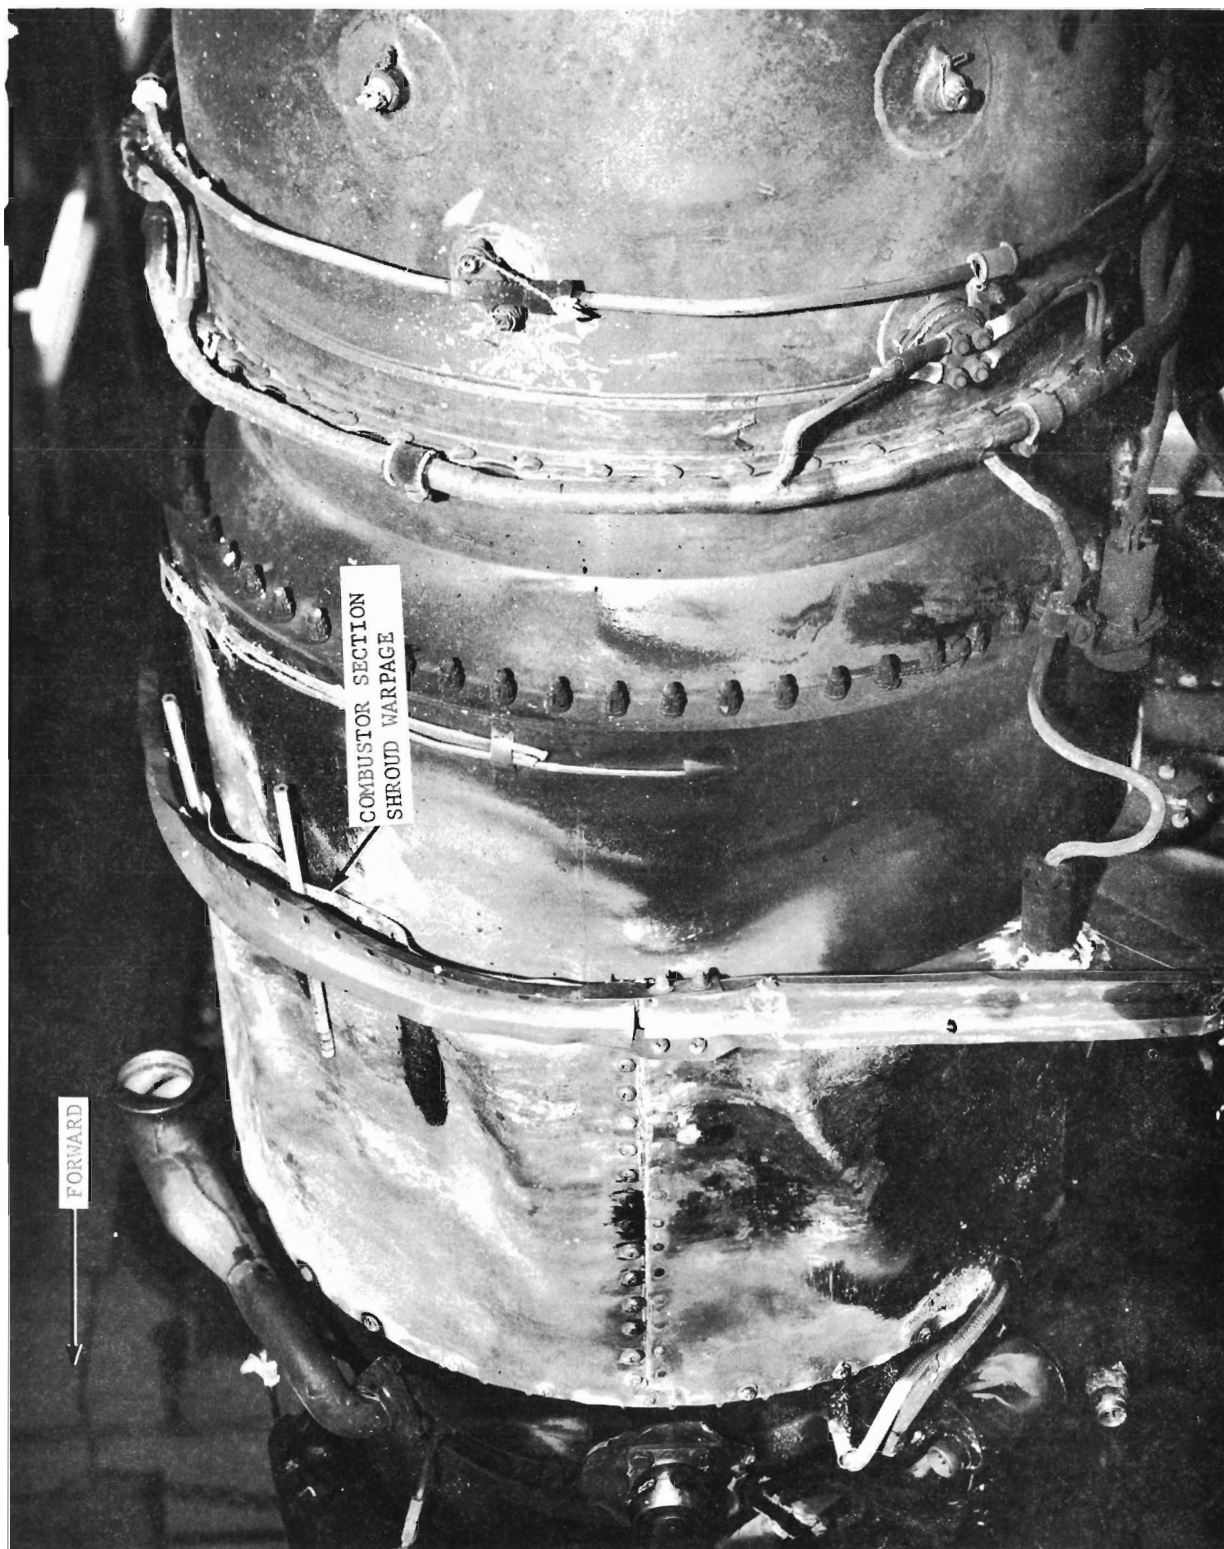
FIG. 25 DAMAGE TO STAINLESS STEEL ENGINE COMBUSTOR SHROUD AND ATTACHED "U" FRAME
