Rebuild of the Cargo MPS Test Article

International Aircraft Systems
Fire Protection Working Group

Presented to: IASFPWG Meeting

Date: Oct 31, 2018

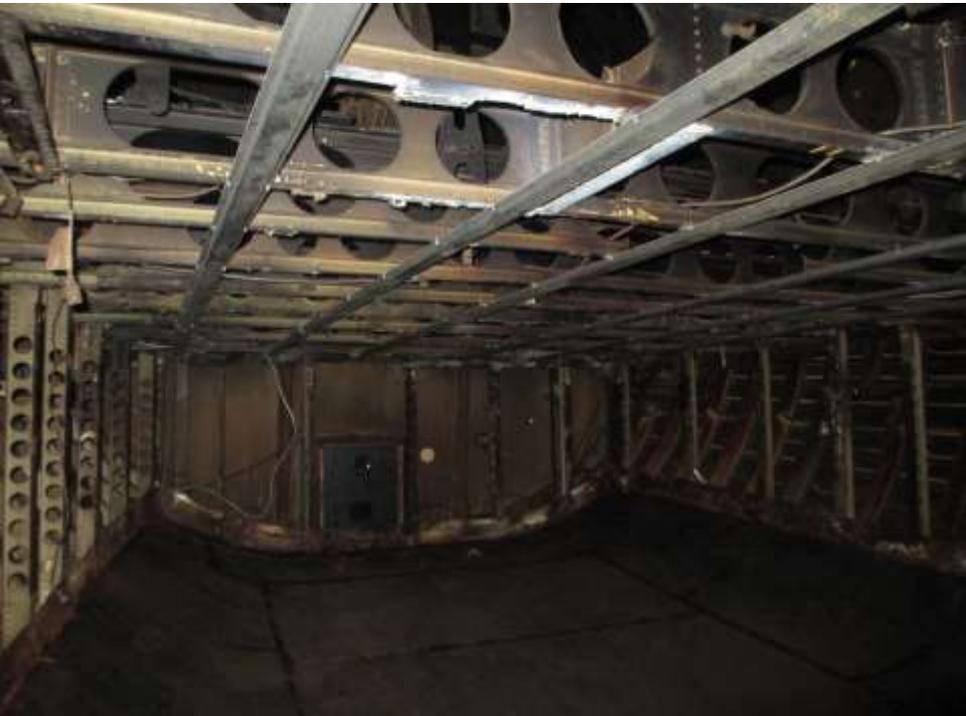
AFT Compartment

Gutting and Framework

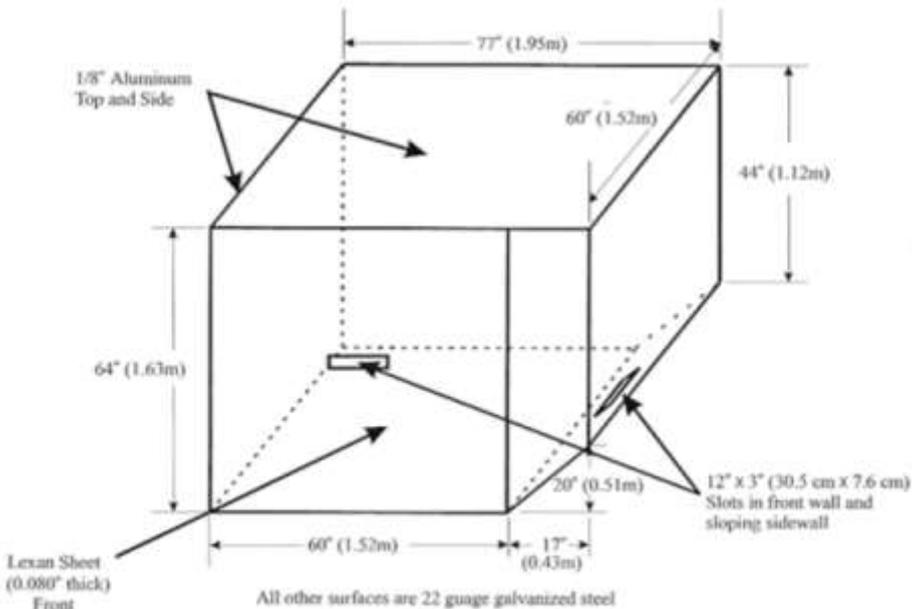
- Galvanized steel used on 5 faces of the LD3 container.
- Concerns of toxic zinc fumes when temperatures reach above 392°F

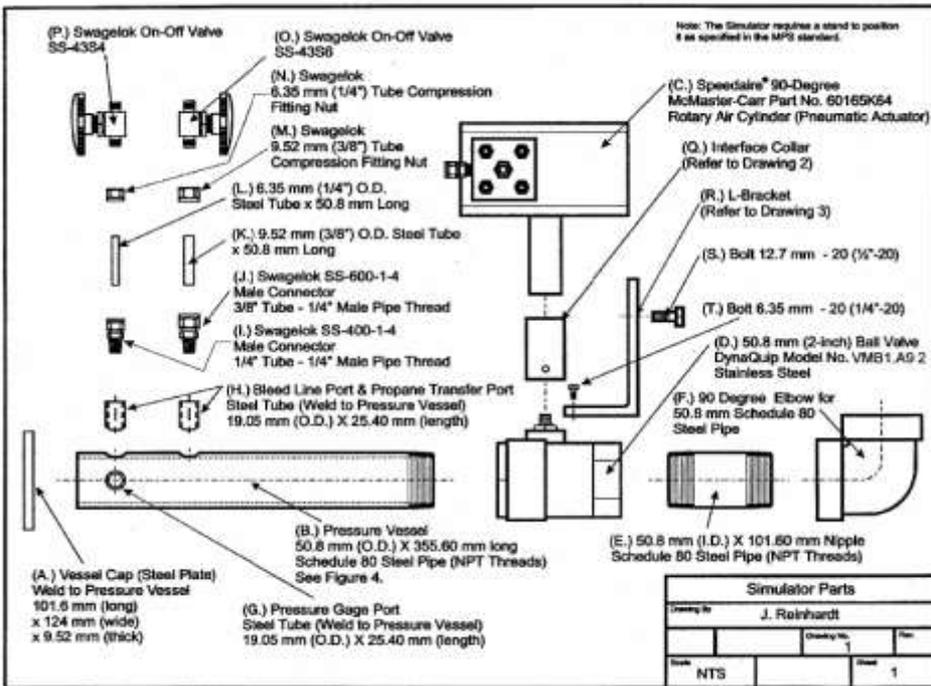
- Ball valve specification to be capable of opening in less than 0.1 seconds.
- The pneumatic actuator specified in the MPS is not capable of opening the ball valve at that rate.
