Investigation of Accidental DC-7 Fire Damage Occurring June 28, 1989

DOT/FAA/CT-TN89/55

U.S. Department of Transportation
Federal Aviation Administration

Technical Center
Atlantic City International Airport, N.J. 08405

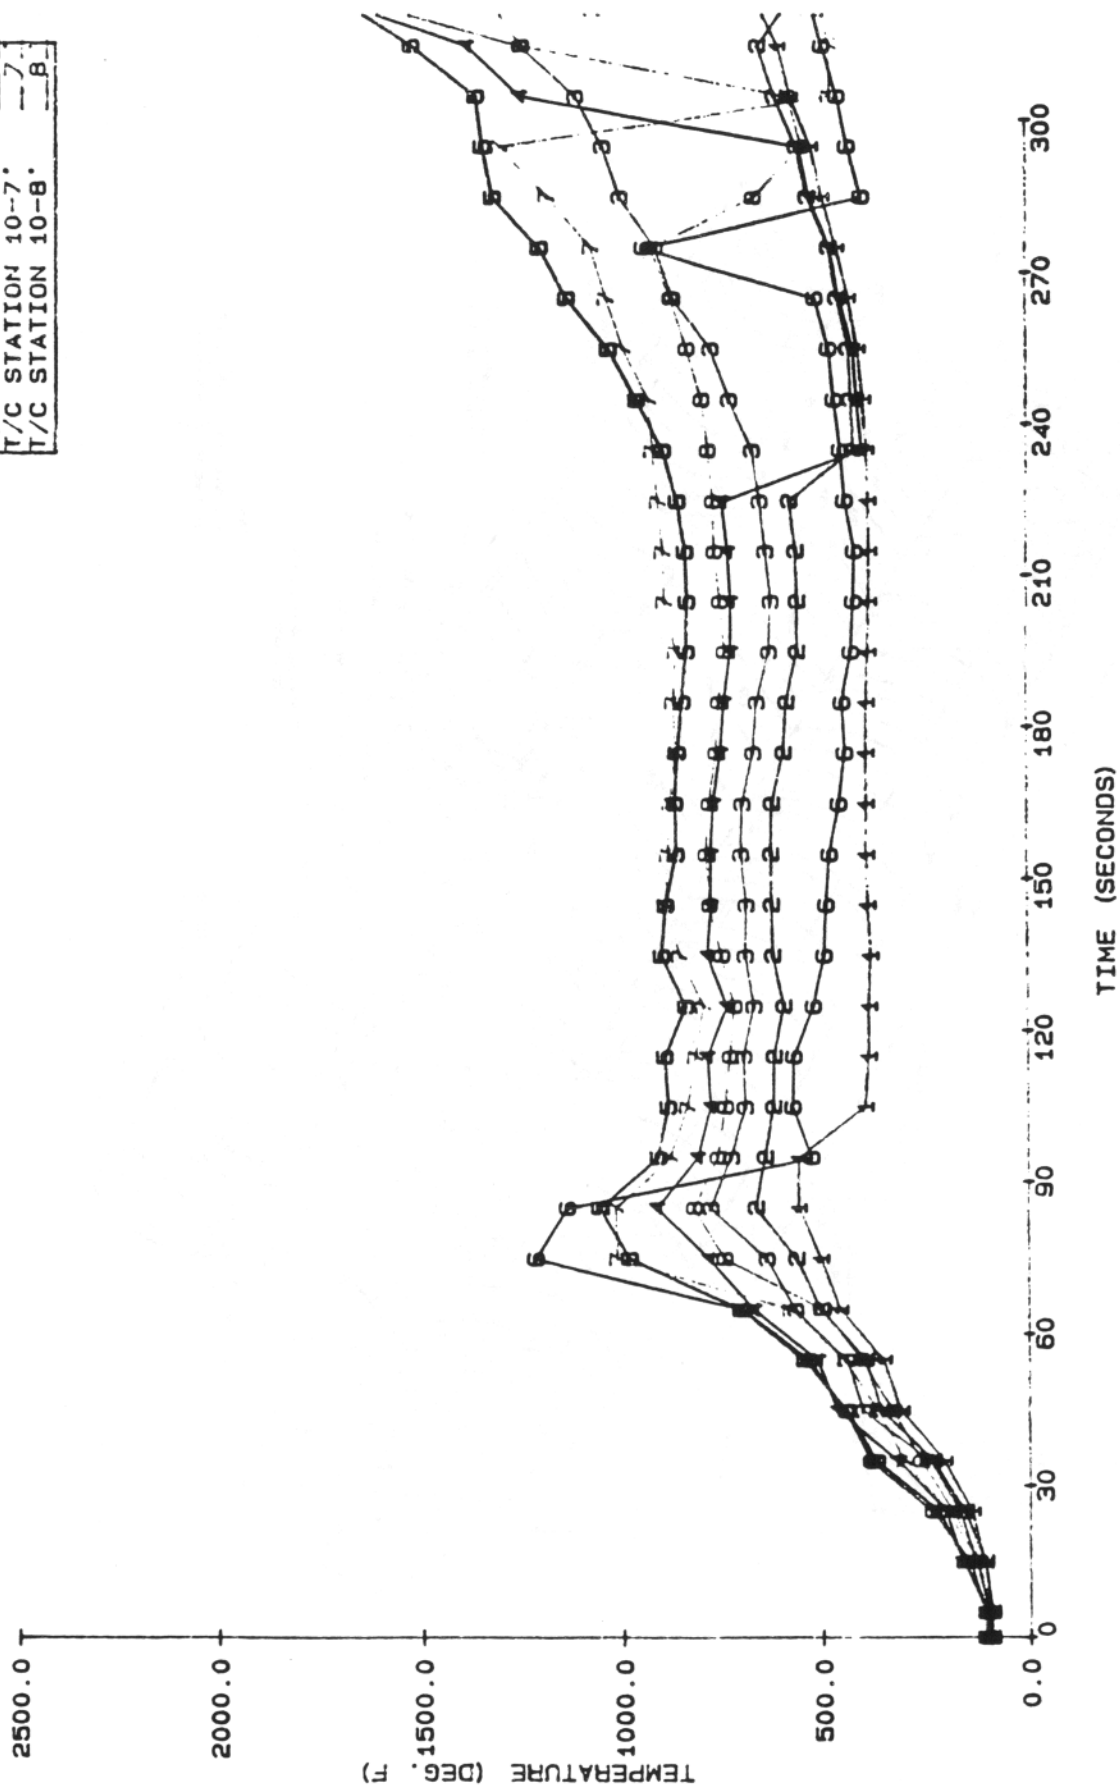
Temperature and Gas Environment. From figures 3 through 7, it should be noted that the temperatures within the cabin reached extremely high levels with the maximum indicated at close to 2000 degrees at 90 seconds into the test at

FIGURE 3. TEMPERATURES AT STATION 10 DURING TEST

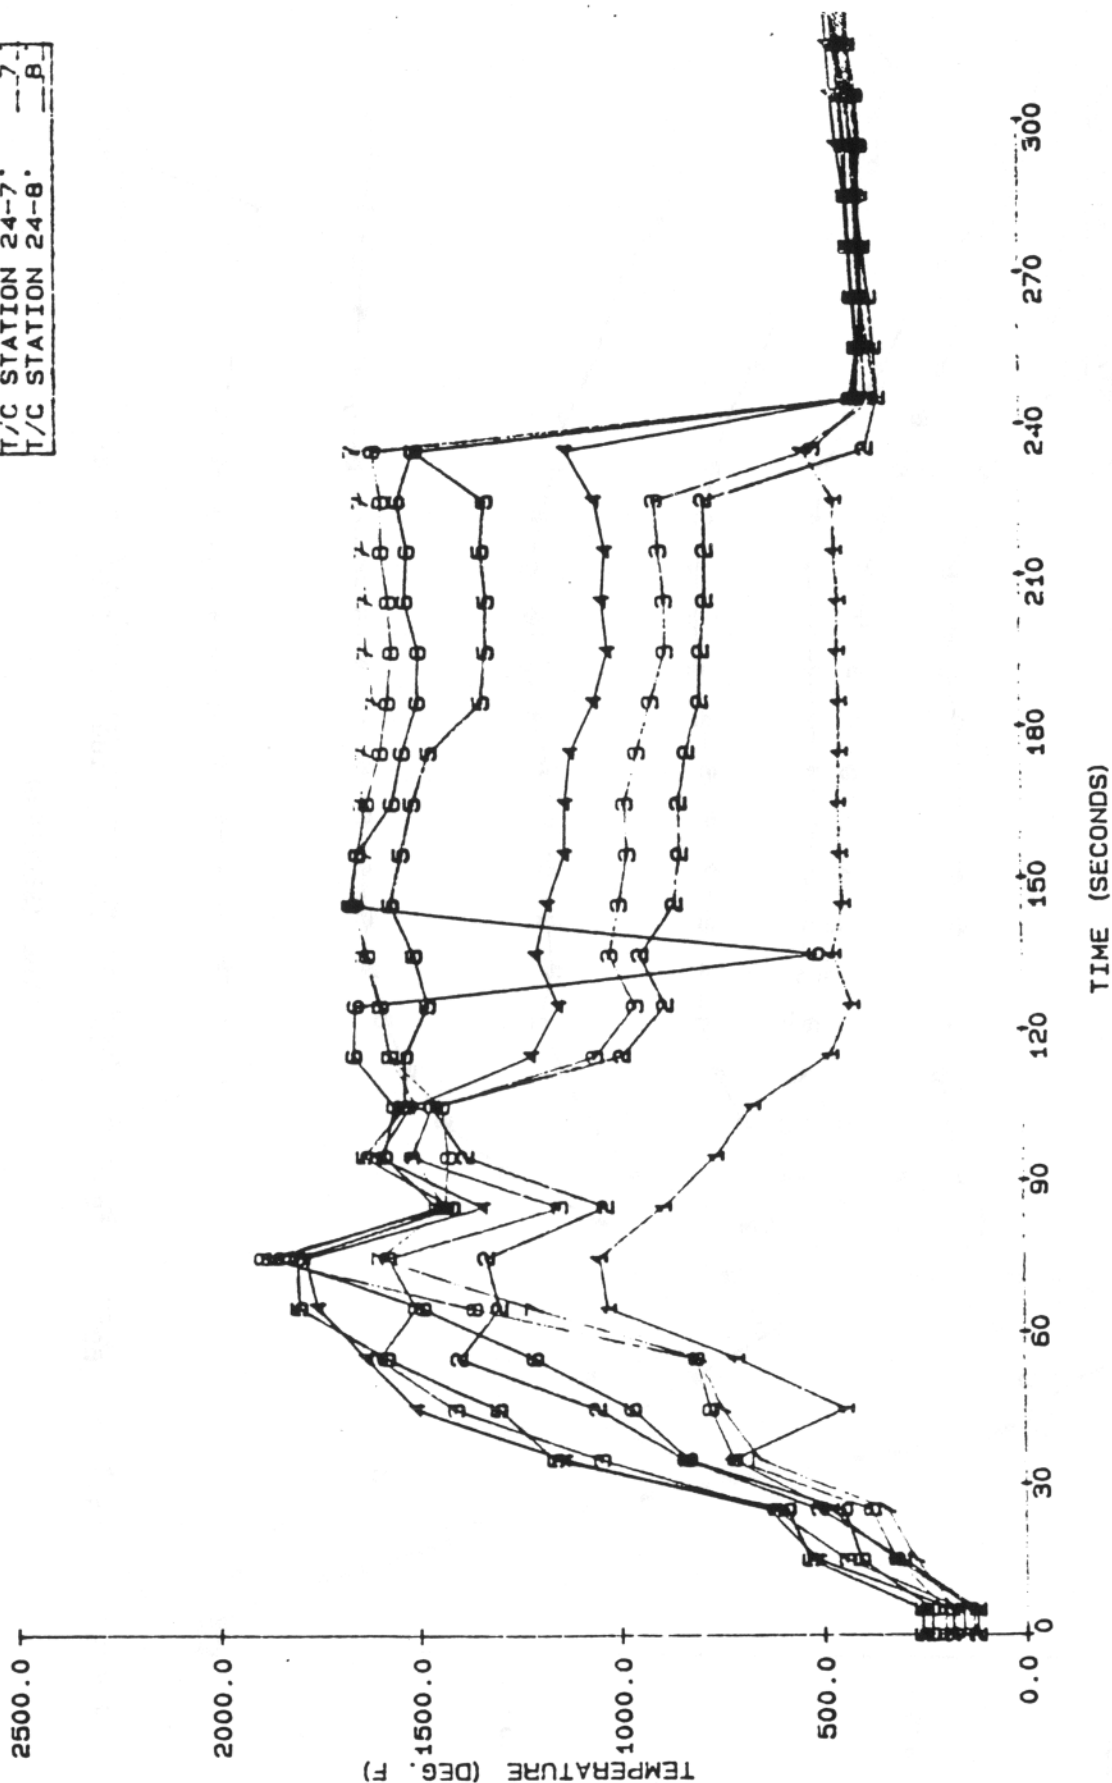
station 24. Once the peak temperature was reached, the subsequent temperatures remained between 1000 and 1500 degrees at the upper thermocouple locations.

FIGURE 4. TEMPERATURES AT STATION 24 DURING TEST

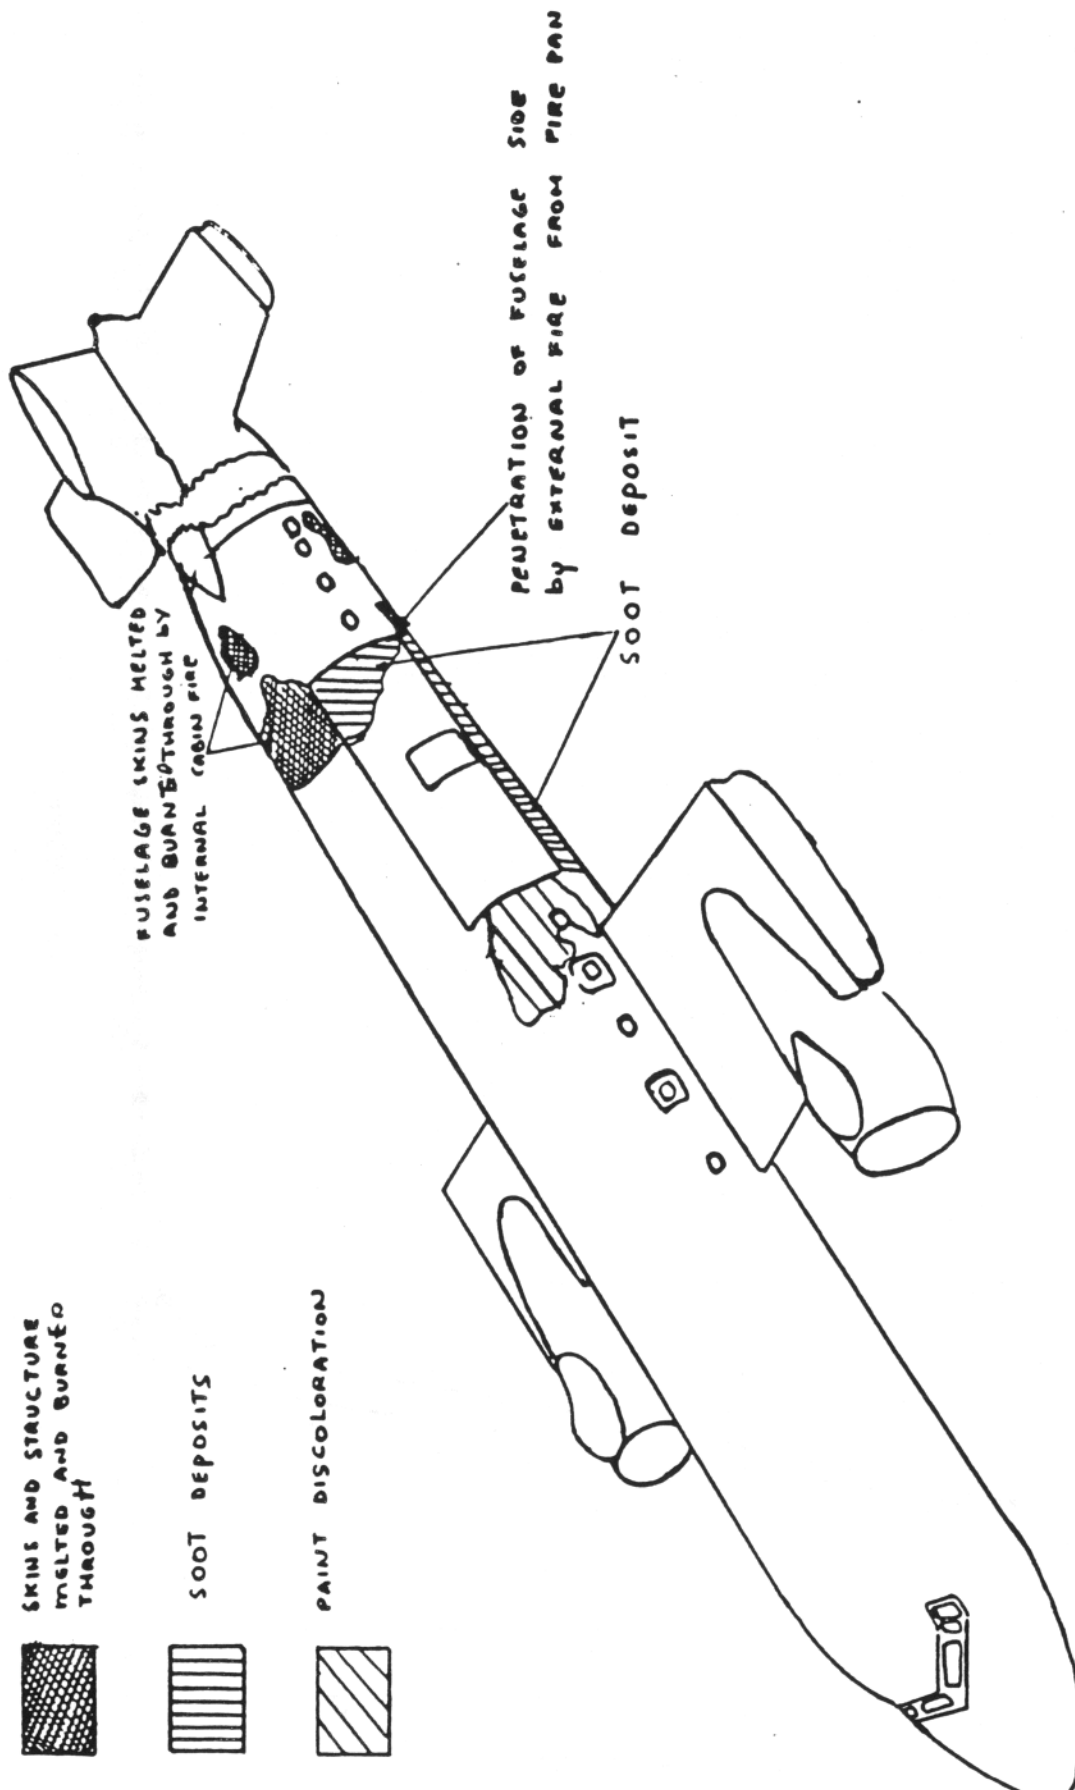
External Fuselage. The upper fuselage cabin area aft of the passenger entry door was heavily damaged by fire. The empennage and tail cone separated from the aircraft at the pressure bulkhead, except for a portion of the belly skin. A 6-foot section of the fuselage extending aft from the pressure bulkhead to the leading edge of the horizontal stabilizer was completely destroyed except for the belly section located under the plywood floor. There were three holes in the fuselage into the cargo compartment area (figure 21).

FIGURE 21. PRINCIPAL FIRE DAMAGE

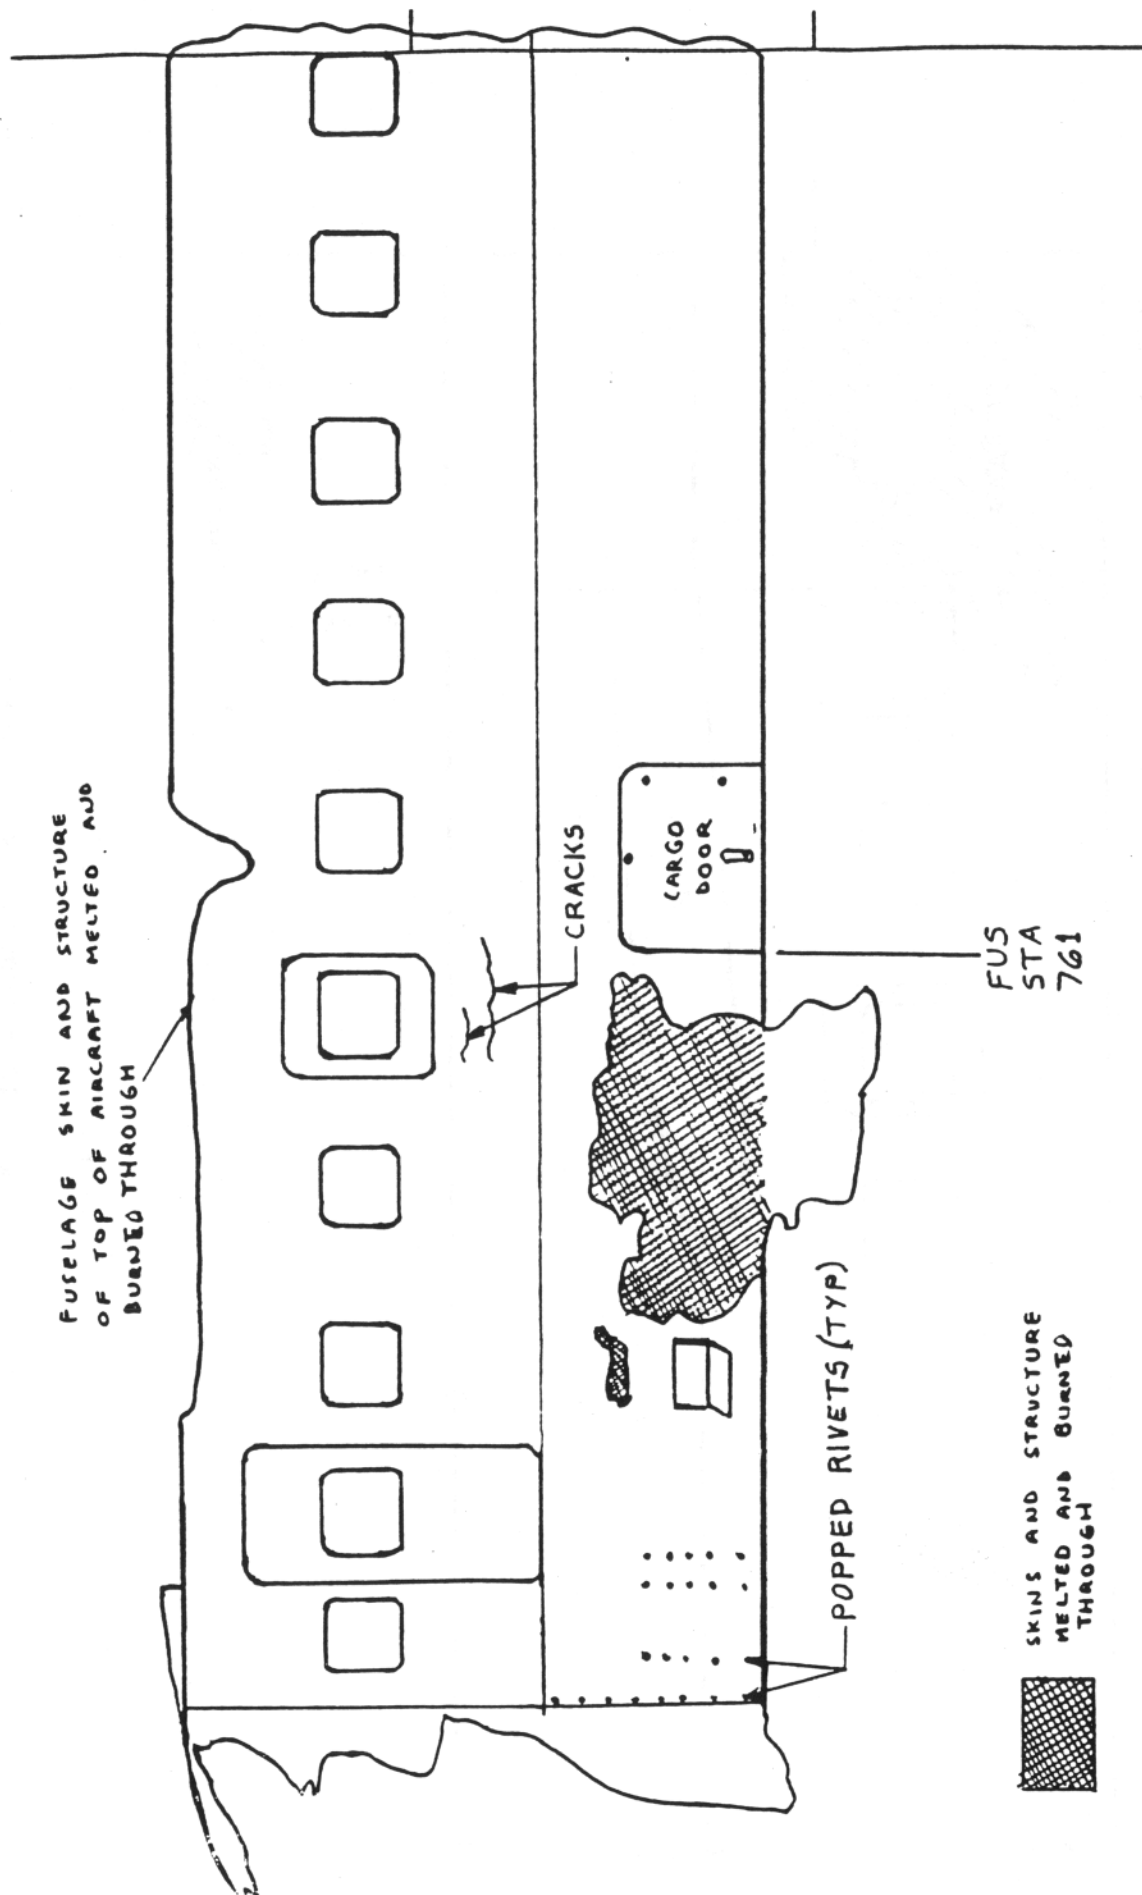
Starboard Side. The skin rivets at station 946 were melted out or the skin had pulled through the rivet heads on the starboard side from the floor level to the center of the belly (figure 22).

There was a horizontal crack on the starboard side, 14 inches below the emergency exit (station 935), approximately 6 inches long. A second crack was 16 inches long, 2 inches lower and extended forward of the first crack.

There was a hole, 20 inches long by 7 inches high, on the starboard side at station 916, 48 inches below the bottom of the window.

There was a large hole, 67 inches wide by 60 inches long located aft of the cargo door (station 800-867). A portion of the fuselage skin was still attached, bent out and downward.

FIGURE 22. VIEW OF STARBOARD SIDE DAMAGE

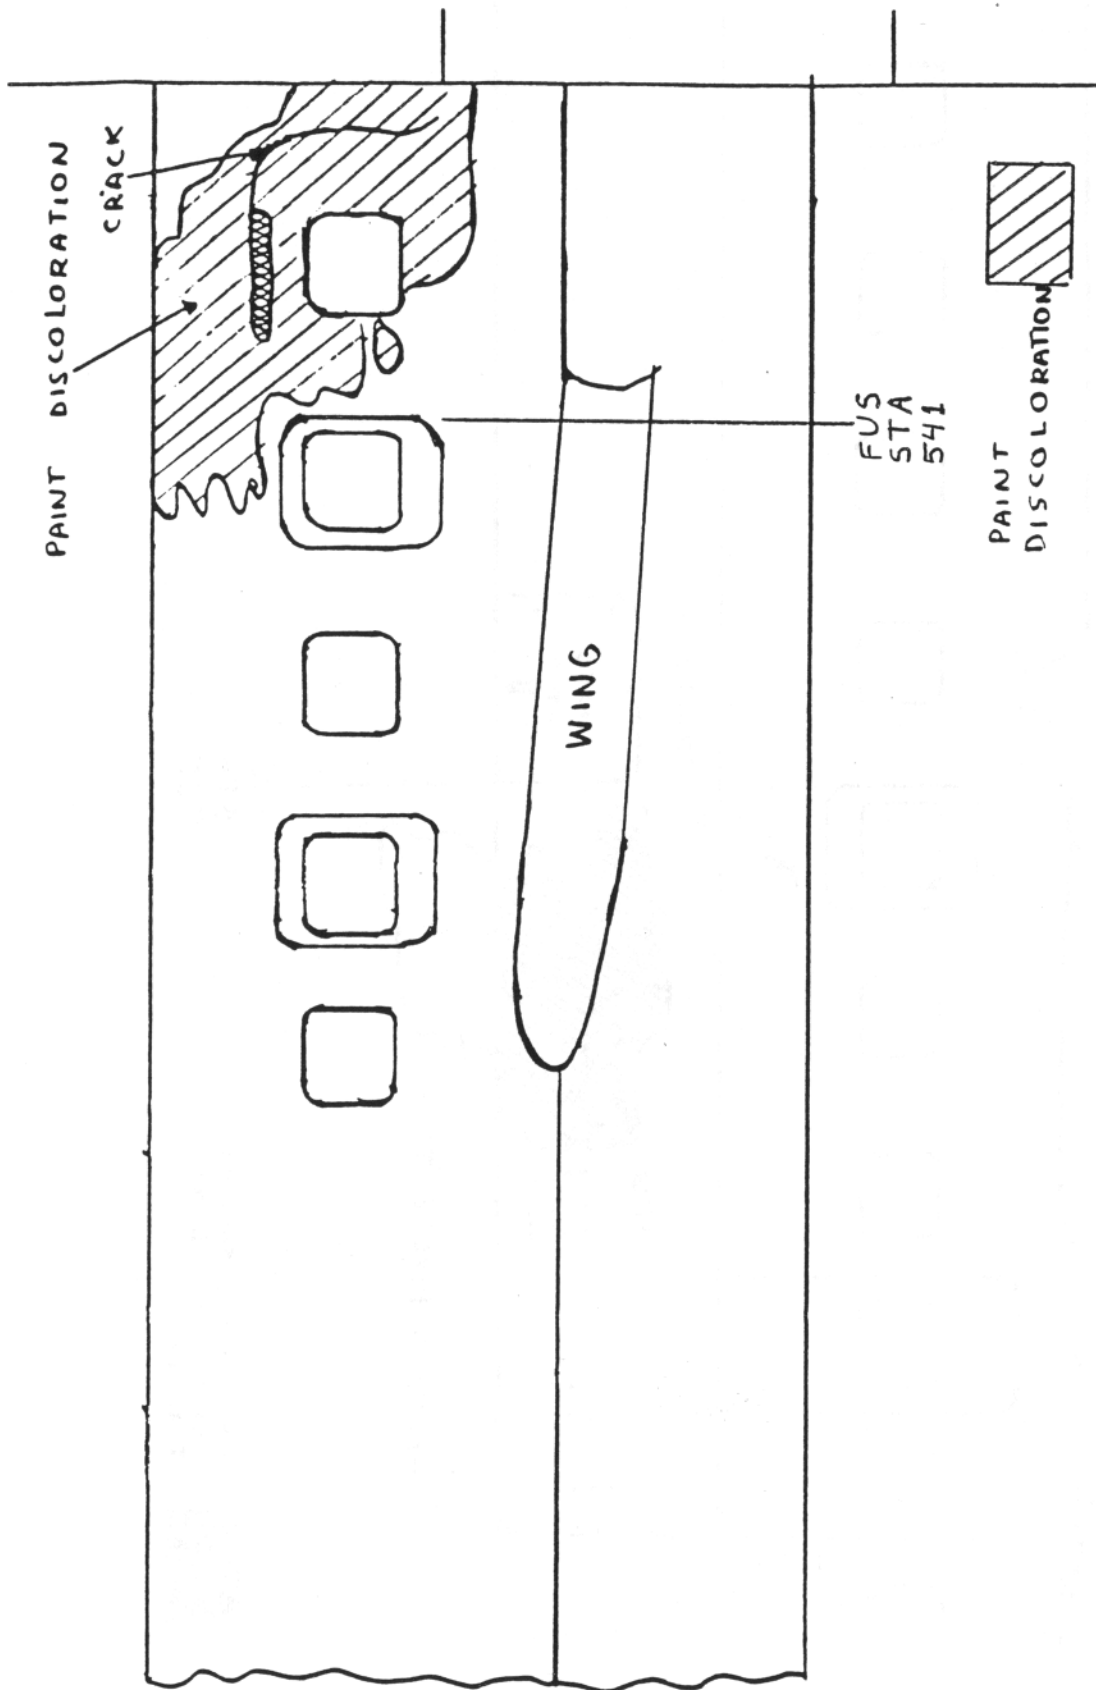
Port Side. Below the horizontal stabilizer, on the port side, there was some sooting of the skin and an area of blistered paint. There were two horizontal cracks and bulged and blistered skin toward the bottom of this area (figures 23 and 24).

There was a large hole, 55 inches long by 6 inches high, located just aft and below the protective steel fire hardening on the port side (station 807-862). The damaged aluminum skin in this area was deflected in towards the interior of the aircraft. The soot on the fire hardening around the passenger entry door was burned off, trailing downward and below the fire pan. This "burned clean" area continued down the fuselage across the hole.

FIGURE 23. VIEW OF PORT SIDE DAMAGE (FORWARD)

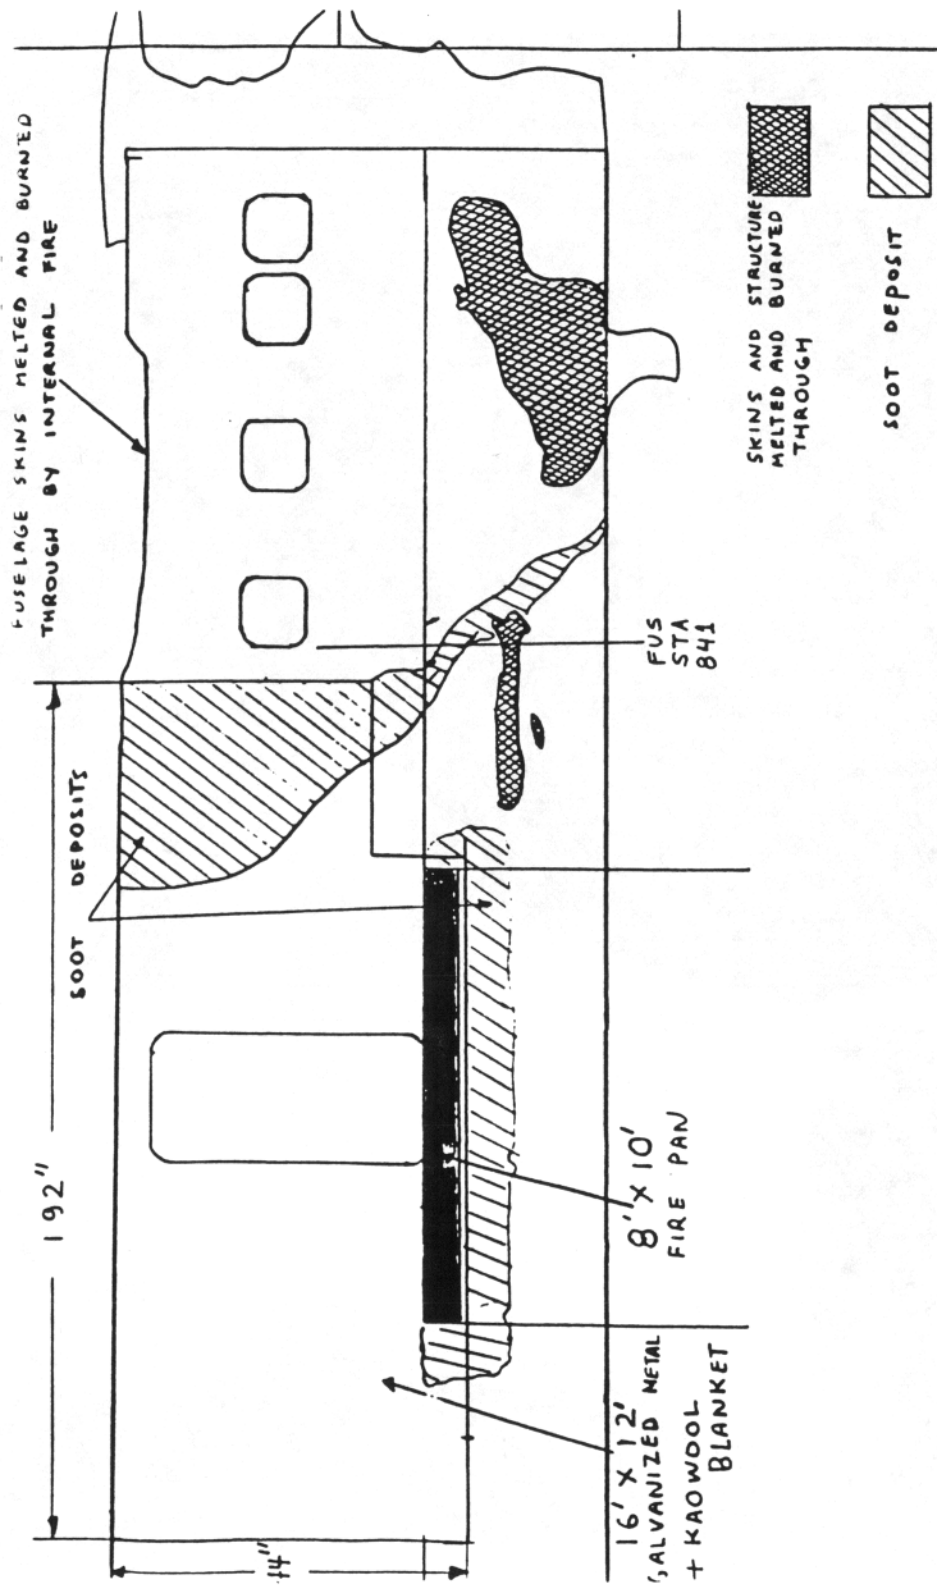
There was a large hole, 55 inches long by 20 inches high, located on the port side, 40 inches below the bottom of the windows extending from station 911 to 966. The skin around the hole had sagged and bent downward.

FIGURE 24. VIEW OF PORT SIDE DAMAGE (AFT)

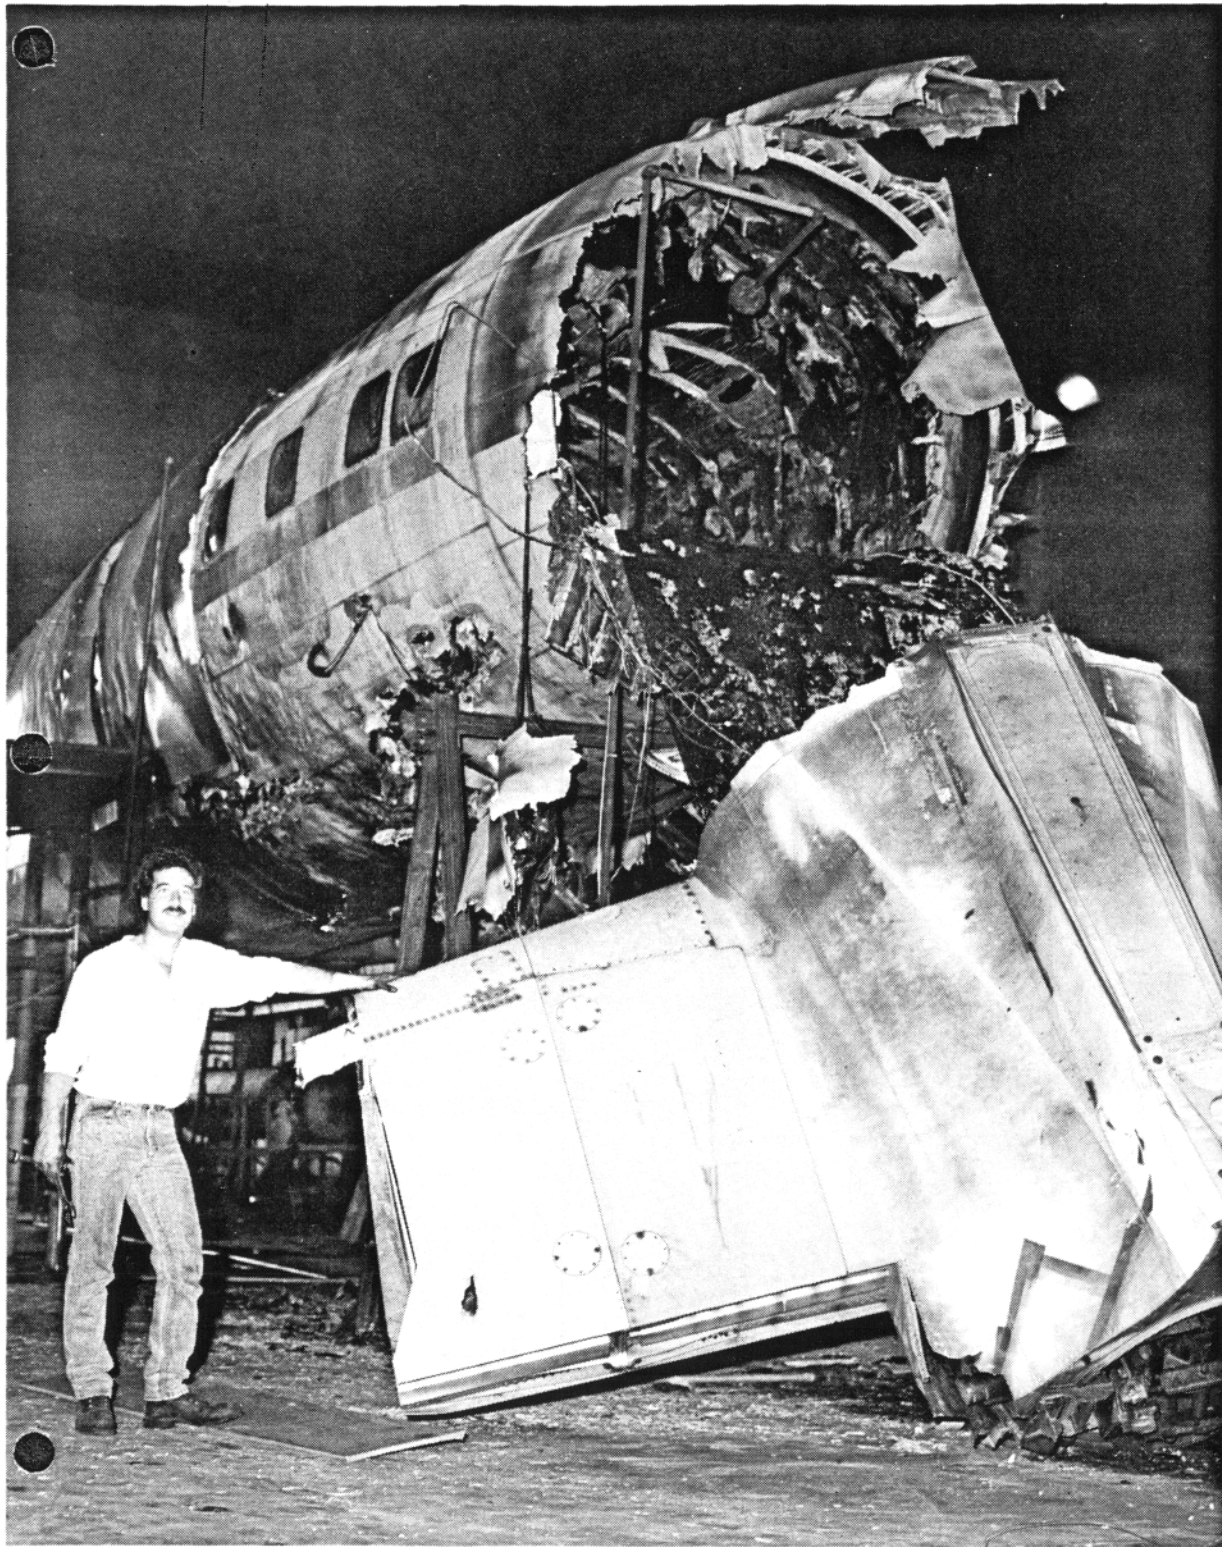
There were two large holes through the cabin ceiling. The forward hole extended from station 800 to 884, 3 feet wide and 7 feet long. Aft of this hole and continuing to the end of the fuselage was a second hole, 7 feet wide and 9 feet long (station 870 to 978). An overall view of the damage to the aircraft was presented in figure 25, a view looking forward from behind the aircraft.

FIGURE 25. AIRCRAFT AFTER FIRE WAS EXTINGUISHED
