Paper Reprinted from  
Conference Proceedings No.467 - 1

**AIRCRAFT FIRE SAFETY**

**INVESTIGATION AND CHARACTERISTICS OF MAJOR  
FIRE-RELATED ACCIDENTS IN CIVIL AIR TRANSPORTS  
OVER THE PAST TEN YEARS**

Richard G. Hill  
Fire Safety Branch  
Federal Aviation Administration Technical Center  
Atlantic City International Airport, NJ 08405  
U.S.A.

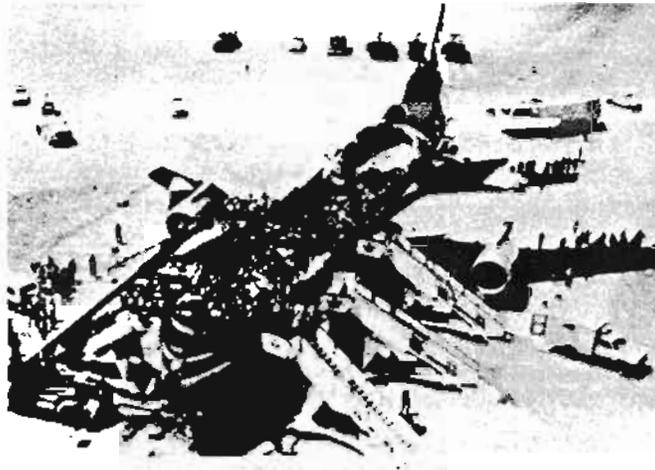
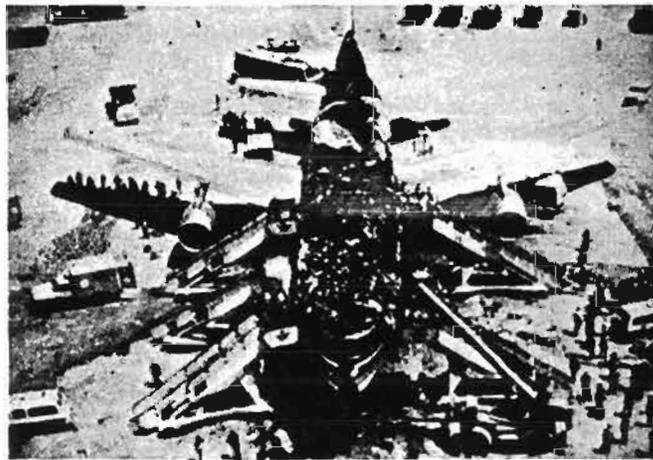
In August of 1980, a Saudia L-1011 experienced an in-flight fire. A short time after takeoff from Riyadh, a cargo fire warning light activated in the cockpit. After the crew experienced some problems in determining the proper procedures, the aircraft returned to Riyadh. The voice recorder indicated an uncontrolled fire in the rear of the aircraft prior to touchdown. The aircraft did not stop on the runway, however, it ran the full length and turned onto the taxiway before stopping (figures 1 and 2). The investigation concluded that "the probable cause of the accident was the initiation of fire in the C-3 cargo compartment. The source of the ignition of the fire is undetermined" (4).

The fire in the cargo compartment had burned through the cargo liner and impinged on the cabin floor, fanning out between the cargo compartment ceiling and the cabin floor. The heat melted the pulleys for the number two throttle cable. Oxygen was consumed in the cargo compartment and the fire subsided in the compartment. As the pulleys cooled, the plastic hardened and the number two engine throttle stuck. Air was then drawn into the compartment through the hole as it cooled, until the flames began again. This time the fire entered the cabin through the floor. Passengers in the aft section were moved forward in the cabin. Flight attendants fought the fire with handheld extinguishers. The fire cycled from flaming to smoldering a number of times.

**Figure 1. Saudi L-1011 parked on taxiway.**

**Figure 2. Saudi L-1011 as seen from overhead.**

This accident led to rule changes in the area of cargo compartment fire protection (7). Tests showed that had the seats been fire blocked, they could have stopped the spread of fire from the cargo area to the cabin and prevented the flash fire.

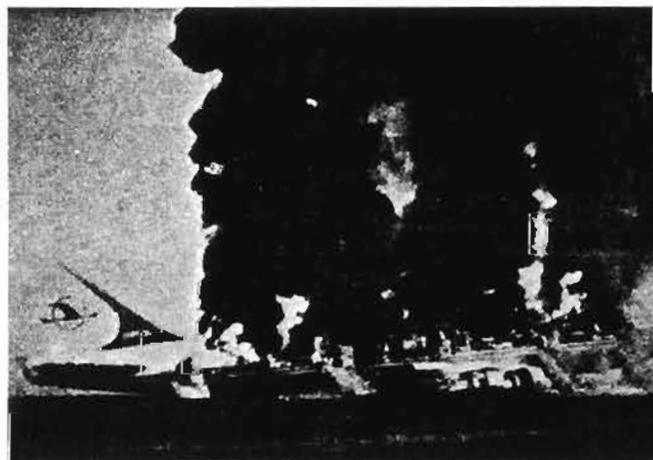
A Korean Airlines 747 landed short of the runway at Seoul, Korea, causing the main landing gear to collapse into the cargo compartment aft of the gear. The aircraft slid approximately 7,000 feet down the runway before stopping. A fire began in the ruptured cargo compartment from sparks igniting the strut fluid and cargo in the compartment. As the aircraft came to a stop, the fire spread up into the cabin through the air grills and through ruptured cargo liners and the cabin floor. Of the 208 passengers and 18 crew members, 15 (9 passengers and 6 crew members) did not survive (figure 3).

The important fact concerning this accident was that there was no jet fuel involvement in the fire (the tanks remained intact). The major contribution to survivability was from the burning of the interior materials. This accident changed the minds of many people who believed that the fuel fire dominated the fire hazards in all aircraft accidents and that material improvements would not substantially improve aircraft safety.

**Figure 3. Korean Airlines 747 approximately 5 minutes after coming to rest.**

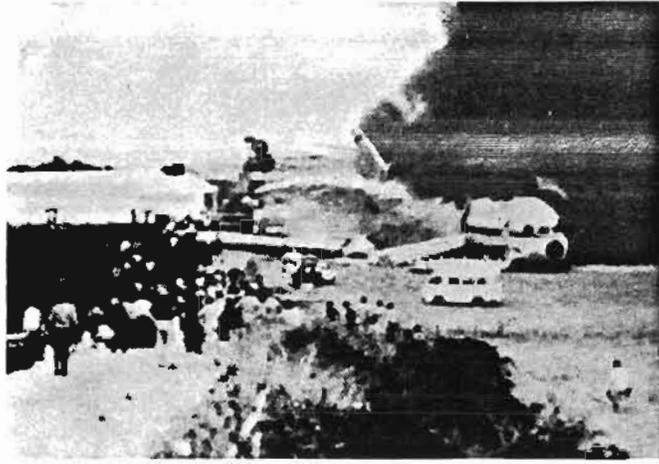
A Spantax DC-10 aborted a takeoff and overran the runway in Malaga, Spain, stopping in a field just off the airport. The right wing was torn off the aircraft and a large fuel fire encompassed the aft end of the fuselage (aft of the wings). The fire entered the cabin in the aft areas through tears in the fuselage and burnthrough of the skin. There were 51 fatalities out of the 393 occupants.

This accident pointed out the problems of evacuation. Evacuation was slowed by debris in the aisles and some passengers failed to begin evacuation because of emotional trauma. The fire burned into the cabin in a very rapid manner. This accident also pointed out the problem that the crash fire rescue crews have in extinguishing a cabin fire. Photographs (figure 4) show that the fuselage was almost fully intact when the first trucks arrived and extinguished the external fire; however, the fire in the cabin almost totally consumed the fuselage before it was extinguished.

**Figure 4. Spantax DC-10 on fire (photo by passanger).**

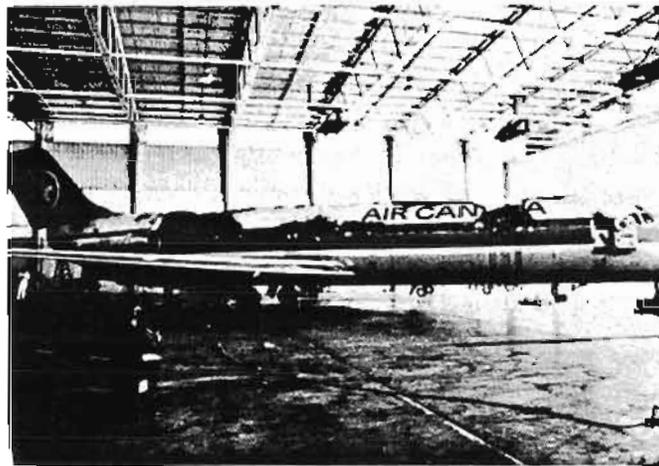
An Air Canada DC-9 experienced an in-flight fire in the area of the left aft lavatory. The fire produced heavy smoke in-flight and progressed very rapidly after the aircraft landed. Twenty-three of the forty-six occupants were able to egress before a flash fire occurred (figure 5).

**Figure 5. Right side view of Air Canada DC-9 after in-flight fire.**

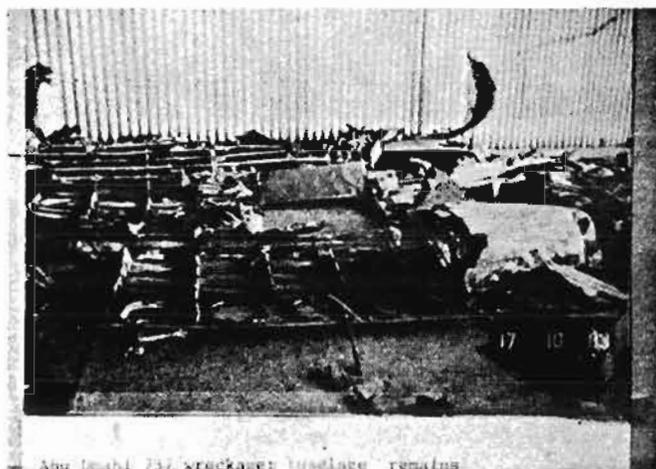
A Gulf Air 737 experienced an in-flight fire probably caused by an incendiary device exploding in the forward cargo compartment. The pressure from the explosion, although not rupturing the pressure vessel, did dislodge cargo lines, thus destroying the integrity of the class "D" compartment. The fire spread to the cabin and caused the aircraft to crash into the desert killing all on board (figures 8 and 9).

**Figure 8. Remains of Gulf Air 737.**

**Figure 9. Remains of Gulf Air 737.**

Testing indicated that a detection and suppression system, that is, as required in a class "C" cargo compartment design, could possibly contain (extinguish) some types of incendiary devices. This testwork raises the question of to what level of fire threat an aircraft should be designed.

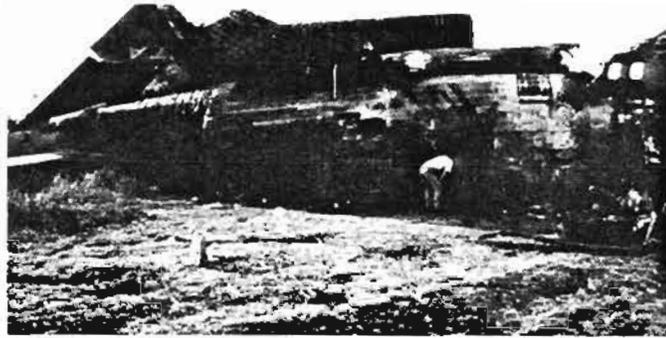
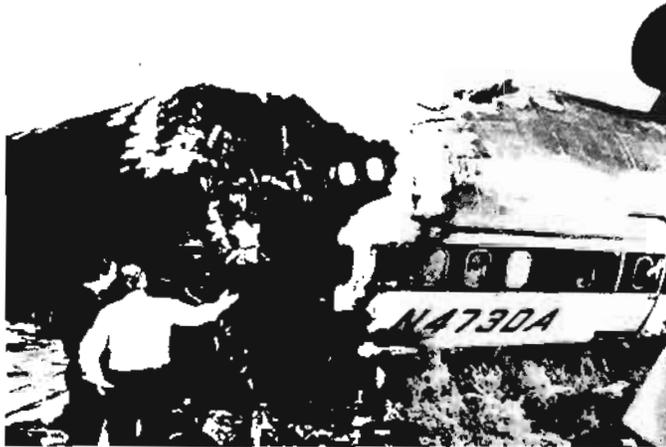
A Delta Airlines 727 crashed on takeoff from the Dallas/Fort Worth Airport. The aircraft suffered severe structural damage as it slid to a stop approximately 3,000 feet from the end of the runway. The right wing was ripped from the fuselage, causing a large fuel spill; and the aft two cargo doors opened and a large section of the fuselage above and forward of the main aft cargo door was torn away. A large circumferential break also occurred just aft of the cockpit. A large fuel fire separated the aft section from the rest of the fuselage at the aft break. All but two of the fatalities were trapped in the aft section. The doors in that area could not be opened from inside because of the angle at which that portion of the fuselage was resting (figures 10 and 11). The evacuation in the forward portion of the cabin was through breaks in the fuselage and the two left over-wing exits. It was estimated that evacuation time from aircraft stop, until the last passenger was out, was 4 minutes and 20 seconds. This was based on recorded crash/fire crews response time, and that the last survivors exited the aircraft as the first truck began fire-fighting. There were two passengers in the forward cabin that succumbed to the effects of the fire.

This accident is of extreme interest since it was the first survivable accident involving fire since the implementation of the floor proximity and fire blocking rules. Initial indications from passenger interviews were that no one utilized the floor lighting in the egress of the aircraft. That could be expected since the accident occurred during daylight and large breaks in the fuselage provided visible means out of the aircraft. From visible remains of the cabin materials and passenger accounts of the evacuation, it could be concluded that fire blocking on the seats did extend the survival time in the forward portion of the cabin. Although an exact additional escape time or added number of survivors that could be attributed to fire blocking cannot be determined, an estimate utilizing past test data was made. The estimate of additional time is based on figure 12, taken from reference 5, which shows curves of survival time versus fire threat for blocked and unblocked seats. If we find the point on the blocked curve equating to 4 minutes 20 seconds, and then find the survival time on the unblocked curve for the same fire threat, the time equals 2 minutes and 50 seconds. Therefore, using this method, an estimate of 1 minute and 30 seconds of added survival time was provided in this accident due to the incorporation of fire blocking.

**Figure 10. Aft right side of Delta 727.**

**Figure 11. Aft left side of Delta 727.**

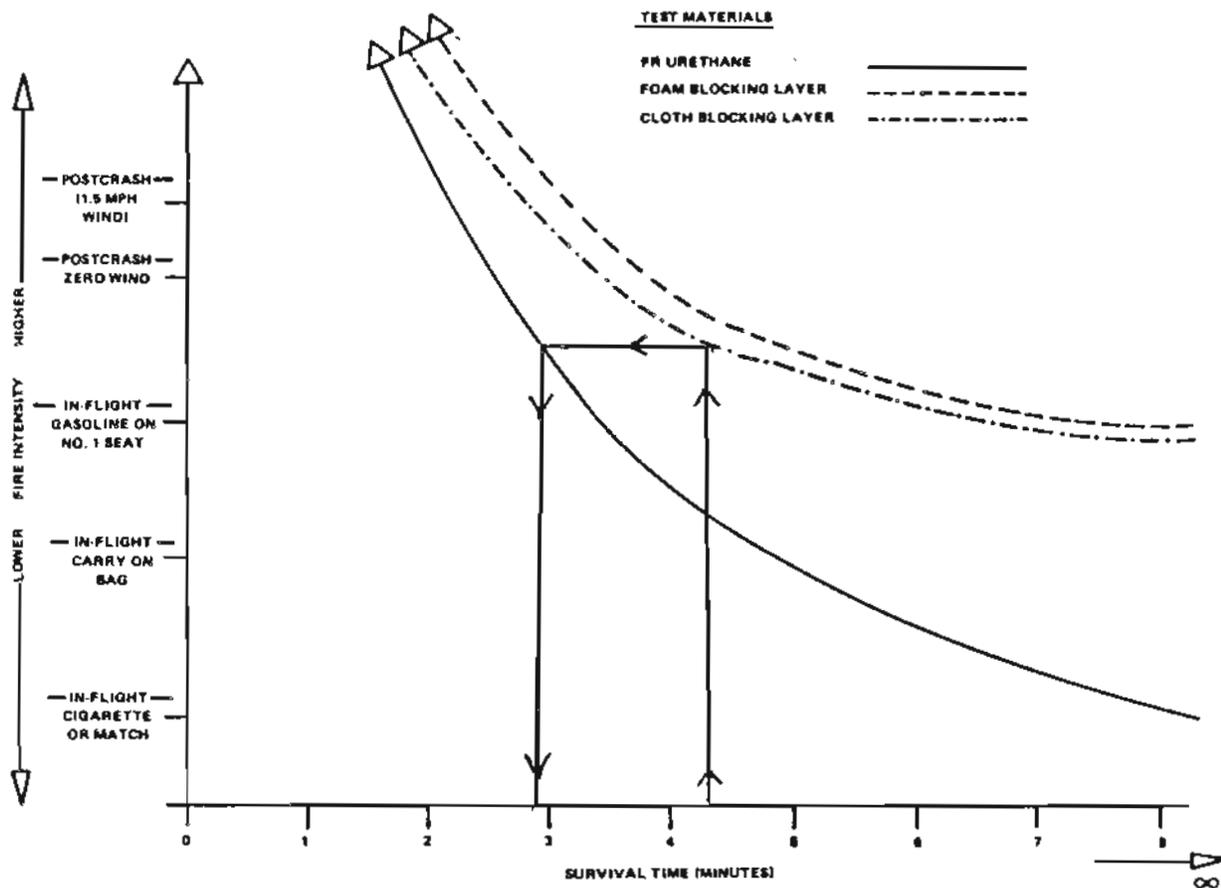
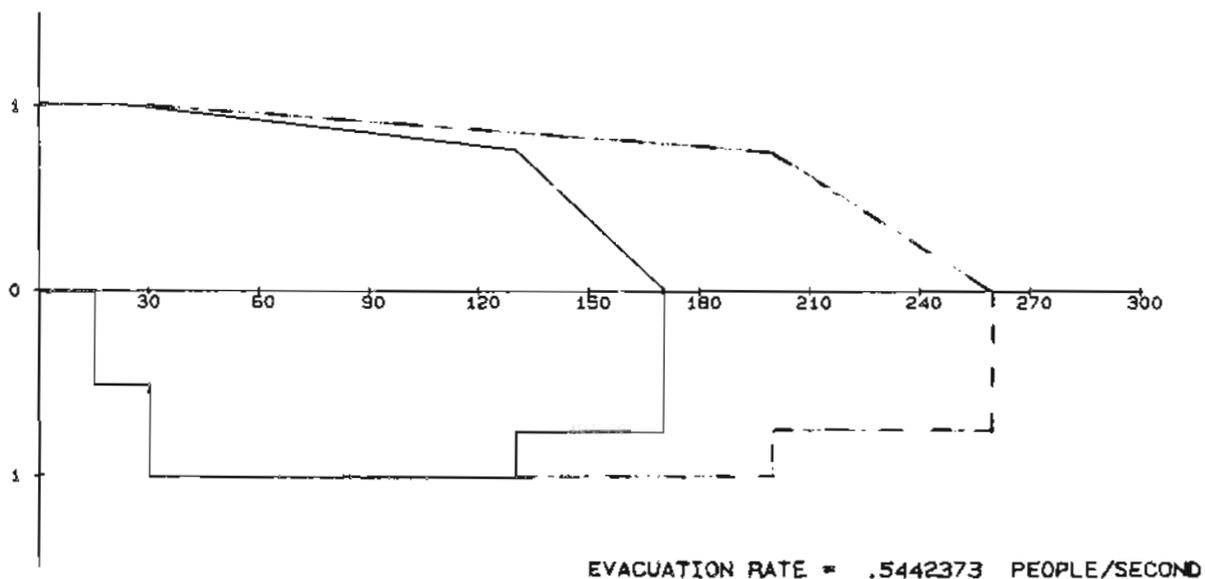
To estimate the number of added survivors we can utilize the model from reference 1. Knowing that the last person exited at about 4 minutes 20 seconds, and because of the breakage in the fuselage and trauma caused by impact, it was estimated that the full evacuation began 30 seconds after stopping, with a few passengers near breaks evacuating in the 15 to 30 second range. Figure 13 shows the curves developed for this accident. The same figure also shows the curves developed under the assumption of no fire blocking (using an evacuation time of 2 minutes 50 seconds). In that case, the total survivors would have been 57. Therefore, the calculated number of lives saved due to fire blocking was 37.

Figure 12. Calculation of added evacuation time due to the use of fire blocked seats.

Figure 13. Calculation of added survivors due to the use of fire blocked seats.

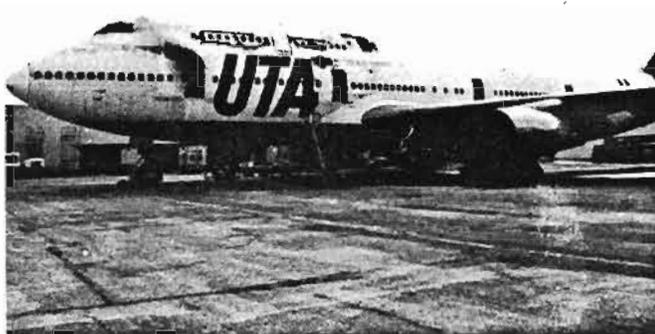
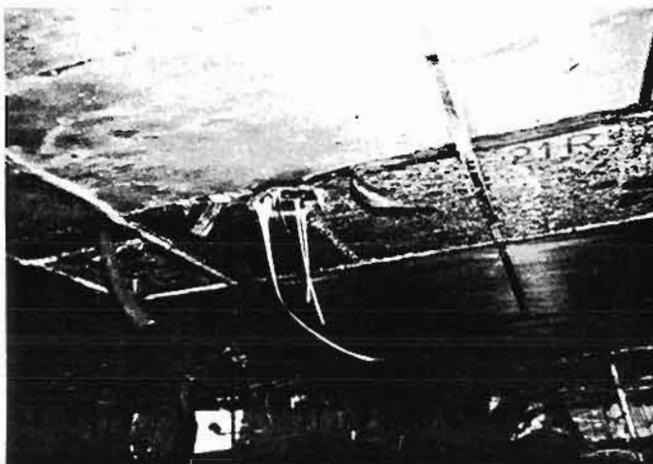
A fire ignited in the lower area of the forward cargo compartment of a UTA 747 as maintenance personnel were cleaning rollers and track in that compartment. The cleaners had some rags and cleaning solvent in the compartment at the time. The maintenance personnel tried to fight the fire and notified CFR. The fire spread rapidly around the cargo liners and up into the cabin. The oxygen system was breached causing a localized, high intensity fire. By the time the fire was extinguished by the CFR, both the main deck and upper deck cabins had been gutted by fire (figures 14, 15, and 16).

Figure 14. Outside view of UTA 747 after ramp fire.

Figure 15. Cargo ceiling with fixtures, UTA 747.

Figure 16. Upper deck view of UTA 747.

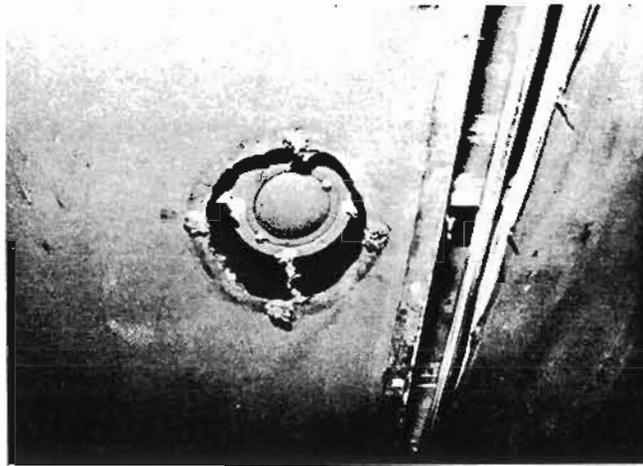
Investigators found that the fire in the cargo compartment destroyed many seams, joints, and fastening systems allowing liners to fall and provide paths of fire egress from the compartment (figure 17). The fire also spread up around the bottom cargo liner seal on the thermal insulations' outer covering. Flames entered into the cabin through the floor grills in the passenger cabin.

**Figure 17. UTA 747 cargo light fixture failure.**

This incident was a major force in including seams, joints, and fasteners in the new testing requirements for class "C" and "D" compartments. The requirement for cargo lining material on the lower sidewall of the cargo compartment was also an outgrowth of this incident.

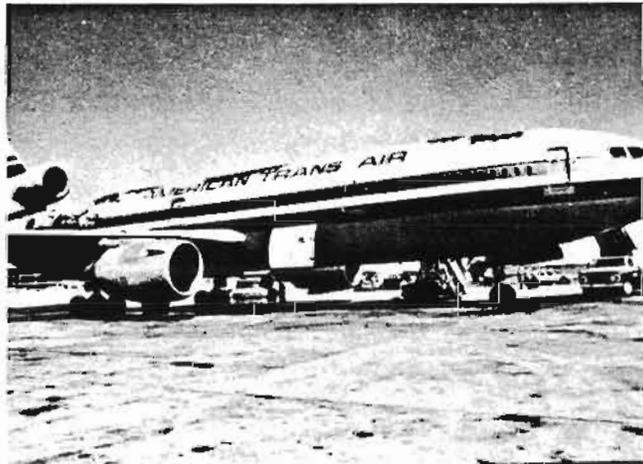
A fire ignited in the forward cargo compartment of a DC-10 as cleaners were servicing the cabin area. The fire was started in a container by an activated solid oxygen generator (the generator had accidentally been activated by a mechanic who a few minutes prior to the fire had entered the compartment and container in search of a replacement seat back) in contact with some bubble plastic wrap. The fire spread quickly, with seams, joints, and fastening systems failing, causing cargo liners to fall and the fire to gain access to the cabin area through the floor. By the time the CFR personnel extinguished the fire it had destroyed the aircraft, burning through the fuselage along the top (figures 18, 19, and 20).

**Figure 18. Outside view of ATA DC-10 after ramp fire.**

**Figure 19. View of main cabin, ATA DC-10.**

Figure 20. Cargo and cargo liner damage, ATA DC-10.

Besides reemphasizing the same problems as seen in the UTA incident, concern was focused on solid oxygen generators and their safety.

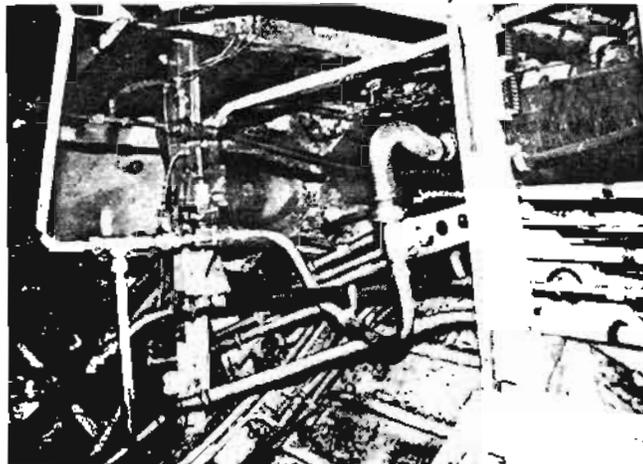
Investigation revealed that a fire began with an arc from a power feeder cable to a titanium bleed air duct. The titanium, ignited and fed by the 400 °F bleed air which exited the ruptured duct, continued to burn. A 3-foot length of duct was consumed in the incident. The hot air and molten titanium (3200 °F) then ignited some epoxy/fiberglass ductwork in the area, and the gases produced by the overheated resins caused the fire to spread around the aft pressure bulkhead and into the overhead. Fire impingement on the aft pressure bulkhead melted and shorted wiring, causing the number two engine fire warning, and then causing a rupture of the bulkhead and depressurization of the cabin (figures 21 and 22). Since most of the burning was on the surfaces of materials and gases produced, the sudden rush of air due to the hole in the bulkhead blew the fire out. Luck was with this flight for, as shown in figure 23, the main fuel line running just under the cabin floor, was almost penetrated by fire just forward of the aft pressure bulkhead. What if the fire had started at a higher altitude, further from an airport, or the pressure bulkhead had not burned through?

Figure 21. View of the check area adjacent to C-3 cargo compartment, Jordanian Air L-1011.

Figure 22. Arced power cable, Jordanian Air L-1011.

Figure 23. Fire damaged fuel line, Jordanian Air L-1011.
