DOT/FAA/82-156

FIRE CONTAINMENT CHARACTERISTICS OF AIRCRAFT CLASS D CARGO COMPARTMENTS

Final Report

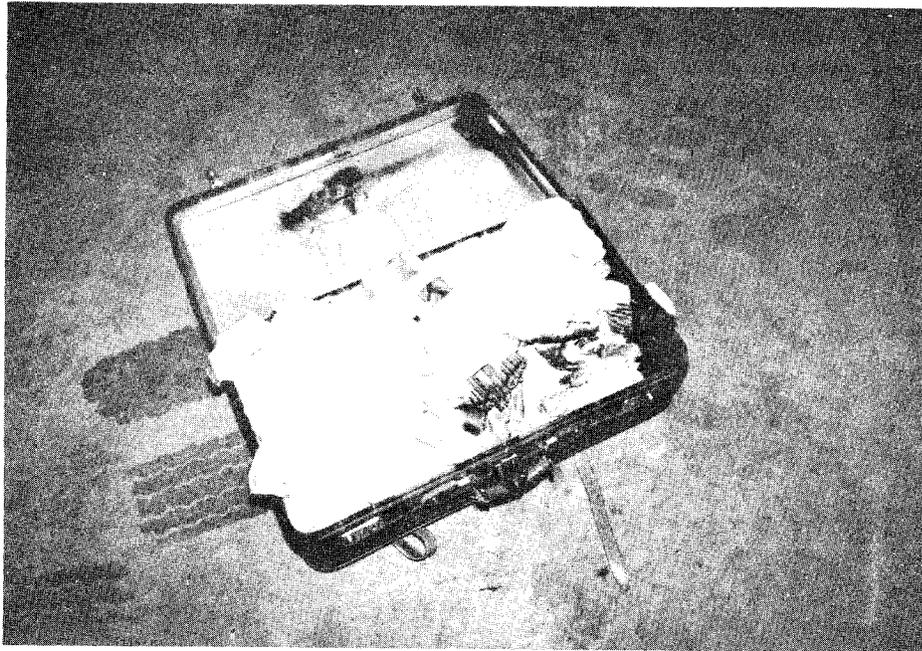
Only one of the four tests conducted with a cloth suitcase resulted in a fire, which consumed the entire case. This was the only test of the single suitcase where forced ventilation was used. Figure 13 shows the scorched clothing after test 15. The clothes in this test self-extinguished after approximately 25 minutes.

FIGURE 13. SCORCHED CLOTHING AFTER TEST 15
