NASA TM X-58141
June 1974

FULL-SCALE AIRCRAFT CABIN FLAMMABILITY TESTS
OF IMPROVED FIRE-RESISTANT MATERIALS

NATIONAL AERONAUTICS AND SPACE ADMINISTRATION
LYNDON B. JOHNSON SPACE CENTER
HOUSTON, TEXAS 77058

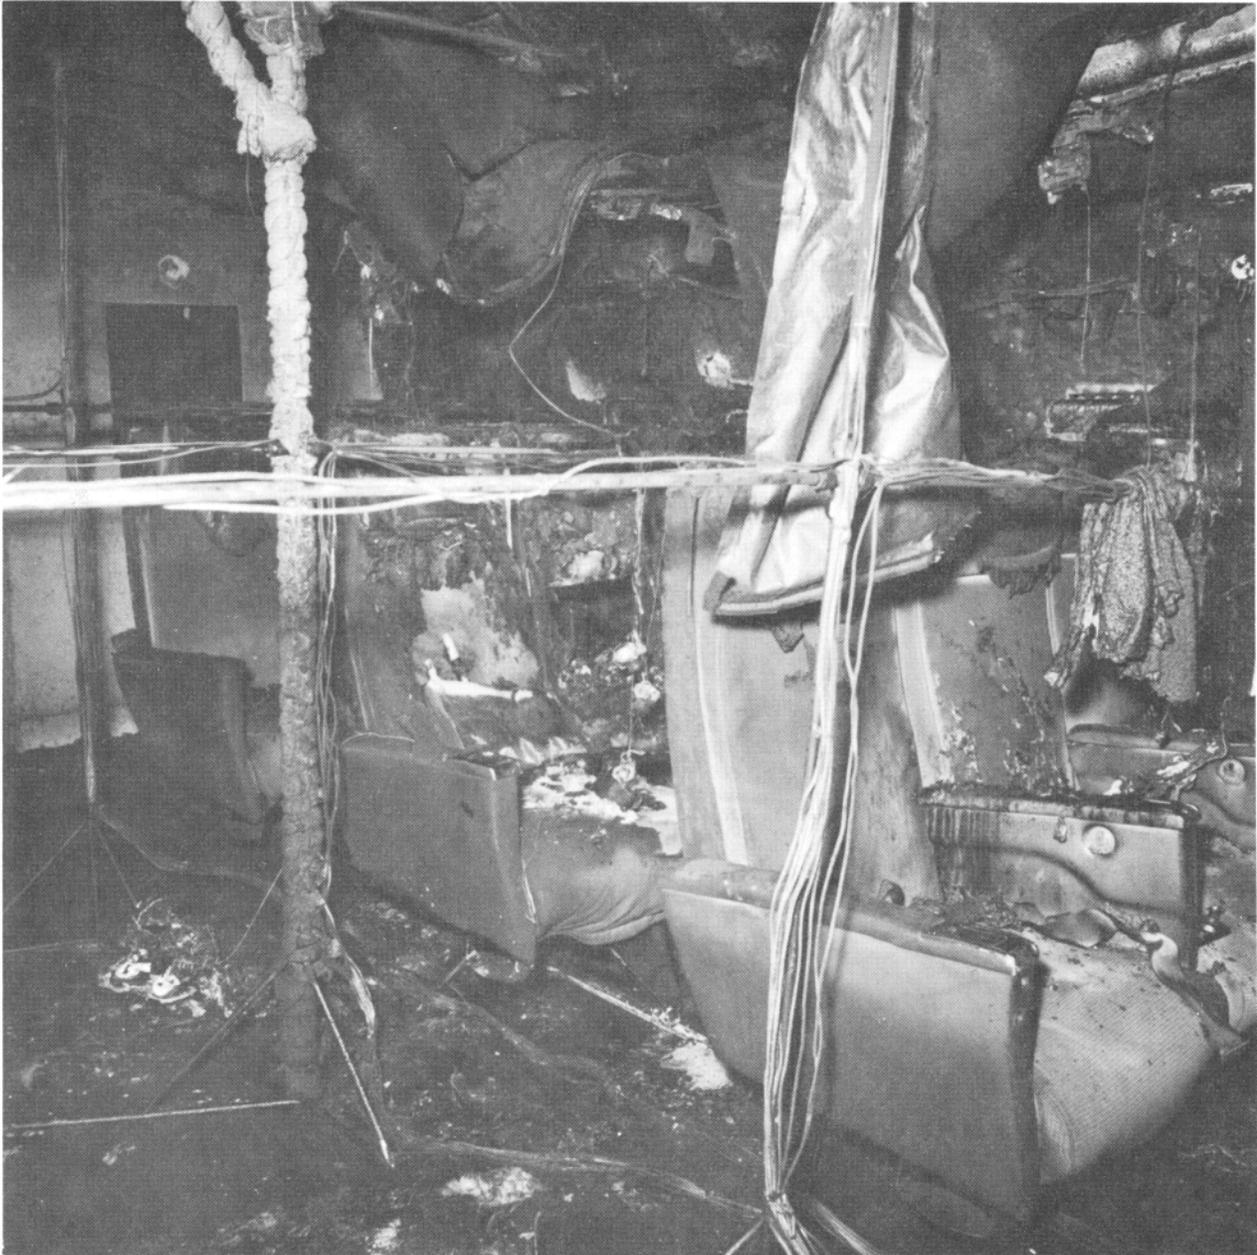
(fig. 8) followed by oxygen depletion to a concentration of less than 5 percent (fig. 9). In addition, the concentration of nonhydrolyzable products of combustion - carbon dioxide, carbon monoxide, methane, and ethylene - increased rapidly as the oxygen was depleted (figs. 10 to 13). Data for hydrolyzable products of combustion - chlorides, fluorides, and cyanides - are not available for test 1 because of an error in analyzing the gas samples. Thermocouple (TC) data indicate that the flash fire originated beneath the hatrack, spread to the ceiling and to the seats, and propagated beneath the hatrack for the full length of the test section. The propagation path along the forward end of the test section cabin walls was downward from the hatrack, as illustrated by a post-test photograph (fig. 14). The damage to the seats other than the one directly above the ignition source was more severe at the top of the seats. This damage indicated heating and burning from above and is further evidence of a flash fire. The damage is shown in figures 15 and 16.

Figure 16.- Fire damage for test 1 using pre-1968 materials, front view.

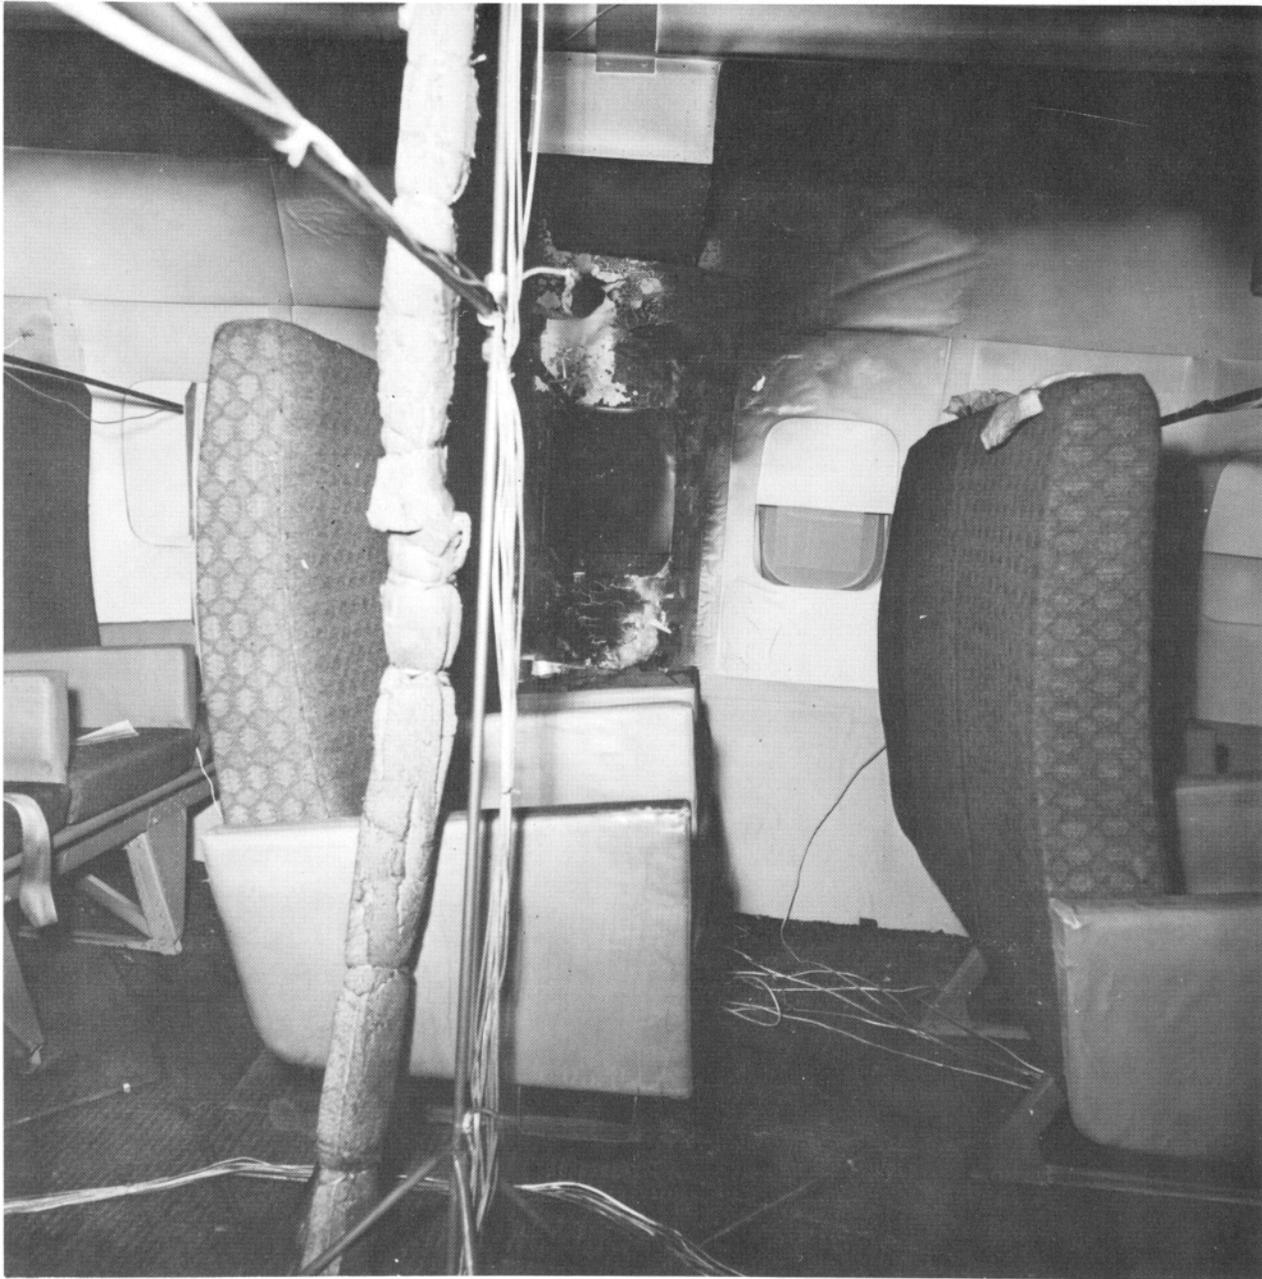
Figures 20 to 24 show clearly that flames did not propagate, and damage was confined to the seat above the fire and the adjacent sidewall. The ceiling was severely damaged (fig. 21), but, because of inadequate insulation behind panels adjacent to the ignition source, flames melted through the sidewall and spread between the sidewall and insulation to the unprotected back side of the ceiling panels, which had a flammable paper honeycomb core. The flames then melted through the aluminum skin above the ceiling panels, and the test was terminated after 280 seconds to prevent destruction of the fuselage. The paper honeycomb ceiling panels were not intended for involvement in the fire since they were known to be flammable and are to be evaluated in subsequent tests using fire-resistant materials.

2. Sidewall: A 61-centimeter (2 foot) wide section of the sidewall covering (Kel-F and Fluorel on Durette) adjacent to the fuel pan was charred from the floor to the hatrack, and the aluminum panels were partly melted. The sidewall extending outward from each side of the charred area was scorched and blistered (fig. 20).

Comparison with other tests.- Far less material damage occurred in test 2 than in test 1, and propagation of the fire was limited (figs. 15 and 20). A comparison of ceiling temperatures (fig. 25) indicated a maximum temperature of 505 K (450° F) for test 2, whereas, during test 1, the

Figure 20.- Fire damage for test 2 using new materials, side view.

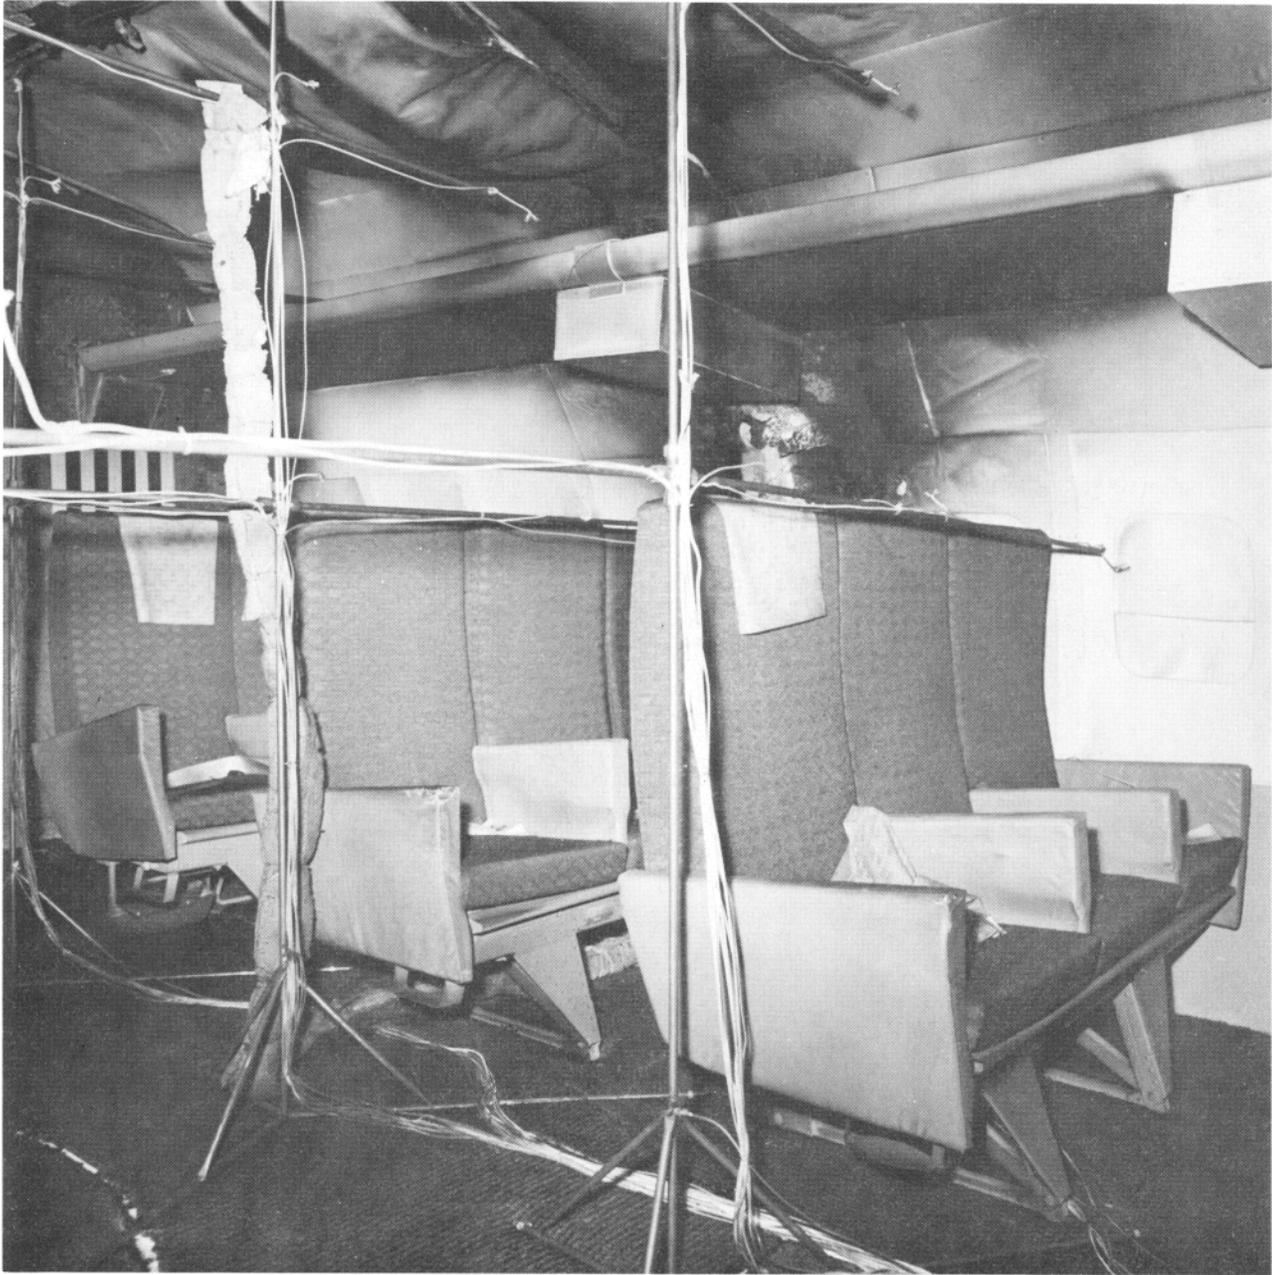
4. Ceiling panels: The ceiling panels were heavily charred where they joined at the middle of the test section (fig. 21). Close examination revealed that the panels had burned from the back side, which had not been covered with the fiberglass cloth overcoated with Kel-F and Fluorel. (The same type of ceiling panel used in test 1 was covered on one side only with the Kel-F/Fluorel/fiberglass-cloth composite for use in test 2.) The back side had been ignited by flames that melted the sidewall and spread between the sidewall and insulation up to the back side of the ceiling panels. The remaining interior side of the ceiling was slightly scorched.

Figure 21.- Fire damage for test 2 using new materials, front view.

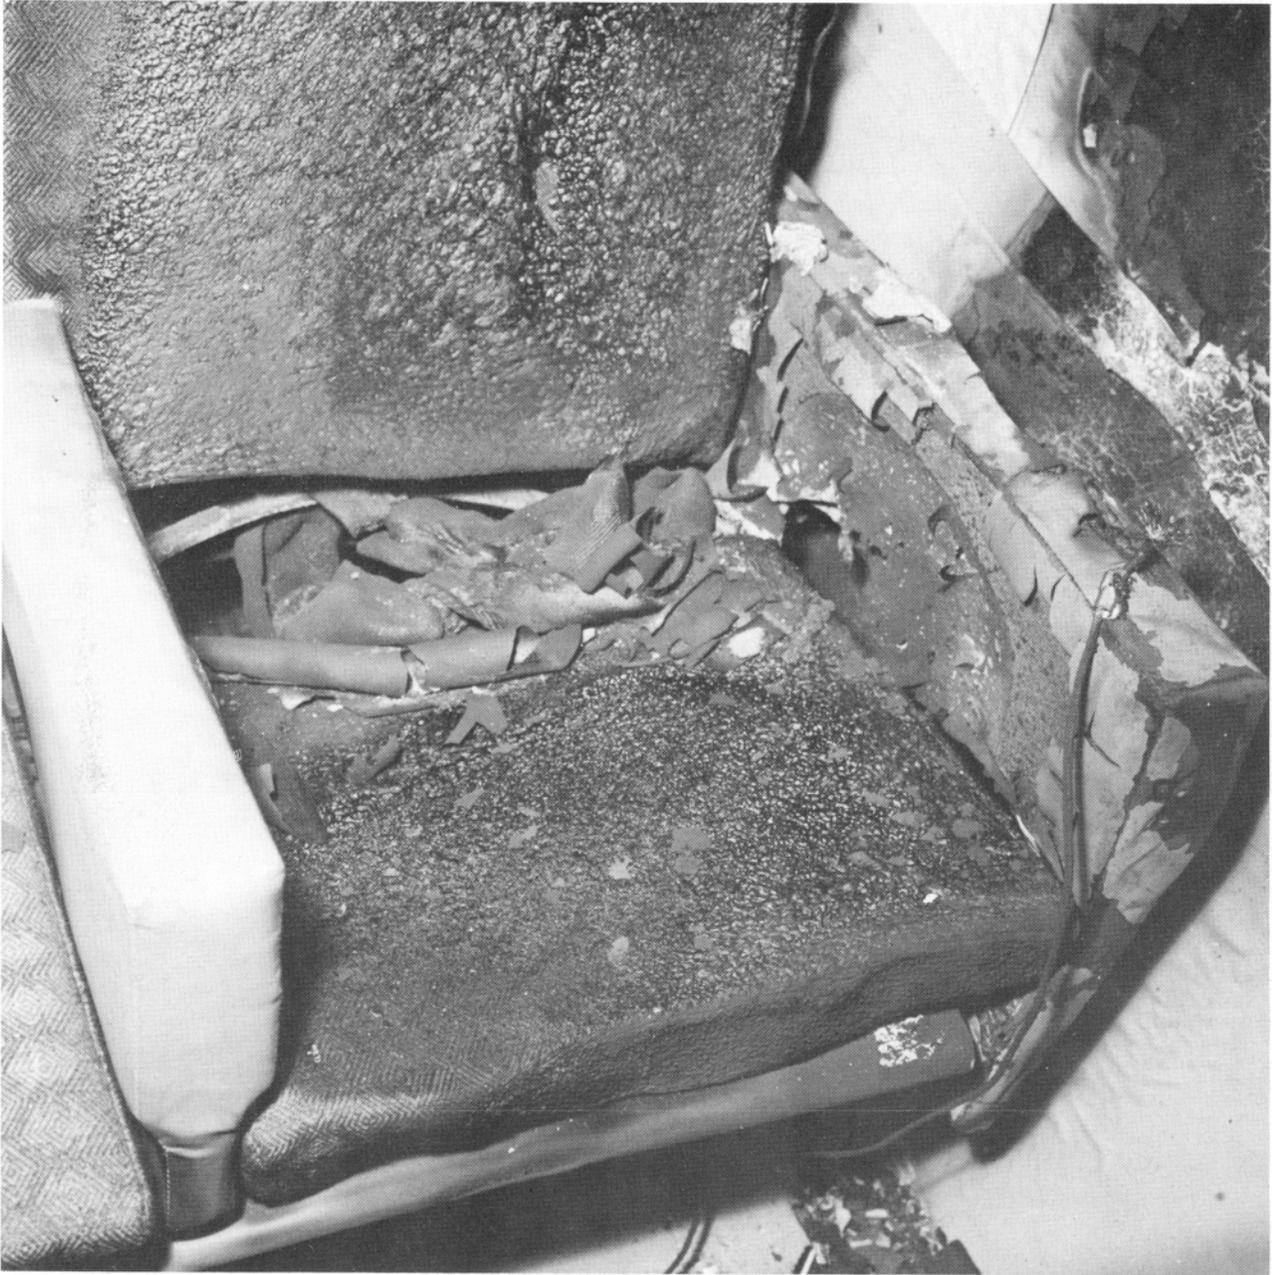
1. Seats: The seat above the fire was partly consumed by the fire, and some of the metal structure had melted away

(figs. 22 to 24). Approximately 95 percent of the bottom seat cushion upholstery was charred, and approximately 50 percent of the fire-retardant foam padding was consumed. The front of the seat-back upholstery was 70 percent charred, the back side was 25 percent charred and 30 percent scorched, and the foam padding was damaged only slightly. The Nomex seatbelt was almost completely charred. The other seats were not damaged except for slight scorching of the seat adjacent to the damaged seat. Fire-resistant, disposable headrest napkins had also been included for evaluation; however, most of the napkins were blown from the seats when the carbon dioxide extinguisher was activated. The napkins that remained in place were not damaged.

Figure 22.- Seat bottom fire damage for test 2 using new materials.

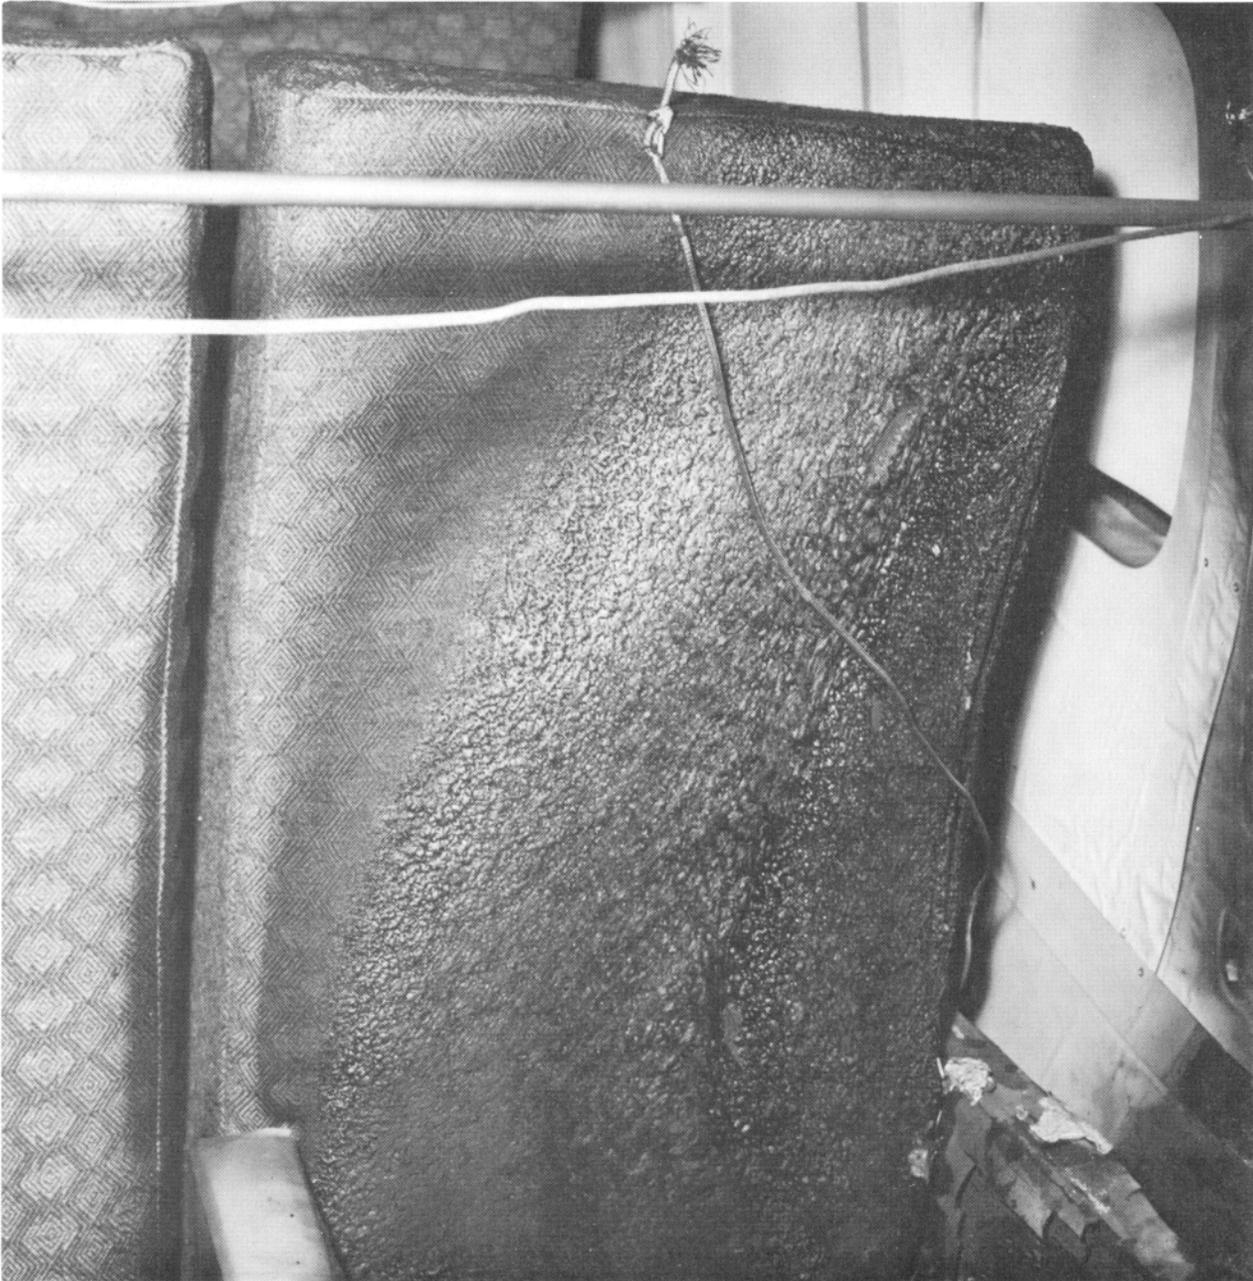
Figure 23.- Seat top fire damage for test 2 using new materials.

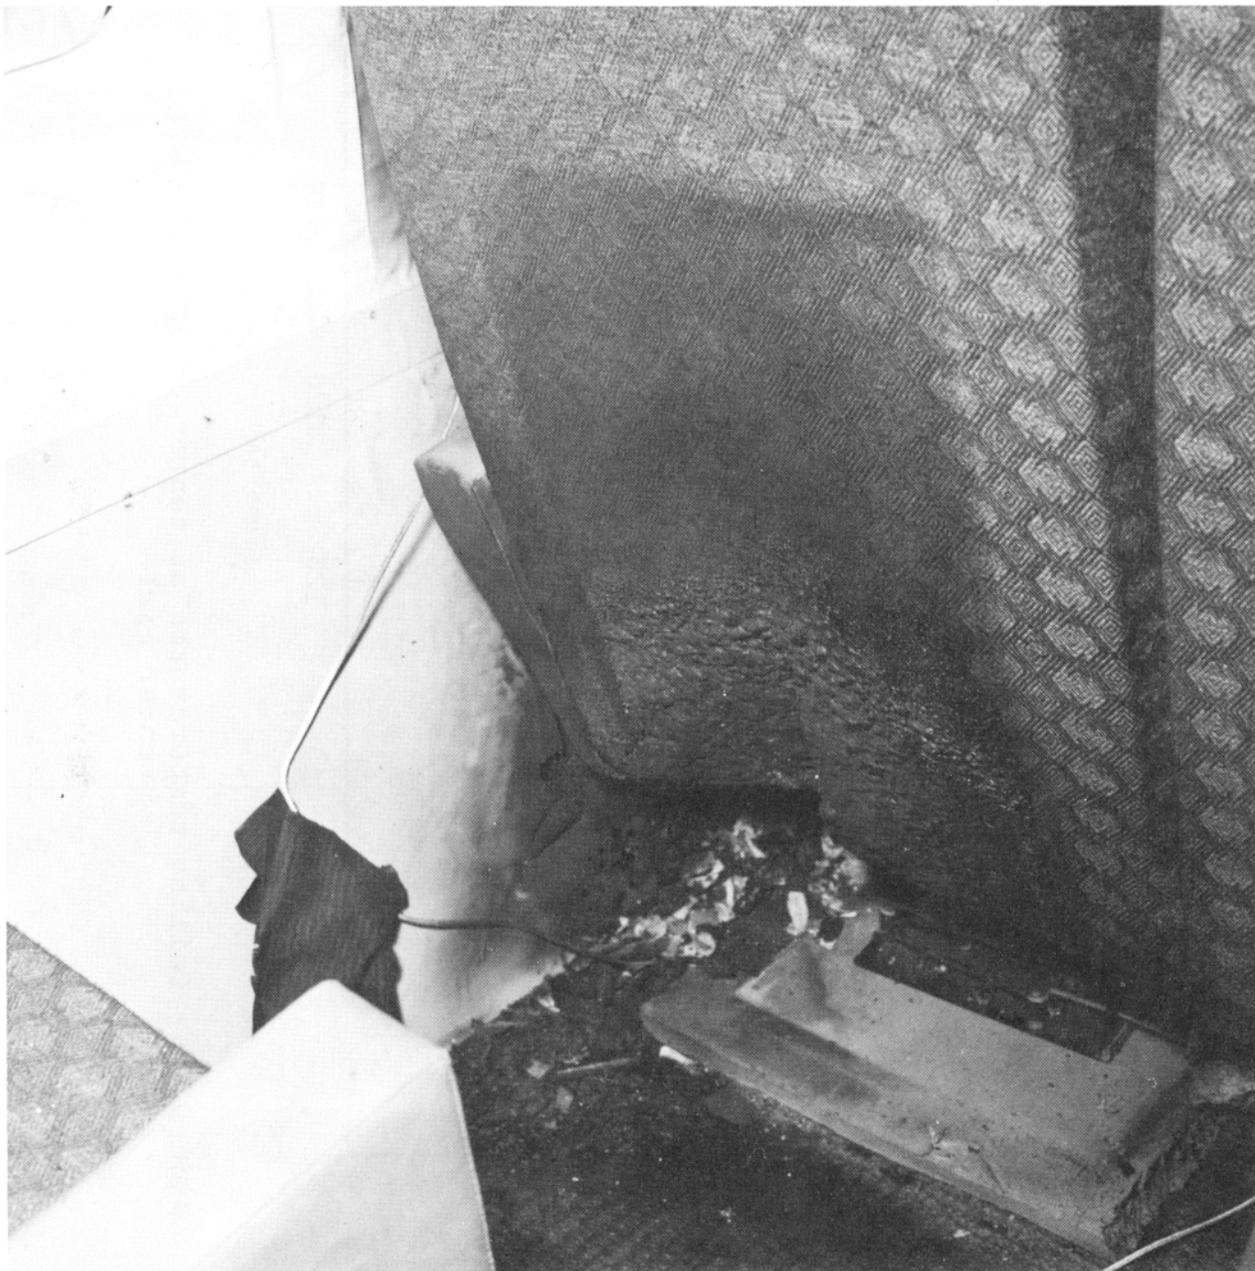
Figure 24.- Seat back fire damage for test 2 using new materials.
