# National Bureau of Standards Smoke Chamber Testing

## International Fire & Cabin Safety Conference

Michael Burns

FAA Office of Aviation Research

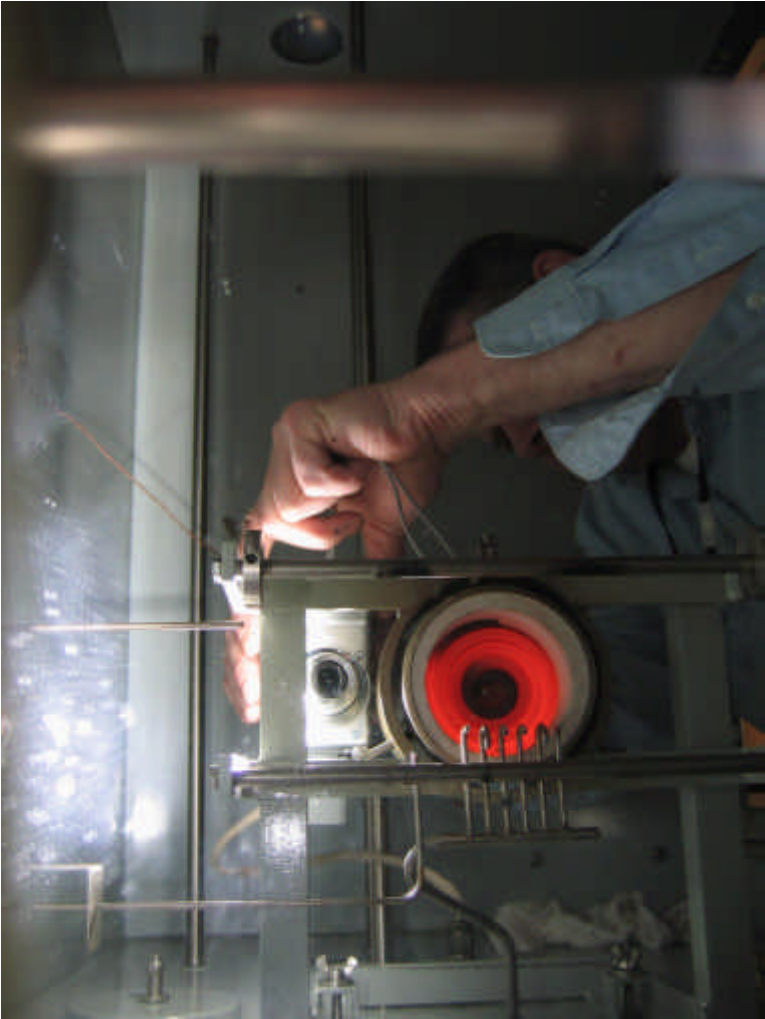
# Furnace Defect

- **A problem with replacement furnaces of the NBS Smoke chamber has recently been observed**
- **A dark “eye” in the center of the furnace has been observed on some coils even after being calibrated to the 2.5 W/cm<sup>2</sup> value**

- **Drawing 40A132880 (NIST report NISTIR 4917, New Heater and Flux Guage for the NBS Smoke Box) is thought to be the most recent authoritative document, however, original designer did not specify tolerances**
- **The manufacturer is actively working to attempt to reduce this dark area.**

- **Mini-Study will be completed and results published**
- **FAA will be the Principal Investigator for next International Round Robin (early 2008)**
- **FAA will address the tolerance issue for the furnace coil specification**
- **Please contact Mike Burns to participate and obtain your lab codes and samples**

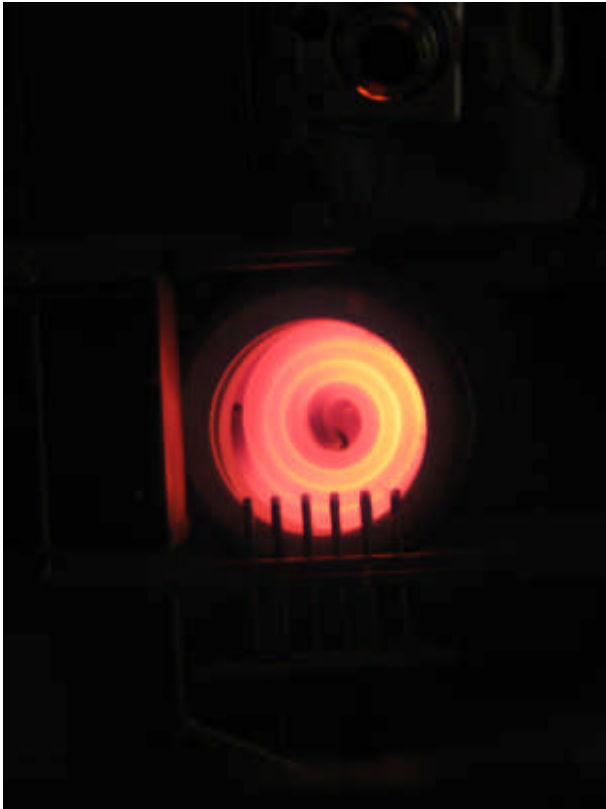
properly functioning  
furnace

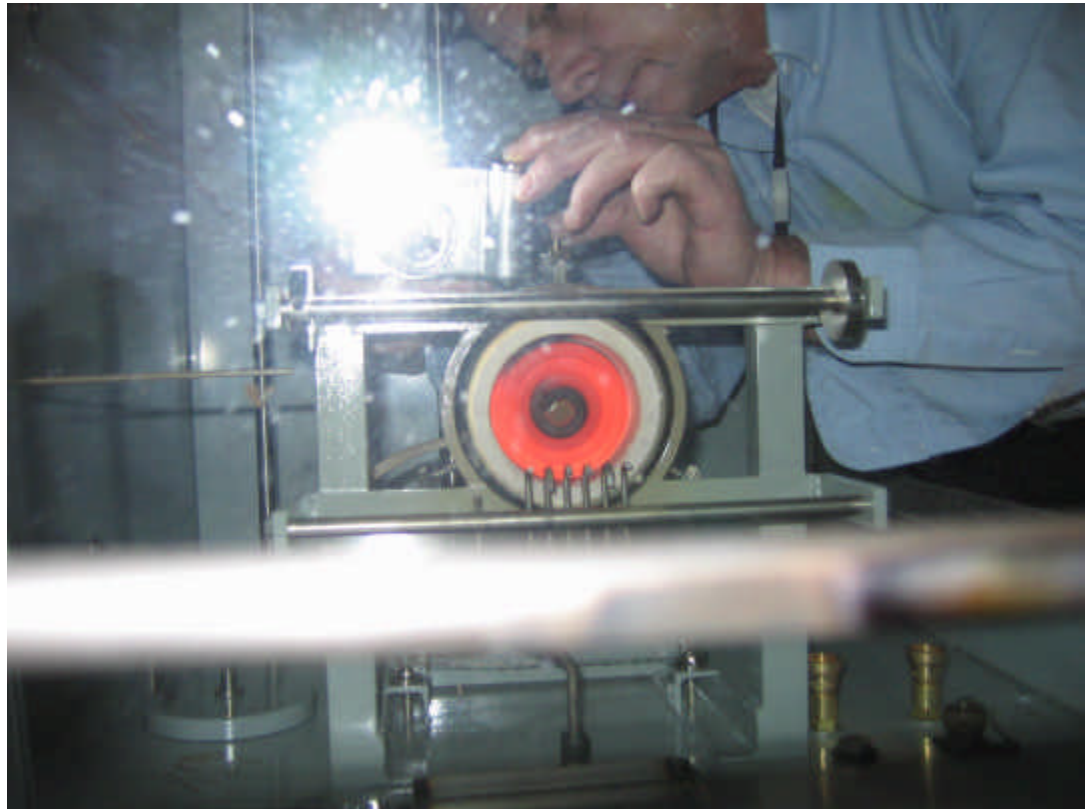
defective replacement  
furnace
