COMPOSITE MATERIAL FIRE FIGHTING

**Presented to: International Aircraft Materials Fire Test Working
Group
Renton, Washington, USA**

**Presented By: John C. Hode
SRA International**

Date: Wednesday, March 3, 2009

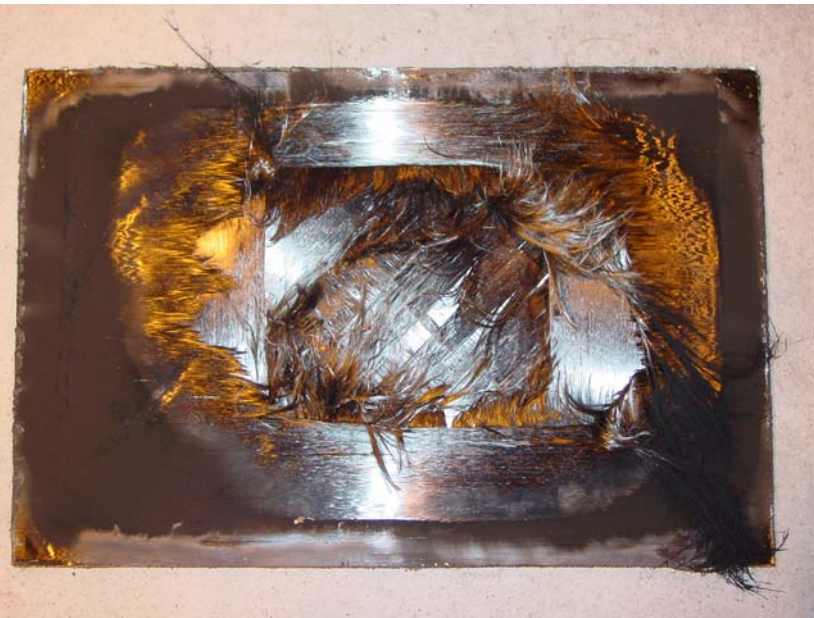
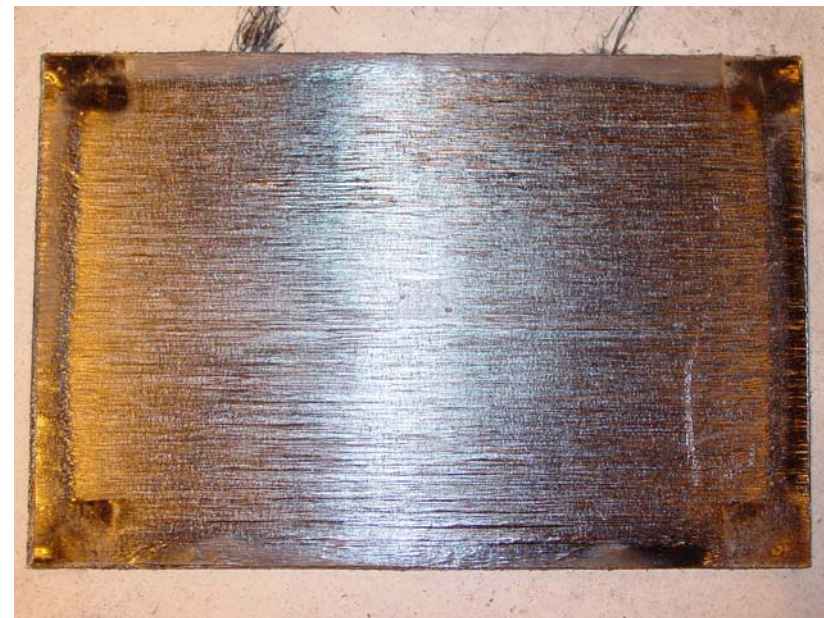
Test 6, a 10 minute exposure

- **At 1 minute exposures (average of 4 tests) 83.875% of the panel weight remained.**
- **After 10 minute exposures (average of 5 tests) 68.68% of the panel weight remained.**
- **Longer exposures burn off more epoxy, and regularly caused release of fiber clusters due to severe damage to the exposed surface.**
- **Burner caused a roughly circular hole in the center of the panel.**
 - Damage penetrated through first 4 plies.
 - Jagged cut and fragile gray fiber ends noted along edges of the hole which appear to be the result of fiber oxidation.

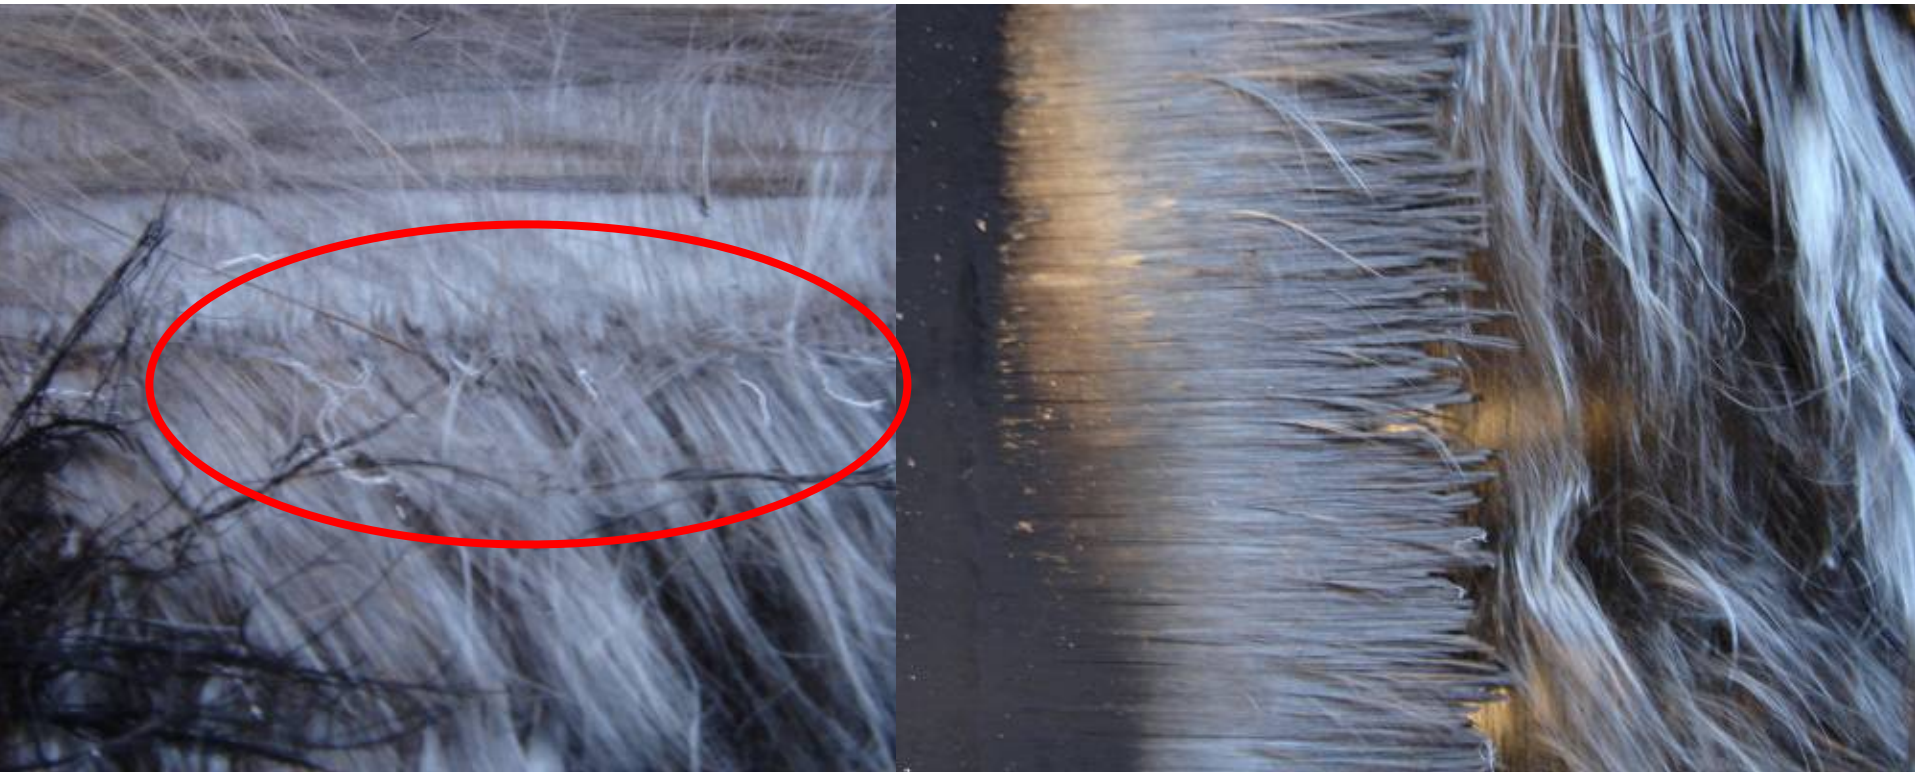
- **Close up of gray and jagged cut fiber ends from Test 15**

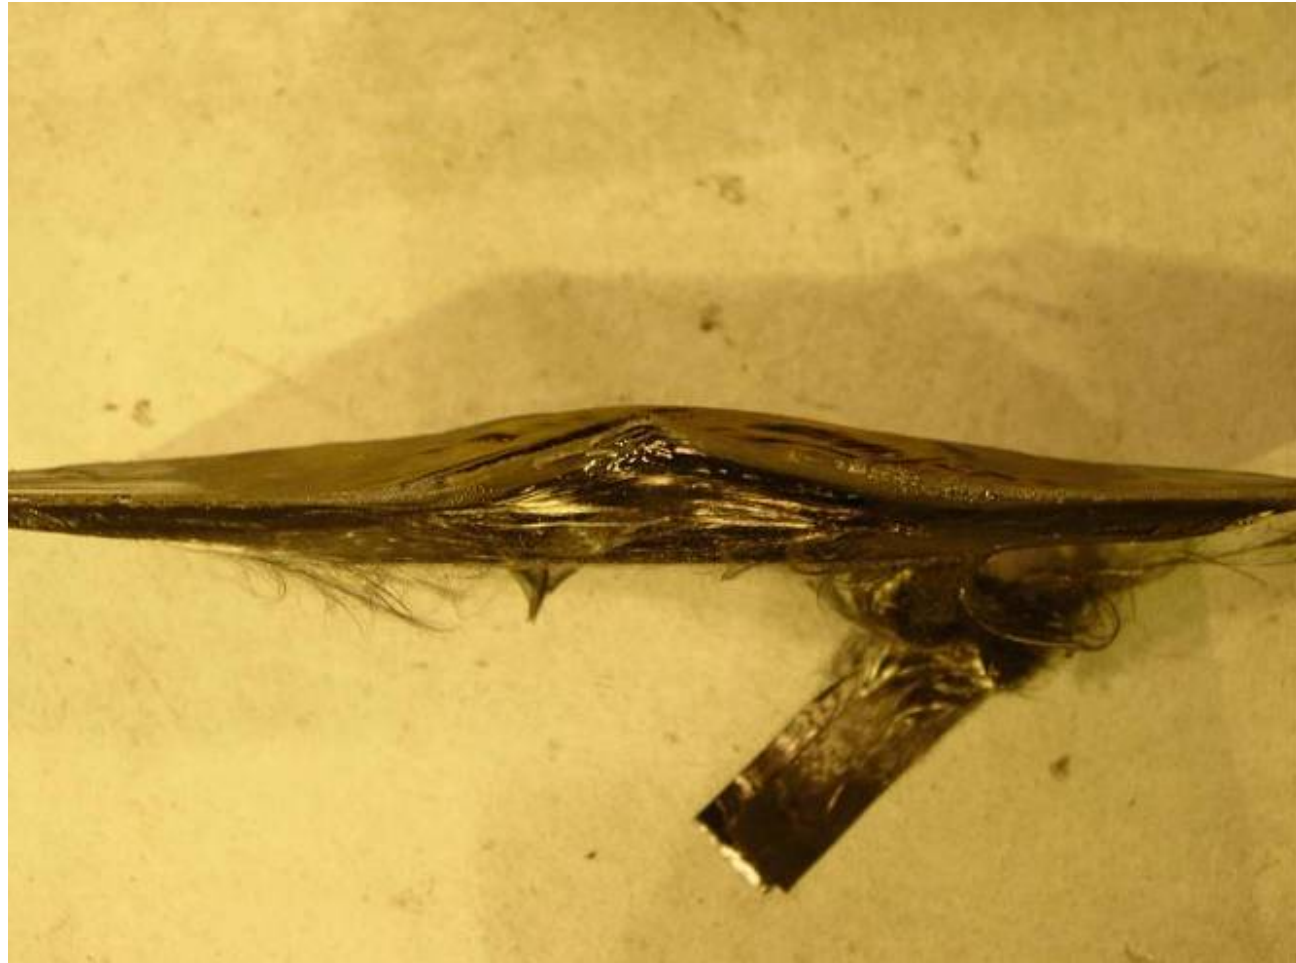
- **Test 4 panel shown**
- **7 tests suffered sudden mechanical failures**
- **Failures occurred in 30 seconds on average**

- **Quintiere [1] attributed swelling to vaporization of epoxy, thereby causing internal pressure.**
- **All panels in these tests produced heavy out-flow of smoke from the edges, not the panel face, and swelled to varying degrees.**
- **In these tests, panel edges were sometimes tightly fit into back Kaowool board.**
 - May have restricted outflow of smoke and off-gassing.
- **It was observed during video review that in one test heavy smoking from the edge markedly reduced, when the failure occurred a surge of heavy smoke erupted from the failure site.**
- **The mechanical failures may have been due to over-pressurization but this was not further explored in this series of tests.**

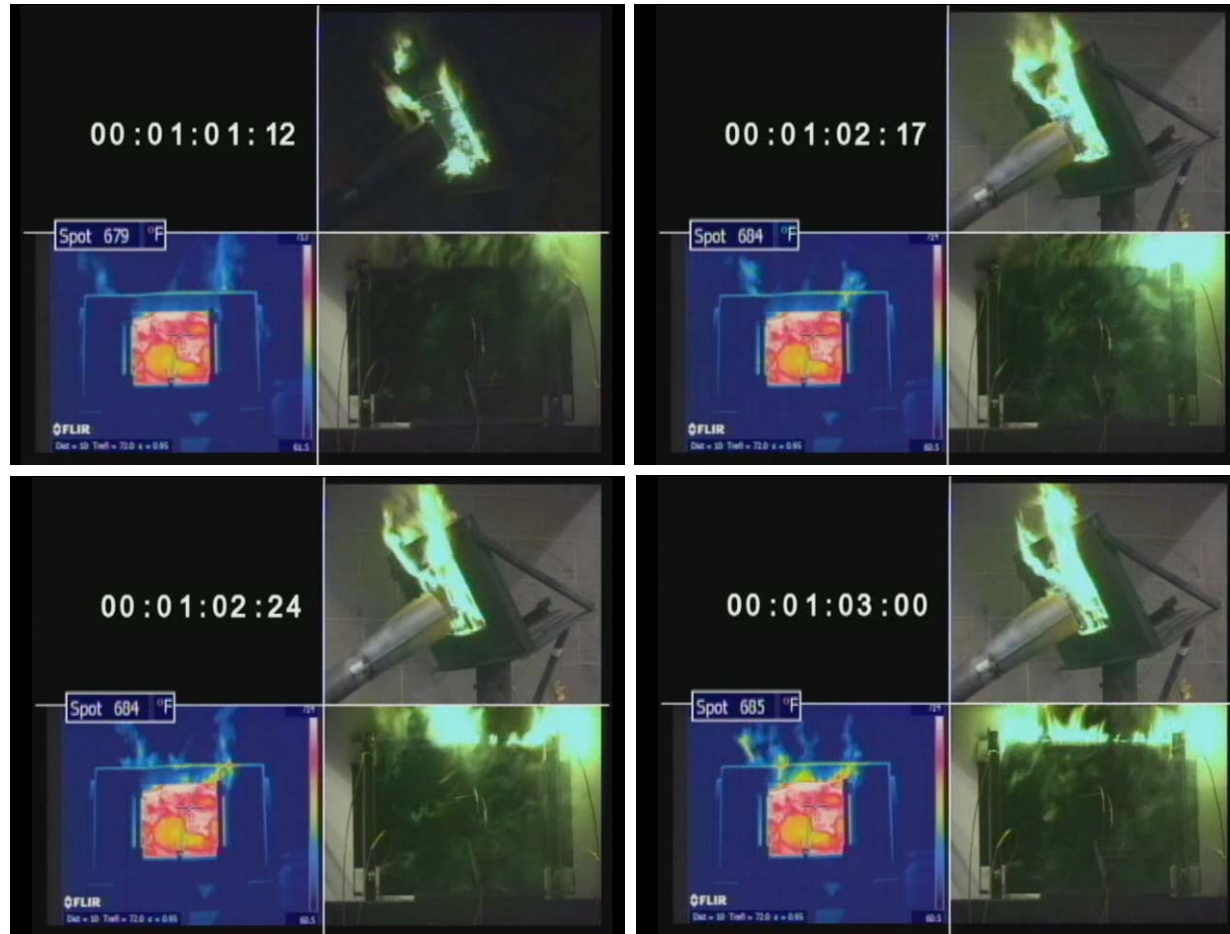
From Test 18 video

- Heavy smoke from the backside was sometimes ignited by the front side flame. This was clearly observed during the video review.
- Here, the ignition of back-side off-gassing happened *after* the burner was turned off.

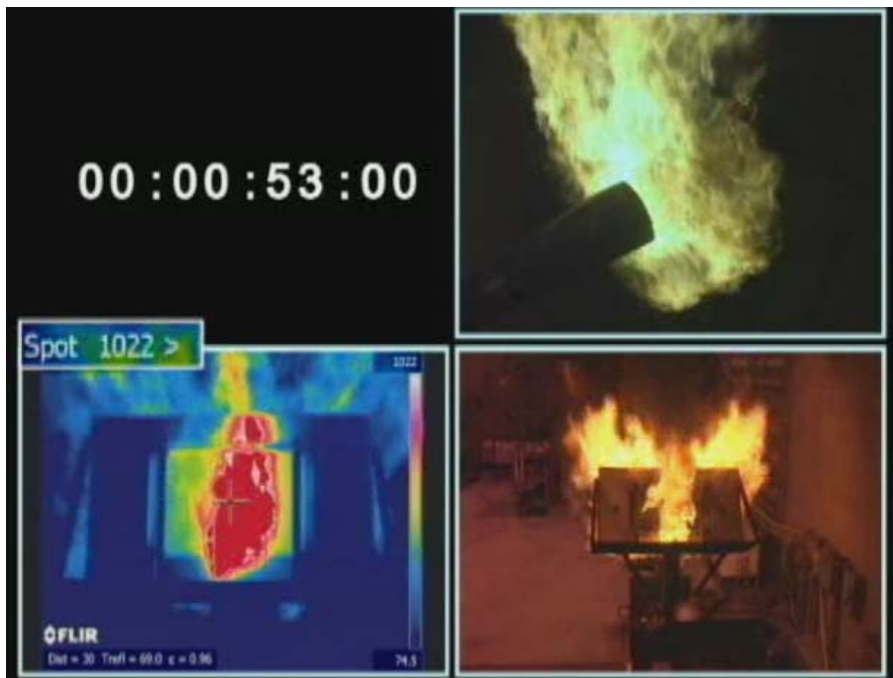
Test 4 Flashover

- Two tests suffered mechanical failures at the bottom edge that allowed high heat to contact and ignite smoke emitting from bottom edge.
- Ignition of edge involved part of the panel face which evolved into flashover of the backside.

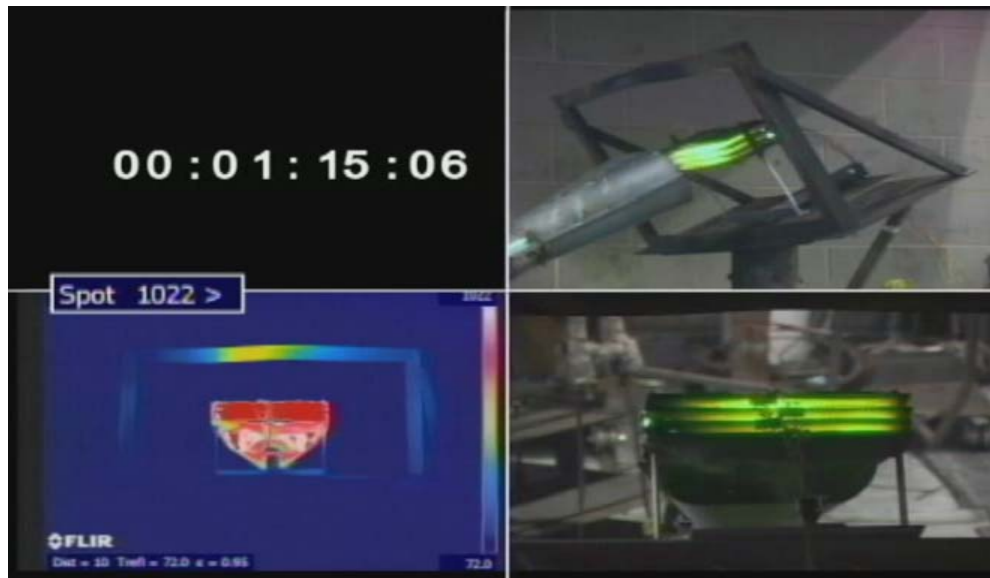
- **Tests 22 and 23**

- The panel was cut into 4 pieces and stacked with $\frac{3}{4}$ inch (76.2mm) spaces between.
- Thermocouples placed on top surface of each layer.
- Exposure time; 1 minute.

- **Measured temperatures in the vicinity of 1750°F (962°C).**
- **As smoldering continued, plies could be seen to drop onto layers below.**
 - When layers were taken apart for disposal they had virtually no structural strength.
- **Wind (in Test 22) caused smoldering to last 52 seconds longer.**
