# NAFEC TECHNICAL LETTER REPORT

NA- 80-17-LR

PRELIMINARY EVALUATION OF THE  
PERFORMANCE OF ADVANCED AND  
CONVENTIONAL AIRCRAFT WINDOWS  
IN A MODEL FIRE ENVIRONMENT

MAY 1980

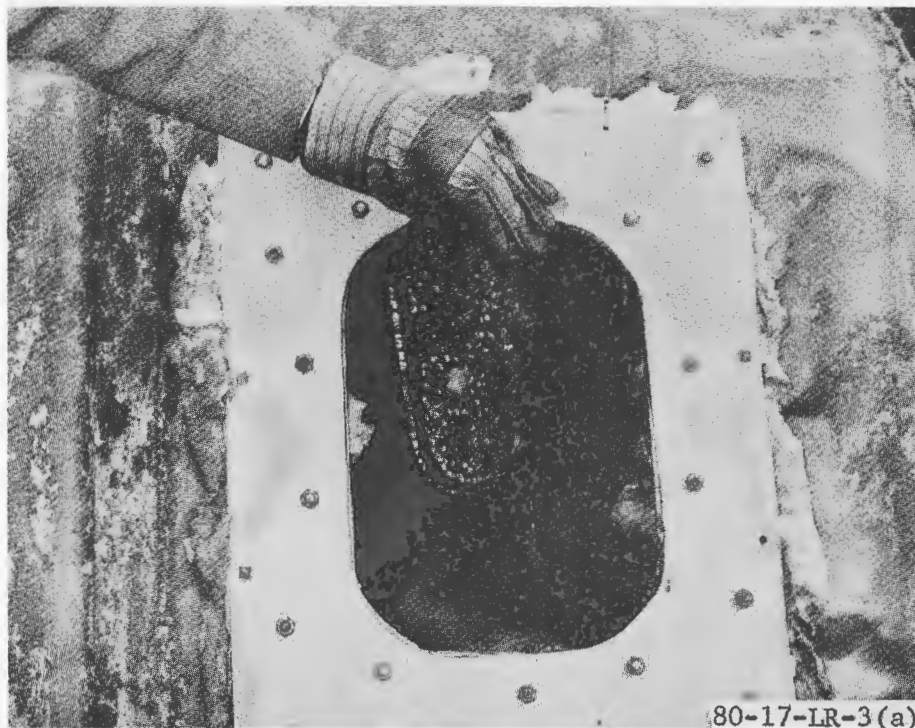
TEST 1

Figure 3 shows the condition of the two full size windows after extinguishment of the fires in tests 1 and 2, respectively. NAFEC firemen started extinguishment when an observer noted burnthrough 108 seconds after the start of test 1 and 240 seconds after the start of test 2. Tests 3 and 4 were run for 113 seconds and 115 seconds, respectively, before extinguishment of the pool fire was started. The tests were halted when an observer could see the fire breaking through either of the window sections. Figure 3 also shows the window conditions for tests 3 and 4, respectively. The photographs show that the stretched acrylic windows failed by means of shrinking. The epoxy/polycarbonate window failed only in test 2 which was run for a considerable length of time. When the epoxy/polycarbonate window was exposed to fire, the outer ply formed a char which apparently served as an effective heat-blocking device.

Noticeable speckling of the stretched acrylic window appeared at 28 seconds into the test. At 52 seconds the window darkened considerably, and at 104 seconds, the first breakthrough of the external fire was noted.

1. The state-of-the-art stretched acrylic windows fail by shrinking and falling out of place and not by burnthrough. Failure generally occurs around 100 seconds into a test.
2. The advanced epoxy/polycarbonate windows perform as designed and appear able to prevent significant fire penetration for at least 4 minutes. The failure mode involves gradual conductive heating through the epoxy char to the polycarbonate structural ply which then melts and falls away.

The principal recommendation is that the FAA perform more detailed evaluations of the performance of these char-forming advanced windows with regard to both resistance to fire and performance in routine use. Particular attention should be given to effects of moisture and aging on epoxy integrity.

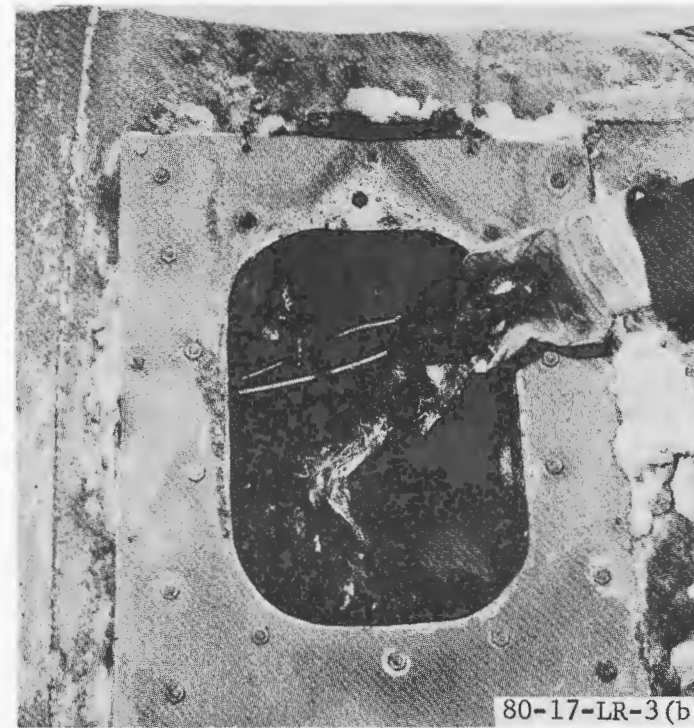
TEST 2

The epoxy/polycarbonate window first showed speckling at 30 seconds and darkened at 70 seconds. By 90 seconds the window was very dark and evidenced some stress cracks in the epoxy layer. From 90 to 190 seconds (when the camera stopped), the window was opaque and showed no signs of failure. Observations from the end of the fuselage indicate that the window failed at approximately 240 seconds. It should be noted that tests 1 and 2 were both run at 7 to 10 knots windspeed. Tests 3 and 4, however, were run at 12 and 3 knots, respectively. In both tests 3 and 4, the lower calorimeter on the window mount read 13 British thermal unit per square foot second ( $\text{Btu}/\text{ft}^2\text{-sec}$ ), while the upper calorimeter read 16 and 15  $\text{Btu}/\text{ft}^2\text{sec}$ , respectively.

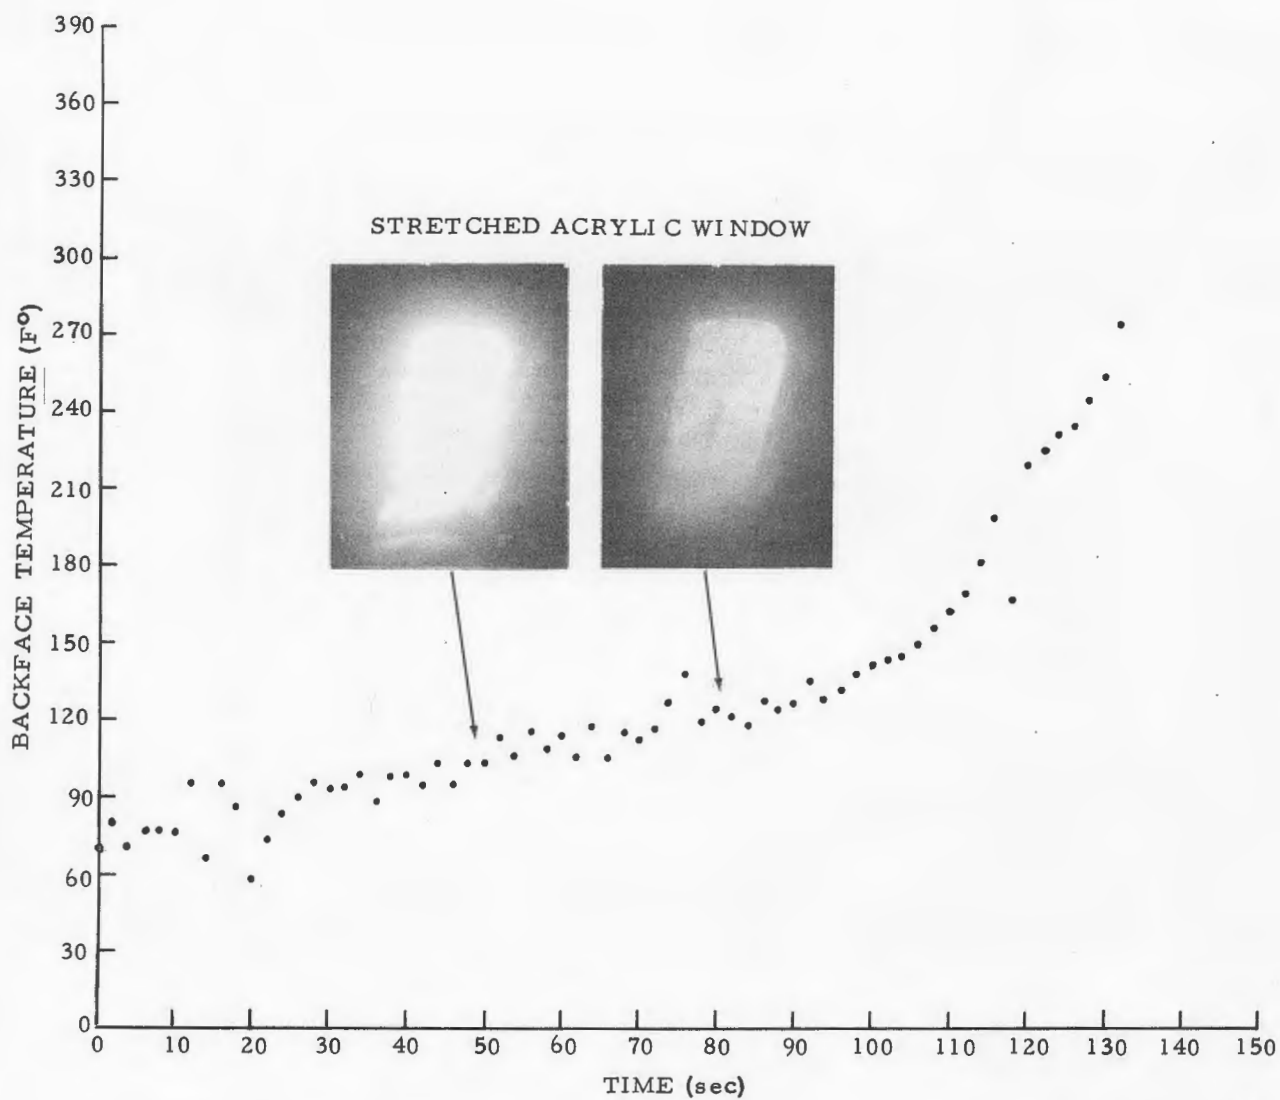
FIGURE 4. BACKFACE TEMPERATURE--(TEST 1)

Figures 4 and 5 shows backface temperature rises for test 1 and 2 along with corresponding photographs taken by the motorized still camera. The behavior of the windows during the fire can thereby be observed. The photographs shown in figure 4 are selected from sets of 35-mm color stills which were sequenced every 2 seconds during the test. The motorized still camera inside the fuselage viewed the fire through the window.

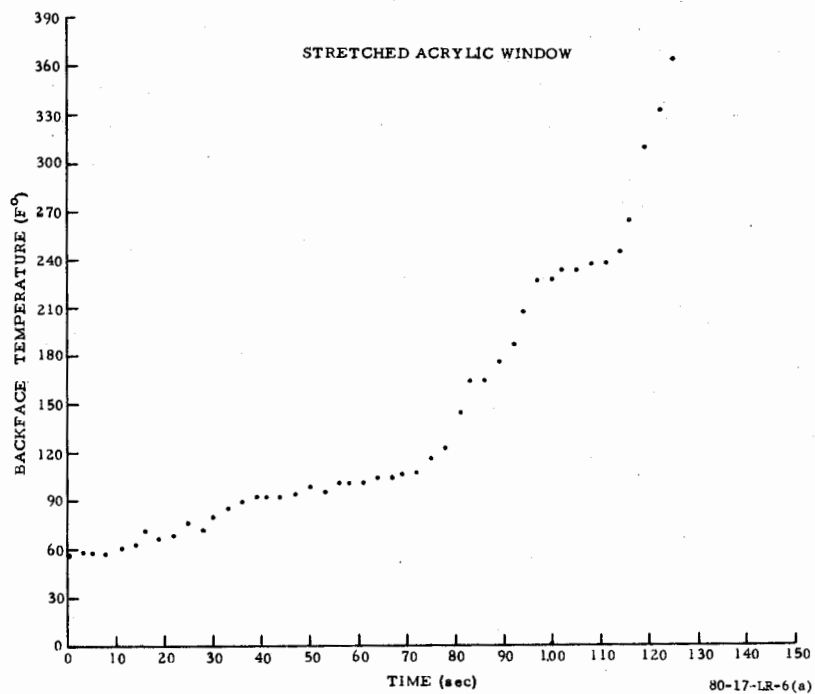
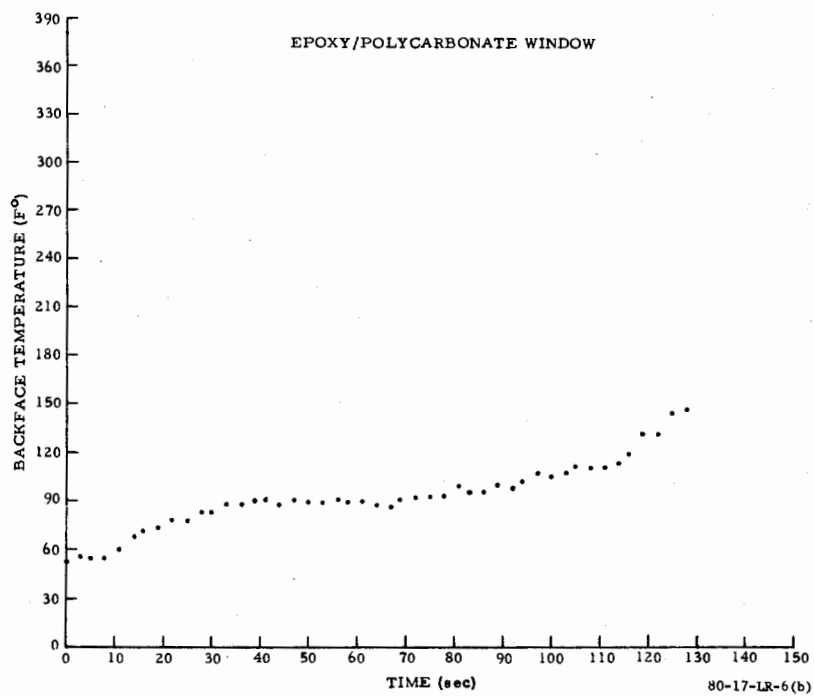
FIGURE 6. BACKFACE TEMPERATURE--(TEST 3)

The backface temperature-rise curves for tests 3 and 4 are shown in figures 6 and 7. For the first 40 to 60 seconds, the backface temperatures of both windows in a given test are equivalent. At this time, the backface temperature of the conventional window becomes higher.

The glass transition temperature ( $T_g$ ) of acrylic will usually be around  $230^\circ\text{F}$ , while that of polycarbonate is around  $300^\circ\text{F}$ . When the backface temperature on either material approaches  $T_g$ , failure results.
