THE FEASIBILITY OF BURNER-CAN BURN-THROUGH THERMAL DETECTION PRIOR TO ENGINE CASE RUPTURE

FINAL REPORT

1. Report No. FAA-RD-72-134	2. Government Accession No.	3. Recipient's Catalog No.	
4. Title and Subtitle THE FEASIBILITY OF BURNER-CAN BURN-THROUGH THERMAL DETECTION PRIOR TO ENGINE CASE RUPTURE		5. Report Date January 1973

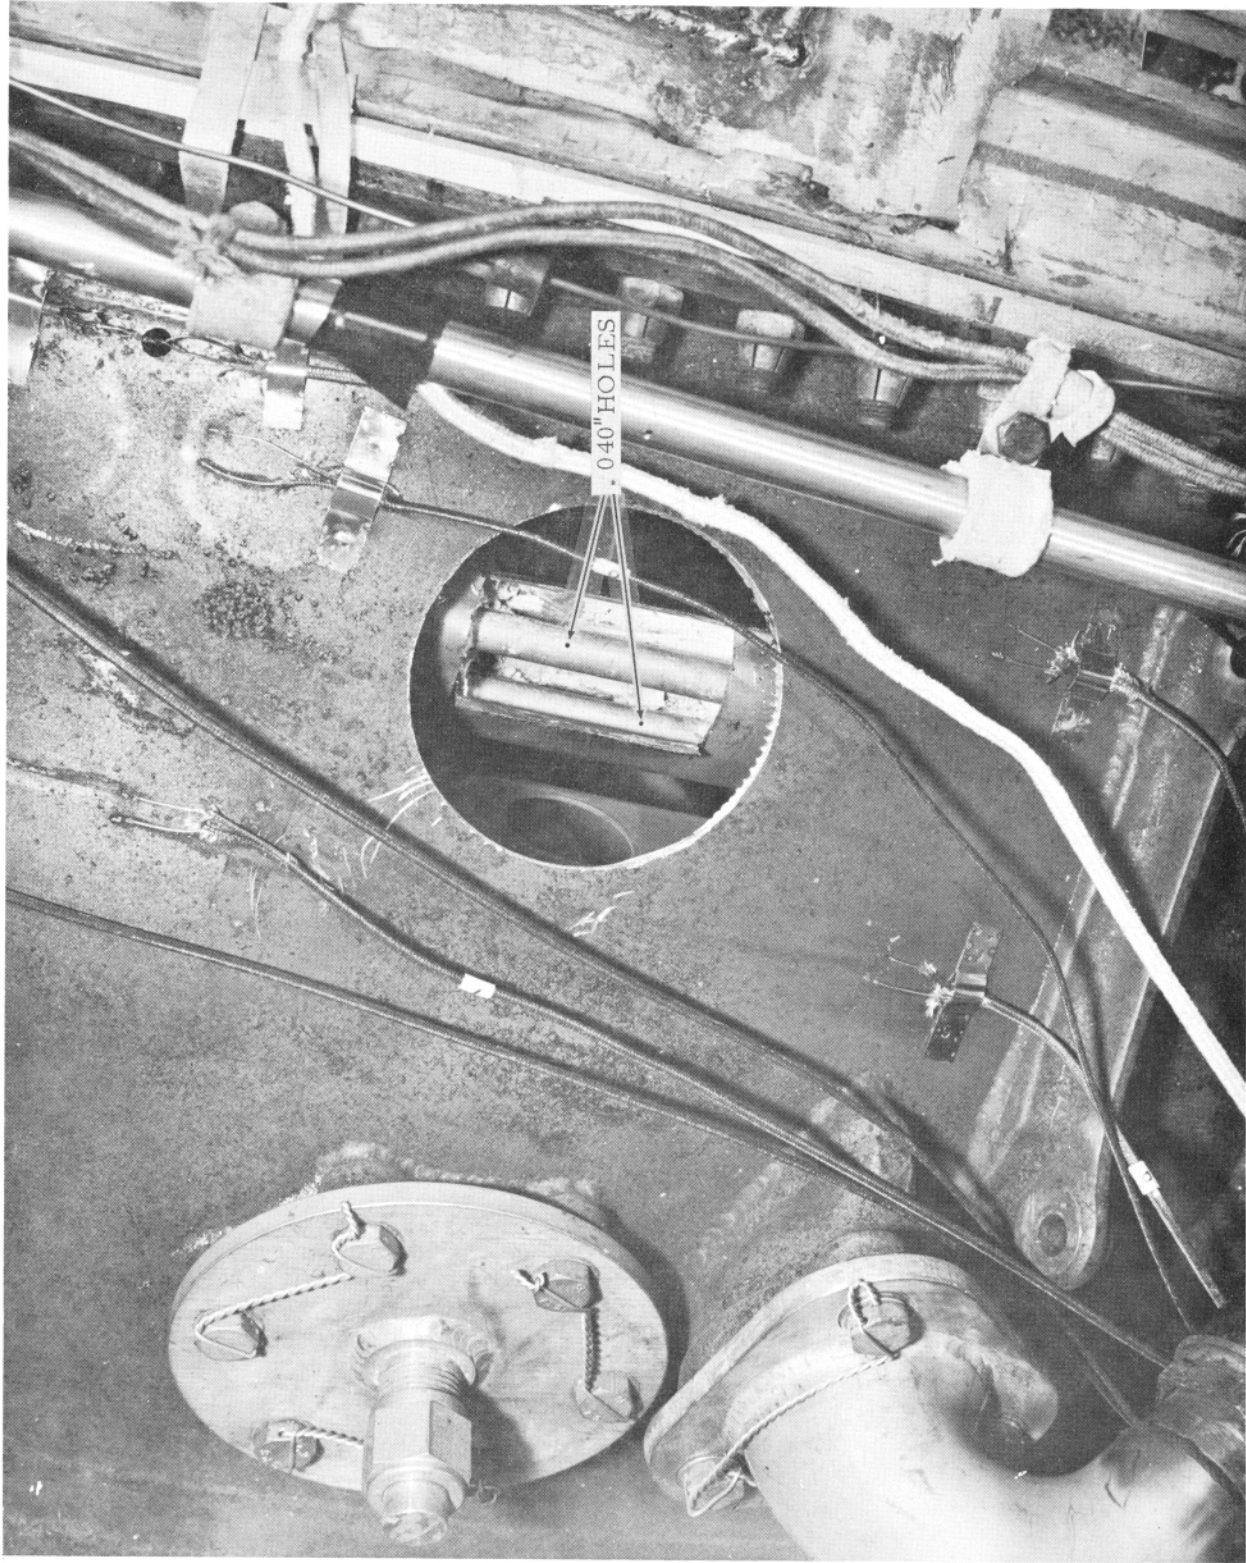
FIGURE 2. HOLES IN J57 INTERNAL FUEL MANIFOLD

In order to cause a burn-through failure in the J57 test engine, a hole was cut in the diffuser case allowing access to the internal fuel manifold. A section of the stainless steel protective shroud around the fuel lines was removed. A 0.040-inch hole was drilled in both the primary and secondary fuel lines (Figure 2). The hole in the diffuser case was then repaired by rewelding the removed piece of material in place.

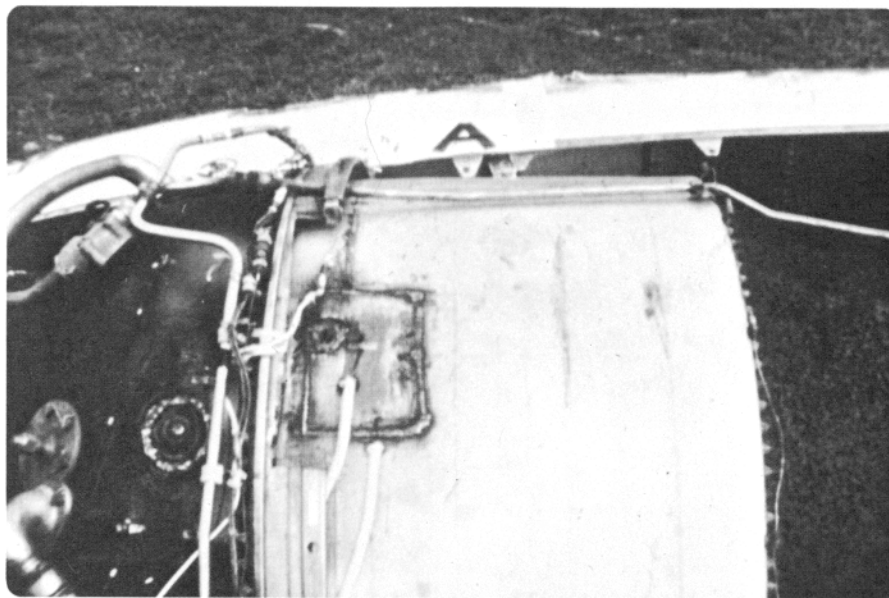
FIGURE 7. J57 ENGINE APPROXIMATELY
40 SECONDS PRIOR TO BURN-THROUGH

The development of a burner-can burn-through was photographed by motion picture cameras and can be seen in Figures 7 through 16. In Figure 7 the internal fuel leak had ignited and the diffuser case was just beginning to overheat (note the two hot spots on the diffuser case). Figure 8 shows the engine just prior to rupture. A large portion of the diffuser case began to glow red, and a small section of the burner can case began to overheat. The following eight photos were taken over a time span of five-tenths of a second. In Figure 9 the flame has just penetrated the diffuser case. As the rupture in the diffuser case enlarges the flame increases in diameter and length. As a result of rough and bowed edges on the burn-through hole the flame transforms itself from a single concentrated jet (Figure 12) to a larger diffused jet (Figure 16).

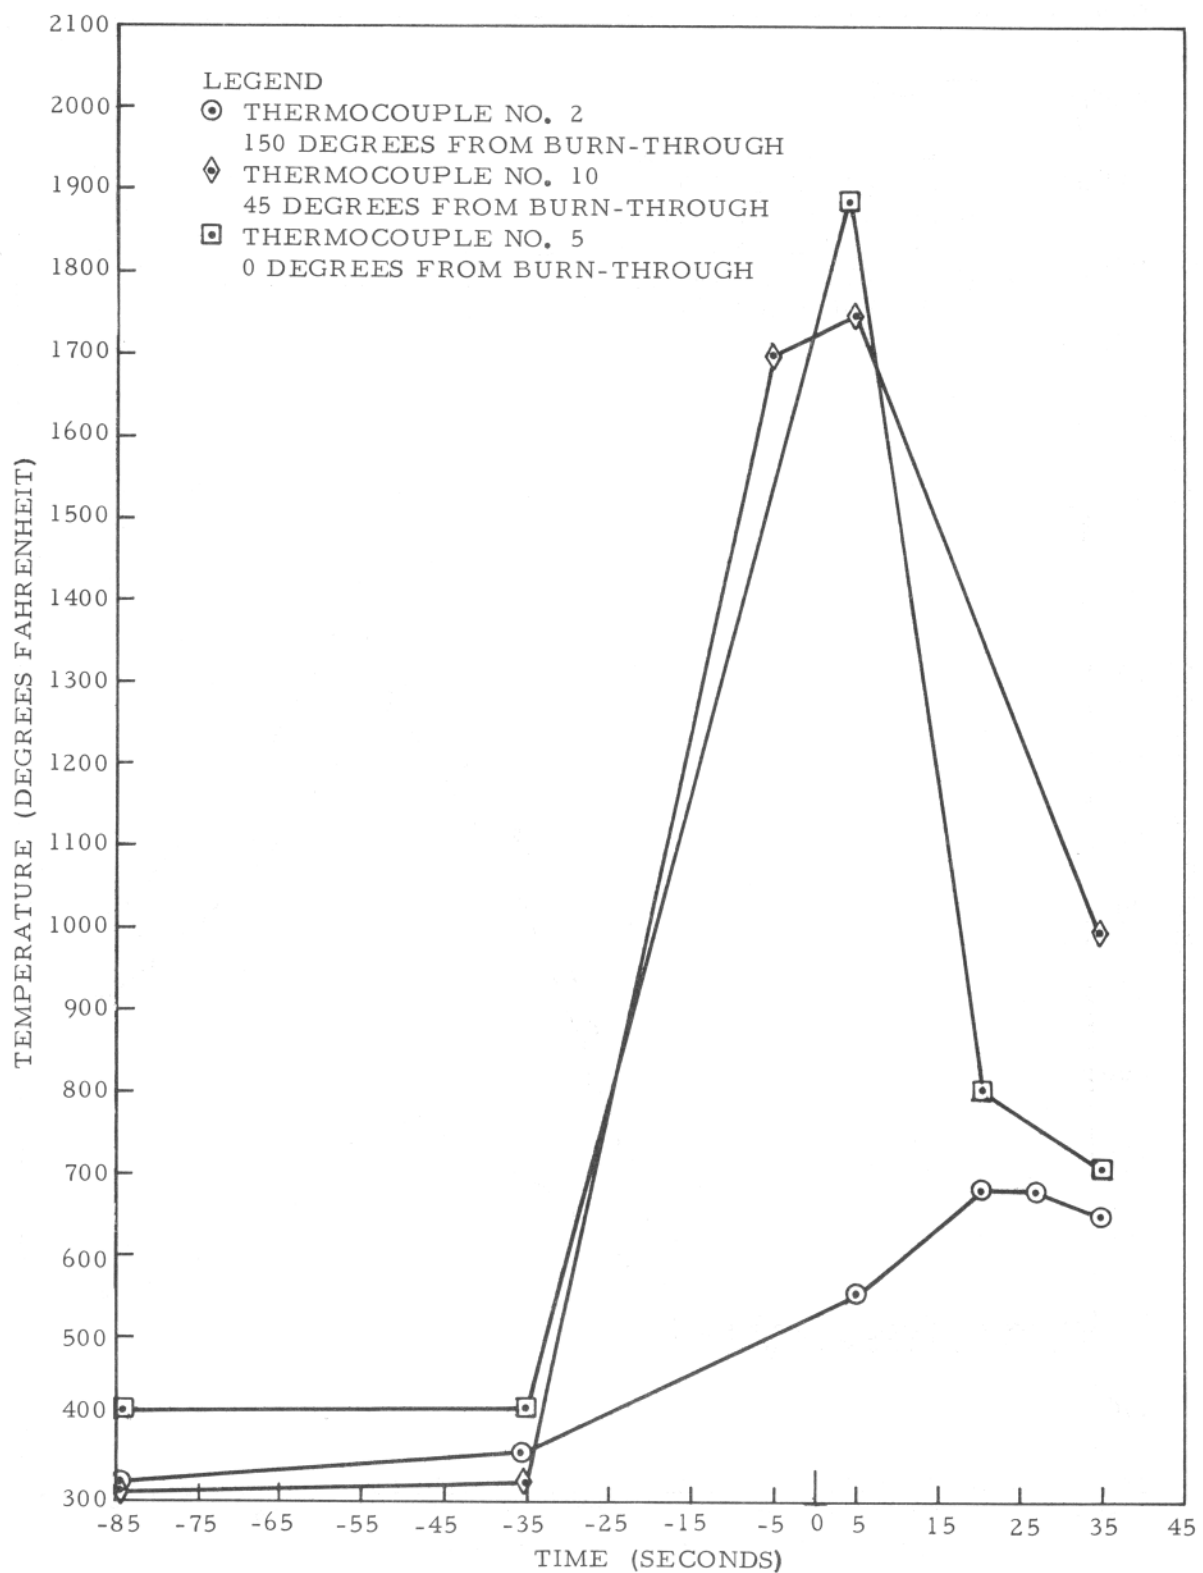
FIGURE 17. DIFFUSER CASE TEMPERATURES DURING TEST NO. 1

Test No. 1. Figures 17 and 18 show the temperature profile of selected thermocouples on the diffuser case and the burner can case prior to, during and after a burn-through. The thermocouples in the general proximity (within 45°) showed a rapid and large increase in temperature beginning 40 seconds prior to burn-through. The thermocouples located approximately 150° around the engine from the burn-through also showed an increase in skin temperature, but of a much lower magnitude.

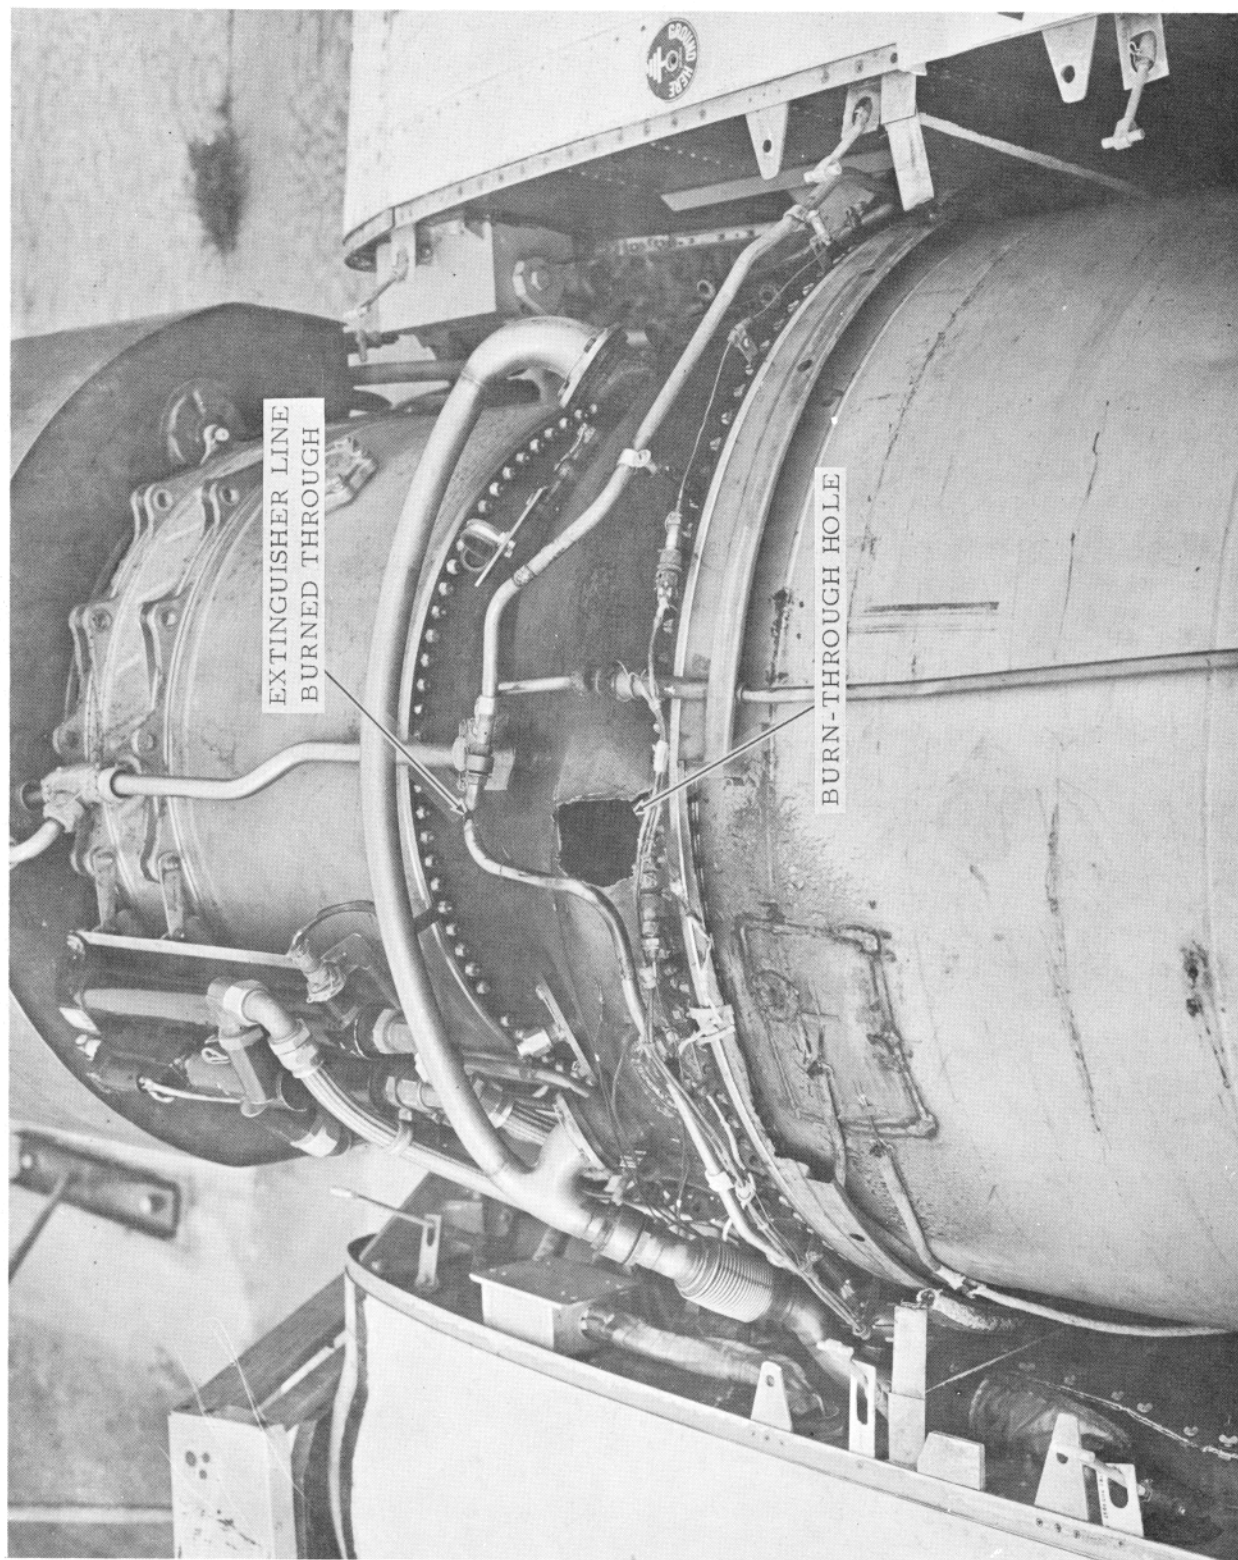
FIGURE 19. J57 BURN-THROUGH DAMAGE, TOP VIEW

Figures 19 and 20 show the damage, from this burn-through, to the diffuser case. The size of the hole was approximately 3 X 4 inches. (Note the holes in the stainless steel fire extinguisher discharge line.) Burn-through time for the 0.030-wall tubing was approximately 1 second.

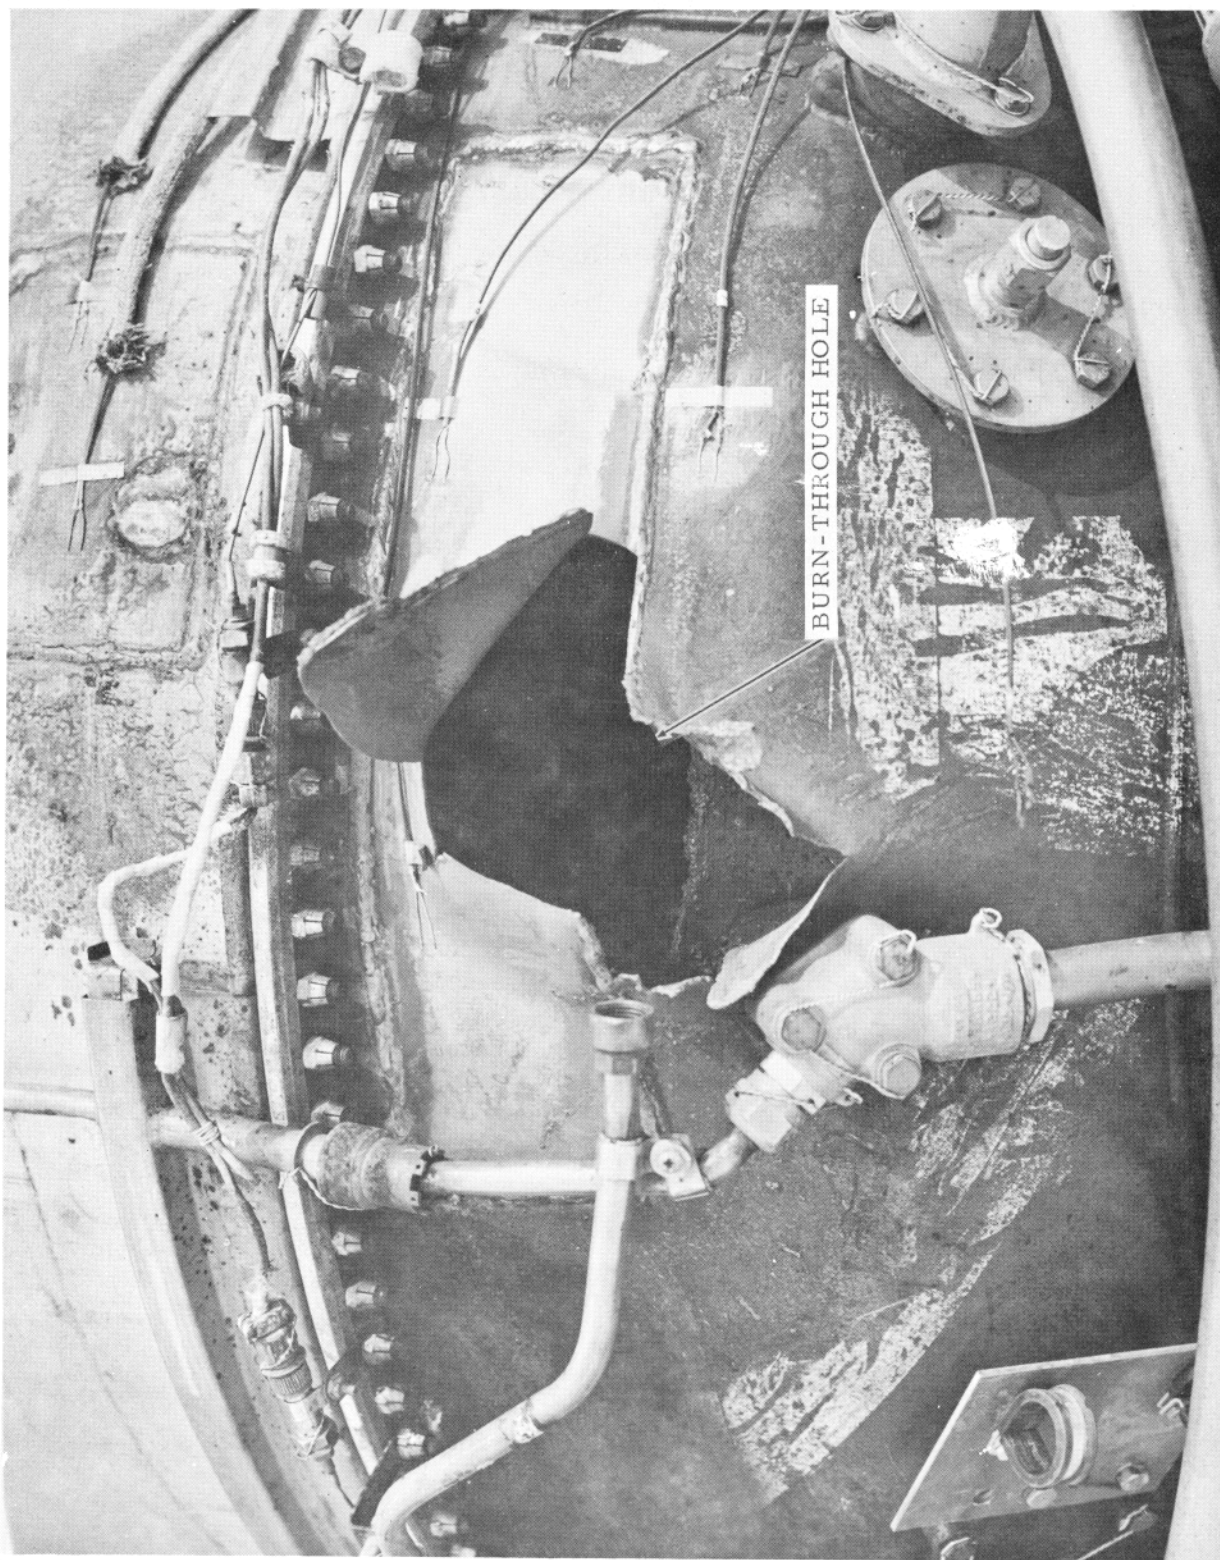
FIGURE 23. TEST NO. 2 BURN-THROUGH DAMAGE

Test No. 2. The results of Test No. 2 can be seen in Figures 21 and 22 and the resultant damage from the burn-through in Figure 23. The burn-through hole in Test No. 2 was slightly larger than that in Test No. 1. The results of the test was similar to the first test, except the magnitude of the temperatures was not as high. This could have been caused by an earlier rupture of the diffuser case due to its weakened condition.

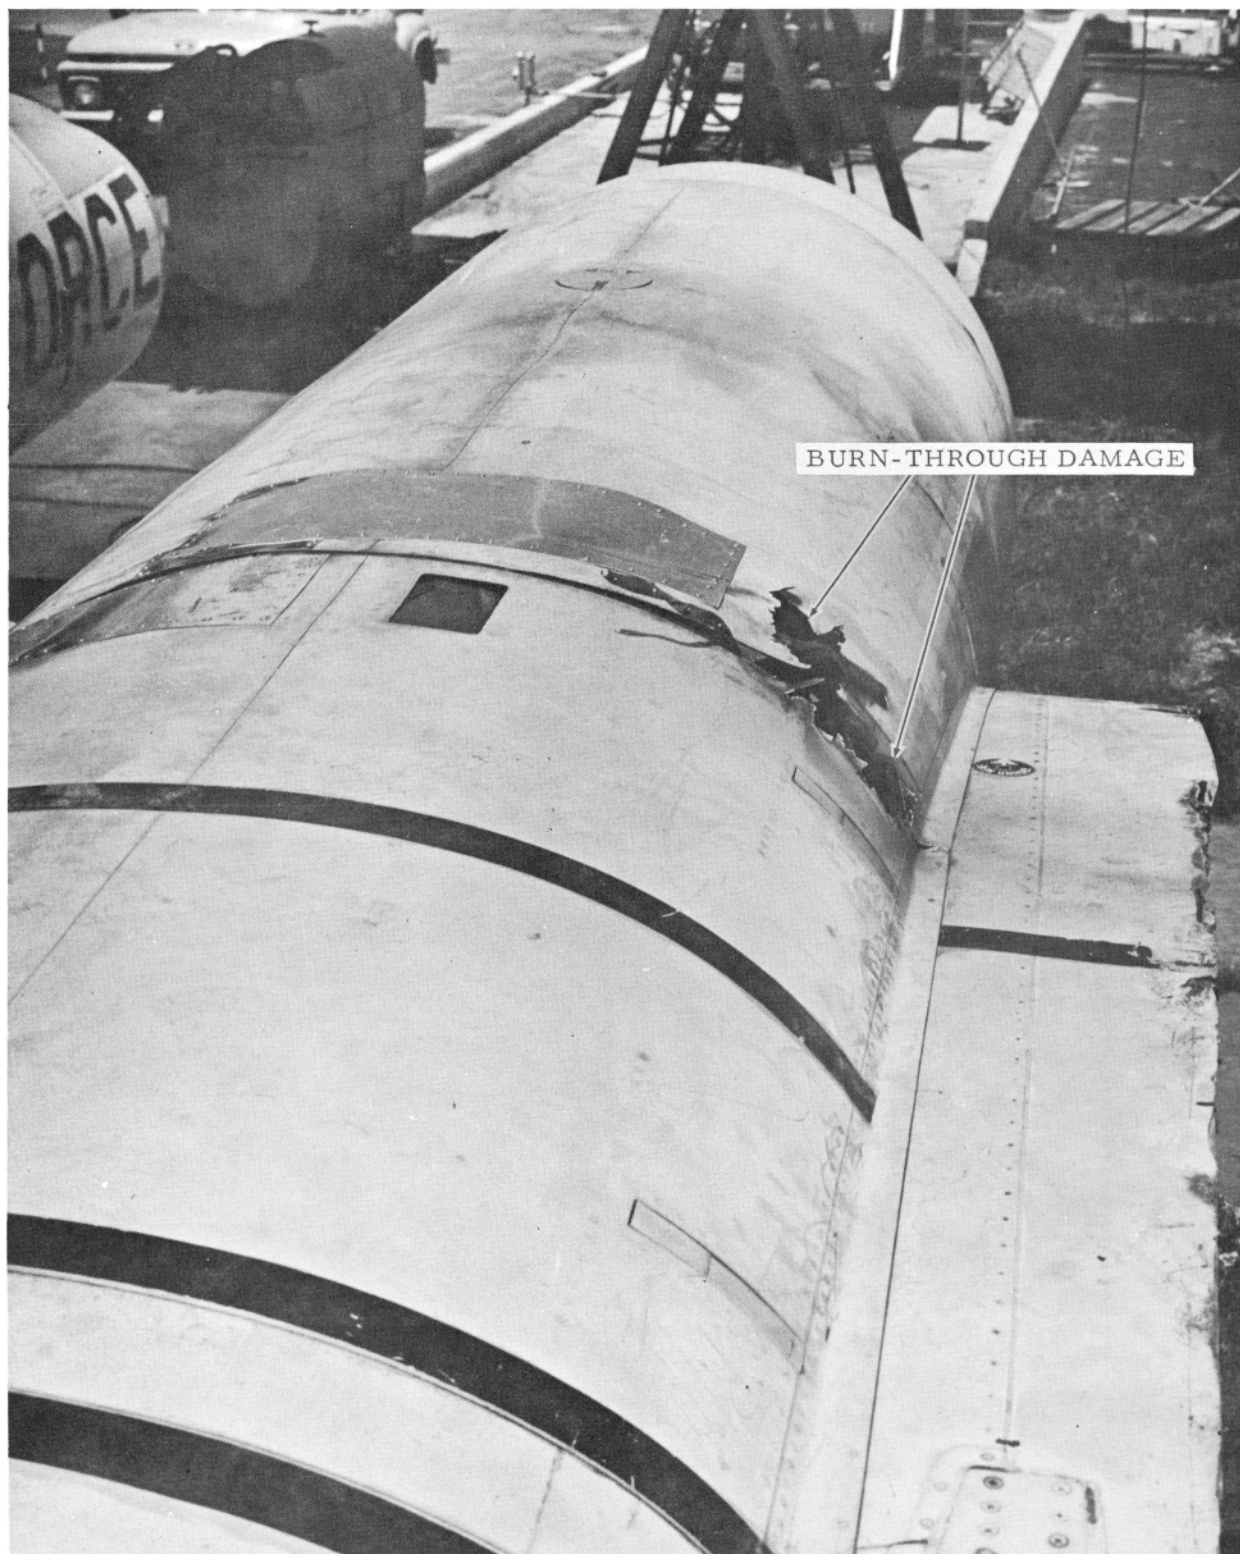
FIGURE 26. DAMAGE TO COWLING FROM BURN-THROUGH (TEST NO. 3)

Test No. 3. The results of this fully-cowled-engine test is shown in Figures 24 and 25. Figures 26 through 28 show the damage caused by the burn-through. Unlike the prior two tests, the burn-through occurred in the burner can case an inch or so aft of the split line. A smaller secondary burn-through did occur just forward of the split line in the diffuser case. As a result of the location of the burn-through, the burner can case showed a much higher peak temperature than the diffuser case, whereas, the diffuser case still showed a much larger area of temperature rise.
