IN-SERVICE HISTORY OF THERMAL/ACOUSTICAL INSULATION

Steve Giordano, Director of Marketing, The Mexmil Company, Santa Ana, California
Dave Indyke, Manufacturing Improvement Mgr., The Mexmil Company, Santa Ana, California

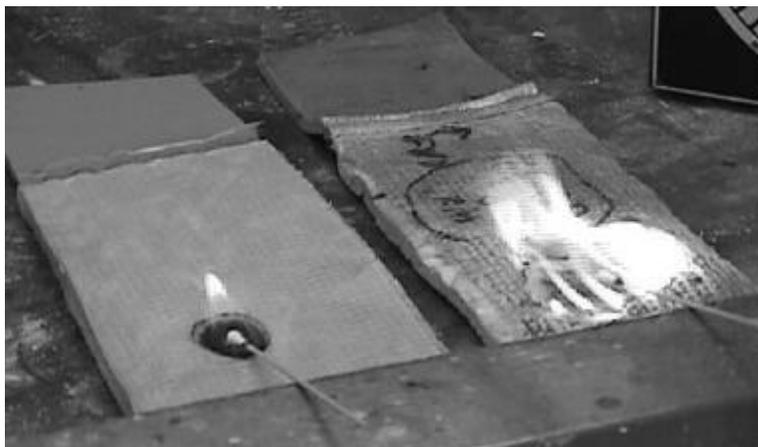
FIGURE 1: HORIZONTAL FLAME PROPAGATION TEST #1

Figures 1 and 2 are photographs taken during two different tests in which samples of new and used insulation blankets were ignited simultaneously. The new ones are on the left in each. Holes approximately the sizes of the flaming cotton swabs were burned in each, but no propagation occurred. On the used blankets, the flames were self-sustaining, became enlarged, and spread far from the initial spot of ignition.

Horizontal flame propagation tests were performed on 100 mm (4 inches) × 300 mm (12 inches) sections of used and new insulation blankets. The specimens are lain flat, and a draft fan is turned on in the test cabinet to simulate airflow across their surfaces. Flaming cotton swabs are applied as in the BSS 7358 method. Johns Manville Corporation is developing this procedure.

Flame spreads on the new blankets tested were always less than 20 cm (8 inches) from the point of ignition. The used blankets invariably gave burn lengths exceeding 20 cm (8 inches). This pass/fail criterion was adopted from the regular flame propagation protocol.

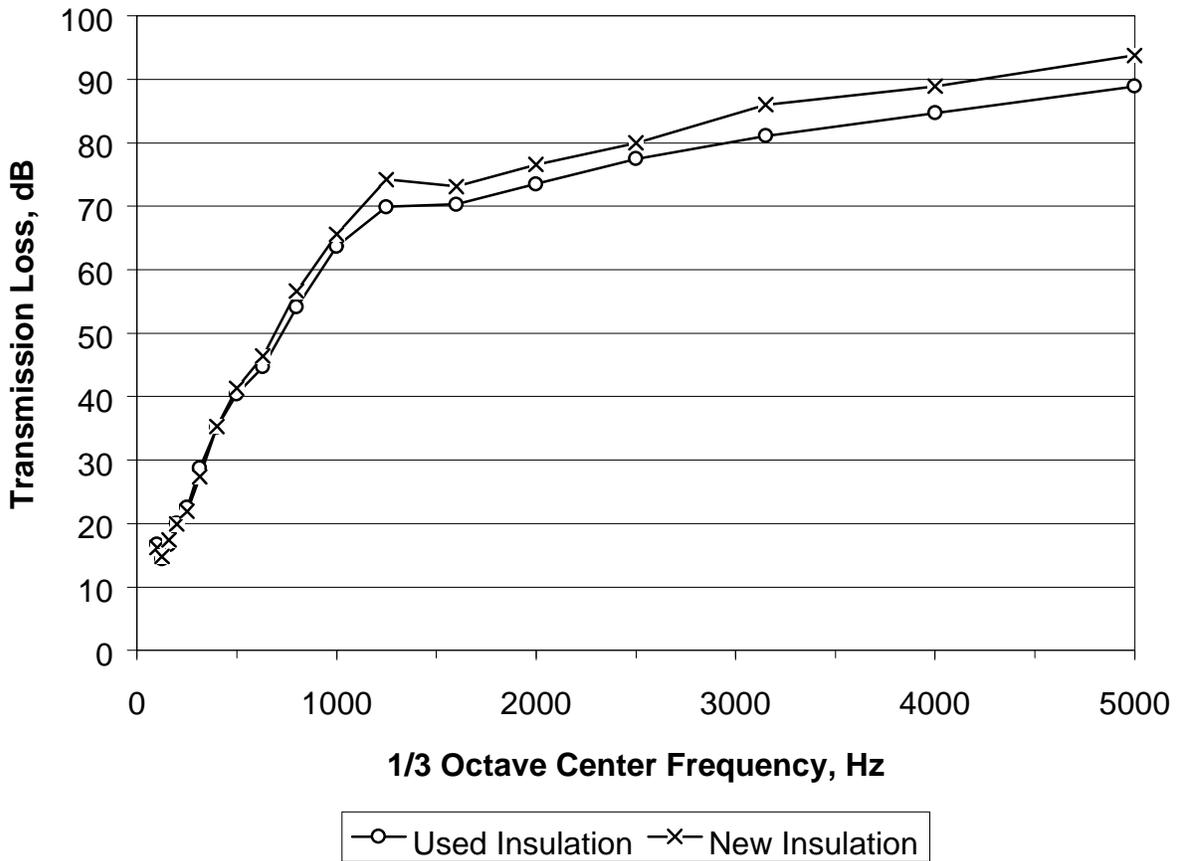
FIGURE 3: SOUND TRANSMISSION LOSS DATA

Acoustical performance of used versus new insulation blankets was measured by the sound intensity technique of the ISO 140-5 draft standard. A mock passenger jet aluminum sidewall about 0.17 m (70 inches) square was mounted in the opening between a reverberation room and a hemi-anechoic chamber. Two window blankets were installed in the middle of one side of this partition. Areas not covered by the test specimens were filled with insulation materials common to the tests. The inboard side was enclosed with a mock cabin liner panel. A diffuse sound field was generated in the reverberation room on the skin side of the partition, and the noise received on the inboard side in the hemi-anechoic chamber was picked up by a scanning microphone and averaged across the surface. Transmission loss values for 1/3 octave bands of frequencies between 100 Hz and 5 kHz were calculated from the differences in sound intensities on each side. Figure 3 illustrates the results.

Transmission loss is an indicator of the noise blocking capabilities of the product tested. The used blankets show consistently lower performance than the new ones throughout the critical speech interference level or SIL from about 800 Hz to 2 kHz. The magnitudes of the differences are in the range of 2-5 dB, which is significant, especially considering that part of the partition was blanked in this comparison.

Airflow resistivities of fibrous glass batts are considered to be directly related to transmission loss. Therefore, the used batts should have lower air flow resistivities than new ones according to the results of the acoustical tests. As Table 4 shows, the data confirm this relationship. Fibrous glass batts only from new and used blankets were tested according to ASTM C 522.
