Development of a Laboratory Scale Burnthrough Test for Thermal Acoustic Insulation

Abstract. This report summarizes the research and laboratory-scale tests undertaken by the Federal Aviation Administration (FAA) to develop a standardized test method for evaluating the postcrash fire burnthrough resistance of transport category aircraft thermal-acoustic insulation. Over sixty laboratory scale tests were conducted in various test rig configurations on a variety of insulation materials in an effort to establish a repeatable test condition that was representative of the threat likely to occur from a large external fuel fire. The finalized test apparatus utilizes an oil-fired burner adjusted to produce a flame temperature of 1900°F and accompanying heat flux of 16.0 Btu/ft²sec. The burner output cone was situated 4 inches from the plane of the specimen holder frame, at an angle of 30° with respect to horizontal. This configuration yielded results that correlated with previous full-scale tests using identical materials.

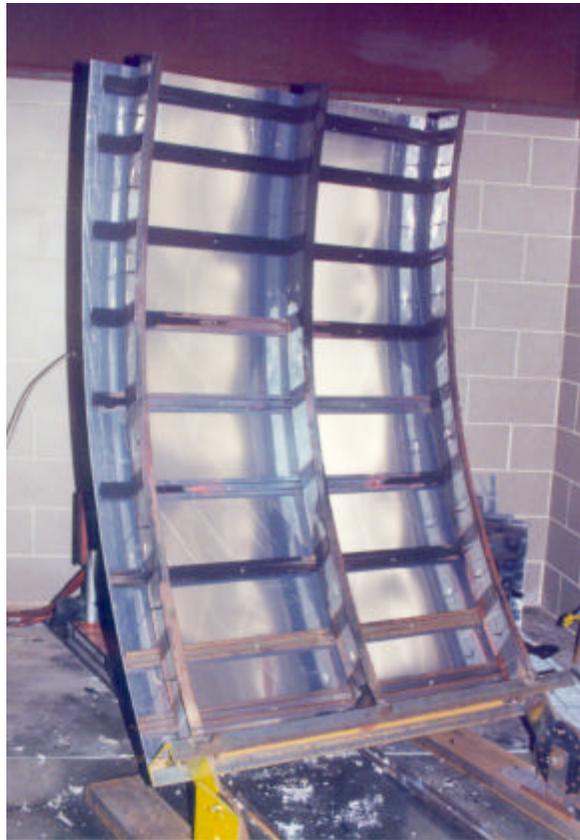
Figure 3. Curved Test Rig

Because of the problems associated with the sample holder and the attachment process in the initial box tests, a larger surface area rig was constructed to more closely resemble a generic aircraft structure. The new steel rig incorporated curved “Z” section formers oriented vertically and hat-shaped lateral stringer pieces (figure 3). This enabled the attachment of the insulation to the test rig using in-service type fasteners. The entire test frame was capable of being rotated to produce a variety of impact angles by the burner flame. Since an actual crash fire situation could result in an infinite number of possibilities regarding the location of the fire with respect to the fuselage, this flexibility would allow a determination of the critical, or most severe angle from a burnthrough standpoint.

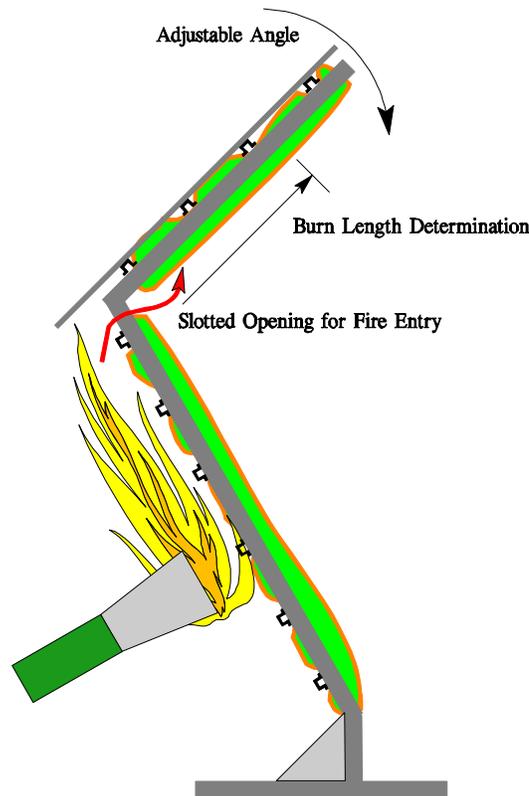
Figure 6. Combined Test Apparatus for Determining Flame Propagation and Burnthrough

Although the concept of a single fire test for insulation had its merits, the development proved to be difficult. As shown during earlier burnthrough tests using the improved test rig (figure 5), the flammability of the insulation surface was directly related to the blankets' burnthrough resistance. If a highly burnthrough resistant insulation material was tested and little or no flames penetrated the sample, there was a reduced likelihood that propagation would occur along the back surface of the test sample. Conversely, when the same film was used in conjunction with a material that allowed rapid burnthrough, there was an increased likelihood that propagation would occur along the back surface of insulation. In order to separate these 2 events in the same apparatus, the upper test frame section was separated slightly from the lower section to produce a slotted area (figure 6).

As shown, the intent of the slotted area was to allow a small portion of the intense burner flame to impinge the lower surface of the upper insulation blanket in order to measure ignition/flame propagation. Simultaneously, the majority of the intense burner flames impacted the lower insulation sample, to measure the burnthrough resistance. Several tests were run but the results had a high degree of scatter, as it was difficult to control the amount of flames entering the slotted area to impact the sample. It appeared that a smaller, more consistent flame was required to fully evaluate the ignition/flame propagation qualities of the insulation. The large, fluctuating flame

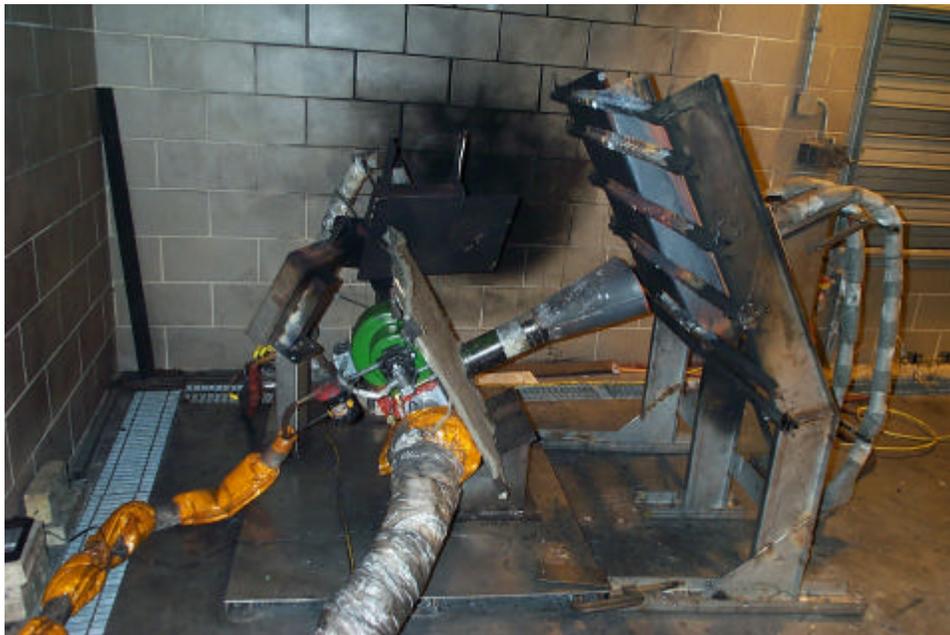
Figure 15. Finalized Burnthrough Test Rig

The finalized test apparatus is shown in figure 15. As discussed previously, the proposed test subjects the insulation blanket specimen to an intense, oil-fired burner flame for a period of 4 minutes. The burner intensity is adjusted to produce a flame temperature of 1900°F and heat flux of 16.0 Btu/ft²sec. The burner cone exit plane is situated 4 inches from the face of the test frame, at an angle of 30° with respect to horizontal.

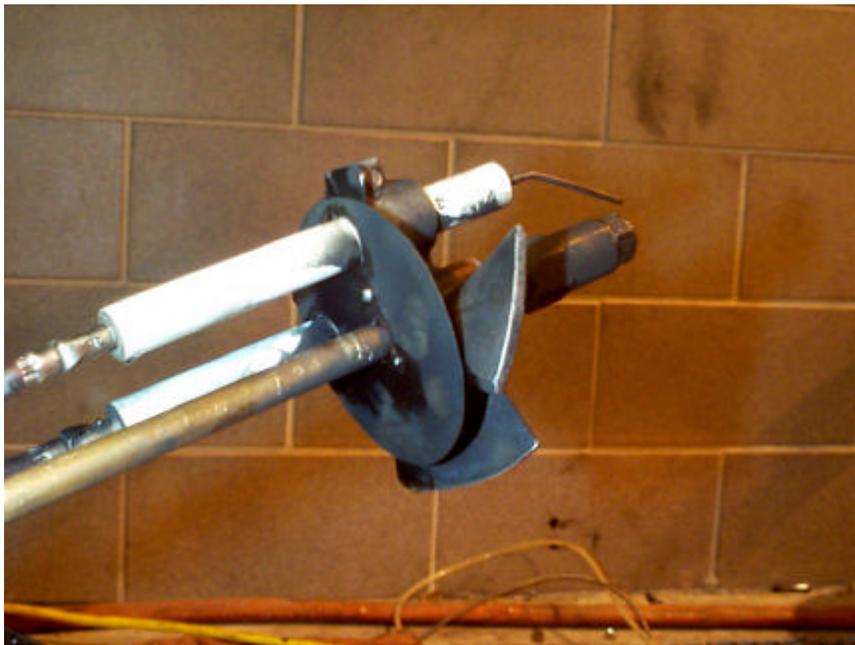
Figure 19. Static Disc Mounted to Mid Stator

Several burners also included a “static disc” that was intended to stabilize the burner flame, while other units were not supplied with it (figure 19).

An exhaustive study found that only one combination of stator types was capable of producing a consistent and even flame (Monarch H215 mid stator without static disc, and Monarch F124 end stator).

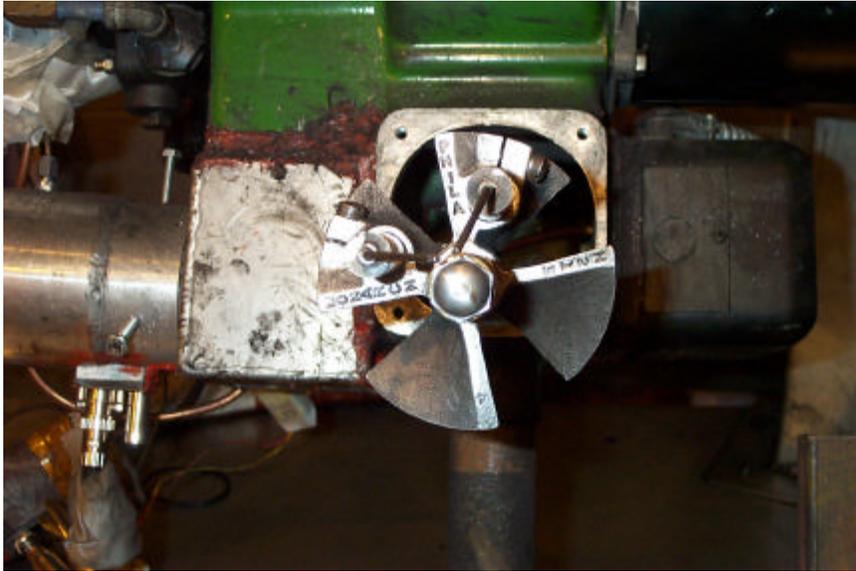
Figure 20. Preferred Position of Igniters to Achieve Calibration

The switch from a semi-solid conical-spray patterned fuel nozzle to a hollow cone nozzle also aided in the evening of the flame profile. In addition, many parameters including the temperature of the fuel and air entering the burner, the position of the igniters, and the position of the stator in the draft tube also affected the flame profile. It was determined that in order to achieve the best calibration, the igniters needed to be set at approximately 10 o'clock when viewed from the draft tube end (figure 20).
