**DOT/FAA/AR-99/87**

# **Vertical Drop Test of a Shorts 3-30 Airplane**

November 1999

Final Report

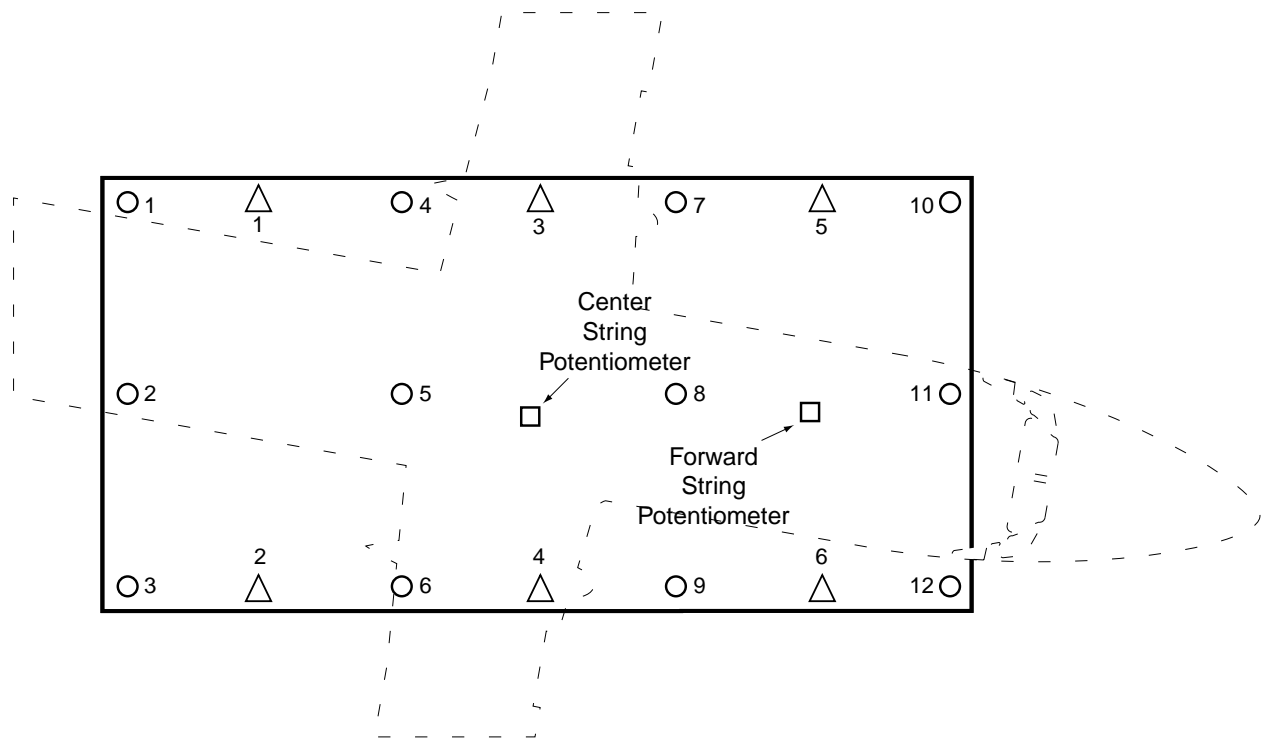
The impact platform rested on 12 Sensotec model 41 (dual-bridge A, B) load cells, numbered 1 to 12, each with a load capacity of 50,000 pounds, figure 5. A hydraulic jack was located above each load cell, and each jack was plumbed to a central hydraulic system. Prior to the drop test, the platform was raised off the ground, leveled, and isolated from the hydraulic system by closing a shutoff valve located at each of the respective jacks. Just prior to the drop test the platform tare weight was electronically zeroed by the computer system. The platform load cells measured the reactive forces generated during the impact of the airplane and were used to measure the impact loads and determine their distribution.

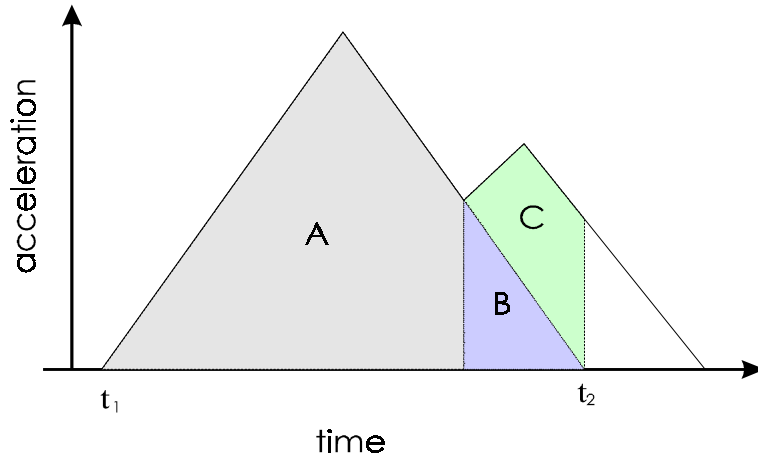
FIGURE 9. TYPICAL PRIMARY AND SECONDARY IMPACT PULSE

The data in the appendix indicates that the airplane experienced a secondary pulse at some fuselage stations during the impact. To determine the  $G_{max}$  level of the impact, only the primary pulse is used and the secondary pulse is considered inconsequential. However, the secondary pulse could cause erroneous values in calculating  $G_{max}$ . To compensate for the secondary pulse in the  $G_{max}$  calculation, the total velocity change was computed by combining the primary and secondary pulse as shown in figure 9. Figure 9 is a simplified presentation of a primary and secondary pulse. To compensate for the secondary pulse in the  $G_{max}$  calculation, the total velocity change was computed by adding from time  $t_1$  to time  $t_2$  to include areas A and B but not C.

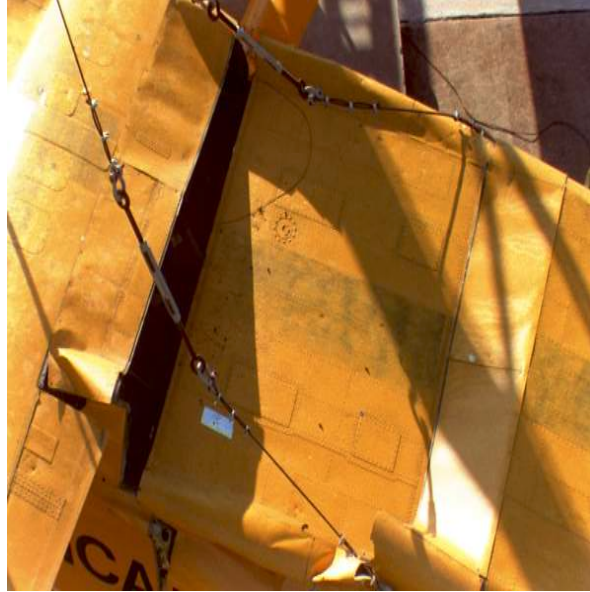
FIGURE 13. FUEL CELL 4 COLLAPSED INTO FUSELAGE

All of the deformation seen in the upper section of the fuselage was caused by the loads imparted by the fuel tanks. This crushing is not as significant, in term of energy absorption, as is the lower section crush because crushing in the upper section does not reduce the loads seen by the occupants. Upper fuselage damage is more crucial with regard to maintaining a survivable volume. This issue will be discussed further in the following sections.

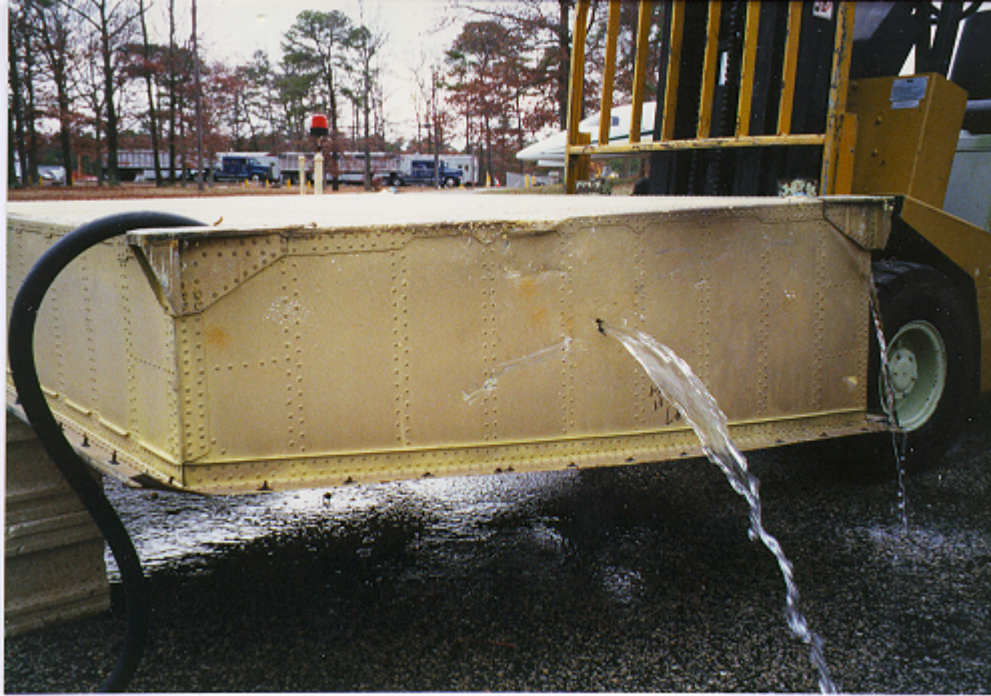
FIGURE 17. CRACK IN CELL 4 PILOT SIDE

The impact caused major cracks in both the pilot and copilot sides of the tank, figures 17 and 18, respectively. The four gravity feed outlets were crushed. Figure 19 shows typical gravity feed outlet damage. Simulated fuel also leaked from the cell 3 to 4 interconnect pipe.

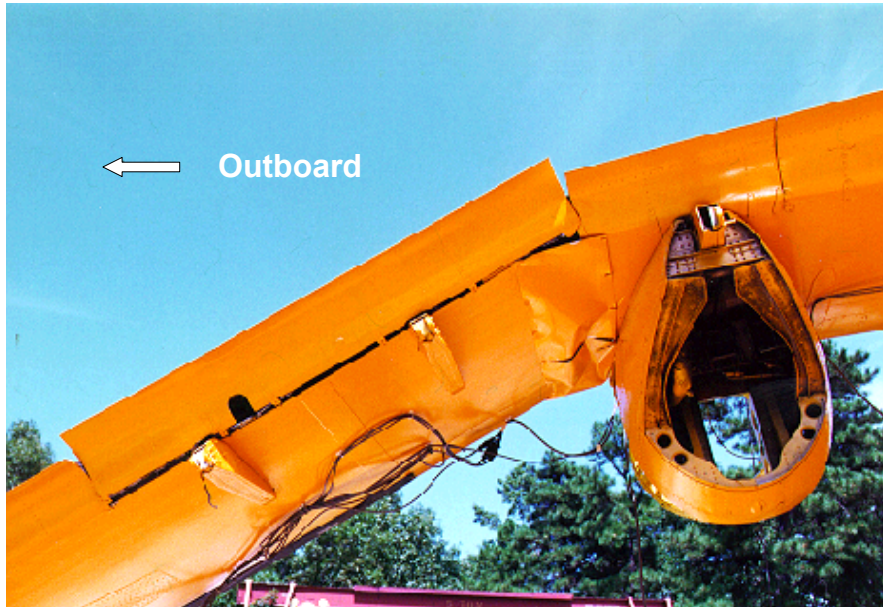
FIGURE 29. PILOT-SIDE WING DEFORMATION POSTTEST

Both wings experienced major structural damage during the test. The pilot-side wing displaced downward causing a compressive failure of the wing strut. The downward deflection of the wing was so severe that the wing tip was below the bottom of the fuselage. The final position of the fuselage was elevated on a platform which allowed the movement past the bottom of the fuselage. In an actual crash the wing tips would have come in contact with the ground. In addition, the simulated engine on the pilot side broke away from its mounting.
