# Fire Resistance Tests of Intumescent-Coated Self-Sealing Fuel Lines

Paul Boris  
Federal Aviation Administration  
Technical Center  
Atlantic City Airport, N.J. 08405

January 1983

Final Report for Period January 1979 - May 1981

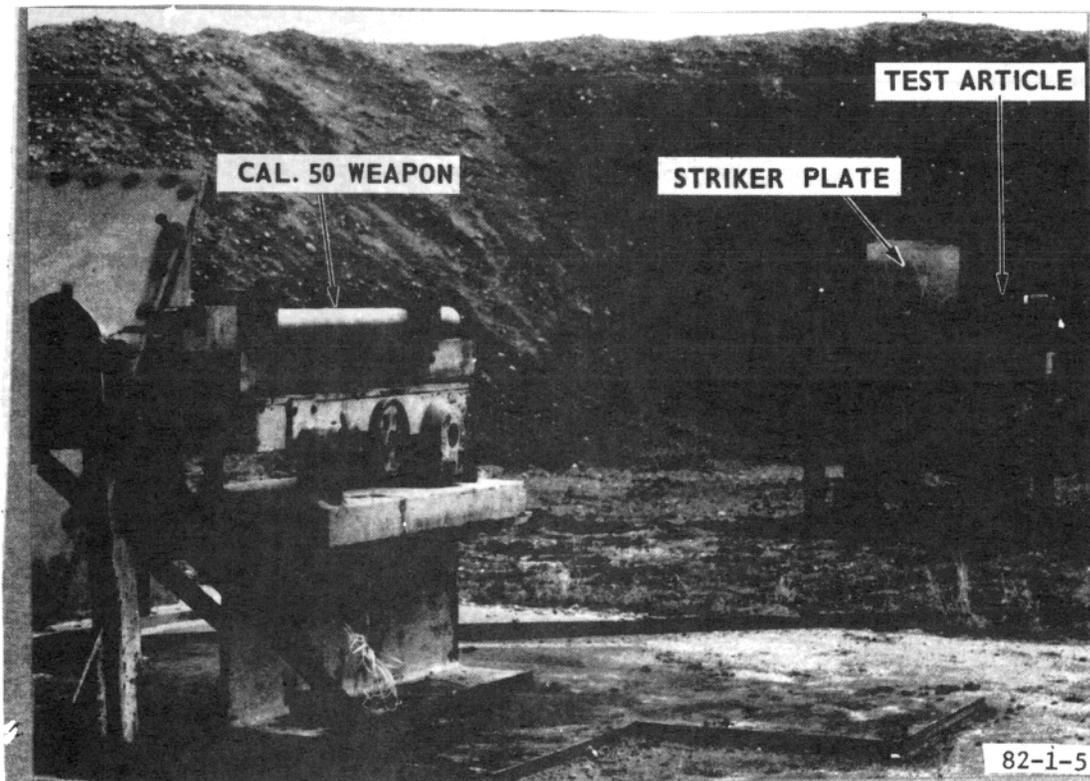
FIGURE 5. TYPICAL TEST SETUP FOR GUNFIRE TESTS

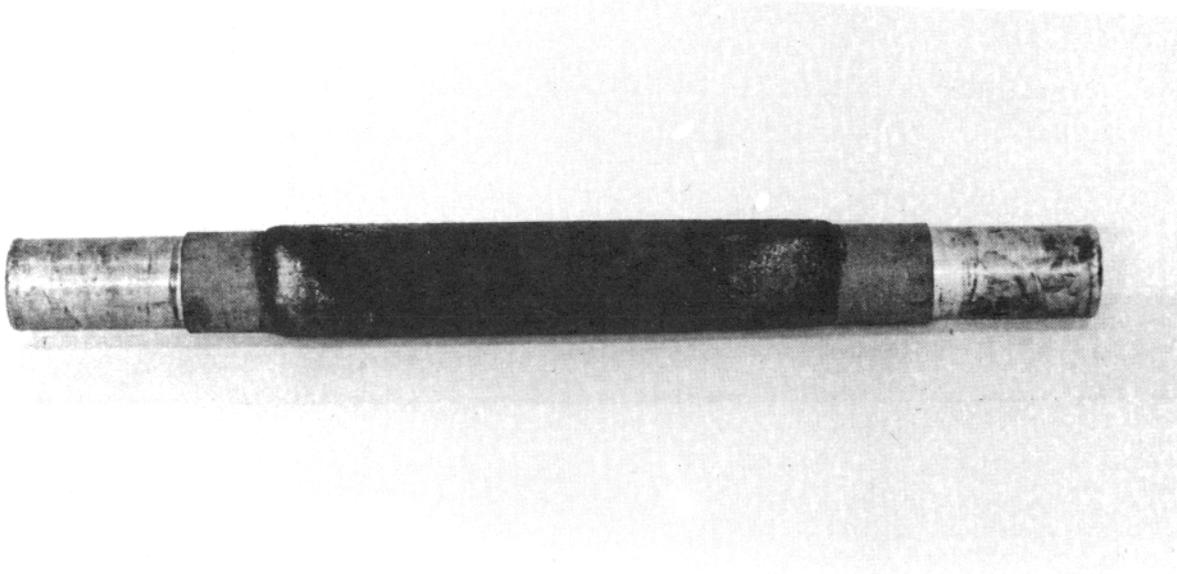
FIGURE 20. TYPICAL 3M COATED ALUMINUM TUBE AFTER TEST IN DRY BAY FIXTURE

When comparing the same product, there was little difference in the char developed by either the dry bay fixture or the FAA standard burner. Typical results are shown in Figures 18 through 23. It is surmised that the underlying aluminum tube, cooled by the circulating water, affected the intumescent action by limiting its growth. As described in a following section of this report, when the intumescent product was applied over an insulating sublayer, namely the self seal, the intumescent action increased. Figures 7 through 11 show the intumescent products as applied to the aluminum tubes prior to testing. Figures 18 through 22 show specimens after testing in the dry bay test fixture, and Figure 23 shows a typical result of exposure of the coated aluminum tubes to the FAA burner. The

fragile char of the AVCO and Ocean products was damaged in handling, and hence the tubes shown in Figures 18 through 23 do not truly indicate the condition of the tubes immediately following the tests. The lighter colored area visible on the AVCO 1400 coated tube in Figure 23 most readily depicts this damage and indicates an area where the char was almost completely jarred loose in handling.

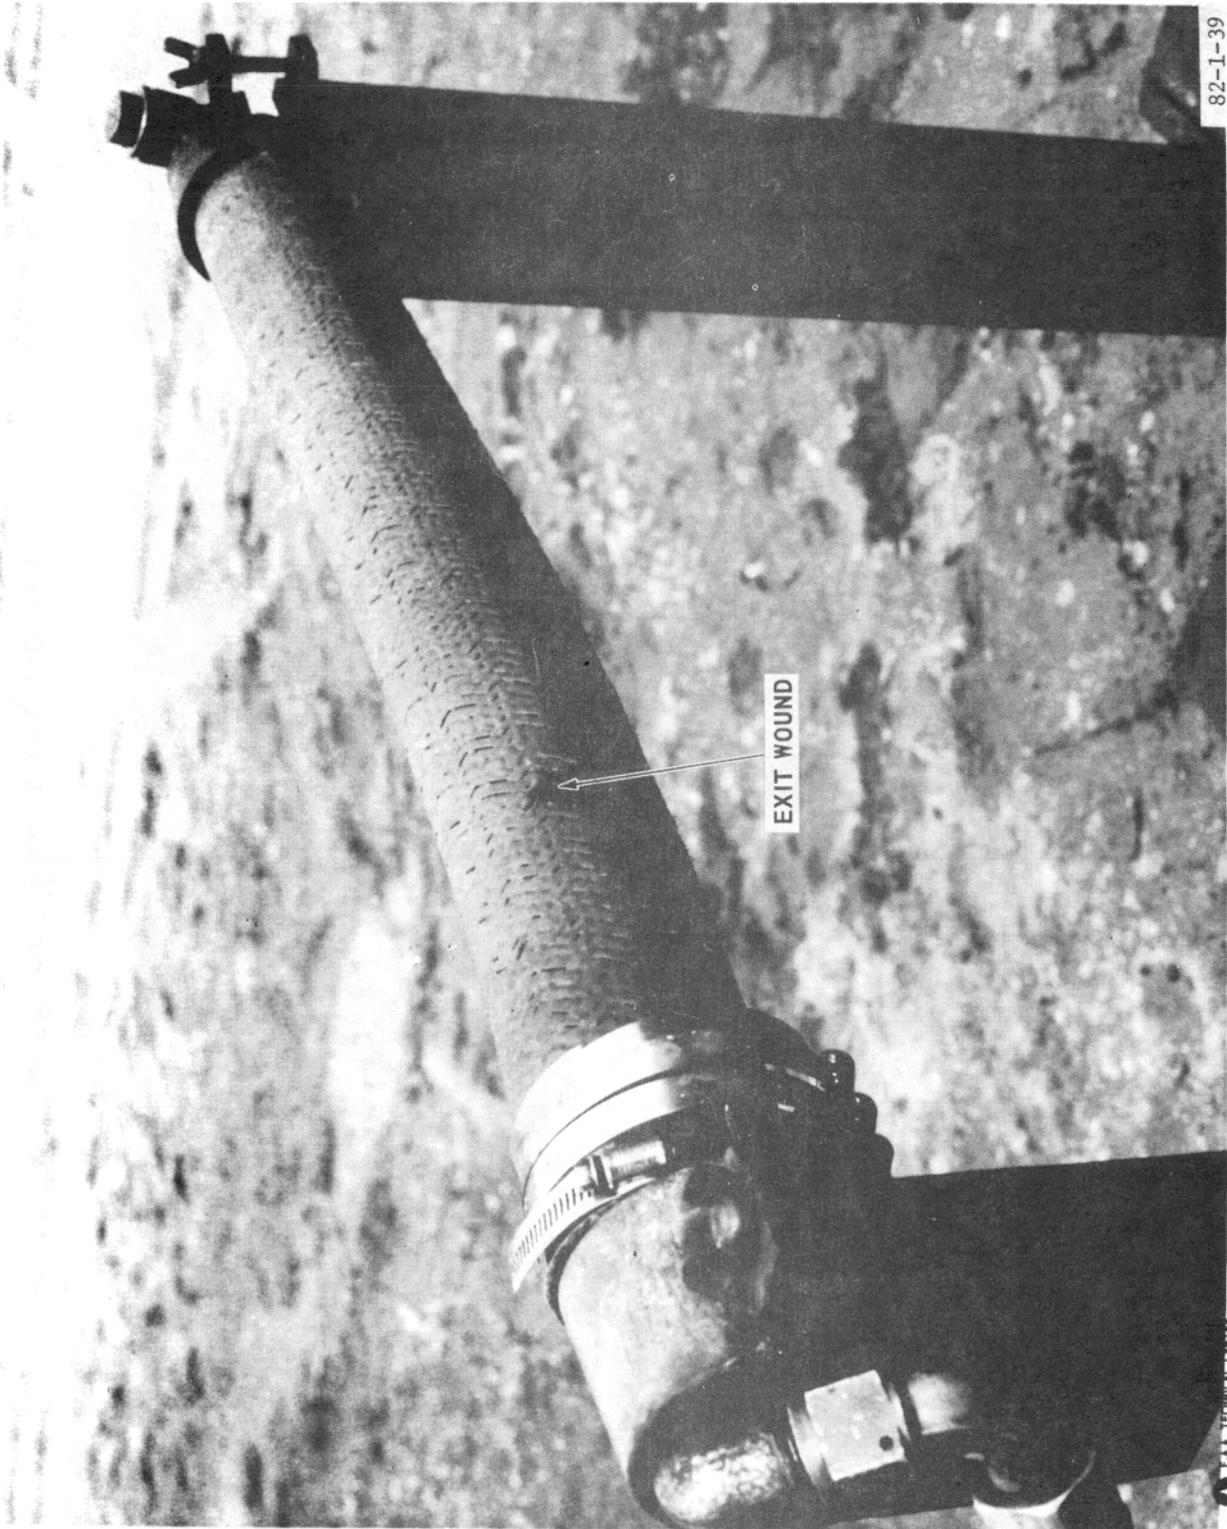
FIGURE 41. AP EXIT WOUND IN AVCO 1400 COATED AEROQUIP FUEL LINE

For those test specimens noted in Table 9 which did not leak after being impacted by an AP round, the entrance and exit wounds were fairly "clean" with only a few fibers protruding from the wounds. Since the type of intumescent coating did not appear to have any bearing on whether or not a line sealed, the intumescent/self-seal interaction aspect can be eliminated from further discussion herein. Of the four Uniroyal lines tested, three self sealed. The Uniroyal line that did not seal (No. 121) had a massive leak resulting from a large exit wound. In five other test shots, large gaping exit wounds resulted which made it impossible for a self seal to be effected. Tube Numbers 102, 114, and 128 were also noted as leaking, but these leaks can be described as relatively minor with only a small spray or dribble. The size of the entrance and exit wounds did vary, with the most variation occurring in the exit wounds. In some cases exit wounds were "clean," and in others a large ragged hole resulted which was characterized by an opening up or petaling of the inner metal tube. The Aeroquip lines did not have an inner aluminum tube and, consequently, did not fail in this manner. Although three of four Aeroquip lines did not seal, the leakage was small in all except No. 103. Table 9 indicates that when entrance wound leaks resulted they were small, whereas exit wound leakage varied. The cause of the variability of the exit wounds was not determined, but some possible causes could have been the onset of projectile tumbling or the deviation of the projectile from a straight line as the projectile passed through the fluid-filled line. Deformation of the AP projectile was not considered a factor, since several were recovered from the dirt mound backstop and no deformation was noted. In any case, where entrance and exit wounds were "clean" there was little or no leakage.
