POSTCRASH FUEL FIRE HAZARD MEASUREMENTS IN A WIDE-BODY AIRCRAFT CABIN

FINAL REPORT

1. Report No. FAA-NA-79-42		2. Government Accession No.		3. Recipient's Catalog No.	
4. Title and Subtitle POSTCRASH FUEL FIRE HAZARD MEASUREMENTS IN A WIDE-BODY AIRCRAFT CABIN				5. Report Date December 1979

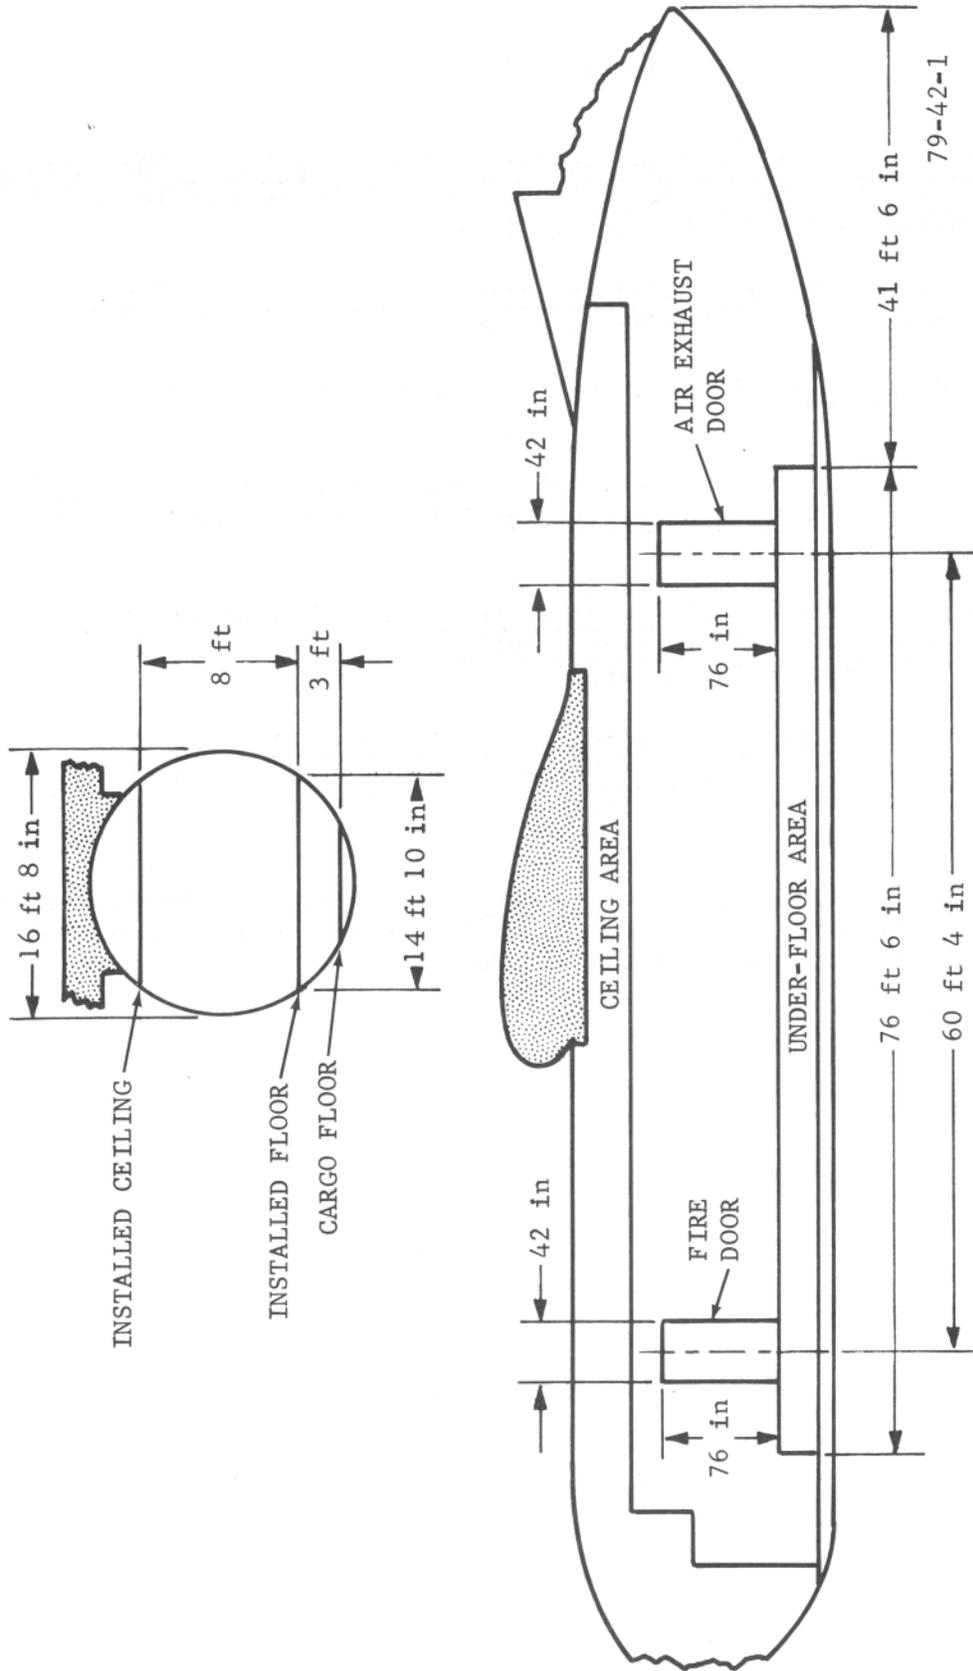
FIGURE 1. C133 WIDE-BODY CABIN FIRE TEST ARTICLE

A surplus United States (U.S.) Air Force C133A cargo aircraft, with the wings and tail surfaces removed, was utilized as the test article. This aircraft provided internal dimensions similar to those of wide-bodied jets currently in airline service. The C133 fuselage diameter is 200 inches, and internal usable length for test purposes is approximately 118 feet (figure 1). The fuselage cargo area was modified by the installation of a metal-covered plywood floor and a fire-resistant ceiling to provide an 8-foot floor-to-ceiling height. The cockpit area was sealed off and not used during the test program. The modification of the cargo area resulted in a calculated volume of interior airspace of 13,200 cubic feet (ft³).

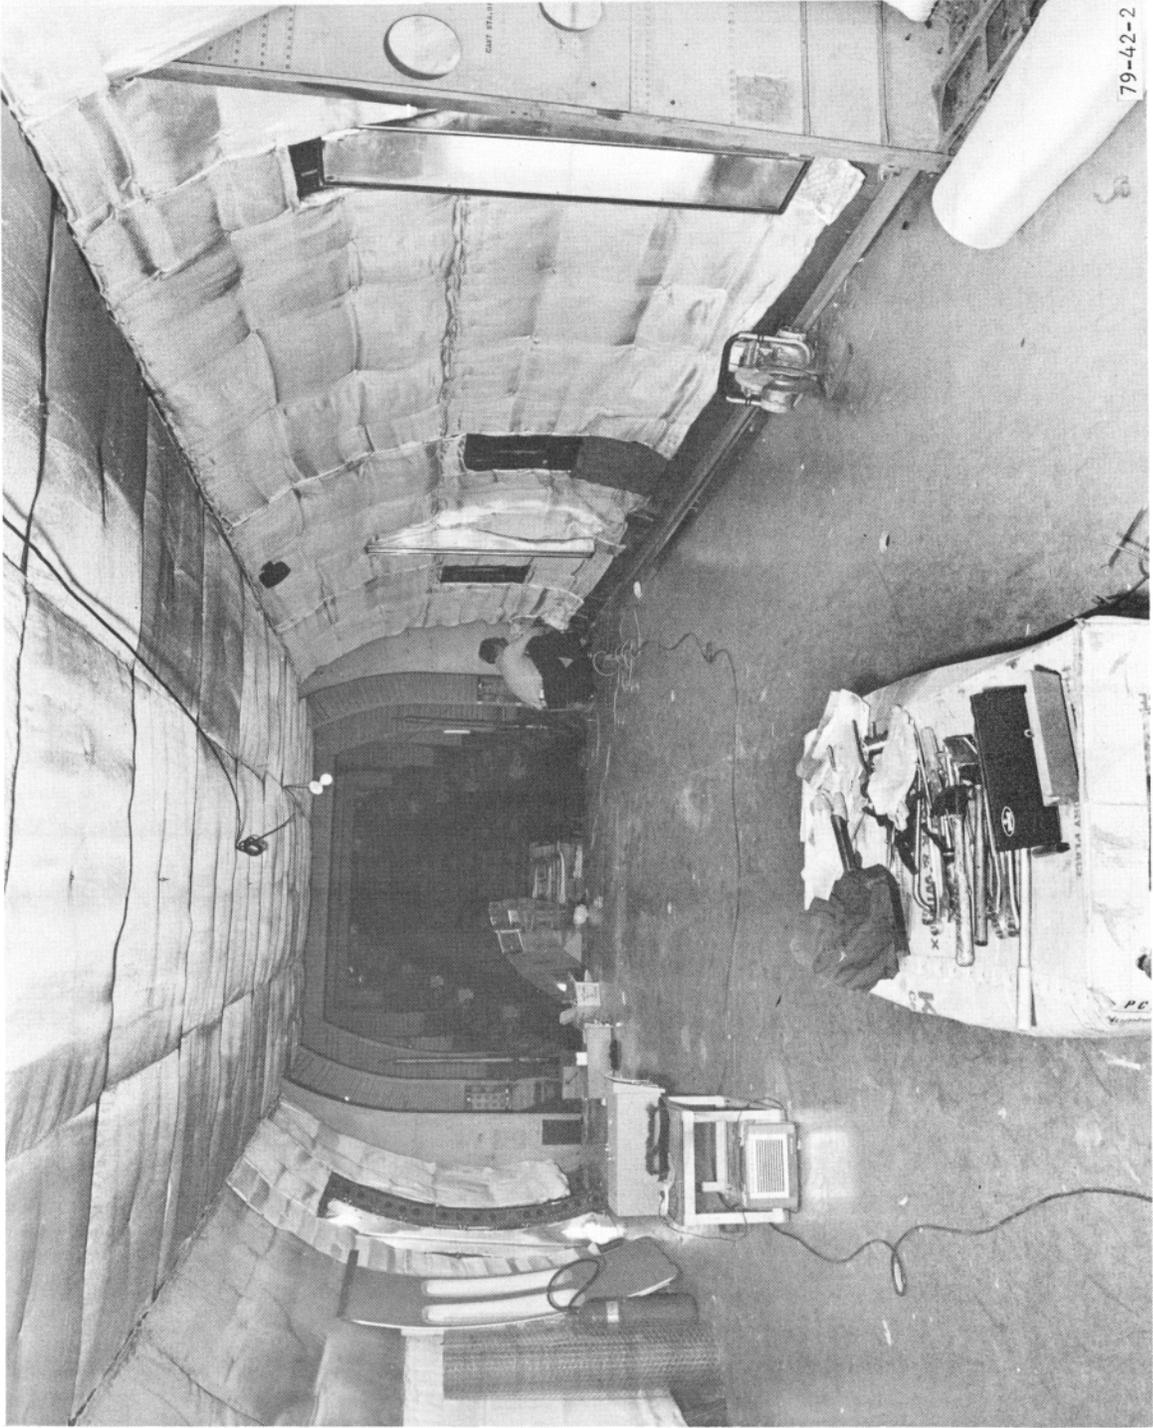
FIGURE 2. INTERIOR VIEW OF C133 PRIOR TO TESTING

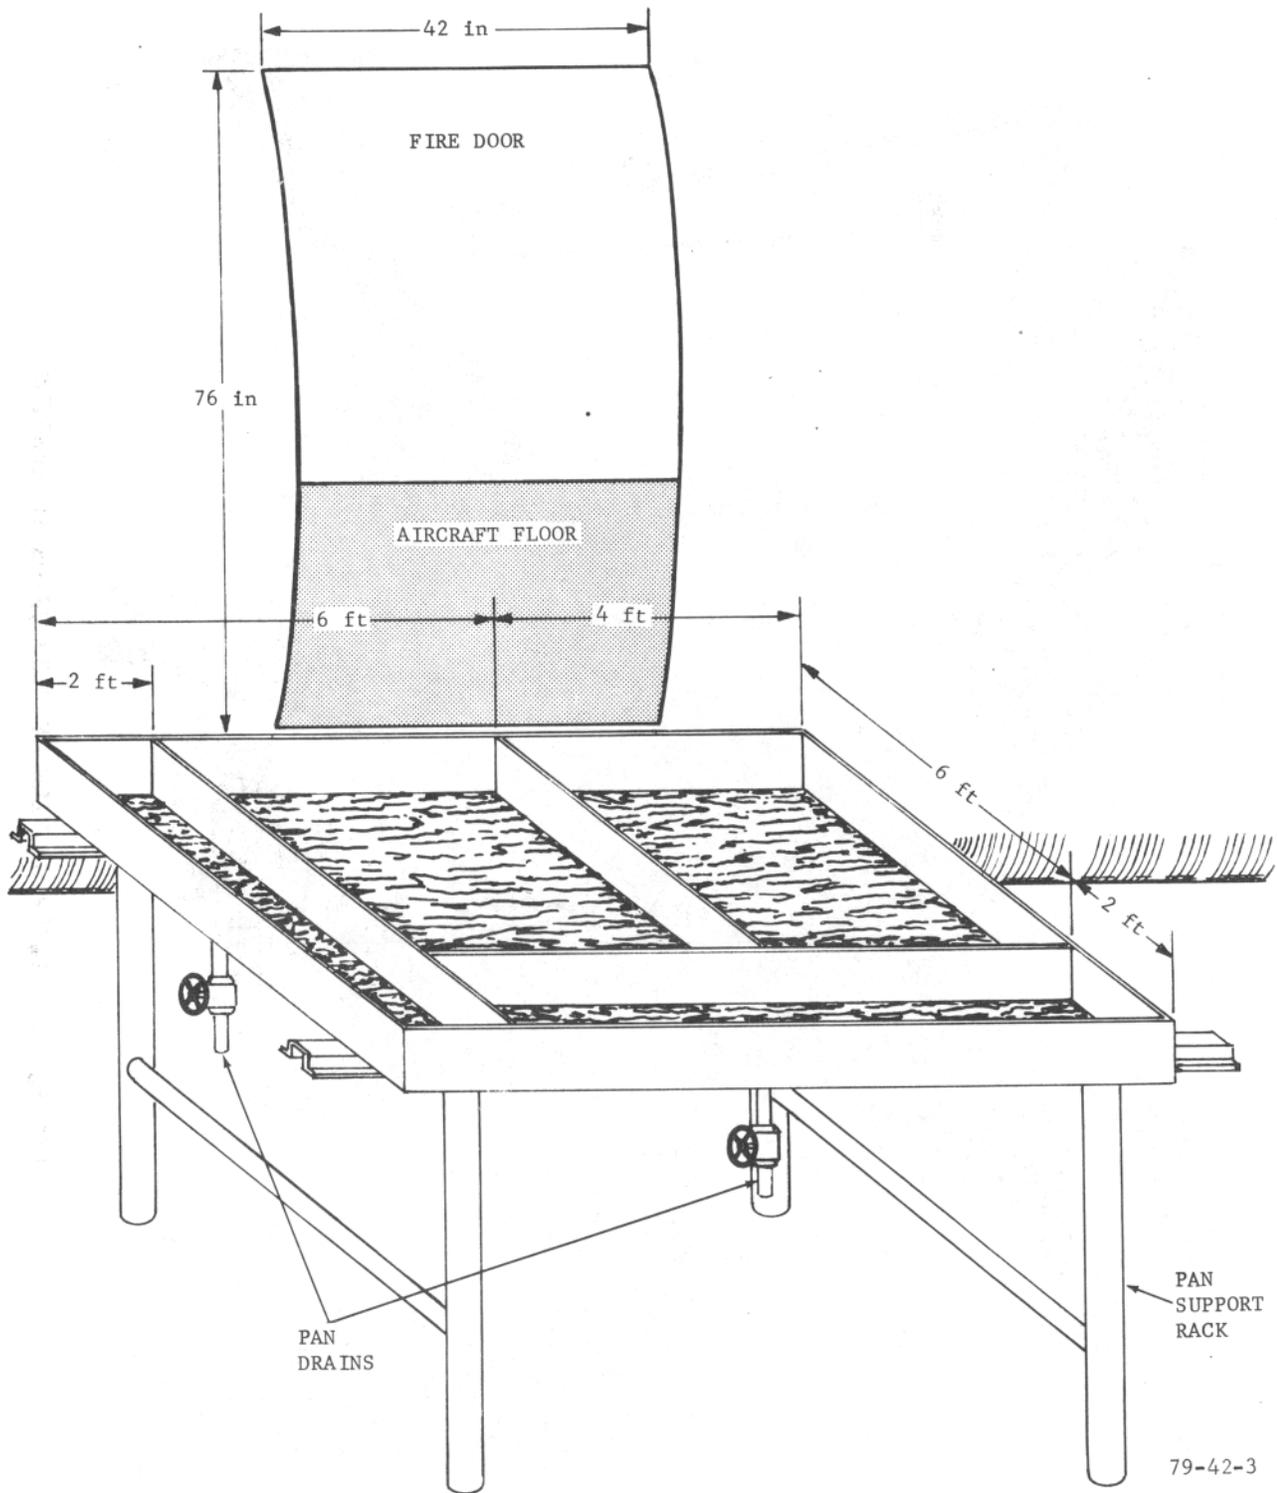
79-42-3

FIGURE 3. FIRE PAN INSTALLATION

The external fire was provided by a measured amount of jet fuel (JP-4) placed in steel pans of various sizes located on a framework adjacent to the fire door. The fire pan was located at the bottom edge of the door, rather than on the ground, in order to best assure that a solid sheet of flame would cover the entire door opening, as would result from a large ground fuel fire. There were four pans, all having a 4-inch-sidewall height. These pans were used singly or grouped together to provide the necessary area required for any particular test (figure 3). Pan sizes were as follows: two 6- by 4-foot pans and two 8- by 2-foot pans.

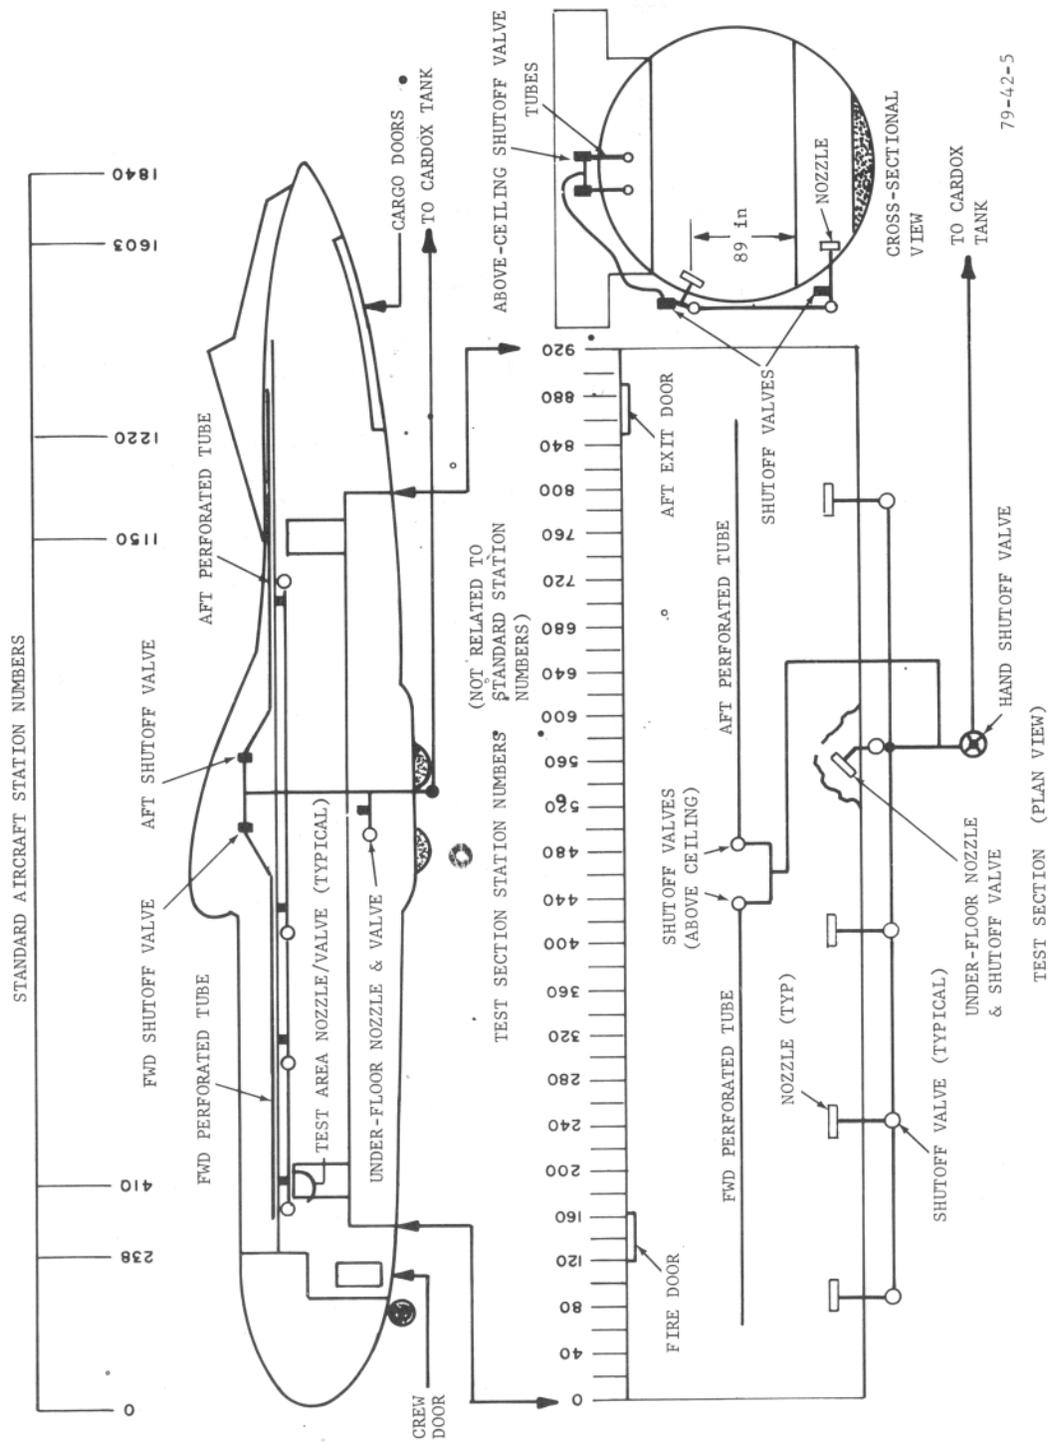
79-42-5

FIGURE 5. TEST ARTICLE FIRE PROTECTION SYSTEM

The fire-extinguishing capability on the test fuselage was provided by two different systems. The primary system was a CO₂ system that protected the

entire test article (figure 5). The fuselage was divided into four fire protection zones: (1) the fire pan area, (2) the above-test section ceiling, (3) the test section, and (4) below-test section floor. All zones utilized Atkomatic "DYMO"[®] 15,000 series solenoid valves to control agent discharge, which were mounted immediately upstream from discharge points and electrically controlled from the instrumentation trailer. The fire pan area had one discharge nozzle positioned to direct CO₂ toward the fire at an angle that would prevent burning fuel being blown out of the pans during agent discharge. The above ceiling system was a 0.75-inch-diameter perforated copper tube mounted on the aircraft structure with the agent discharge being directed downward toward the installed ceiling. Separate control was provided for the forward and aft sections, with the dividing point being the center wing section. Test section protection was provided by four discharge nozzles mounted on the upper left-hand interior wall, positioned to cover the floor area below. Each nozzle could be activated individually as required. Underfloor protection was from a single discharge nozzle mounted on the left-hand sidewall (figure 5). The second extinguishing system was used strictly to extinguish the external fire. The agent was a mixture of 6-percent aqueous film-forming foam (AFFF) mixed with water. This system proved more effective in extinguishing the pan fire than CO₂, since any slight ambient wind would blow the CO₂ away from the fire. The system consisted of a 1,000-gallon storage tank pressurized to 90 pounds per square inch (psi), an electric solenoid discharge valve, and four spray nozzles. A spray nozzle was positioned at each corner of the fire pan configuration and adjusted to cover the entire surface of the pans with foam upon actuation.

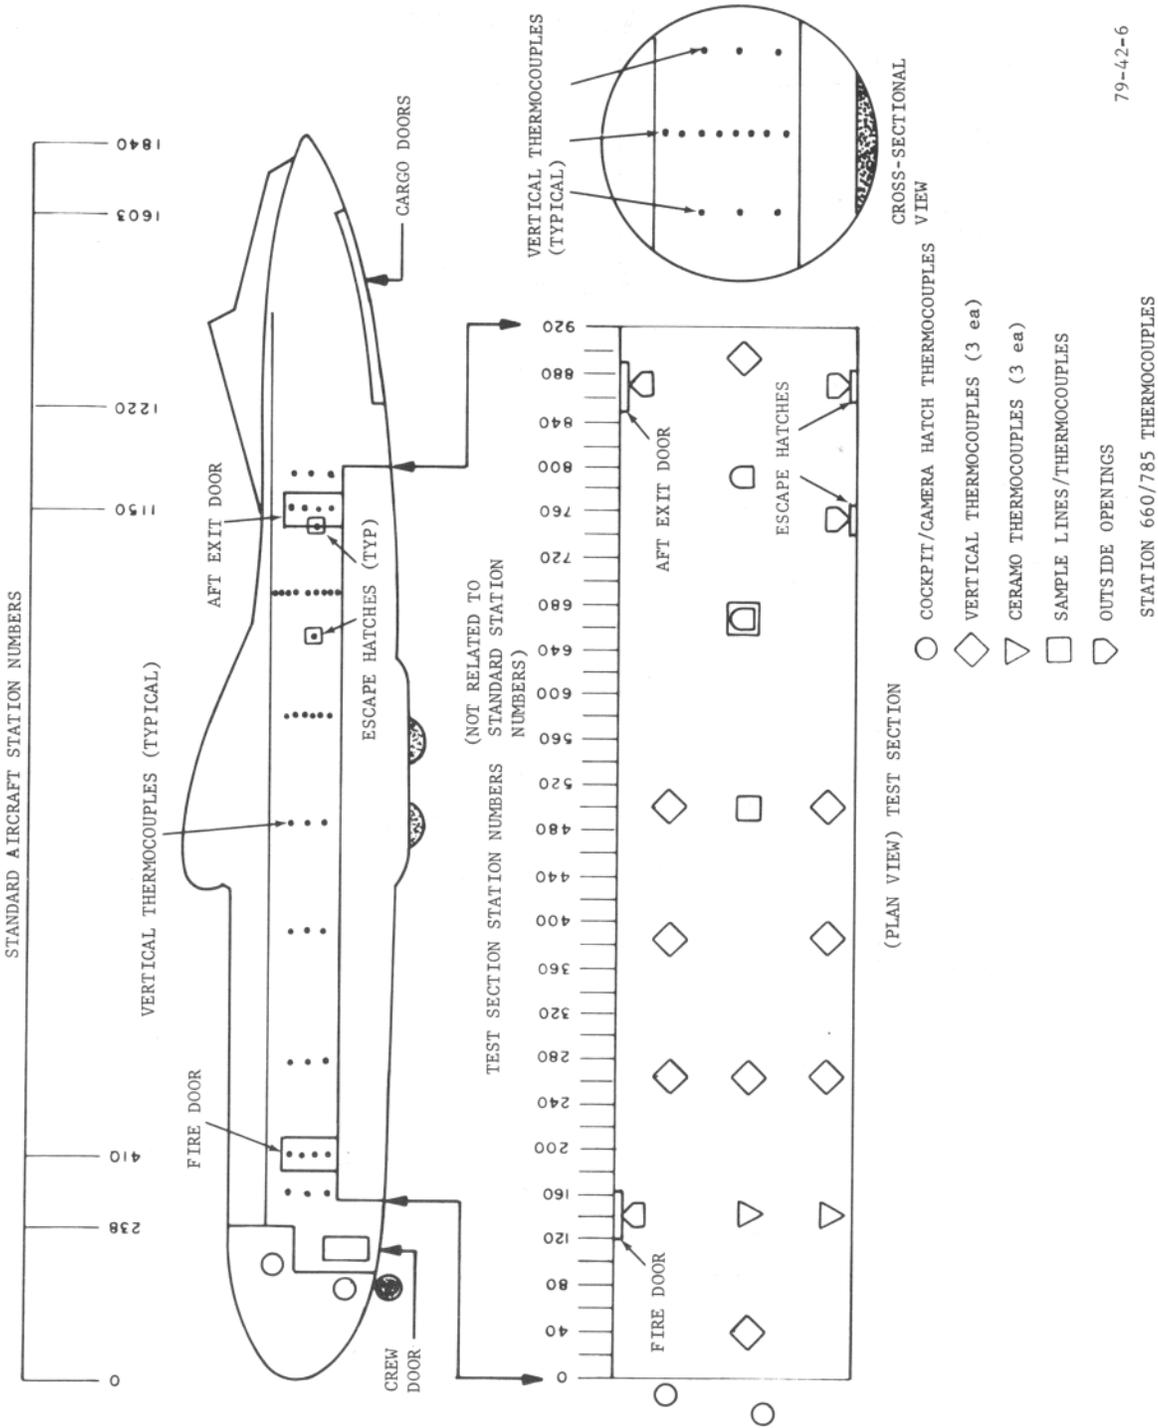
FIGURE 6. TEST ARTICLE AIR THERMOCOUPLE LOCATIONS

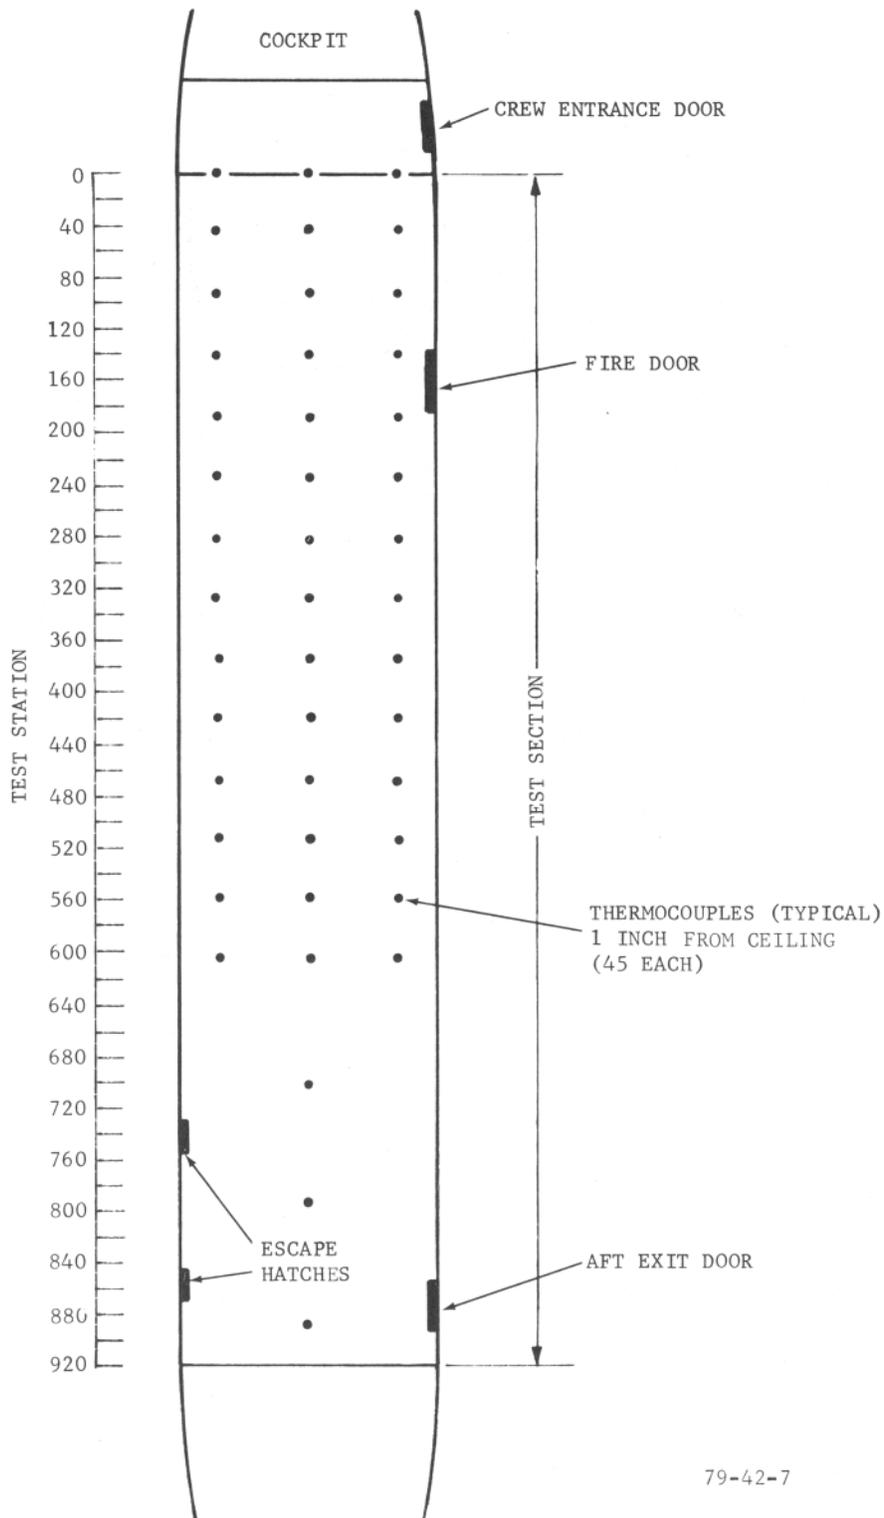
79-42-7

FIGURE 7. TEST ARTICLE CEILING THERMOCOUPLE LOCATIONS

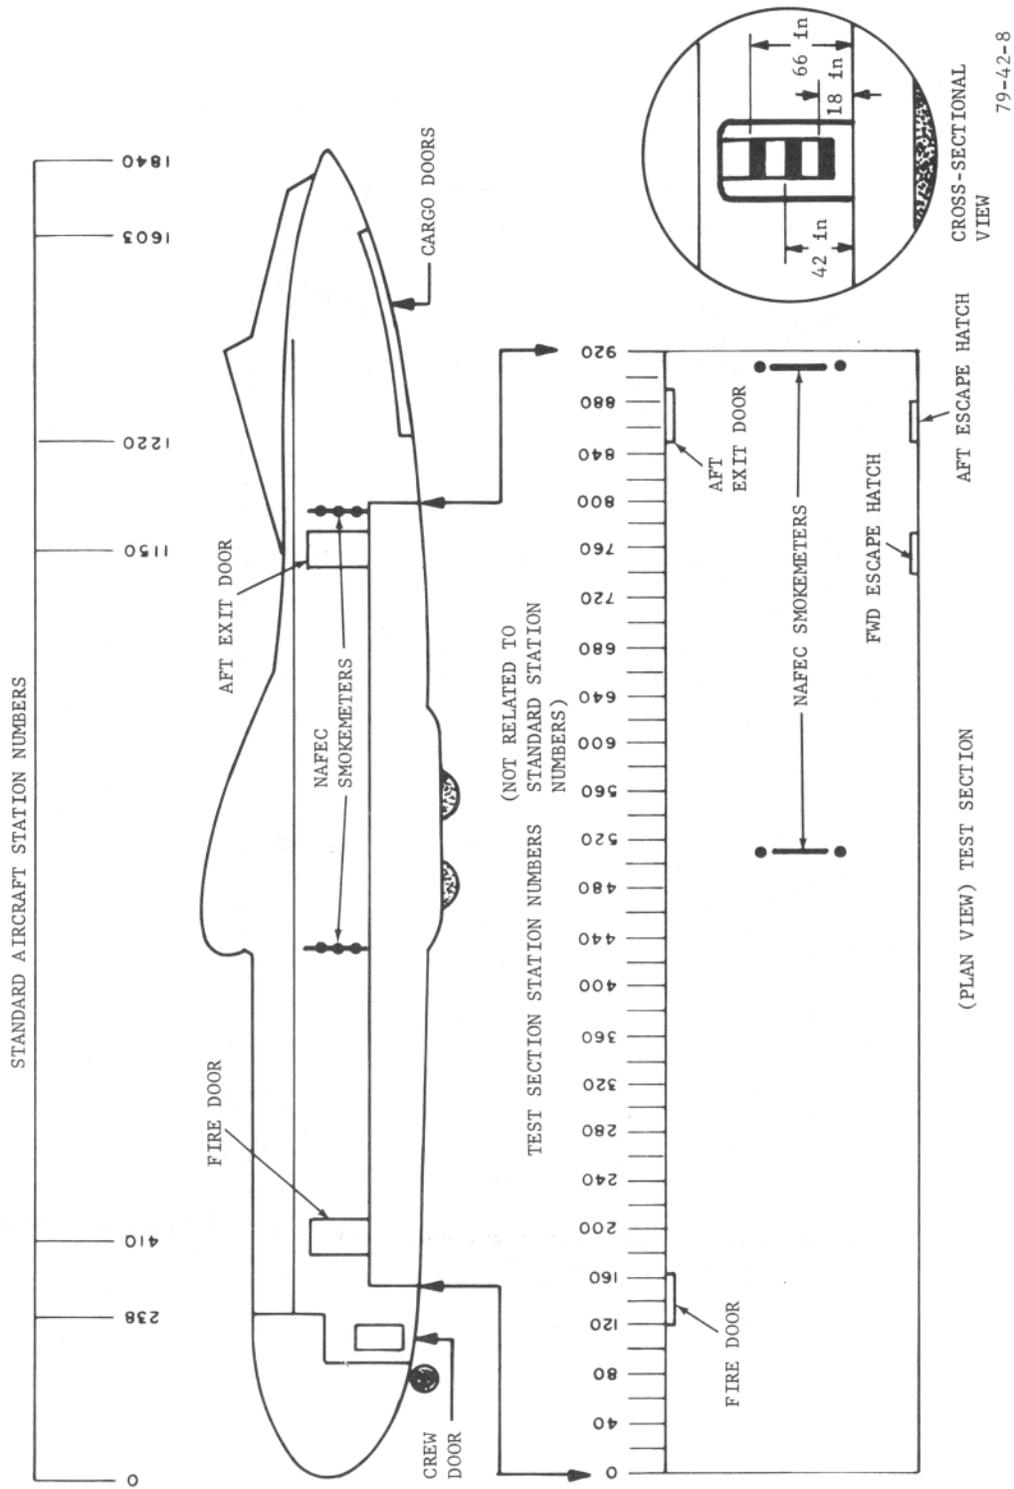
FIGURE 8. SMOKEMETER LOCATIONS

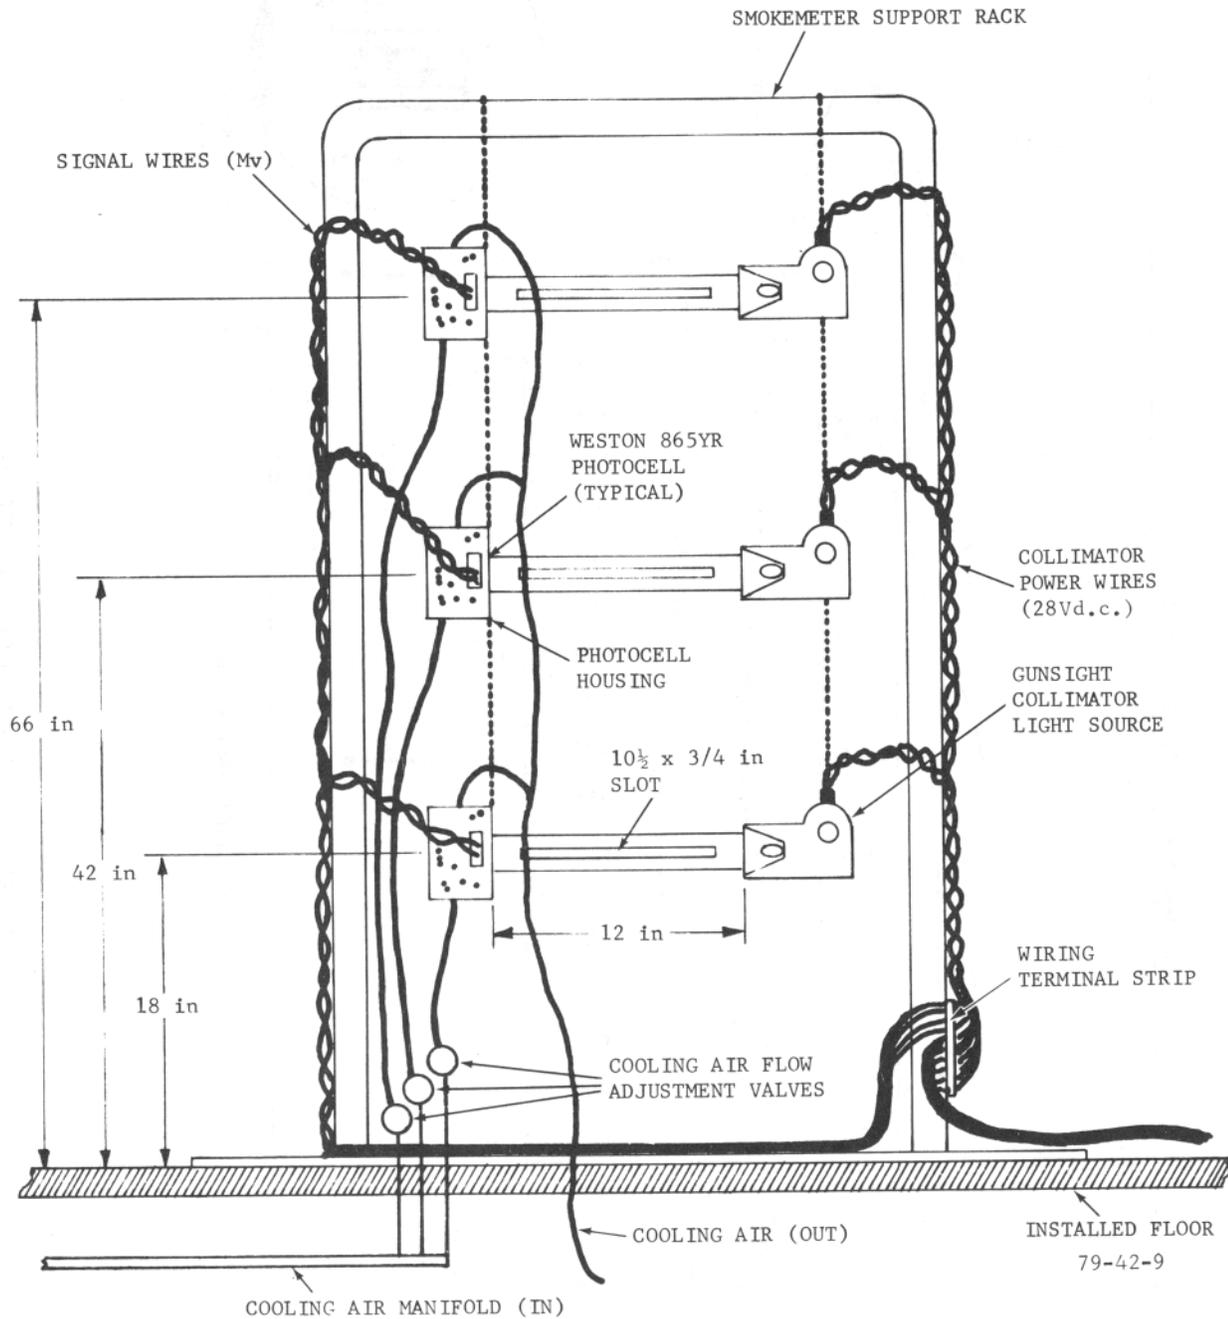
FIGURE 9. SMOKEMETER RACK INSTALLATION

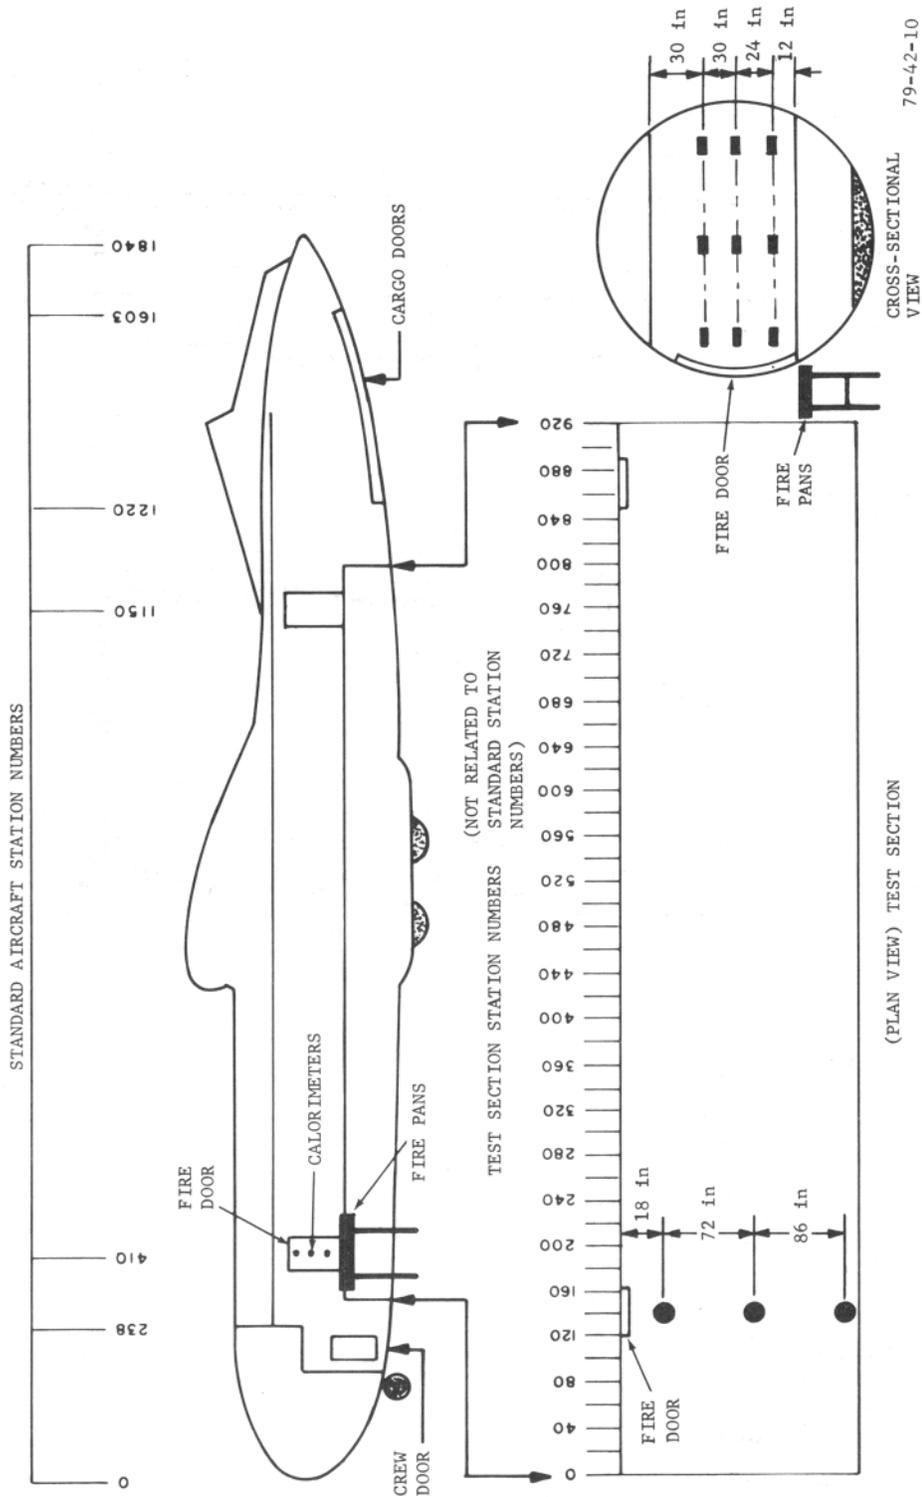
FIGURE 10. LOCATION OF ASYMPTOTIC RAPID-RESPONSE CALORIMETERS

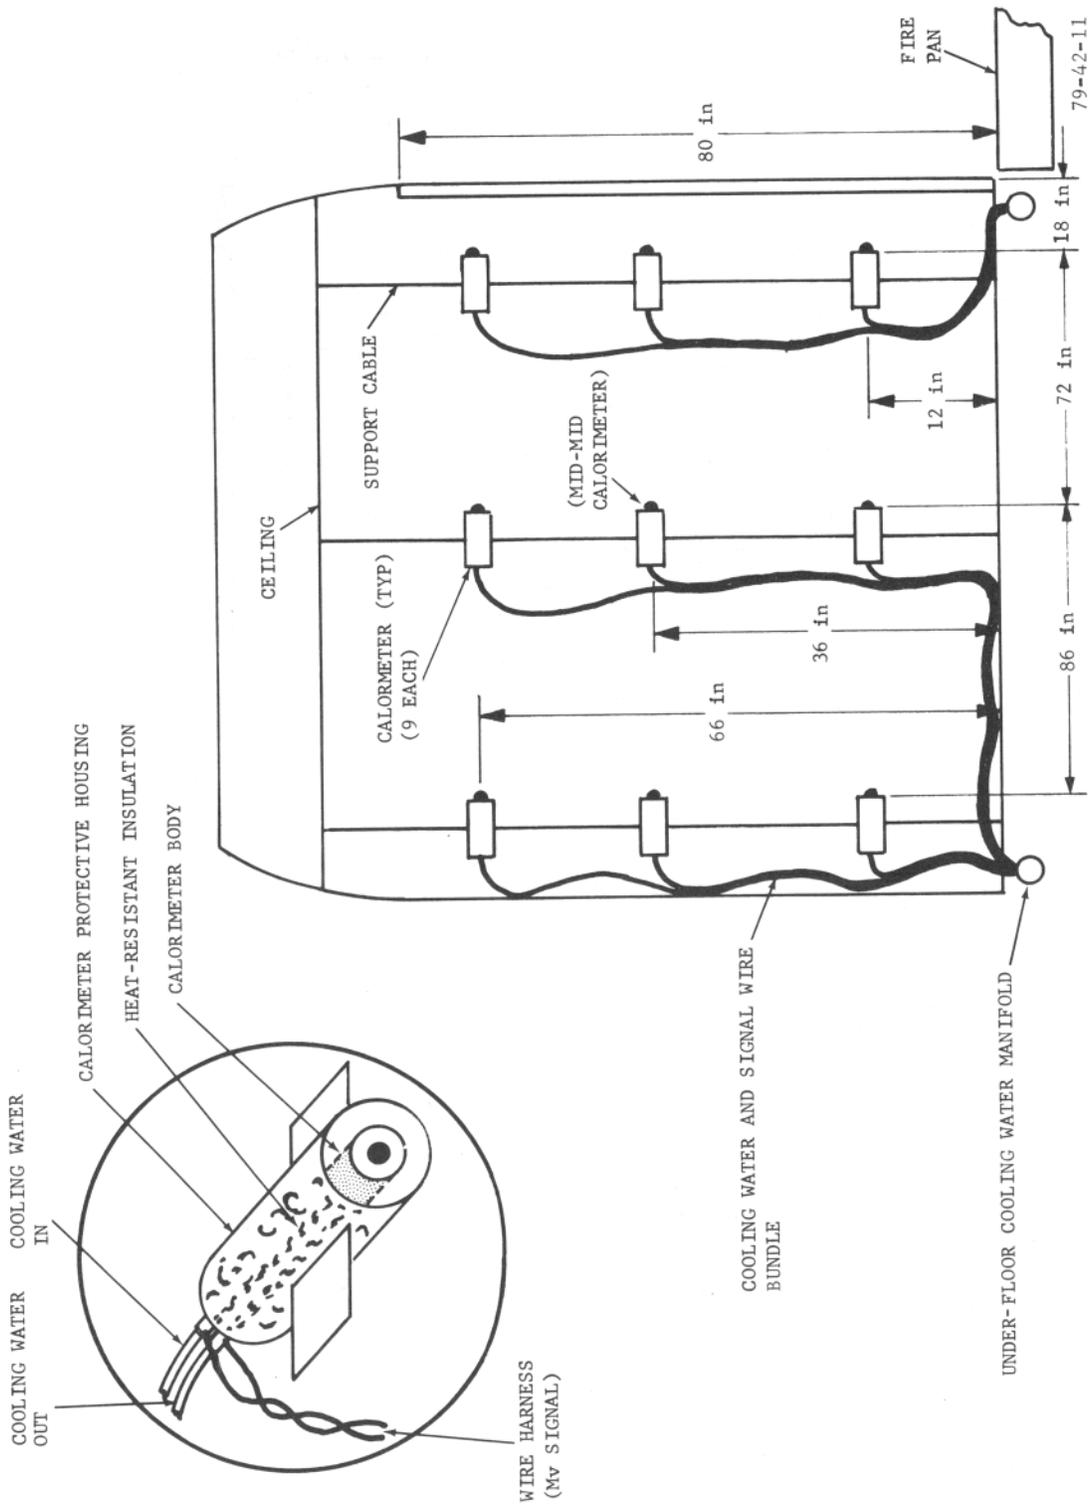
FIGURE 11. CALORIMETER INSTALLATION

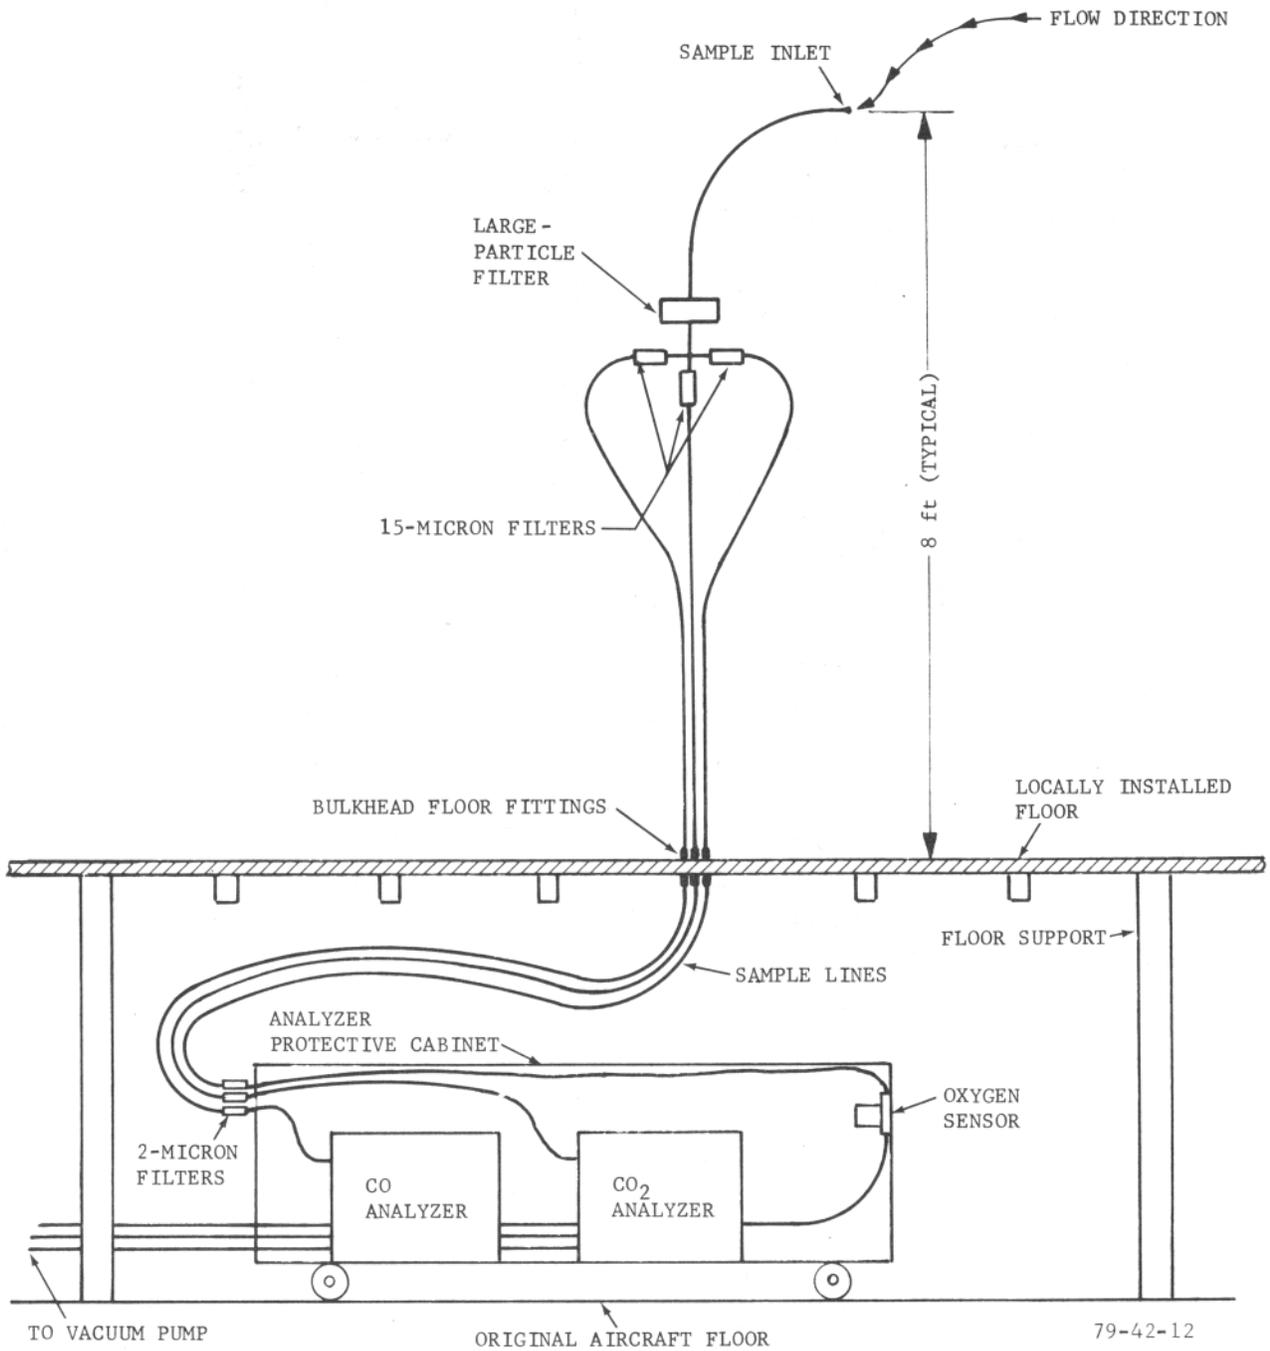
FIGURE 12. TYPICAL GAS SAMPLING LOCATION

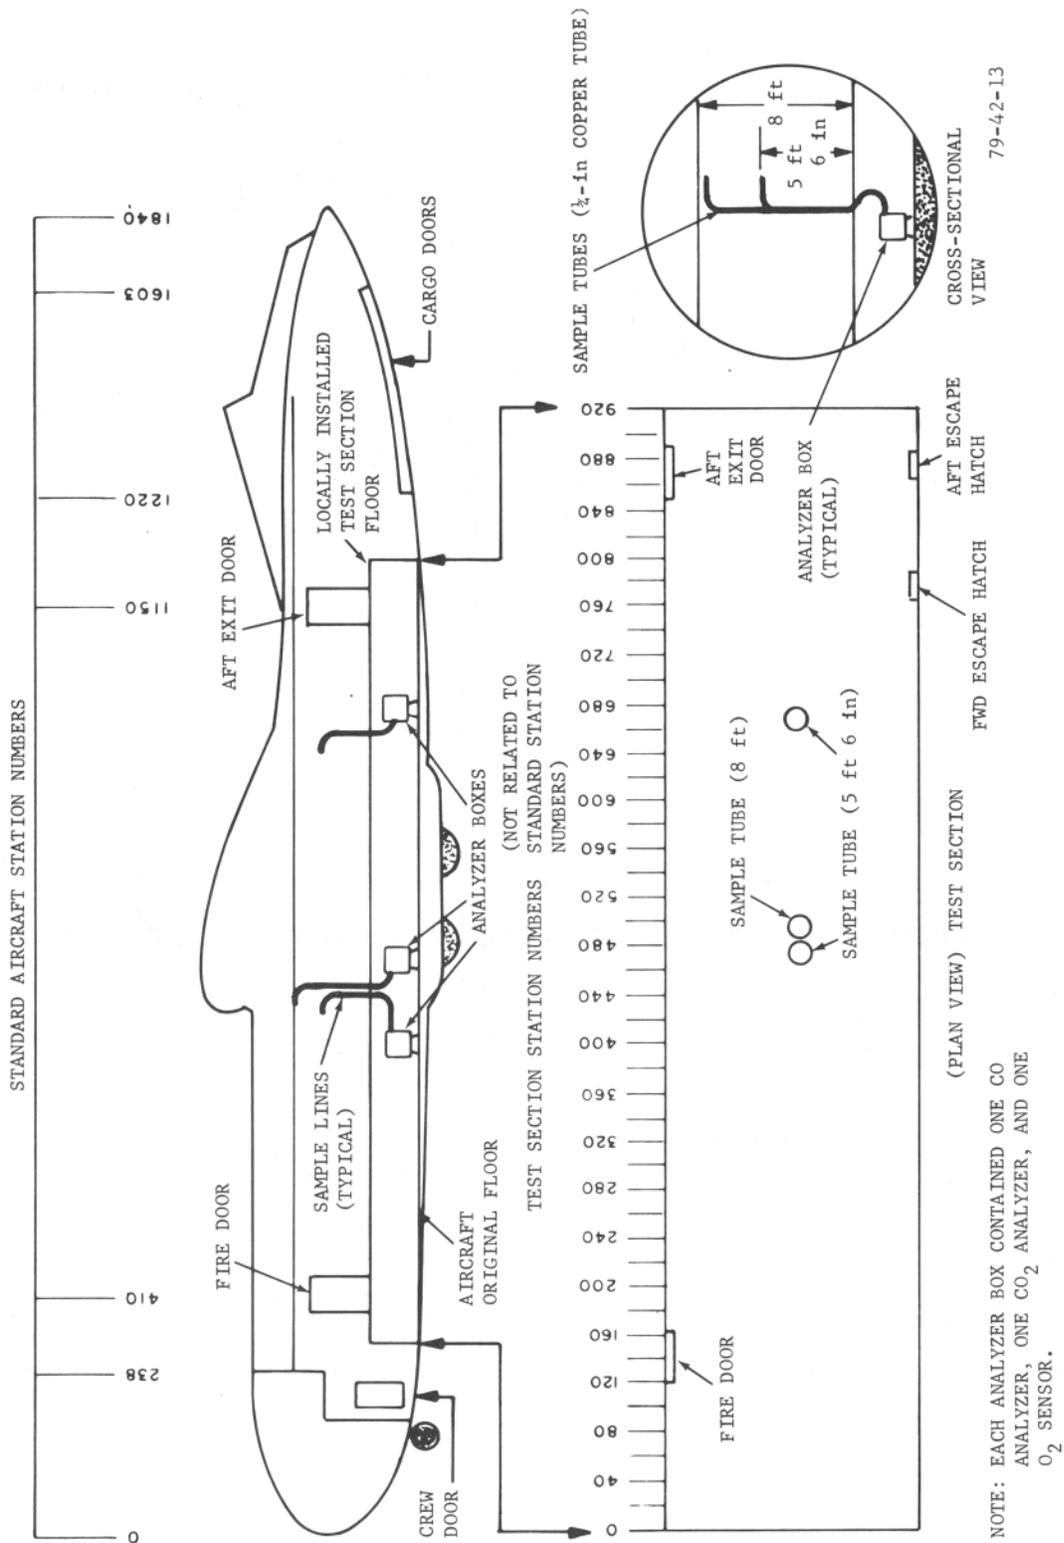
FIGURE 13. LOCATION OF GAS SAMPLE STATIONS

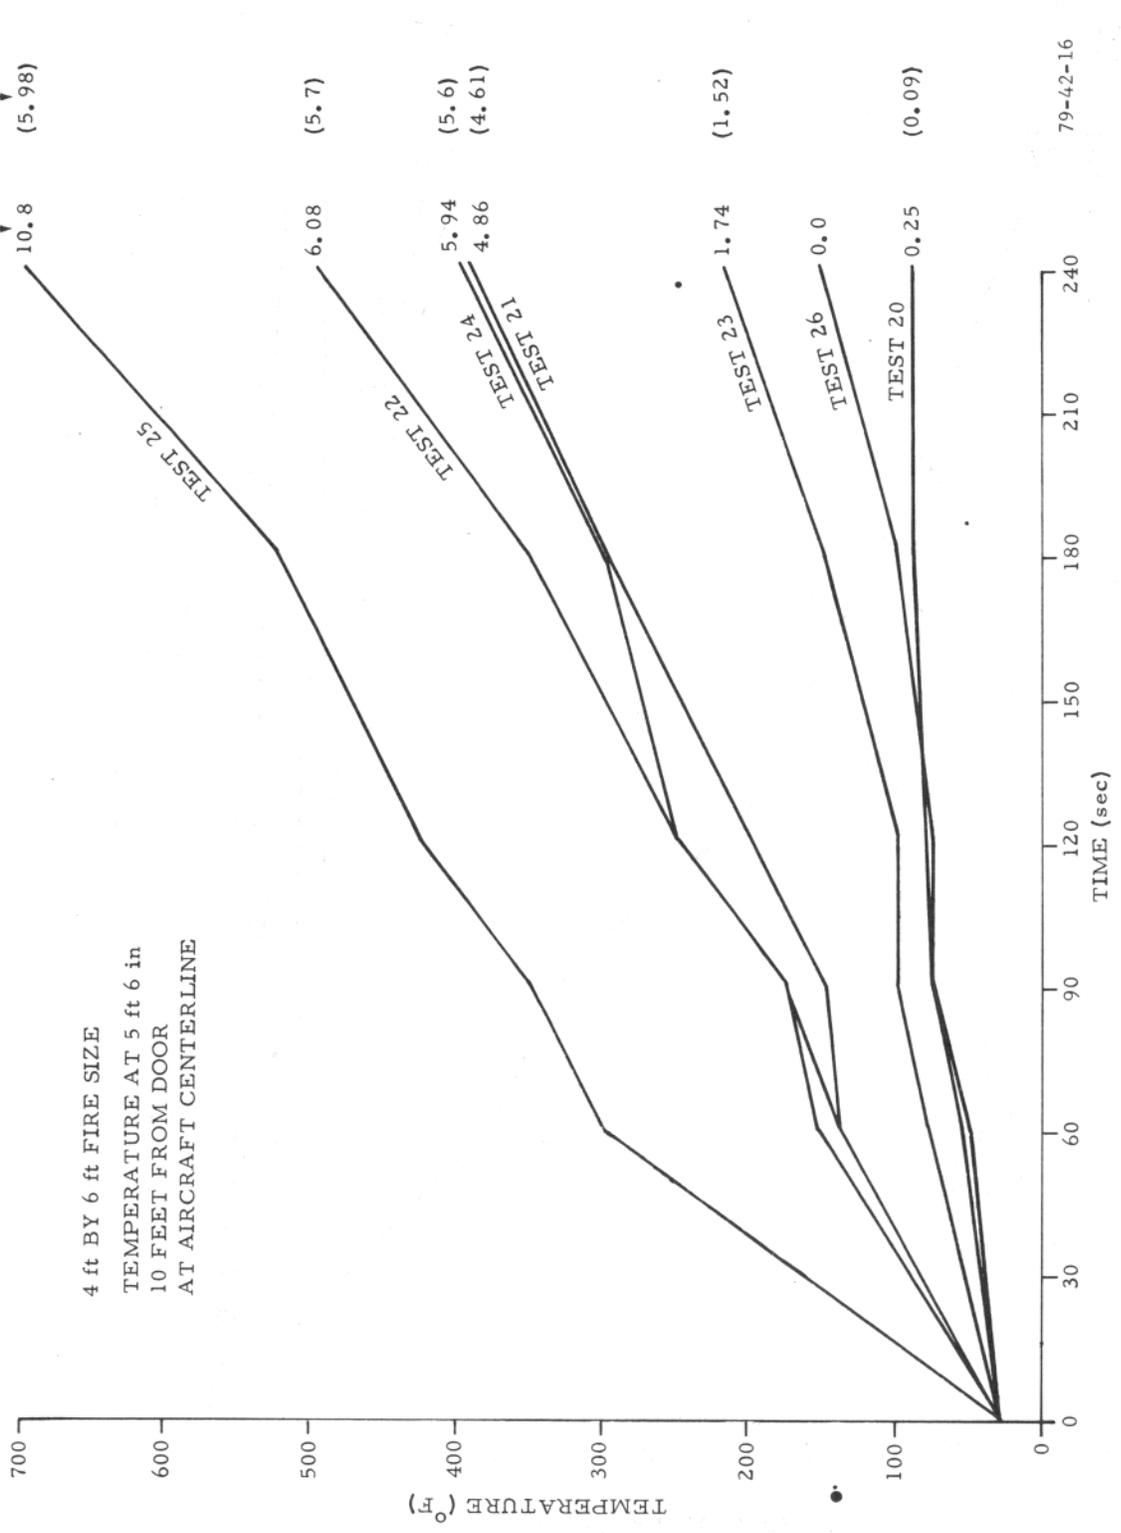
79-42-16

FIGURE 16. EFFECT OF WIND ON CABIN TEMPERATURES (4- BY 6-FOOT FIRE)

The wind was the single most important factor affecting the environmental conditions in the cabin during testing. Figures 16, 17, and 18 show the effect of wind on cabin air temperature using 4-by 6-foot, 6-by 8-foot, and 8-by 10-foot fires, respectively. The thermocouple plotted was 5 feet 6 inches high, 10 feet aft of the fire door and at the fuselage centerline. Windspeeds were averaged for the test duration. Windspeed listed in the parenthesis is the component of the windspeed entering the door perpendicular to the fuselage. Figure 19 shows the conversion for a typical test of the windspeed direction to the corrected windspeed perpendicular to the door.
