POSTCRASH FUEL FIRE HAZARD MEASUREMENTS IN A WIDE-BODY AIRCRAFT CABIN

FINAL REPORT

1. Report No. FAA-NA-79-42		2. Government Accession No.		3. Recipient's Catalog No.	
4. Title and Subtitle POSTCRASH FUEL FIRE HAZARD MEASUREMENTS IN A WIDE-BODY AIRCRAFT CABIN				5. Report Date December 1979

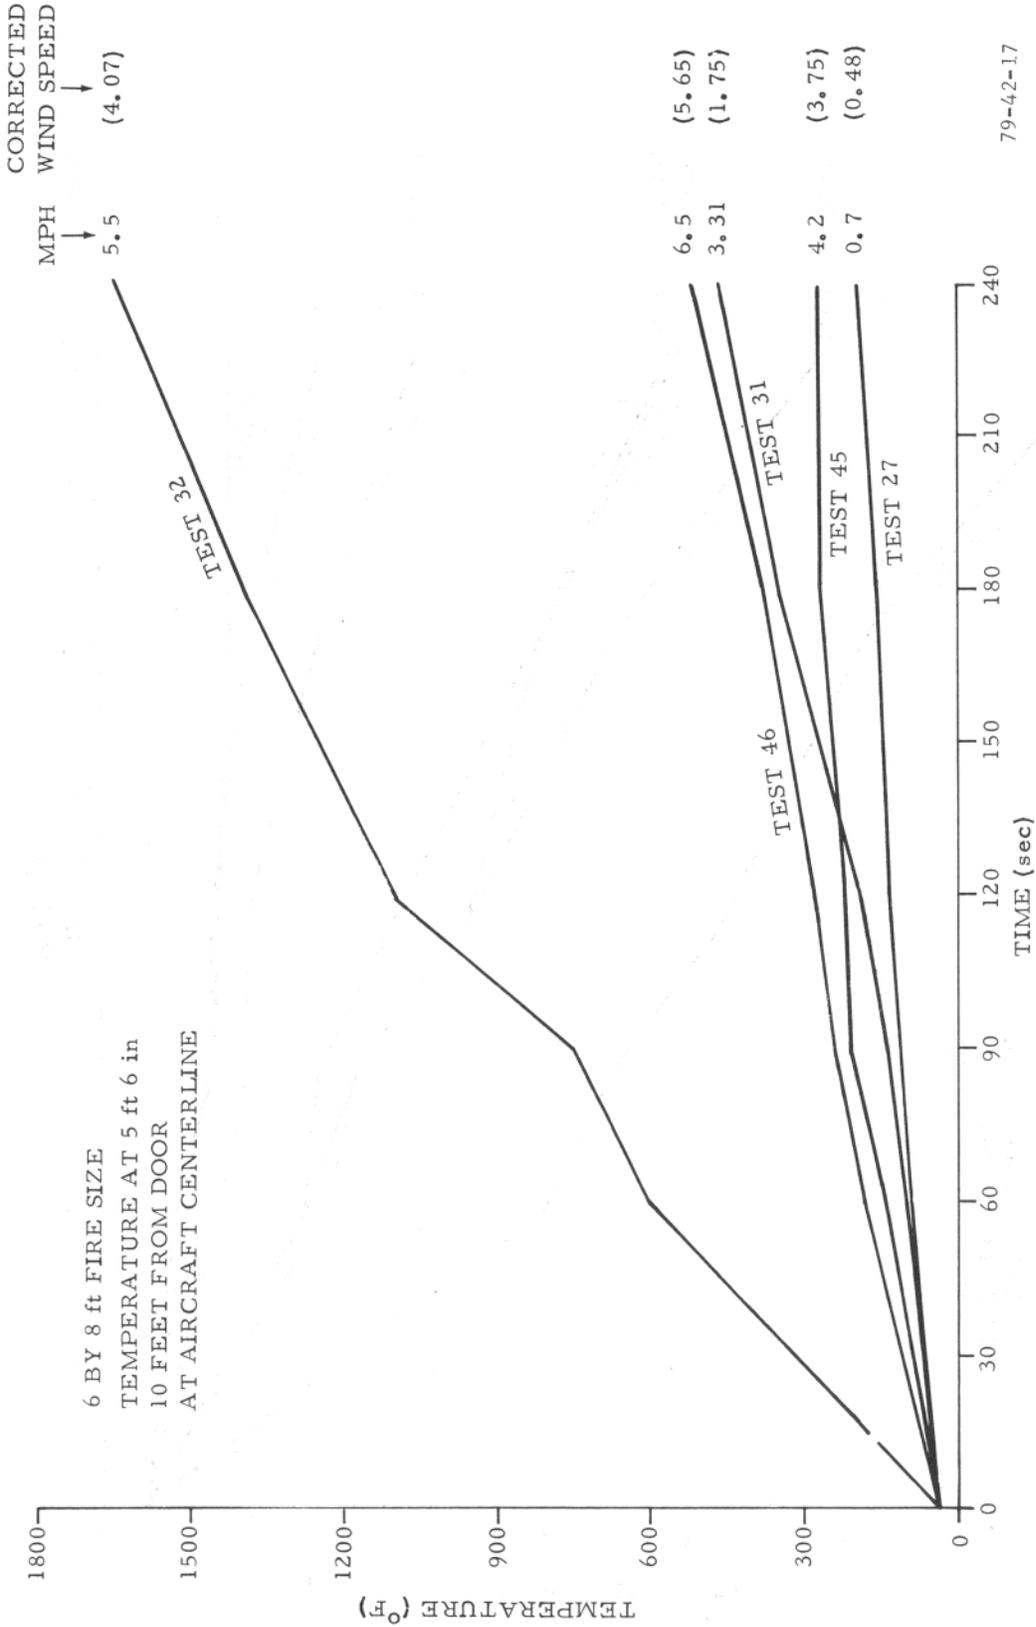
FIGURE 17. EFFECT OF WIND ON CABIN TEMPERATURES (6- BY 8-FOOT FIRE)

The wind was the single most important factor affecting the environmental conditions in the cabin during testing. Figures 16, 17, and 18 show the effect of wind on cabin air temperature using 4-by 6-foot, 6-by 8-foot, and 8-by 10-foot fires, respectively. The thermocouple plotted was 5 feet 6 inches high, 10 feet aft of the fire door and at the fuselage centerline. Windspeeds were averaged for the test duration. Windspeed listed in the parenthesis is the component of the windspeed entering the door perpendicular to the fuselage. Figure 19 shows the conversion for a typical test of the windspeed direction to the corrected windspeed perpendicular to the door.

Generally, the greater the wind towards the fuselage opening, the greater the hazard in the fuselage. However, exceptions to that rule were noted; one in particular, during test number 32, is seen in figure 17. Although the average windspeed and the corrected windspeed were lower than other tests, using the same size fire, the temperature at 5 feet 6 inches height, 10 feet from the fire door at the fuselage centerline was three to four times higher than those of the other tests.

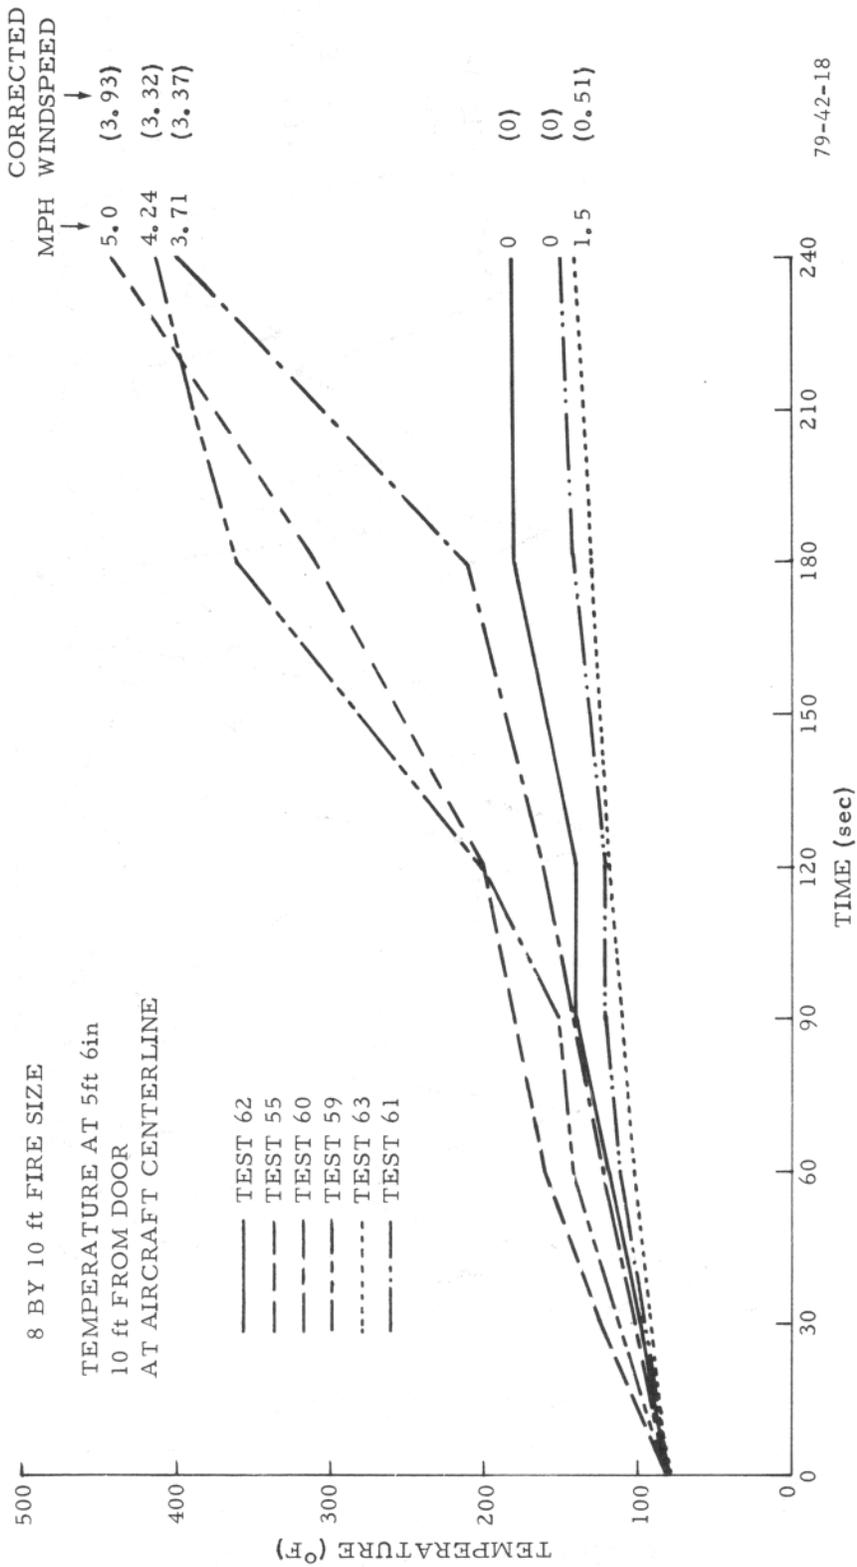
FIGURE 18. EFFECT OF WIND ON CABIN TEMPERATURES (8- BY 10-FOOT FIRE)

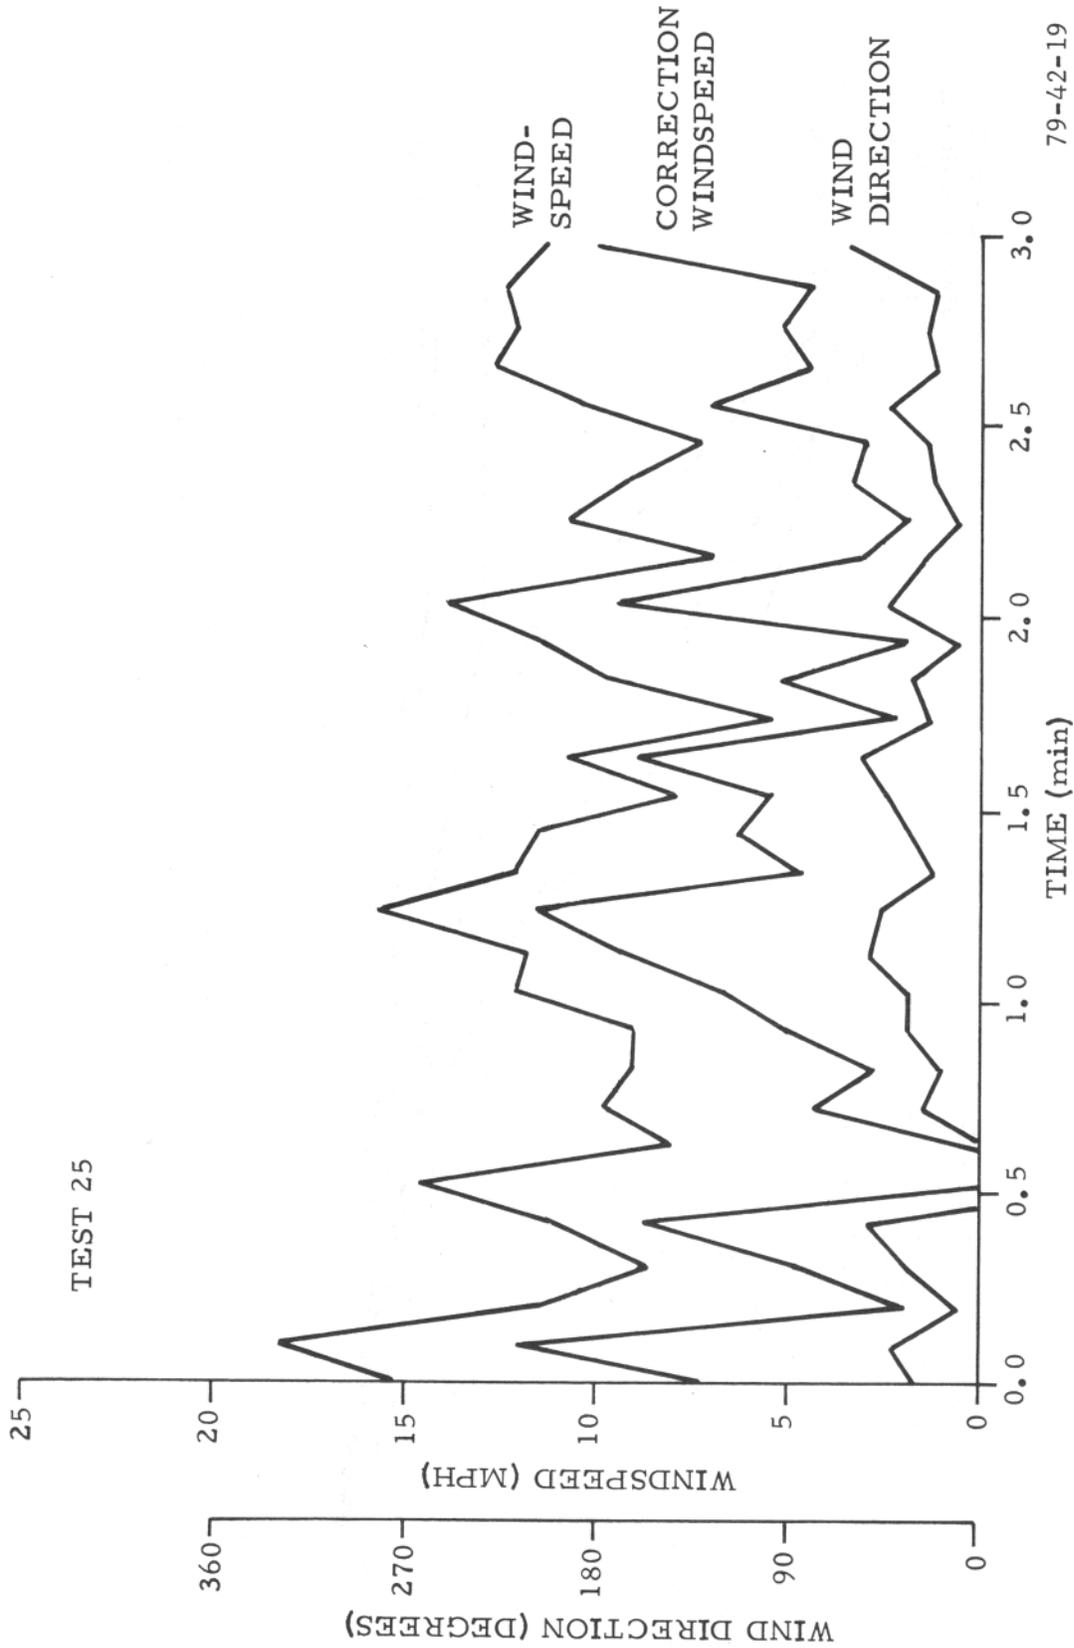
FIGURE 19. CORRECTED WINDSPEED DETERMINATION

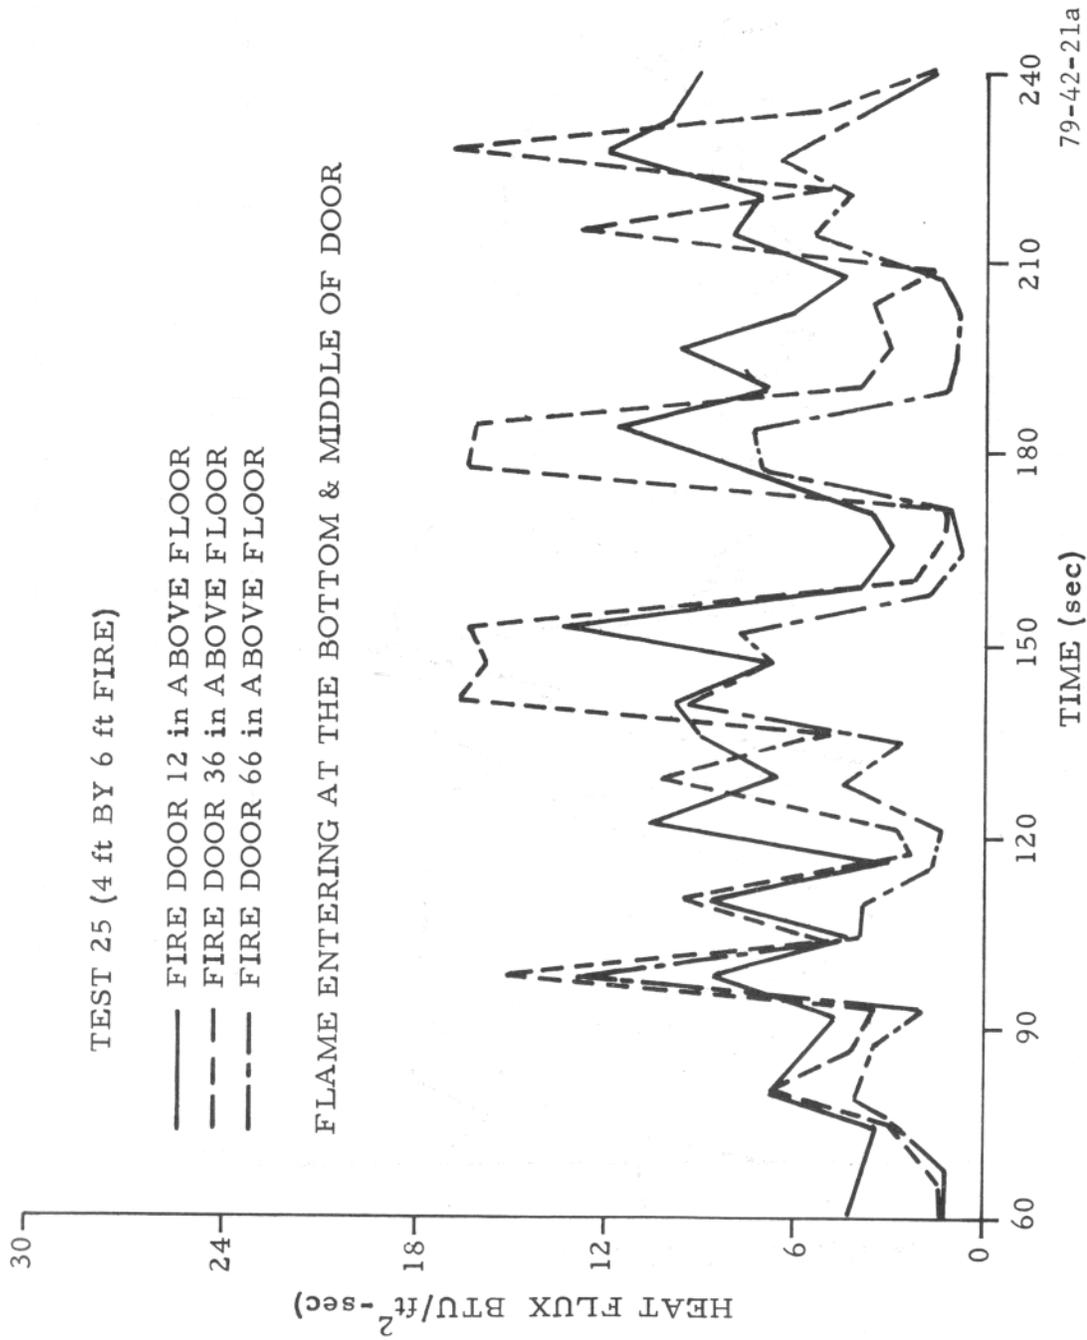
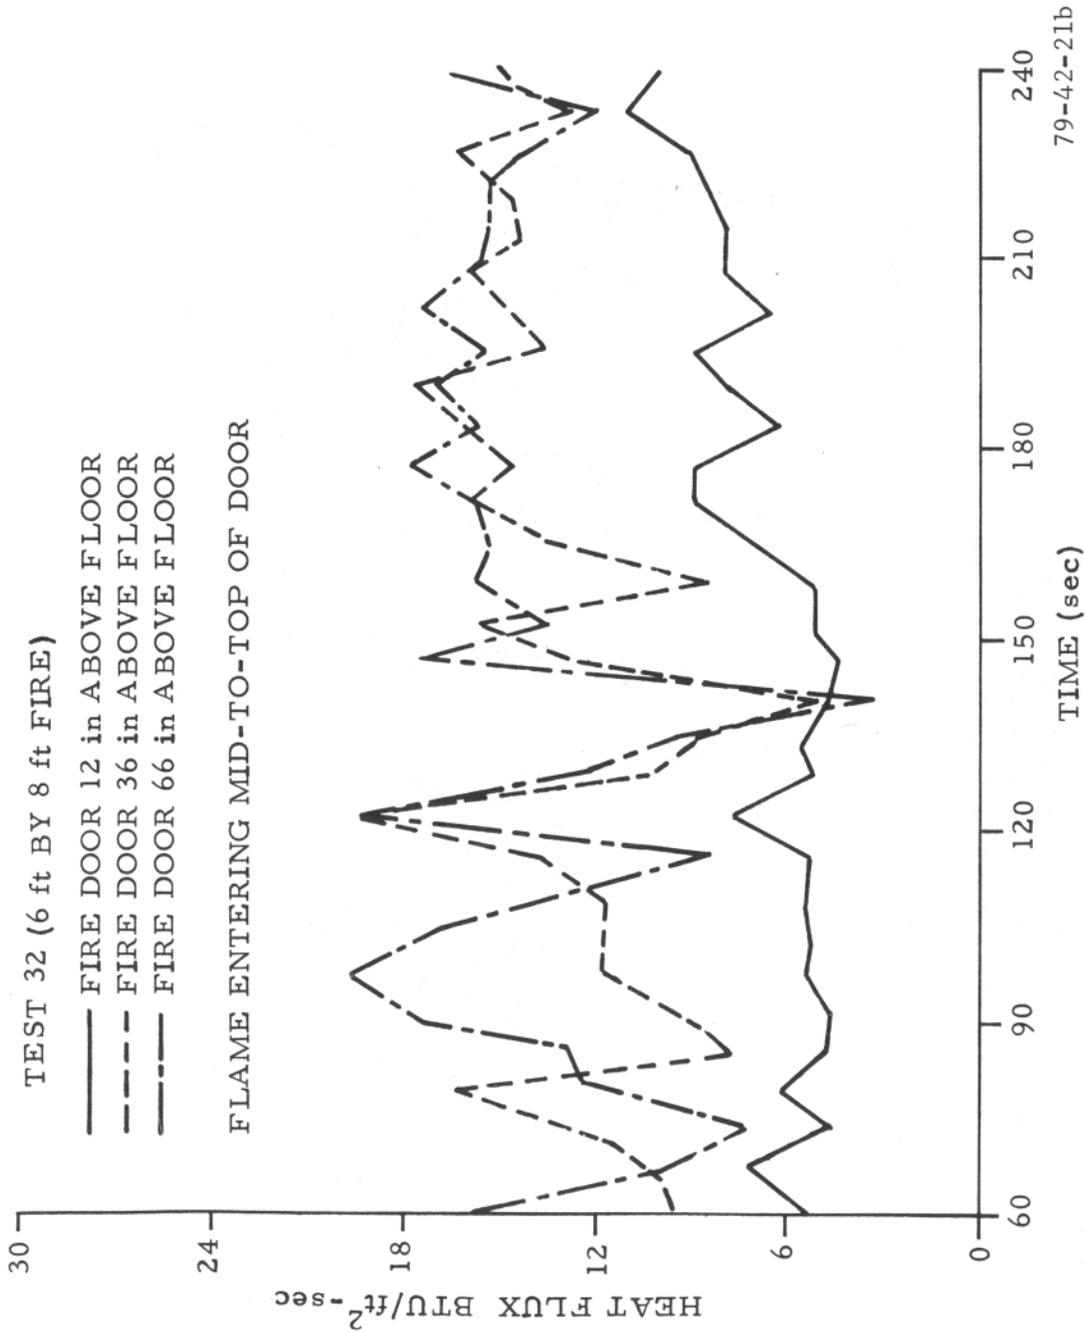
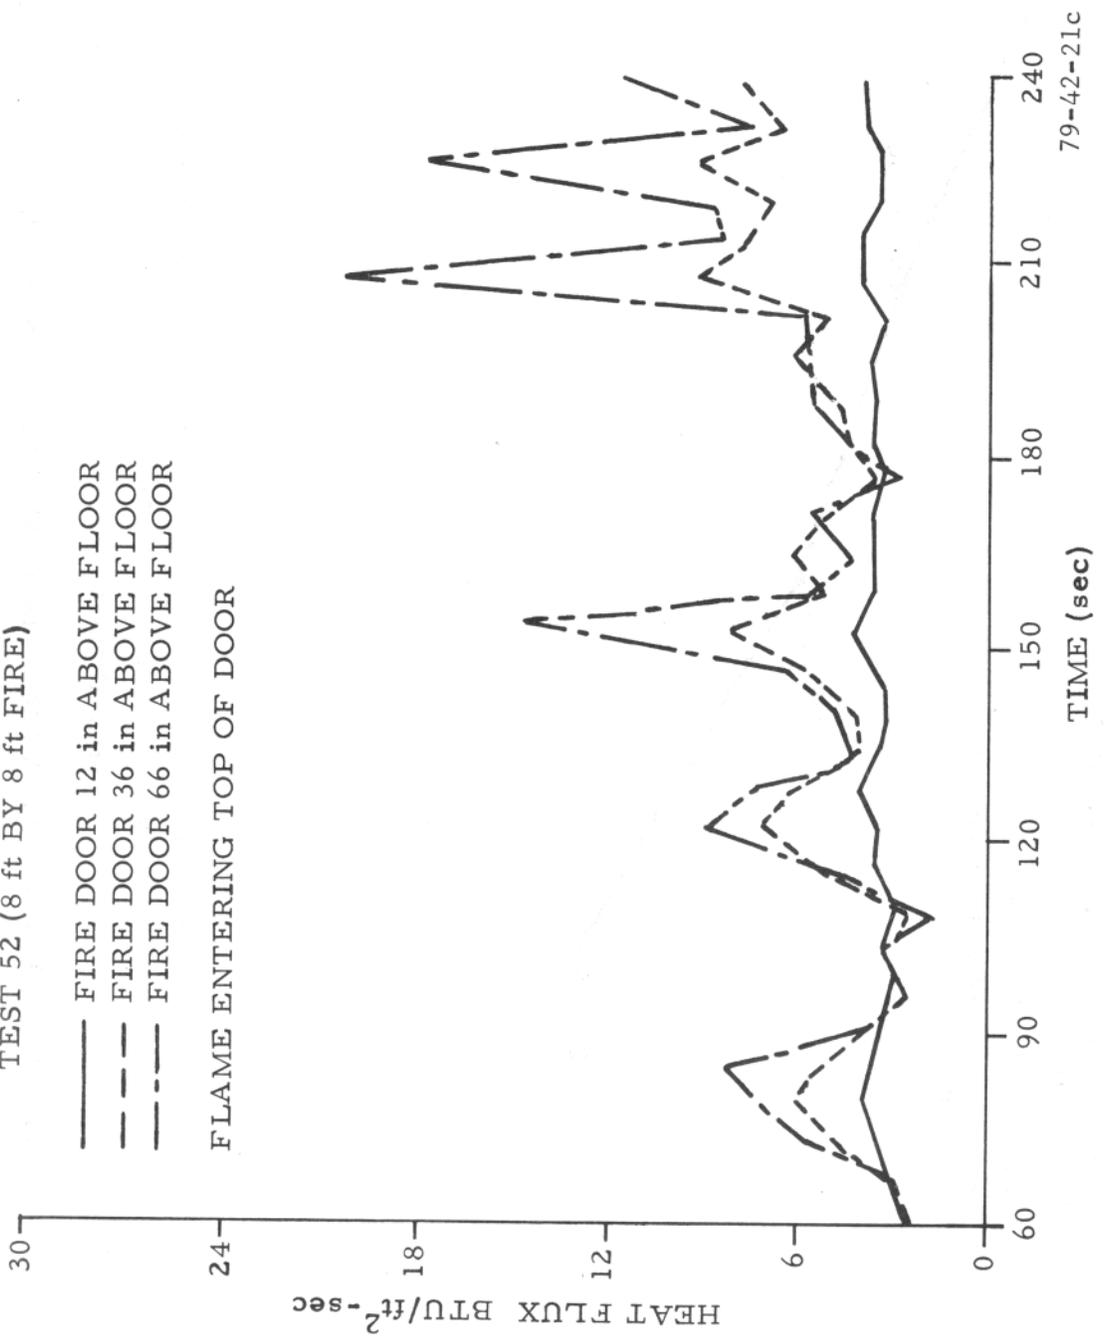
79-42-21a

FLAME ENTERING AT THE BOTTOM & MIDDLE OF DOOR

FIGURE 21. EFFECT OF FIRE SIZE ON FLAME PENETRATING FUSELAGE OPENING (Sheet 1 of 3)

FLAME ENTERING TOP OF DOOR

By varying the fire size, the effect of the wind on the fire also varied. The smaller the fire, the greater the bending of the flame by the wind (figure 21). The heat flux in the doorway shows more penetration through the lower area of the door for the smaller fires, indicating a greater bending of the flame. Therefore, although a smaller fire puts out less heat, smoke, and toxic gases than a bigger fire, a larger portion of the smaller fire can penetrate a fuselage opening for a given wind condition.

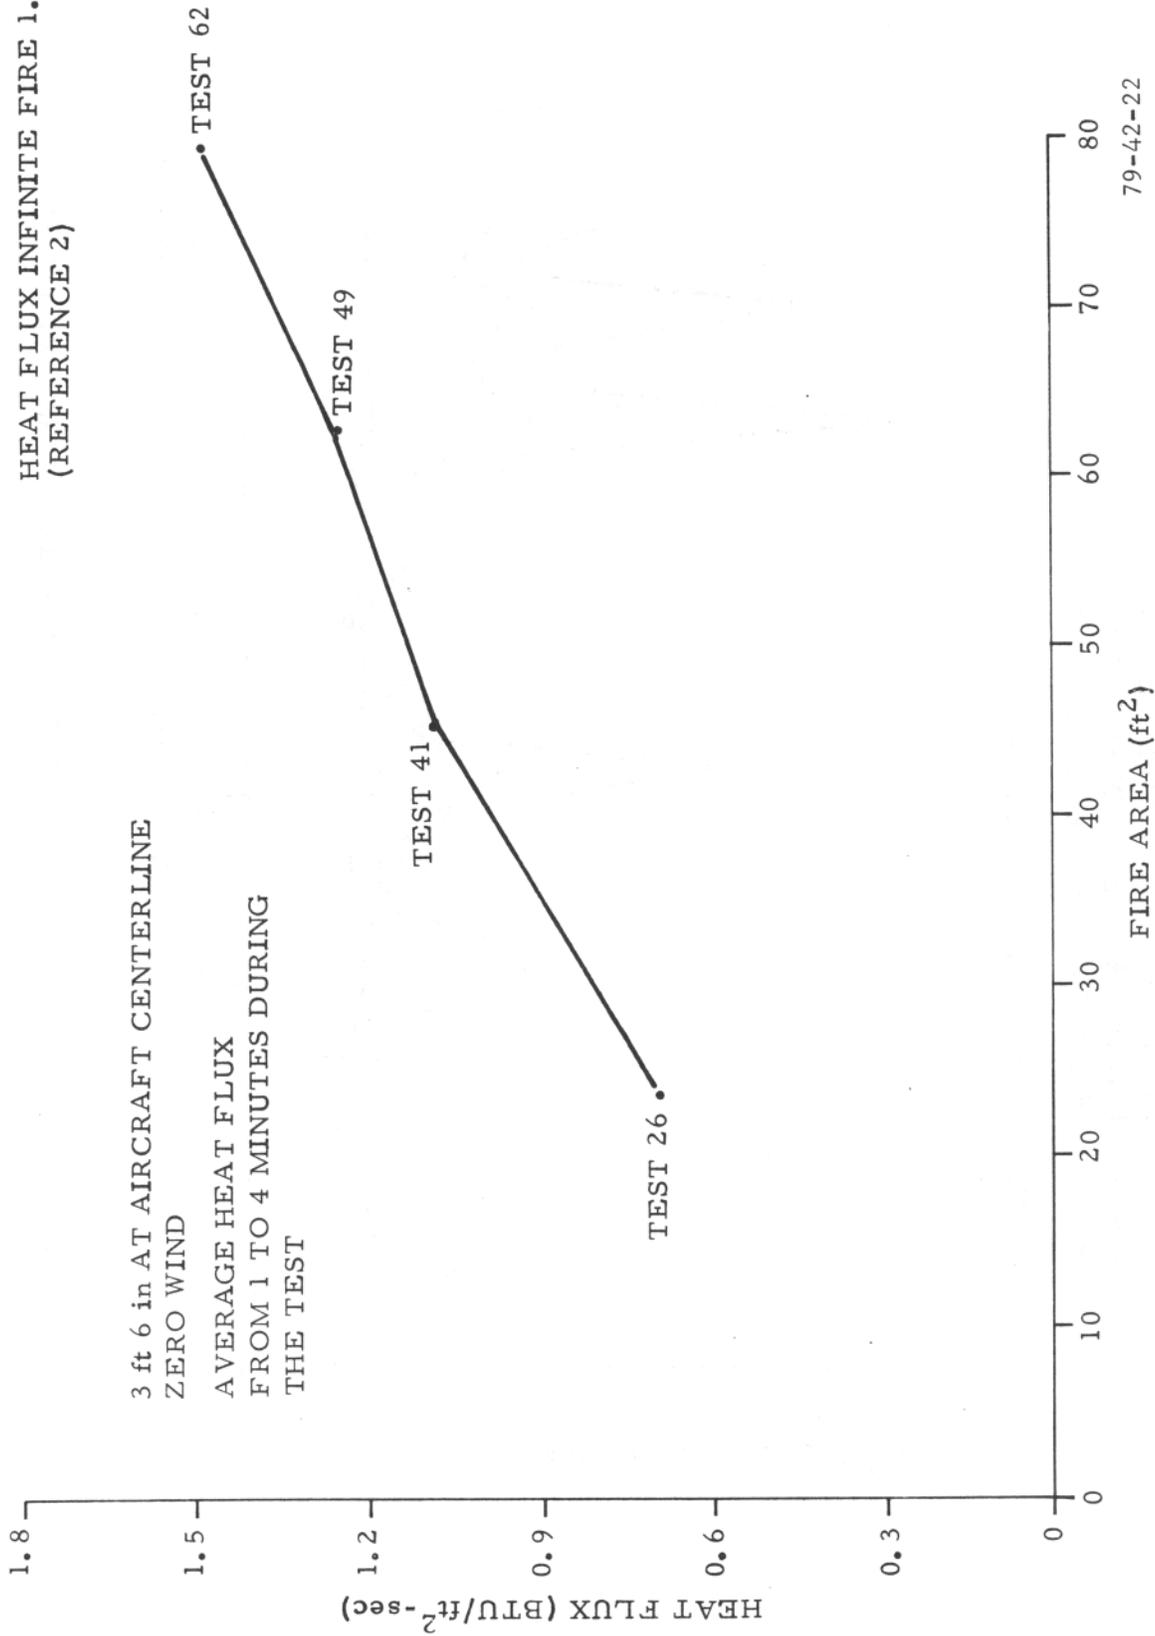
79-42-22

FIGURE 22. RADIANT HEAT IN CABIN RESULTING FROM ZERO-WIND FIRES

5. Fire size dictates the radiant heat level through a cabin opening under zero-wind conditions.

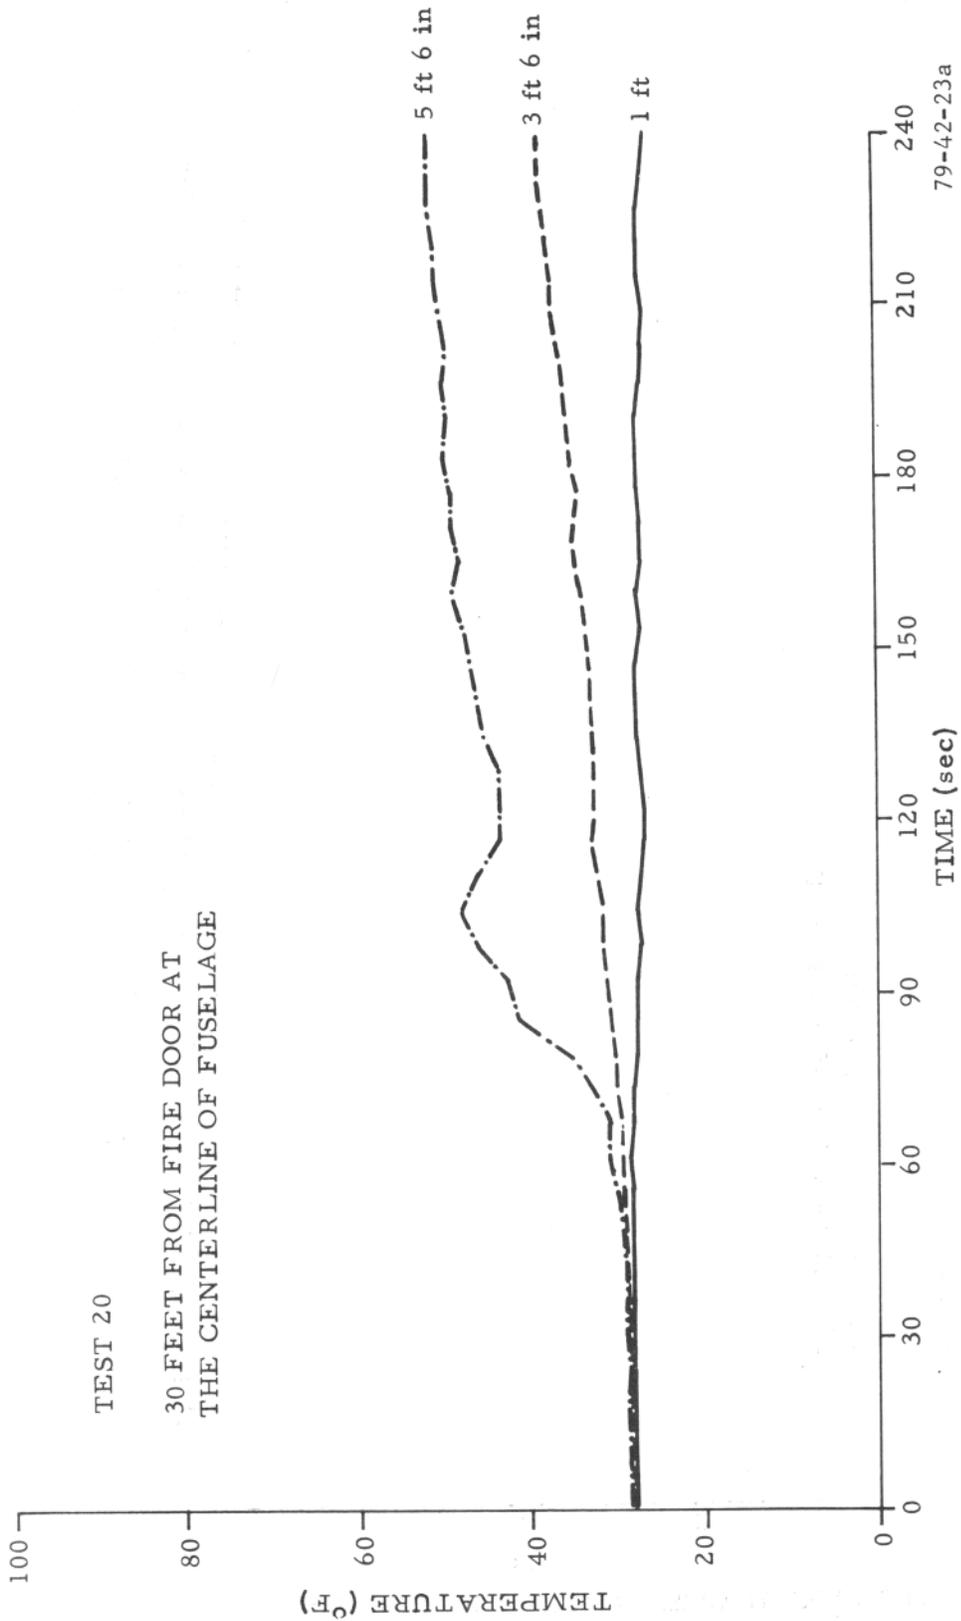
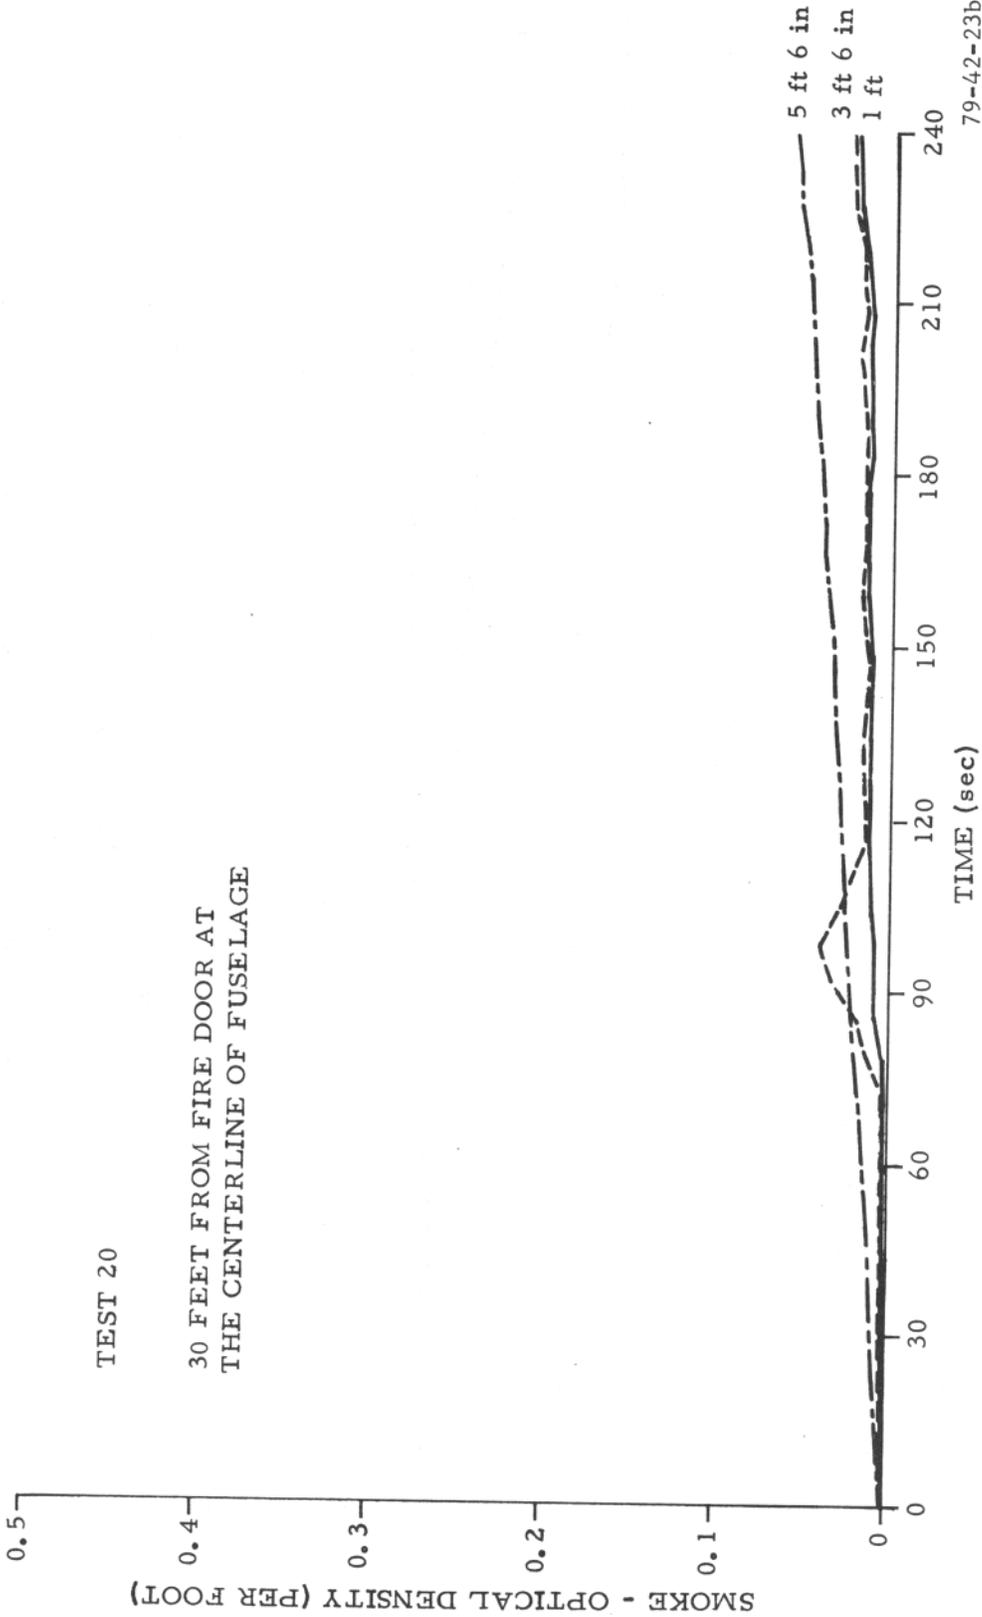
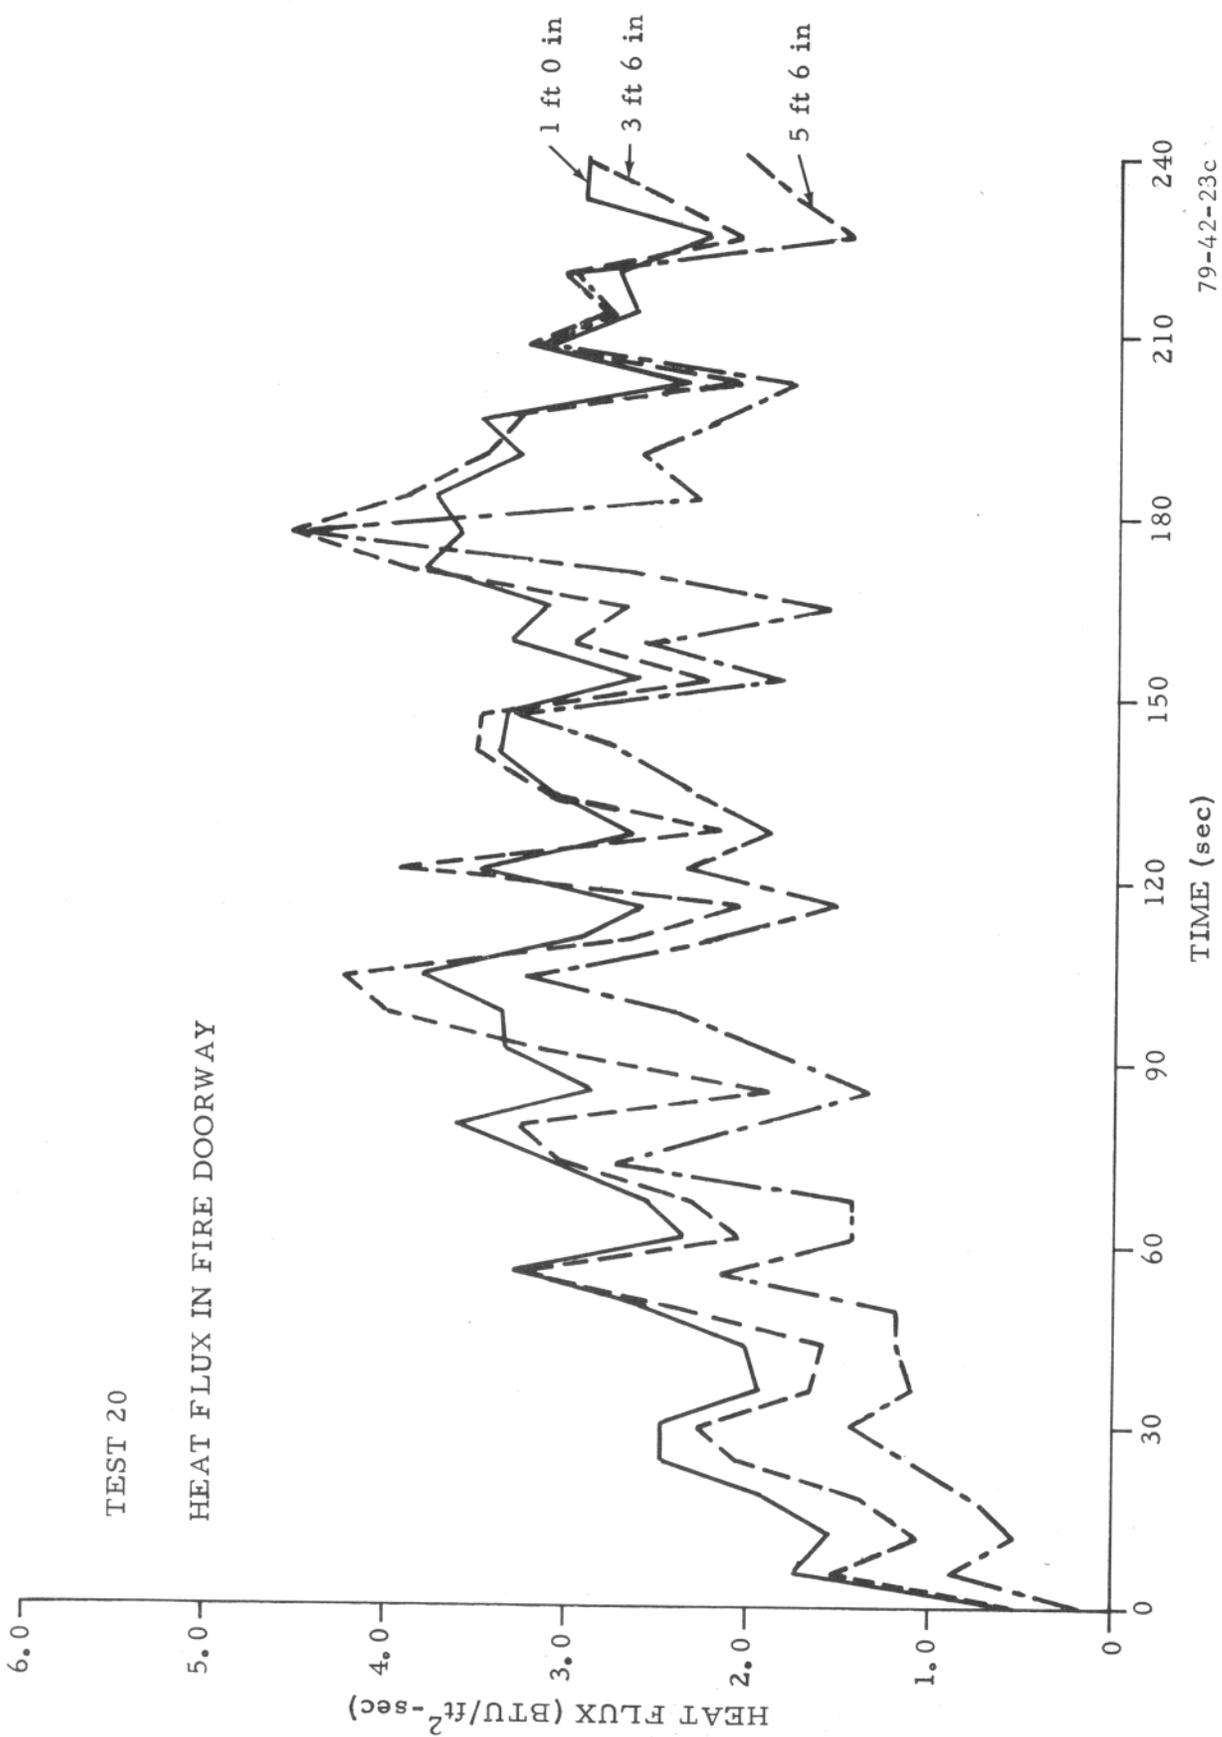
79-42-23b

FIGURE 23. CABIN HAZARDS ASSOCIATED WITH CROSS-FUSELAGE WINDS (Sheet 1 of 3)

30 FEET FROM FIRE DOOR AT
THE CENTERLINE OF FUSELAGE

The cabin conditions resulting from that accident are similar to those found in the C133 under similar wind conditions (little temperature rise, little smoke, and radiant heat near any opening adjacent to the fire) (figure 23). Less smoke should be expected in the C133 tests, since no materials were present to char. Thus, smoking of some of the materials occurred during the DC10 fire. Zero-wind conditions created the same type of cabin environment as a wind blowing the fire away from the fuselage (figure 24). A wind blowing the flame toward the cabin can very quickly create a serious hazard in the cabin.

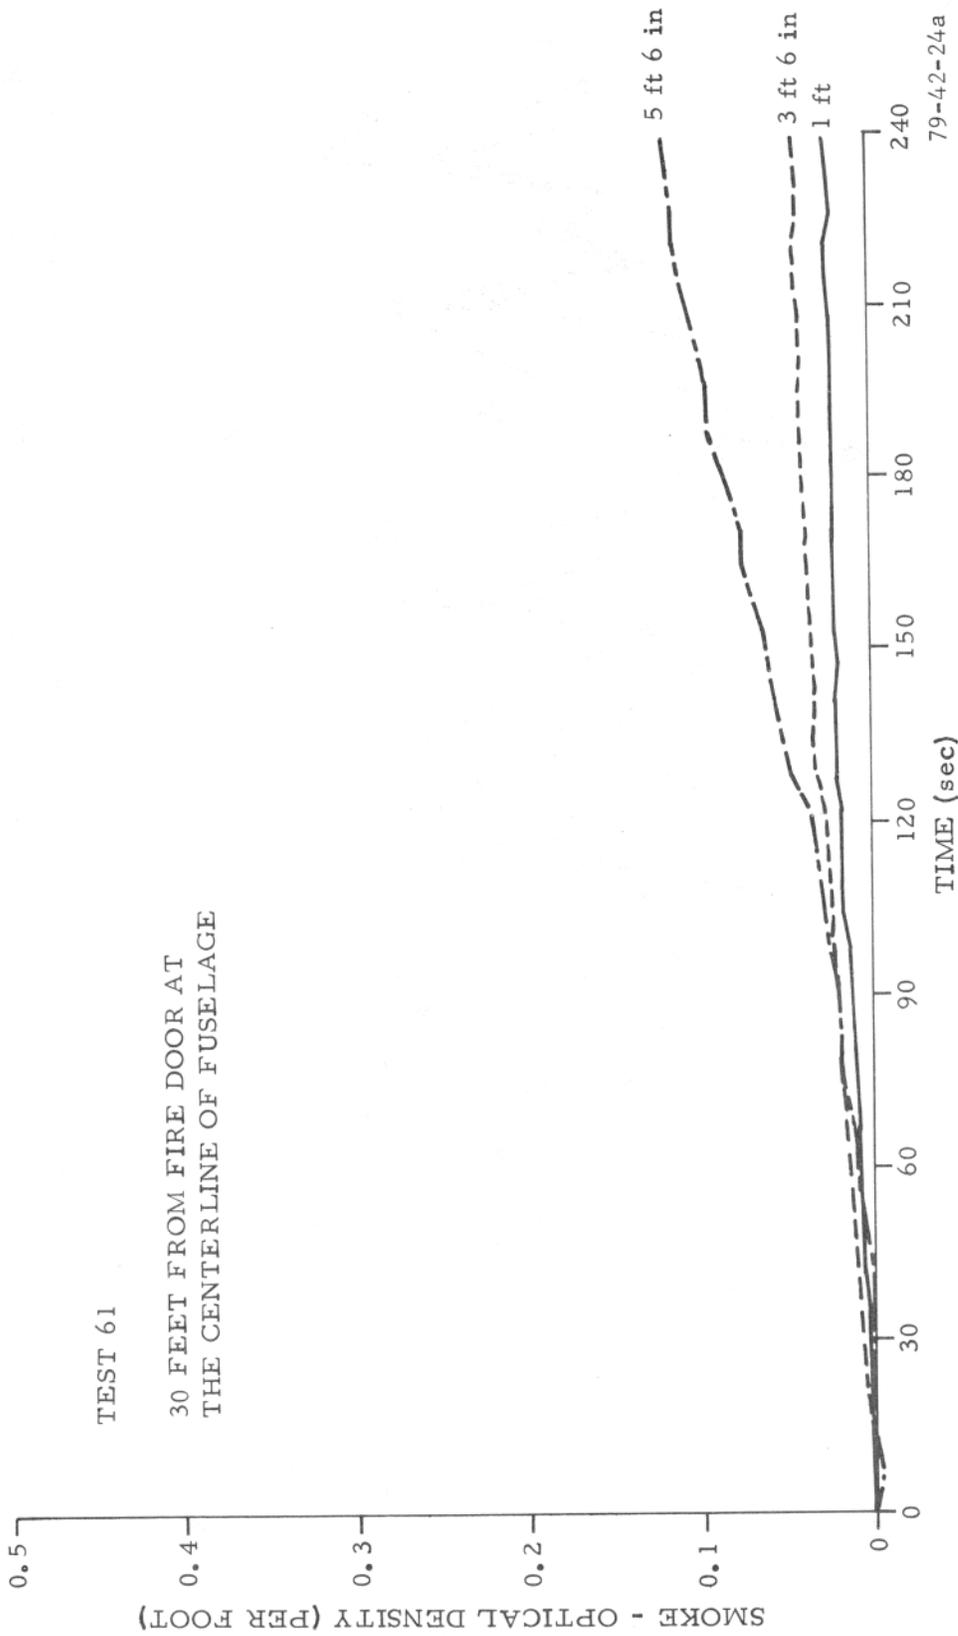
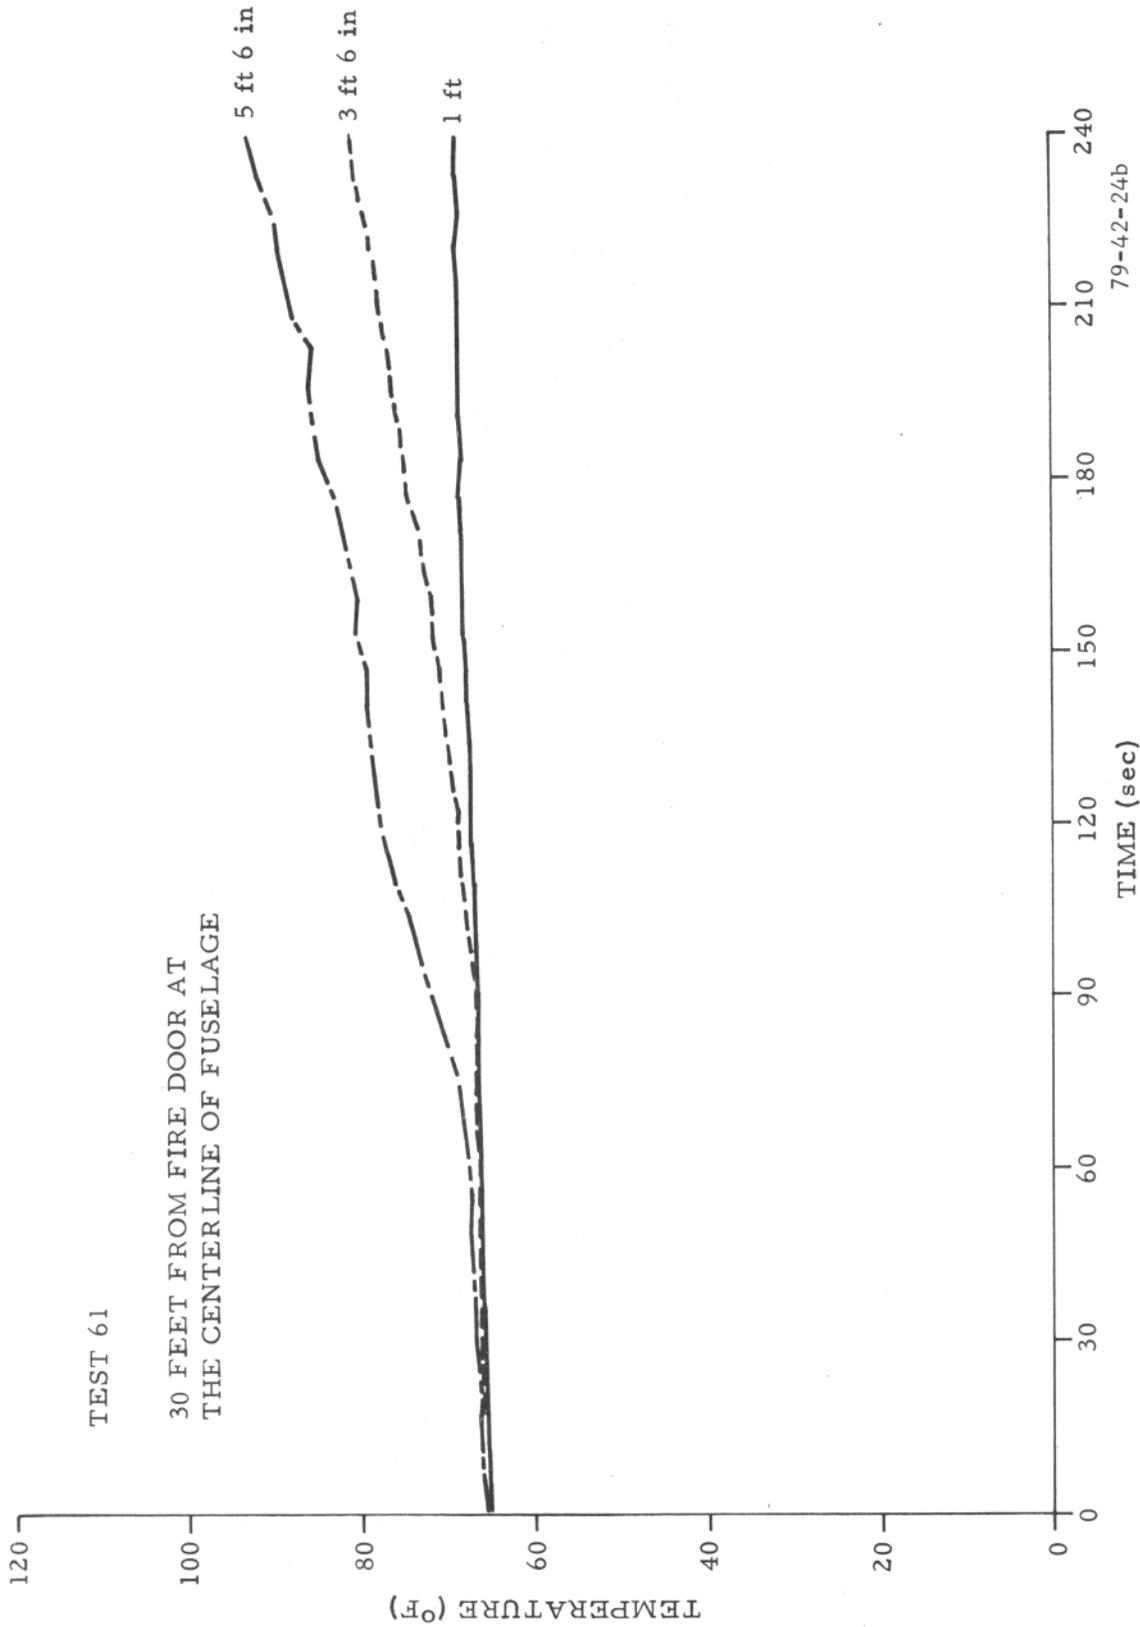
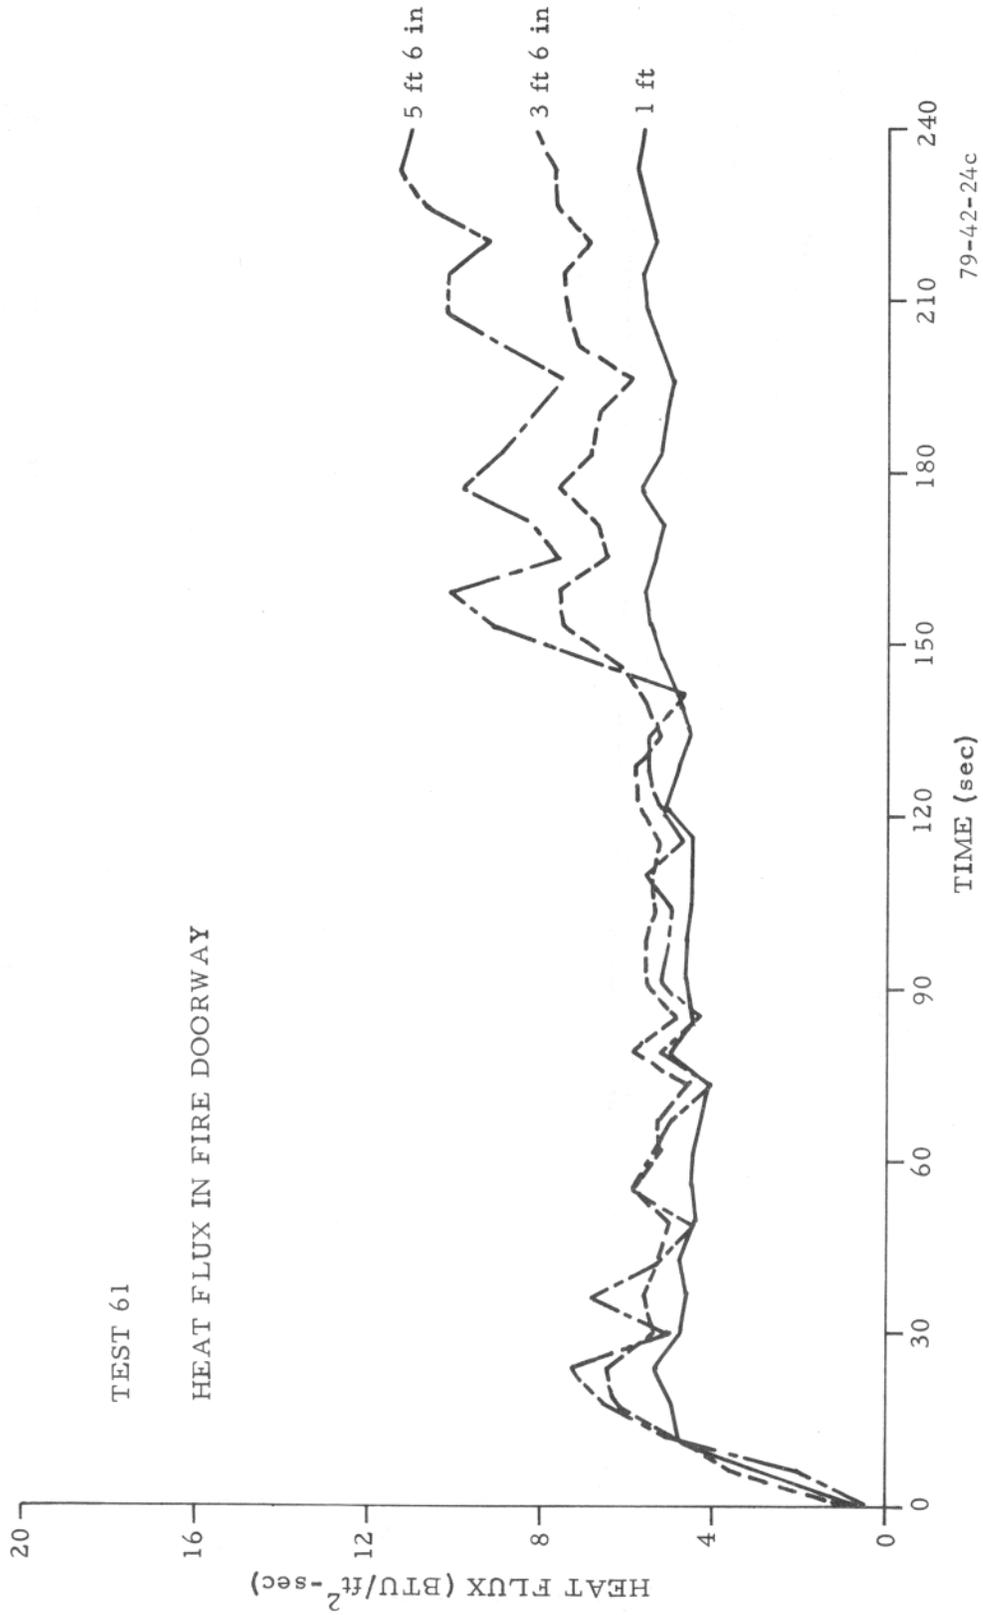
79-42-24c

FIGURE 24. CABIN HAZARDS ASSOCIATED WITH ZERO WINDS (Sheet 1 of 3)

HEAT FLUX IN FIRE DOORWAY
