POSTCRASH FUEL FIRE HAZARD MEASUREMENTS IN A WIDE-BODY AIRCRAFT CABIN

FINAL REPORT

1. Report No. FAA-NA-79-42		2. Government Accession No.		3. Recipient's Catalog No.	
4. Title and Subtitle POSTCRASH FUEL FIRE HAZARD MEASUREMENTS IN A WIDE-BODY AIRCRAFT CABIN				5. Report Date December 1979

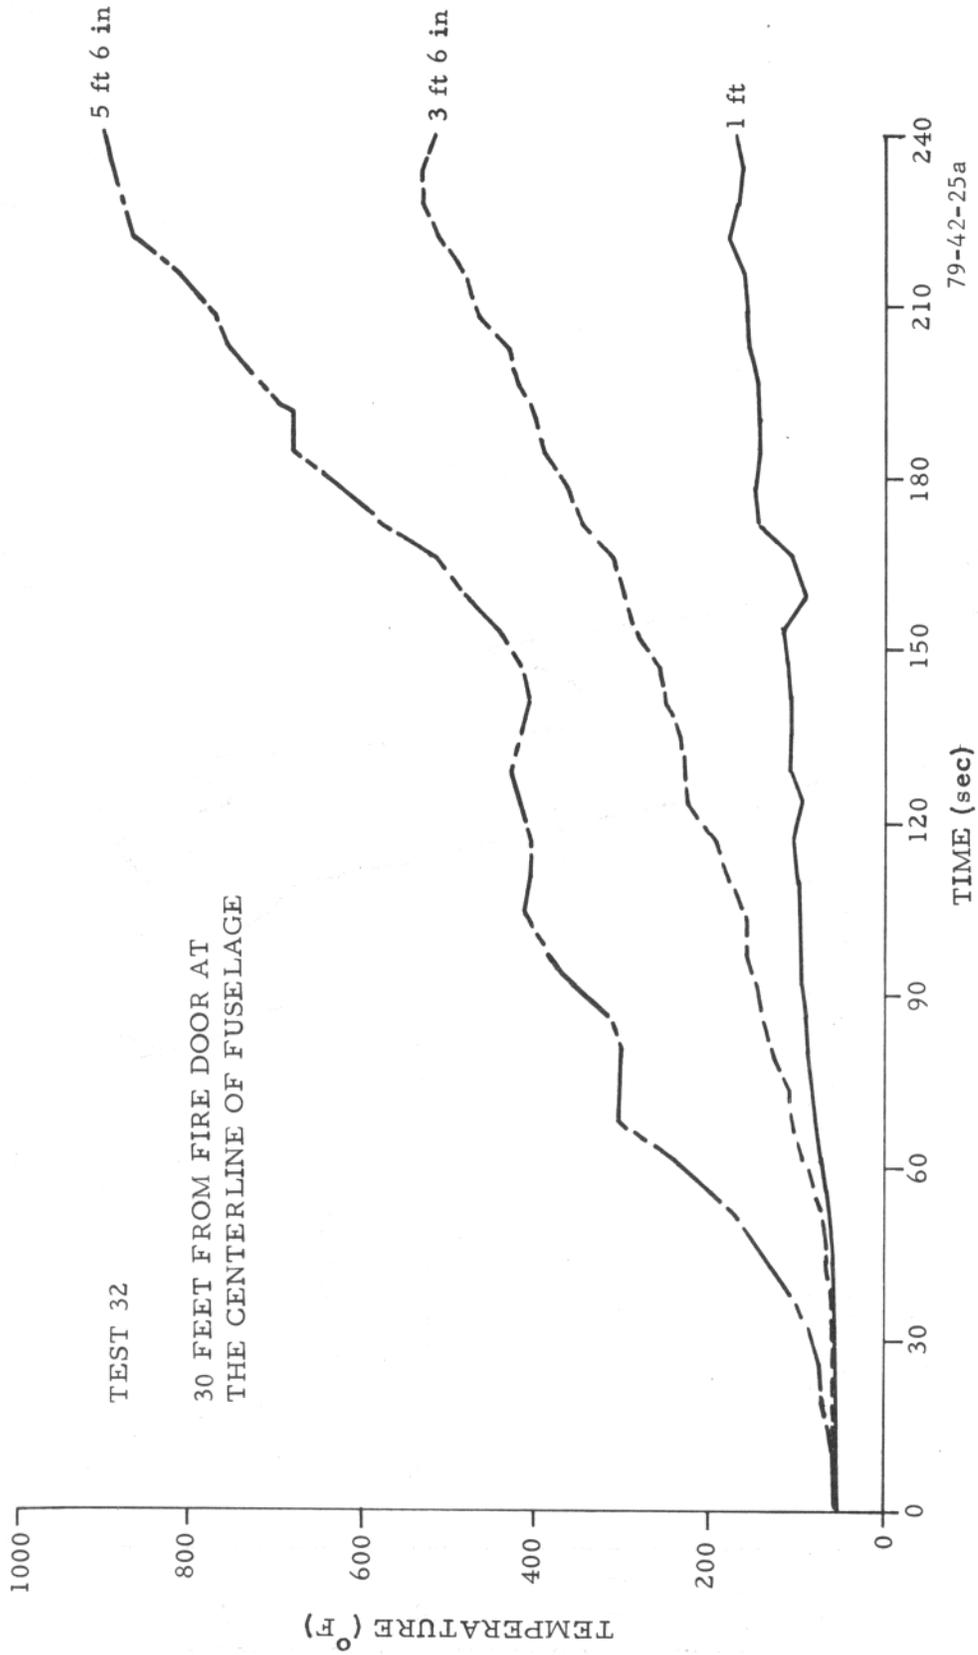
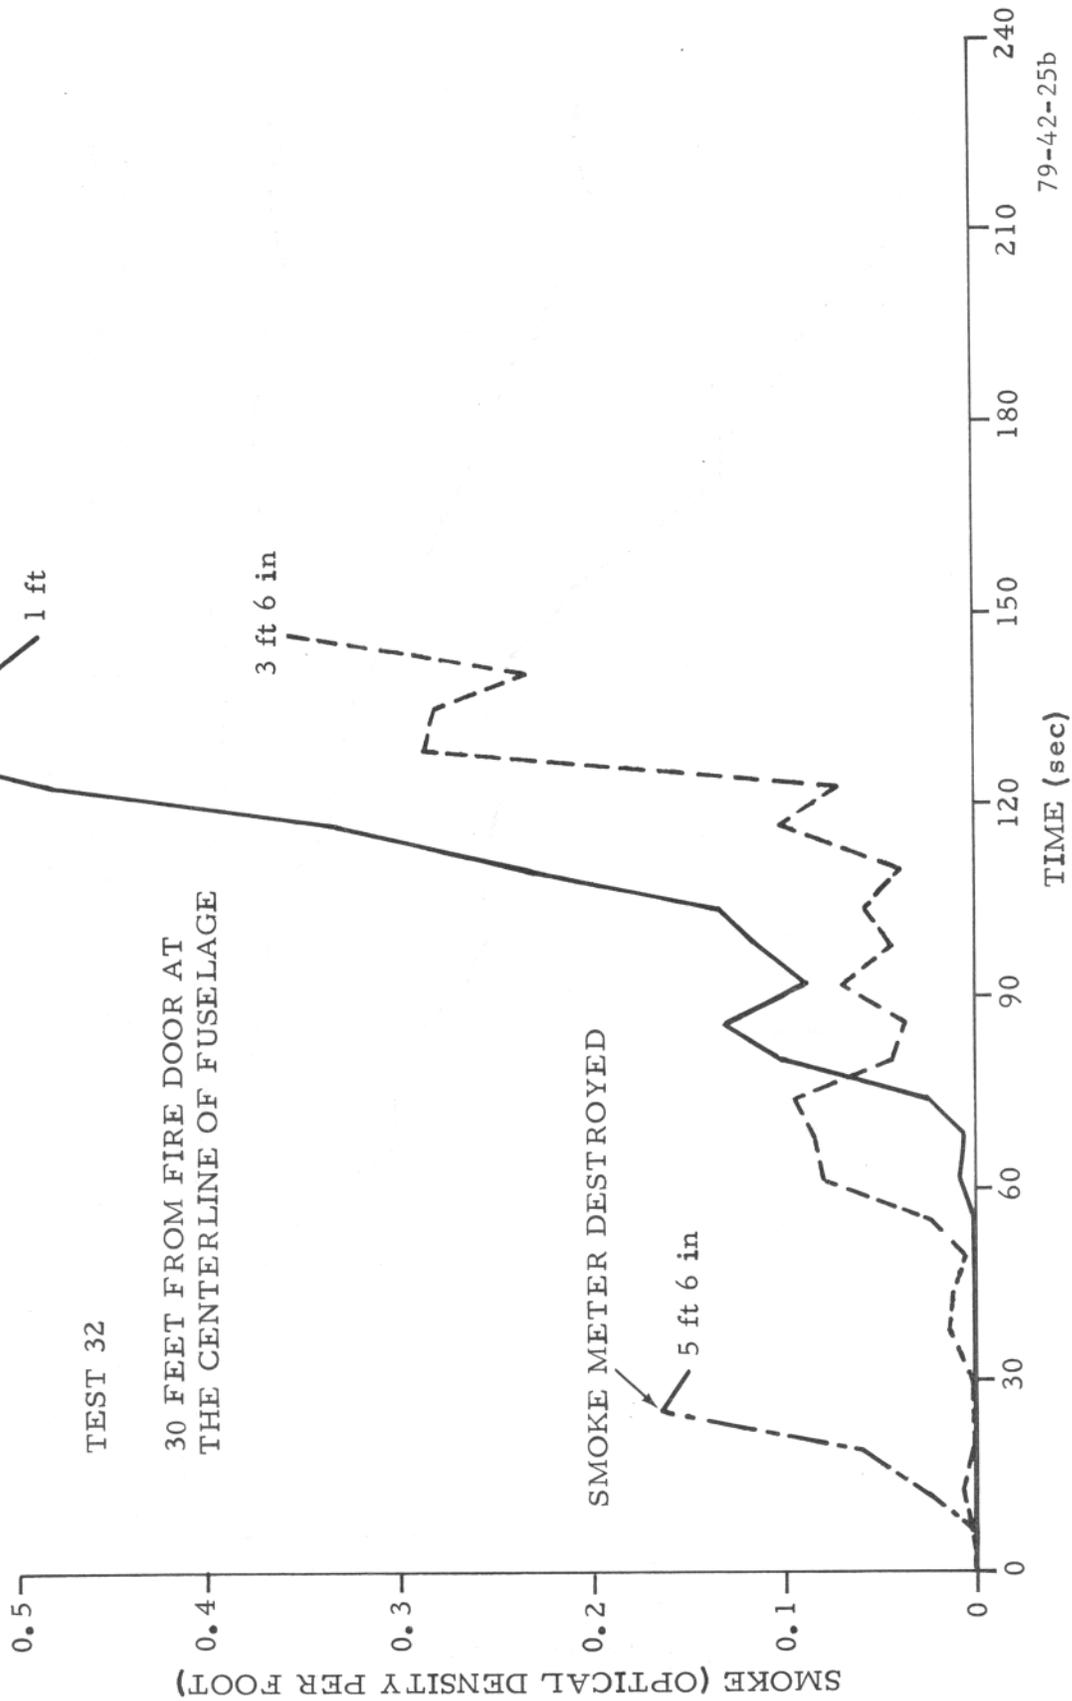
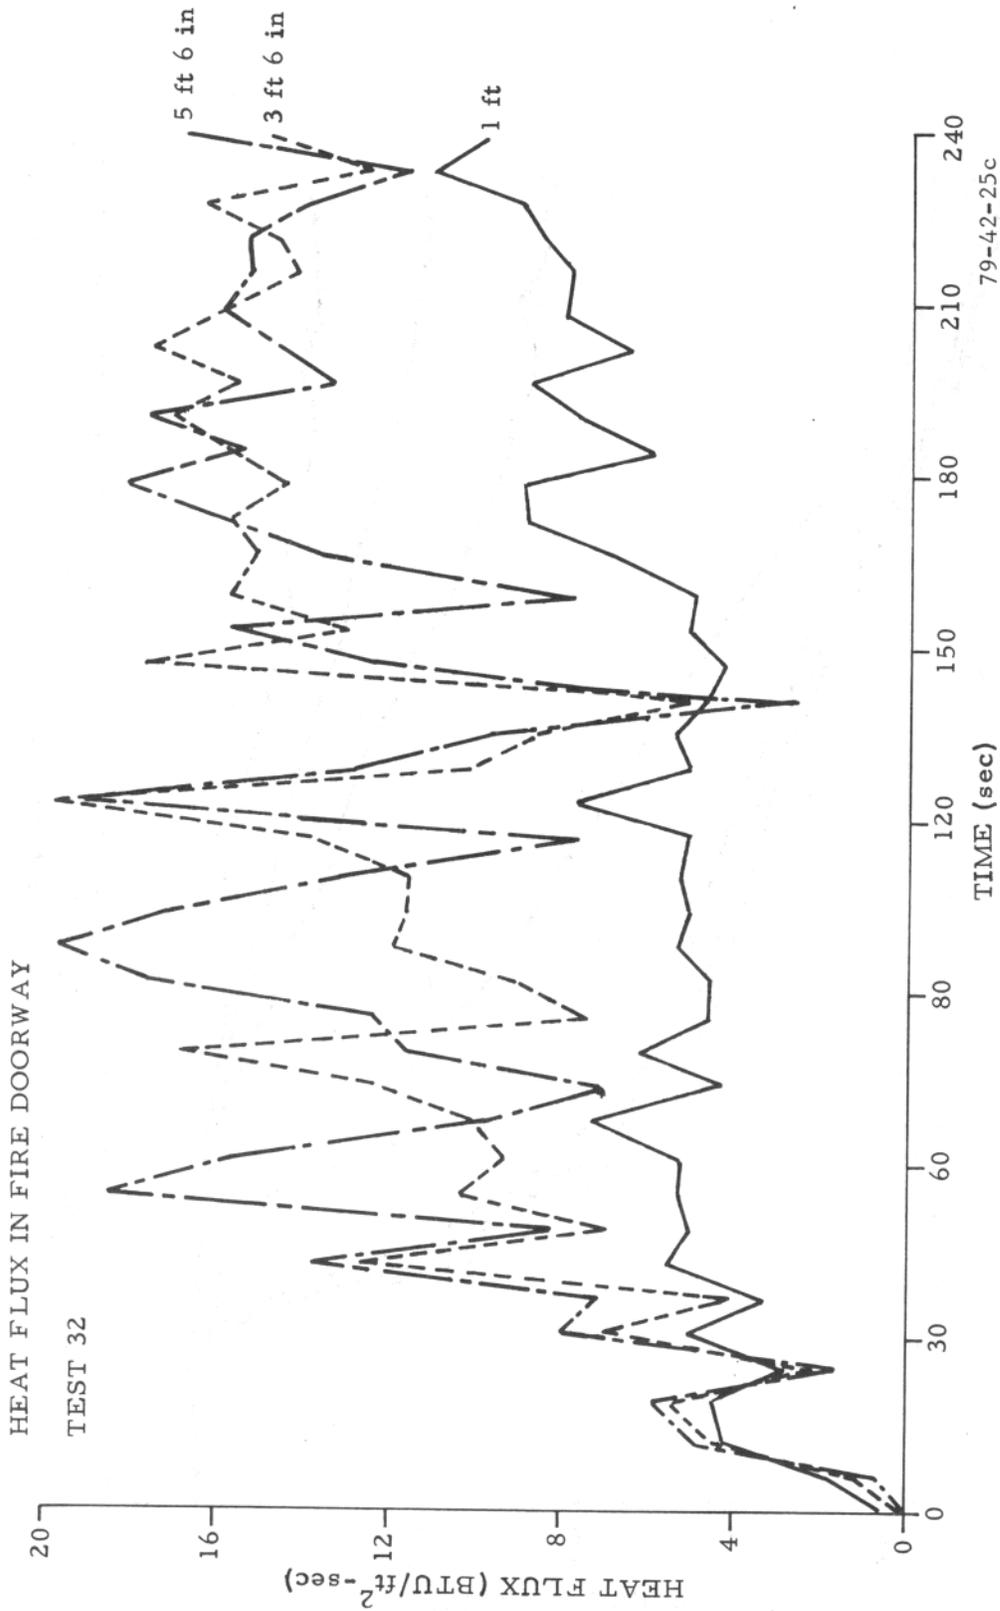
79-42-25b

FIGURE 25. CABIN HAZARDS ASSOCIATED WITH WINDS INTO FUSELAGE OPENING (Sheet 1 of 3)

Figure 25 represents the temperature, smoke, and heat flux from the worst test conducted, test number 32. During this test, the windspeed was 5.5 miles per hour (mph) out of the southwest with a corrected windspeed of 4.07 mph. The fuel pan size was 4 by 6 feet. Since the fire scenario and fuselage configuration of these tests represent one of an infinite number of possibilities, the quantitative measurements mean only that they are obtainable levels dictated by the ambient wind and cabin draft conditions. An important study in these tests was that of the flow of hazards through the cabin, namely: heat, smoke, and gases.

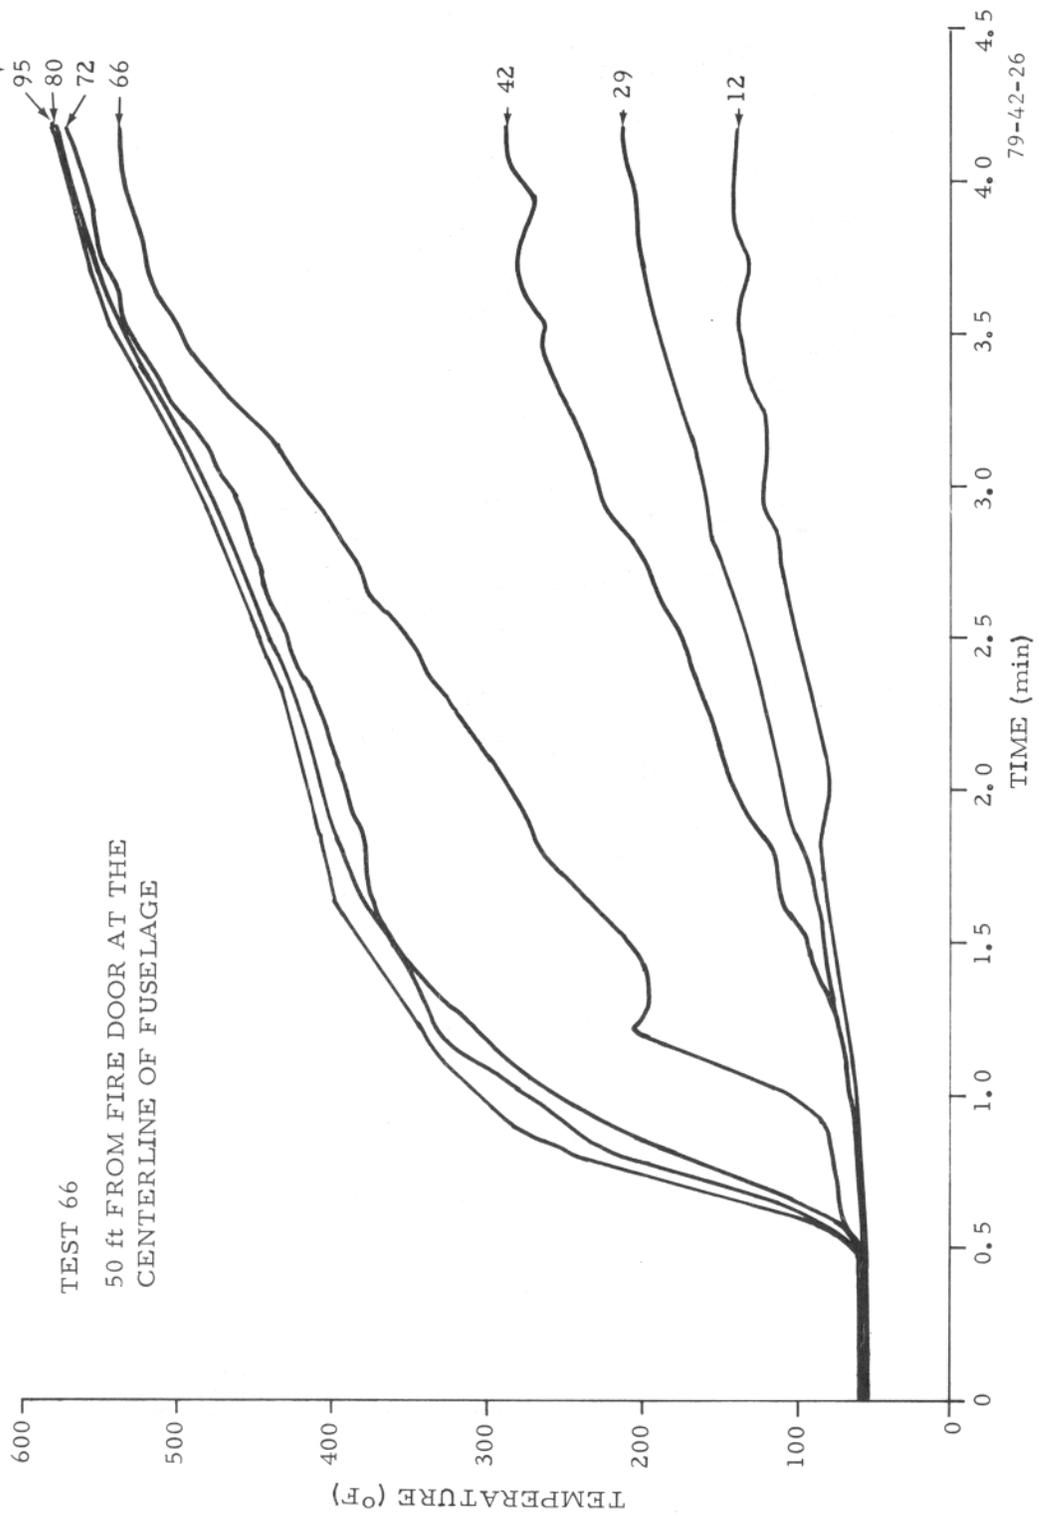
TEST 66
50 ft FROM FIRE DOOR AT THE
CENTERLINE OF FUSELAGE

FIGURE 26. CABIN HEAT STRATIFICATION

HEAT. A major finding of this test program is the stratification of cabin hazards that occur during a cabin fire. Significant stratification occurred for all fire sizes and wind conditions. The most significant stratification was with high winds pushing the flames toward the fuselage, since that condition produced the highest interior cabin temperatures. A temperature-time plot of seven symmetry plane elevations located 50 feet aft of the fire door is shown in figure 26. Note the distinct layer of hot gases that extended from the ceiling down to the 6-foot level. The hot upper layer eventually heated the much cooler lower layer and some mixing occurred. This generally increased the temperature of the lower levels. Figure 27 is a replot of the data from figure 26 and is a better indication of the mixing process. The upper layer of hot gases was very distinct, and the gradual heating of the lower region with time was quite evident. Figures 28 and 29 are different representations of data indicating the cabin temperature from the fire door through the cabin to the aft exit. There is a large increase in temperature early in the tests (1 minute) near the fire door, with very

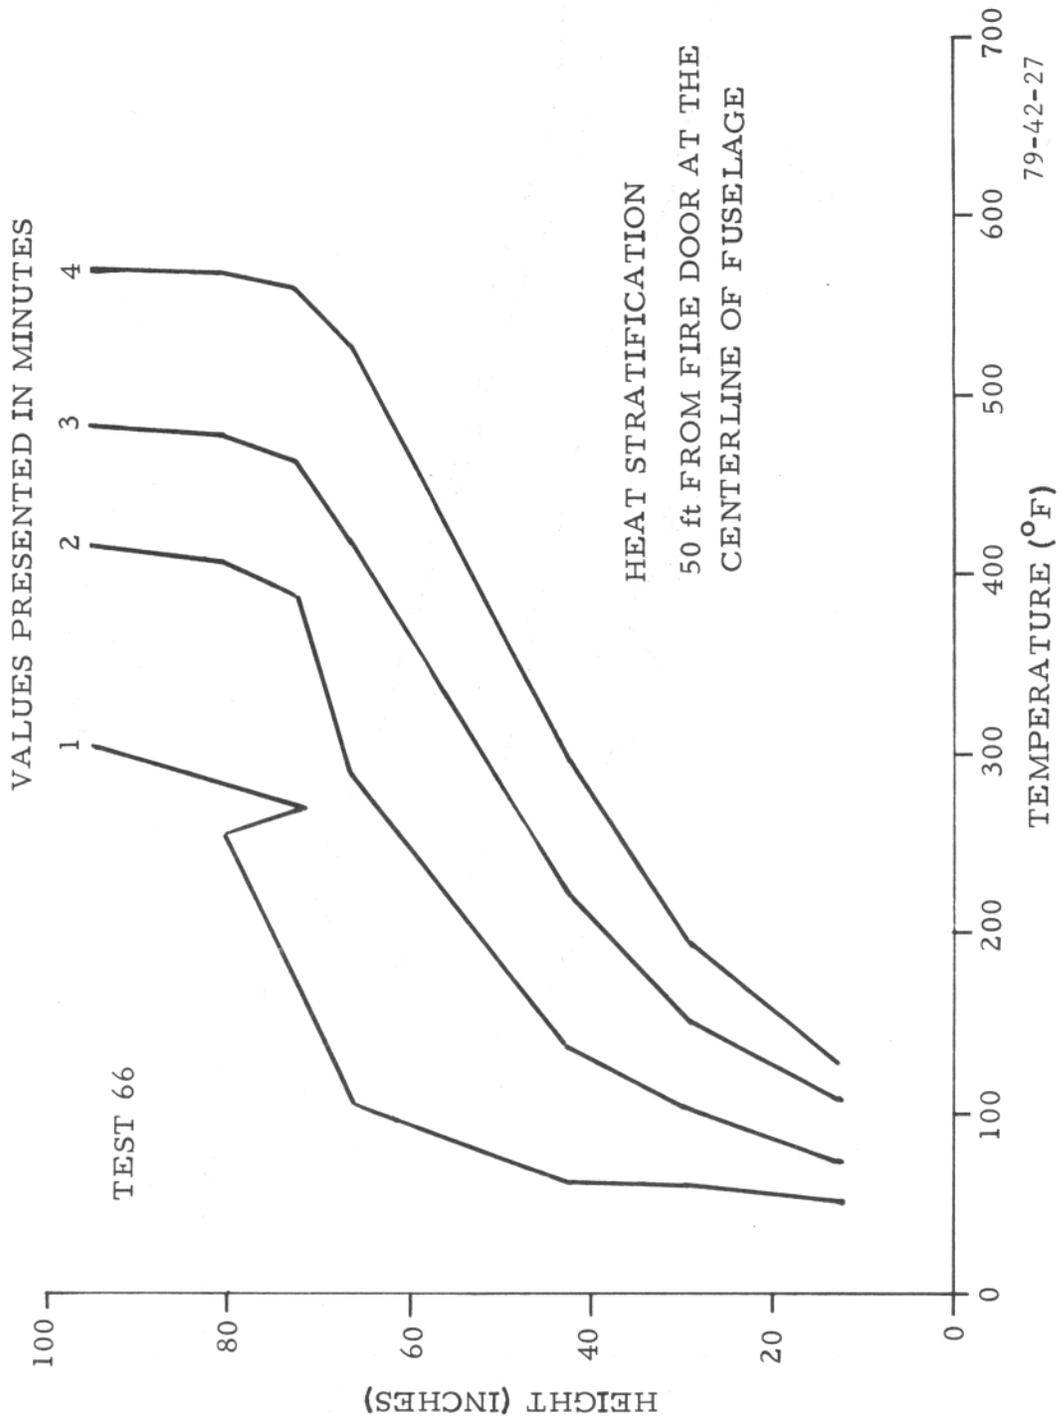
FIGURE 27. CABIN HEAT STRATIFICATION (REPLOTT)

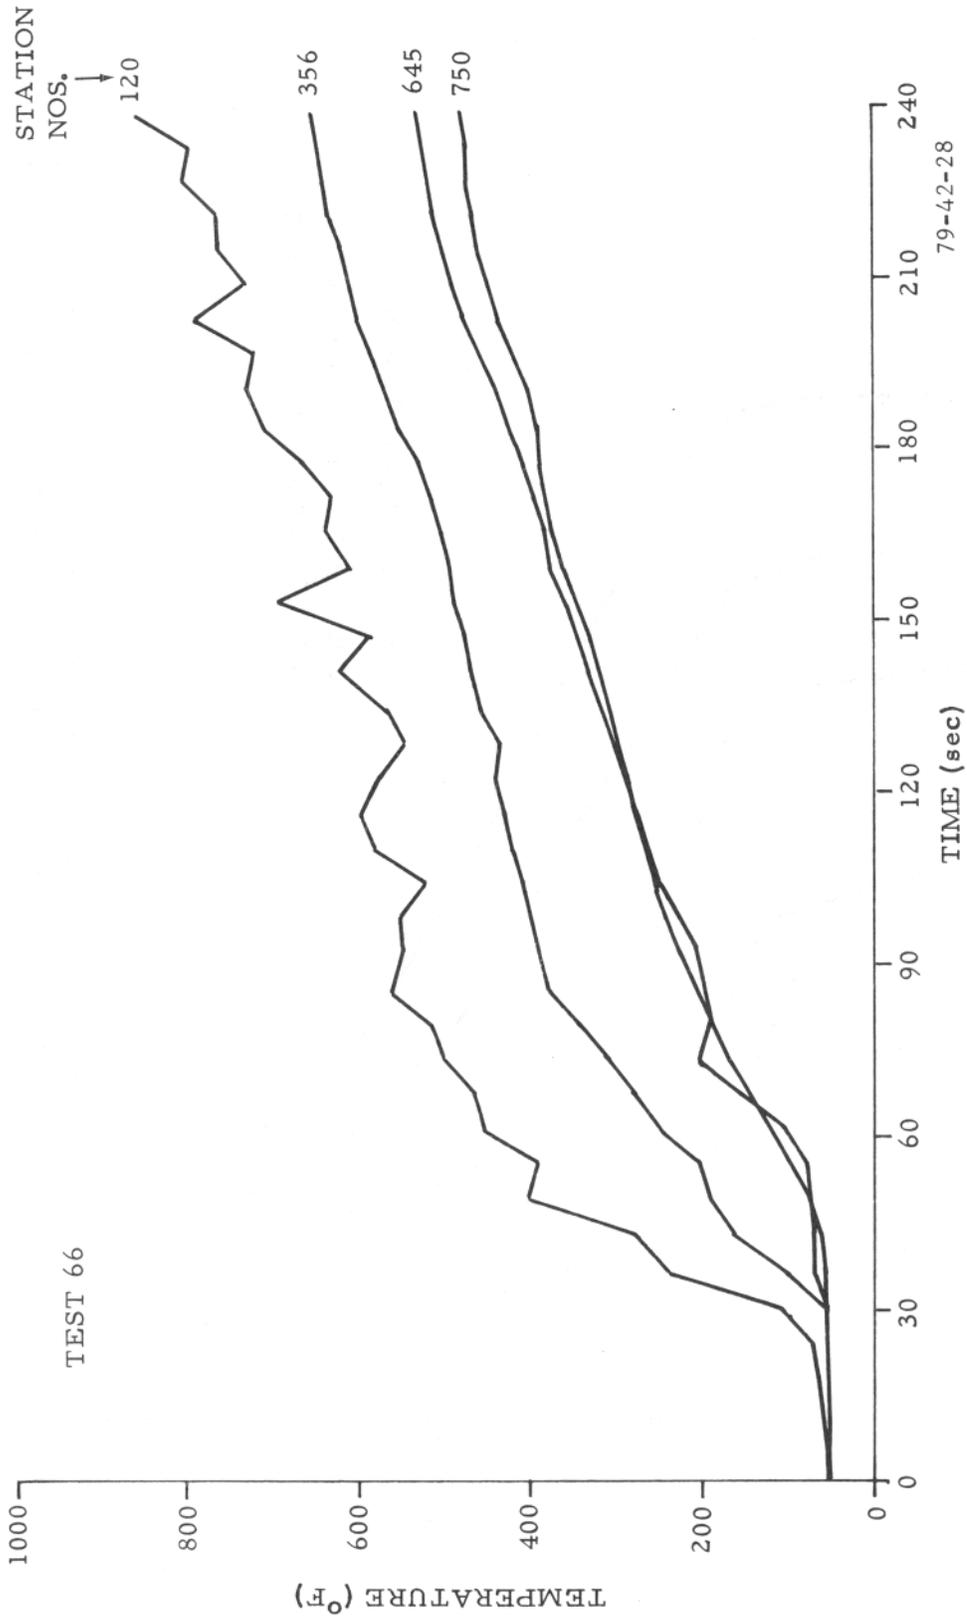
FIGURE 28. TEMPERATURES AT VARIOUS FUSELAGE STATIONS

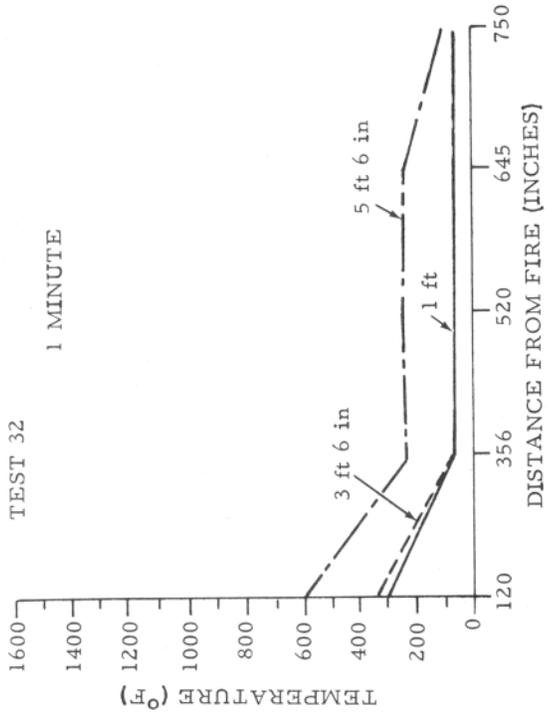
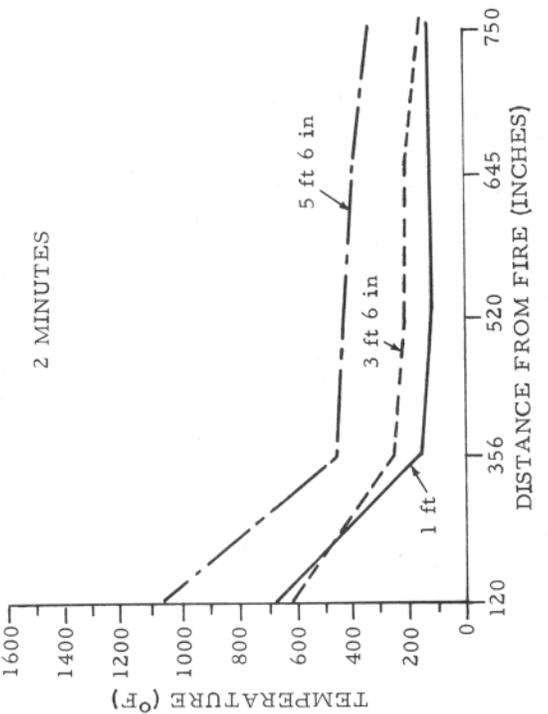
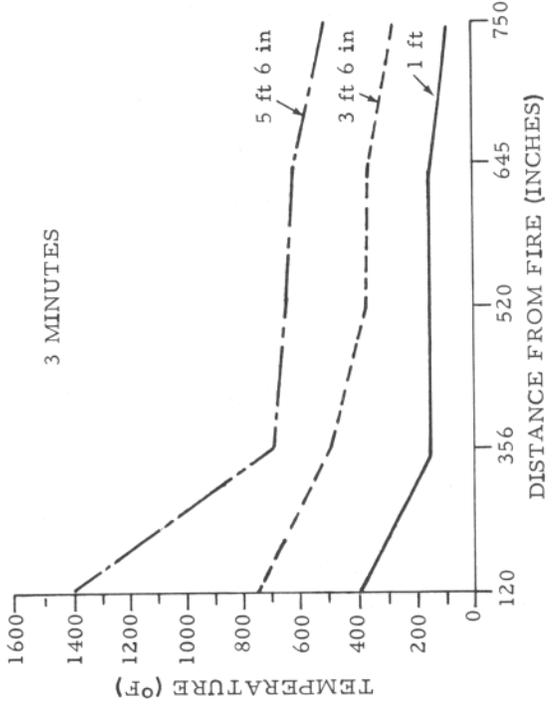
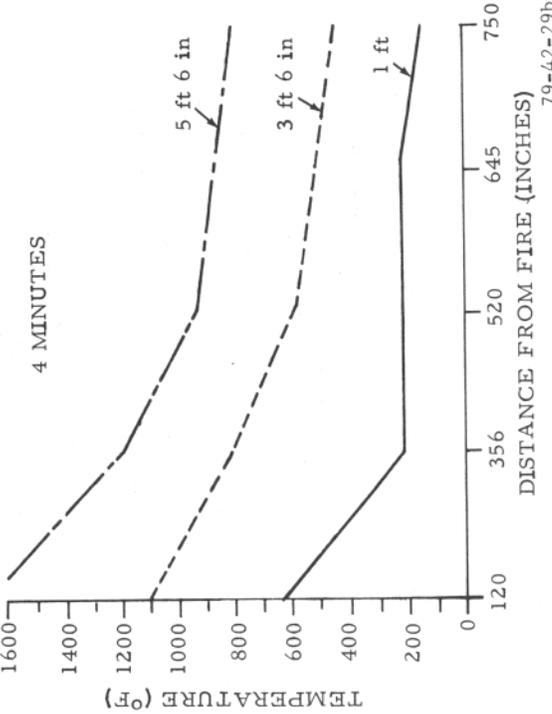
79-42-29b

FIGURE 29. CABIN TEMPERATURE PROFILES (Sheet 2 of 2)

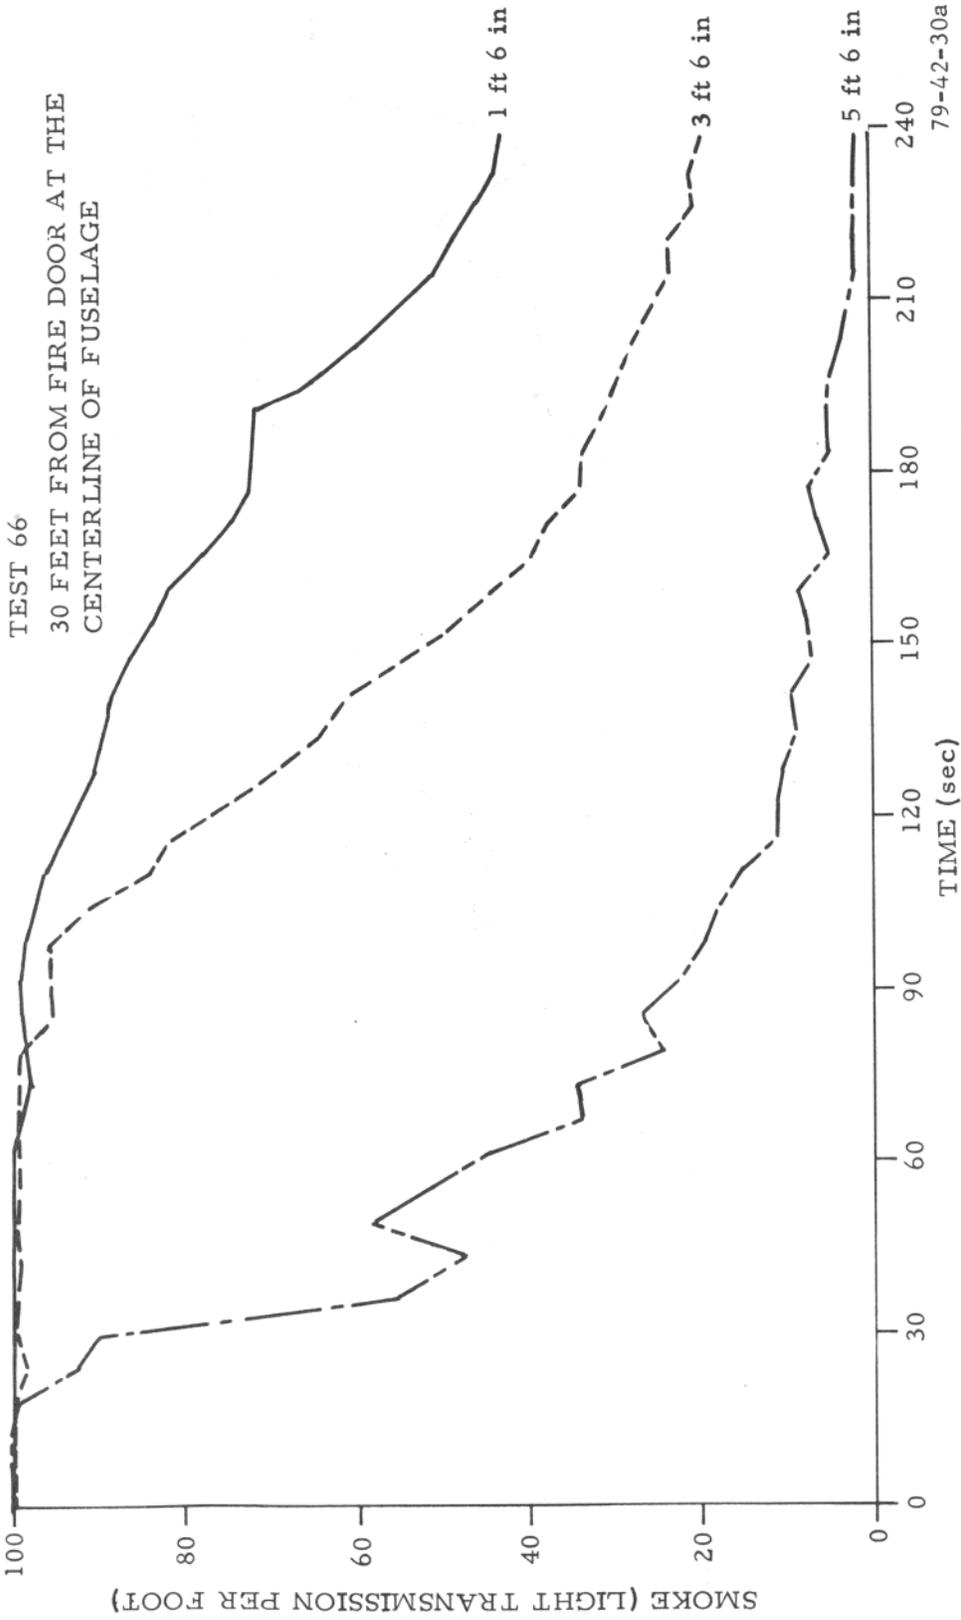
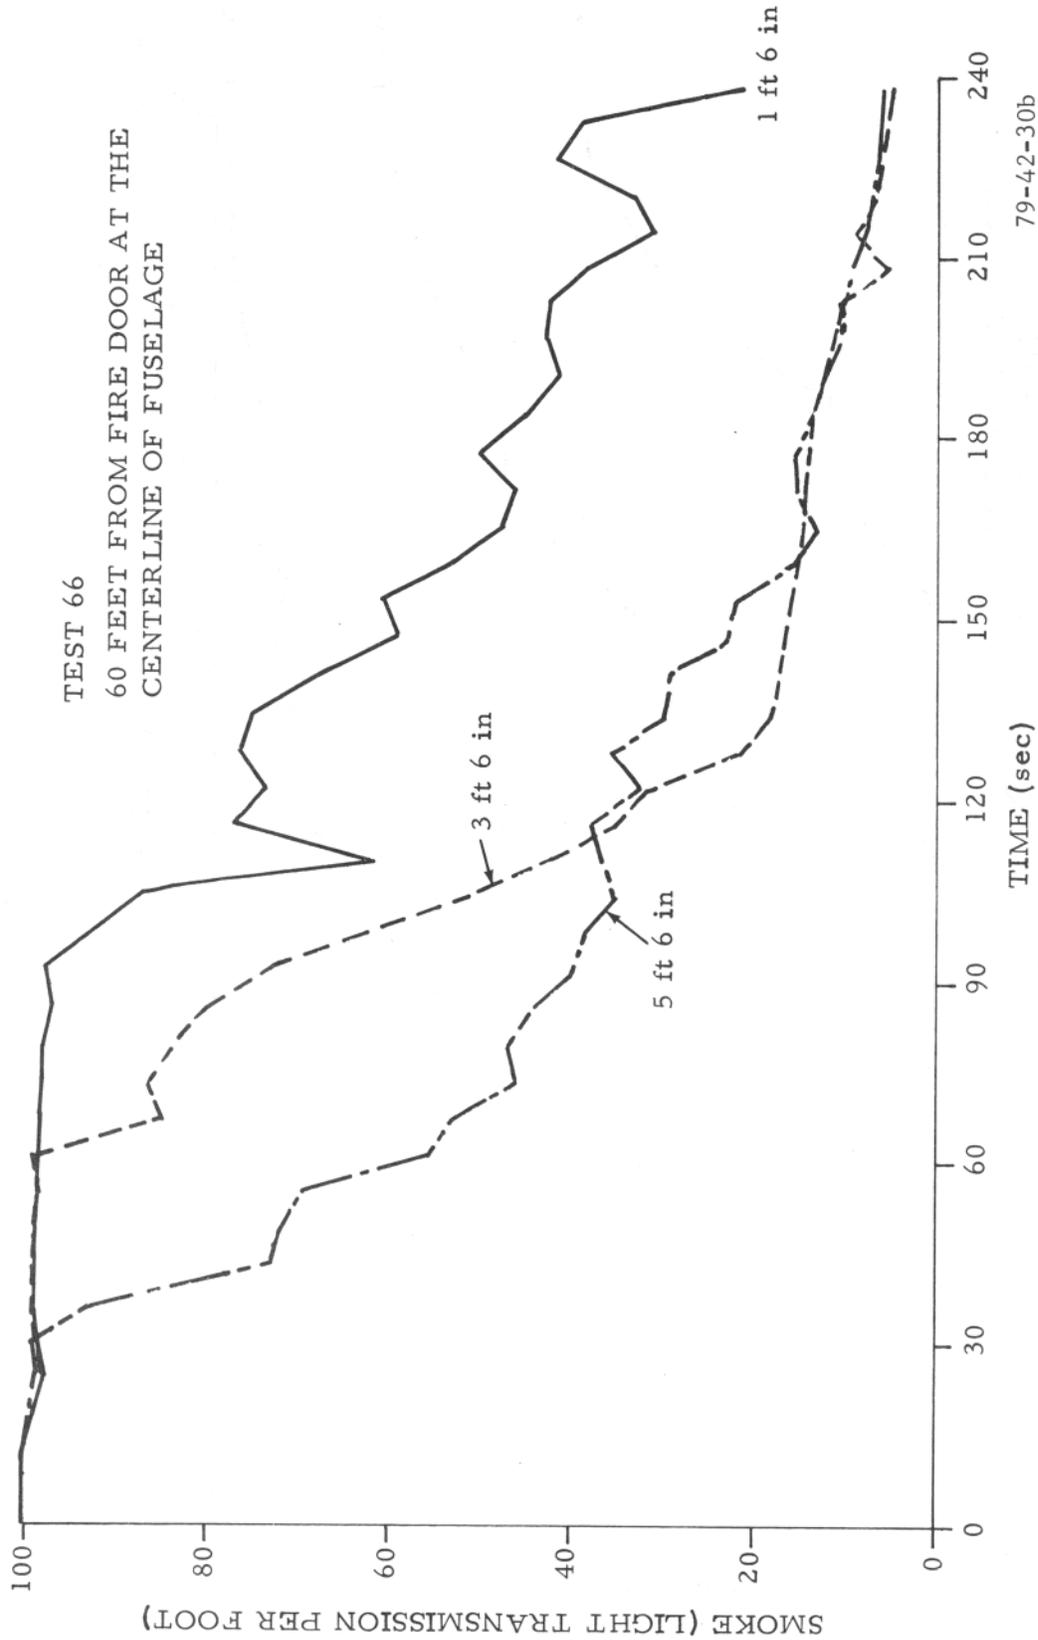
FIGURE 30. SMOKE STRATIFICATION (PERCENT LIGHT REDUCTION) (Sheet 1 of 2)

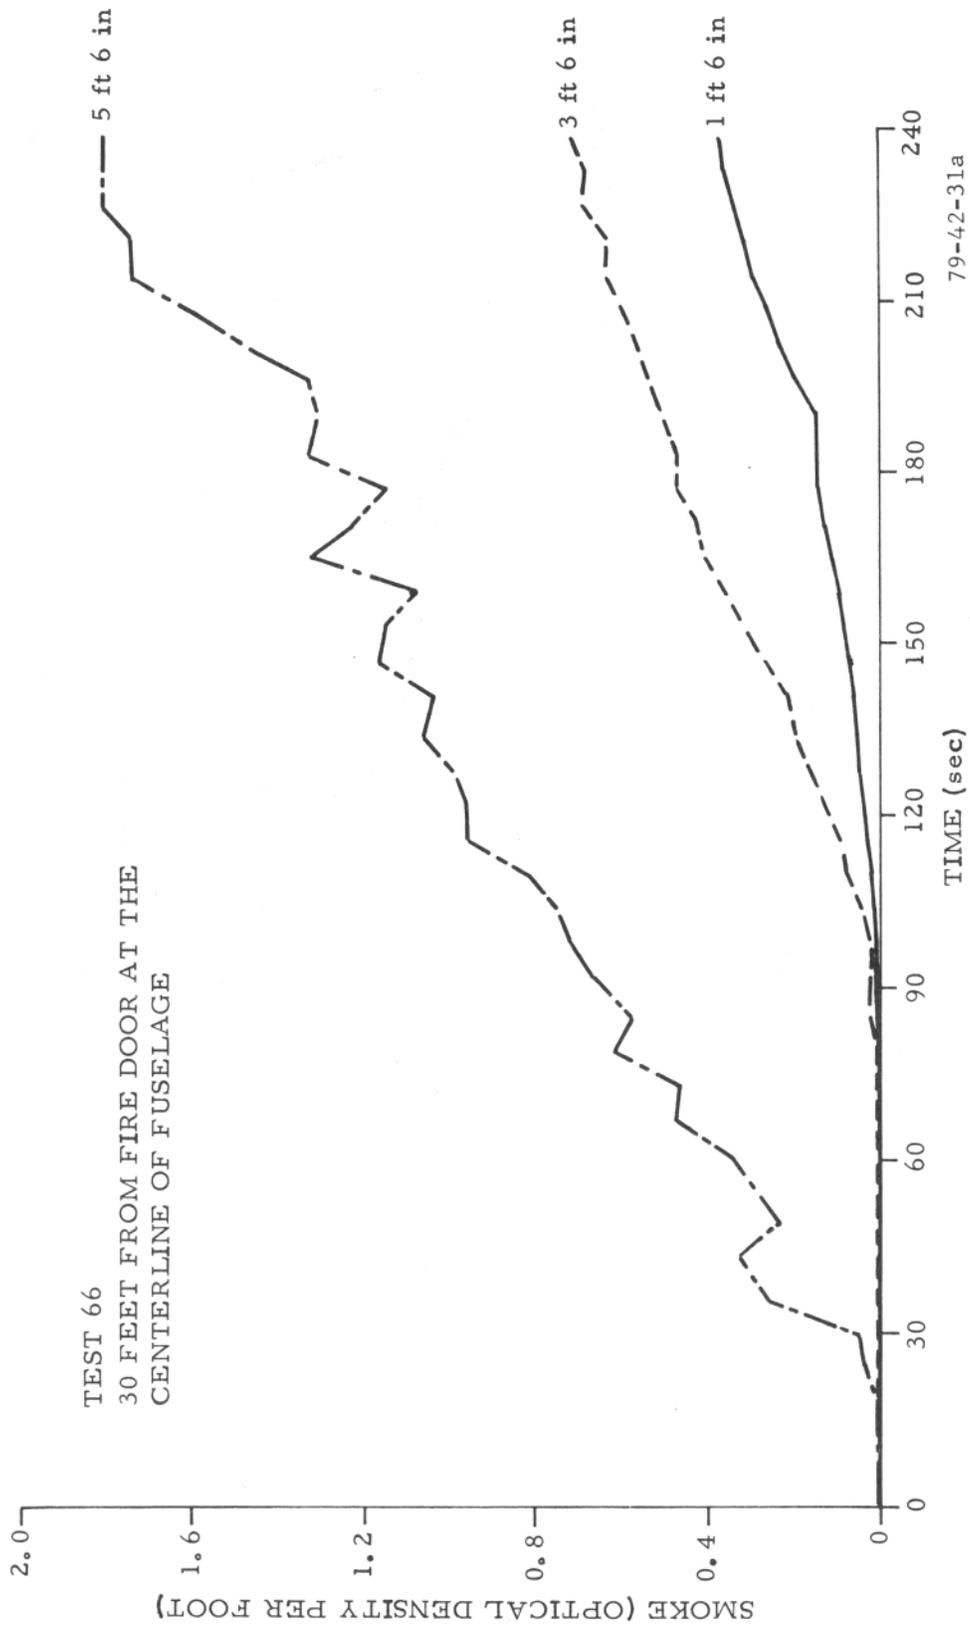
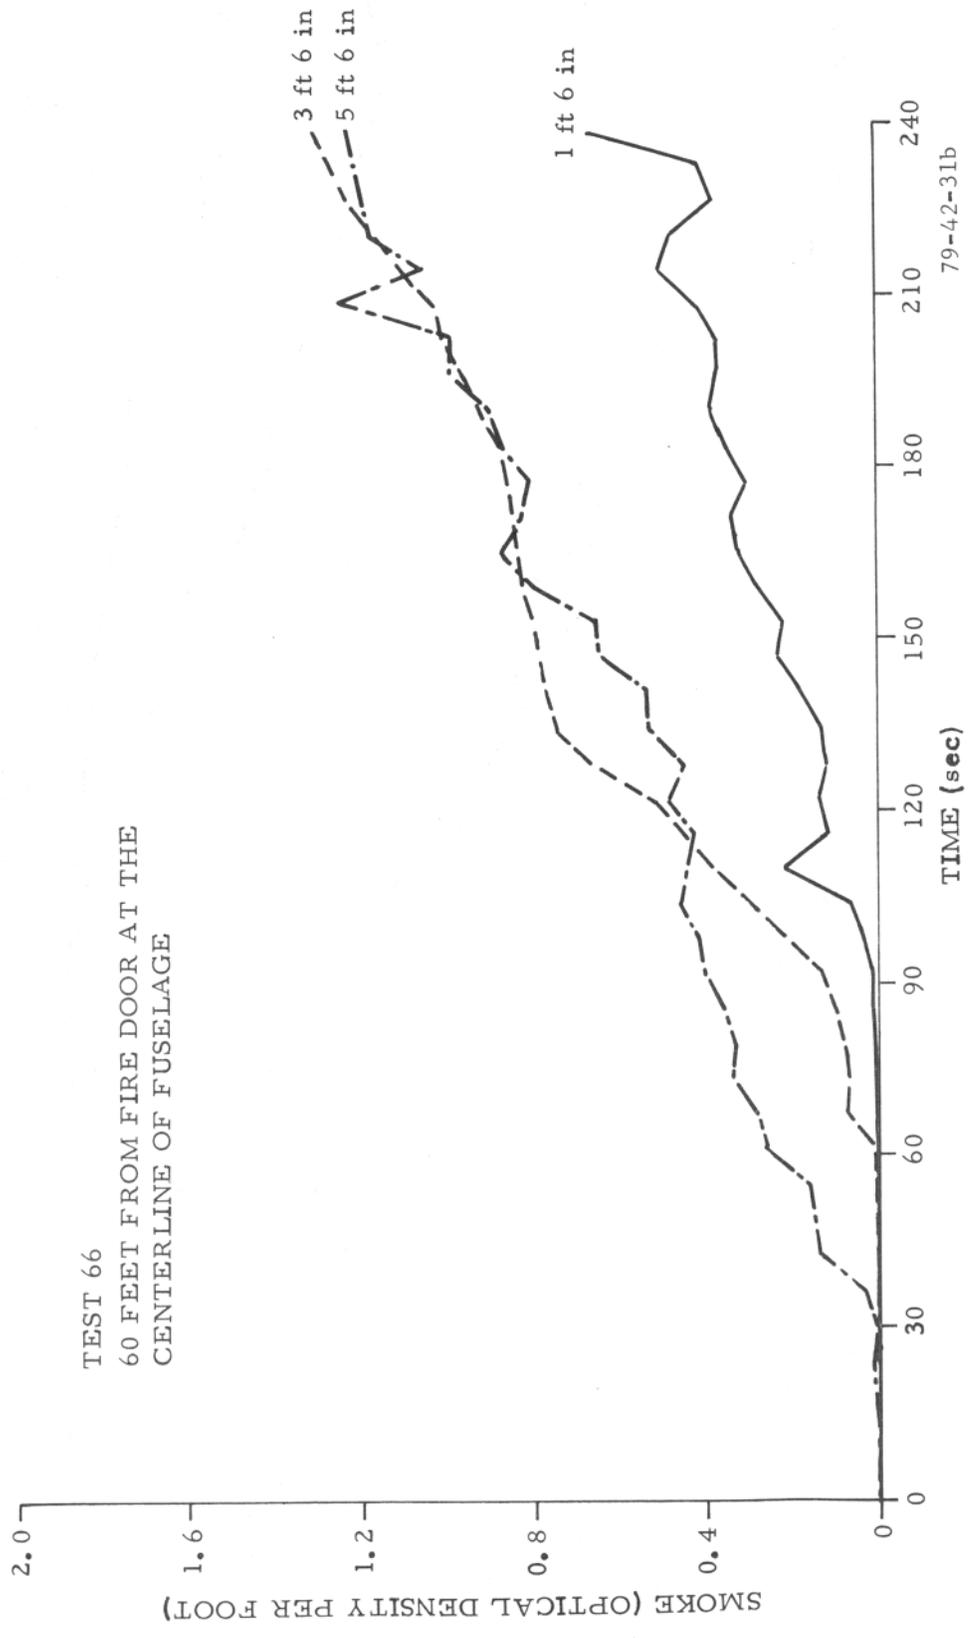
79-42-31b

FIGURE 31. SMOKE STRATIFICATION (OPTICAL DENSITY) (Sheet 1 of 2)

TEST 66
 60 FEET FROM FIRE DOOR AT THE
 CENTERLINE OF FUSELAGE

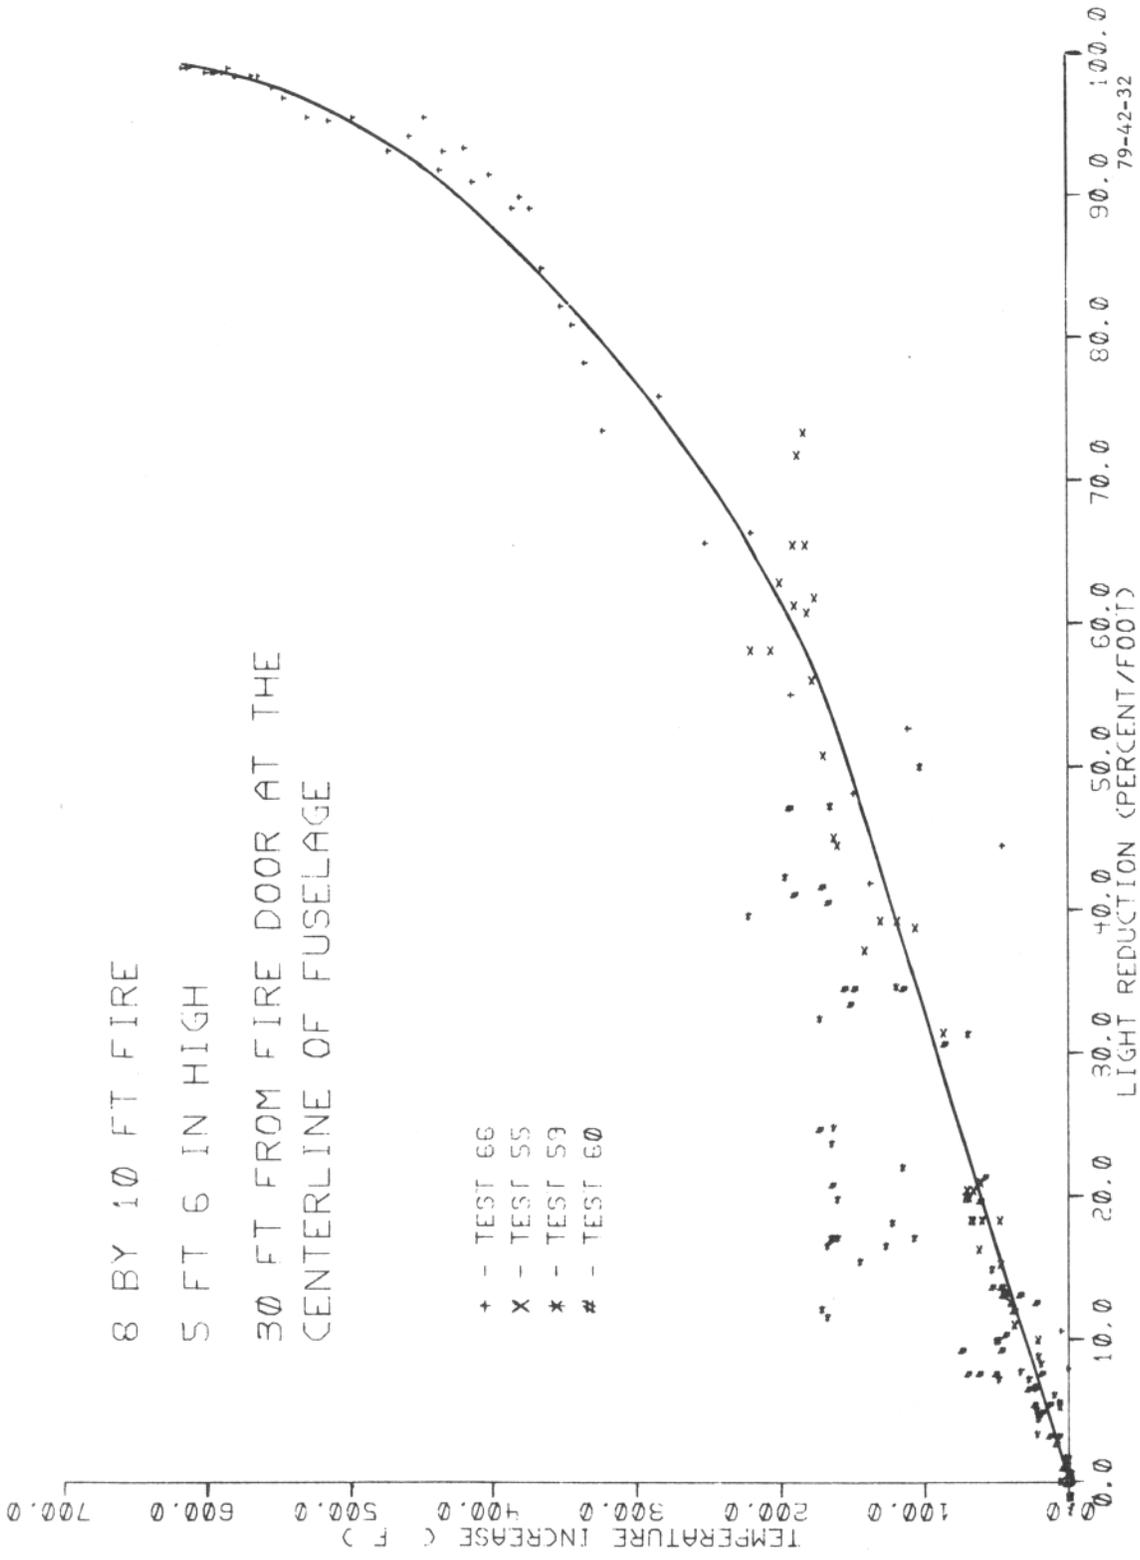
FIGURE 32. RELATION OF SMOKE-TO-TEMPERATURE INCREASE

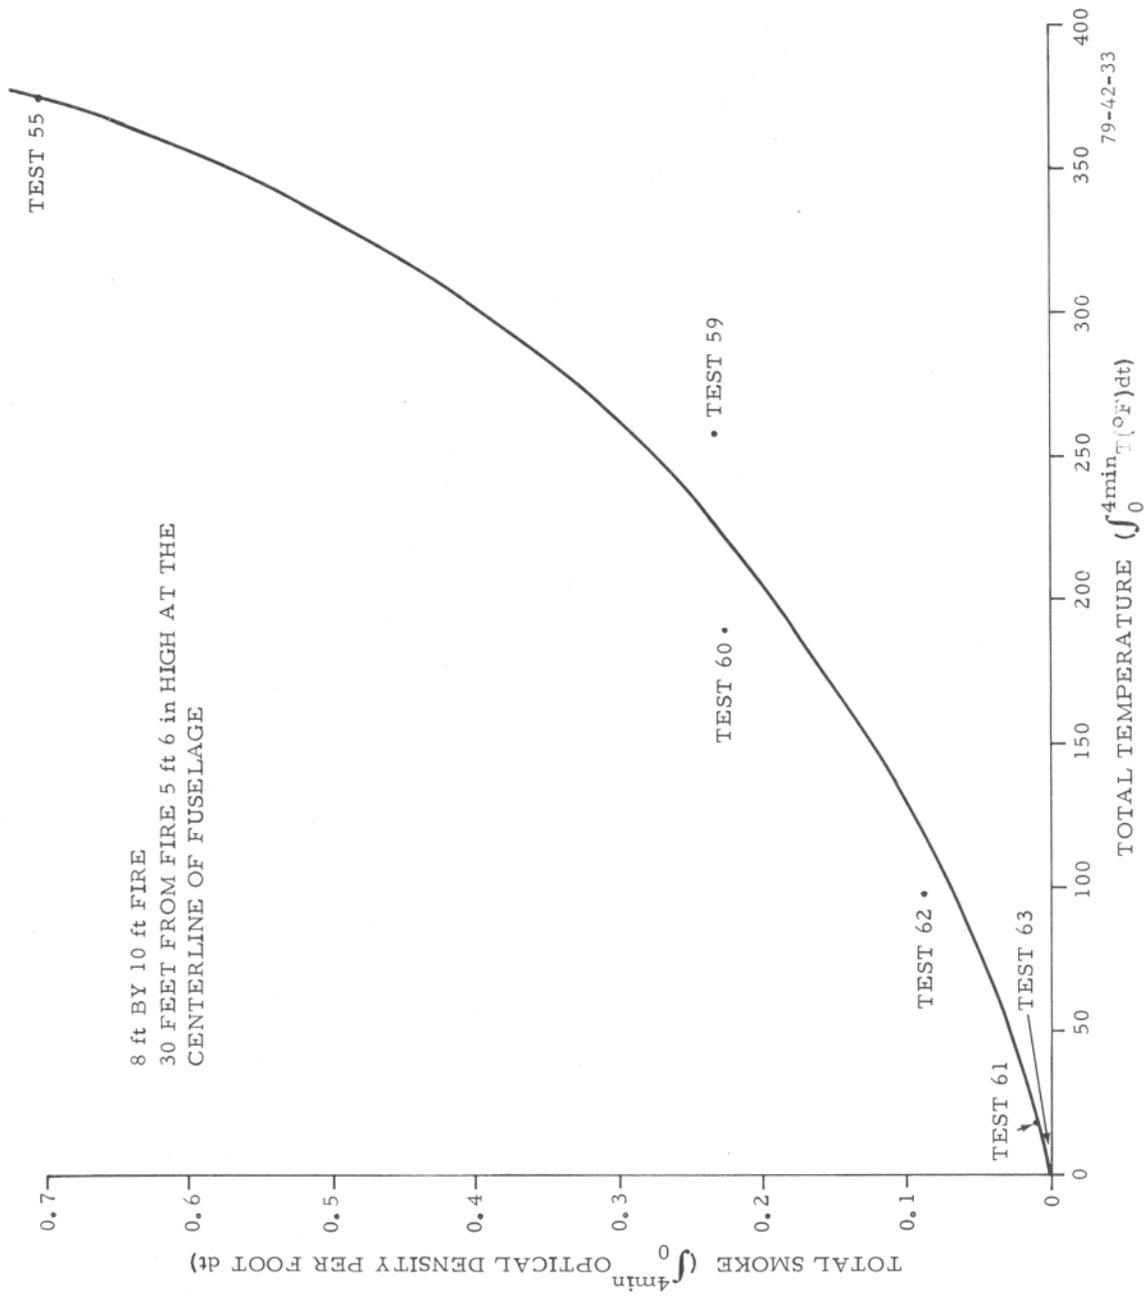
FIGURE 33. TOTAL HEAT VERSUS TOTAL SMOKE FOR 8- BY 10-FOOT FIRE

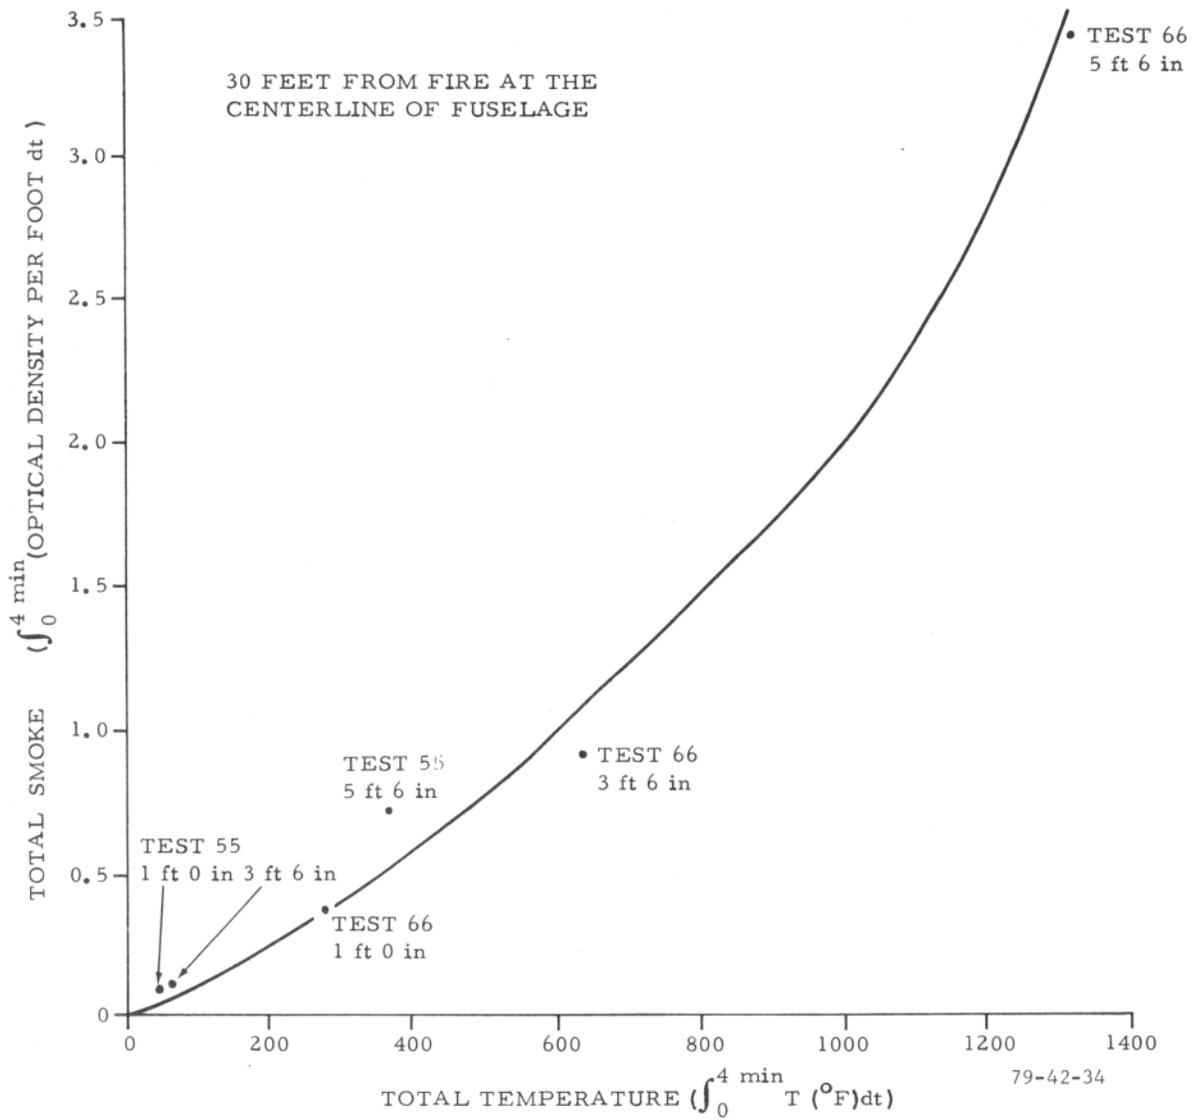
FIGURE 34. TOTAL SMOKE VERSUS TOTAL HEAT FOR VARIOUS FUSELAGE HEIGHTS
